ECal Design and Performance

Don Jones

Mar. 3, 2026

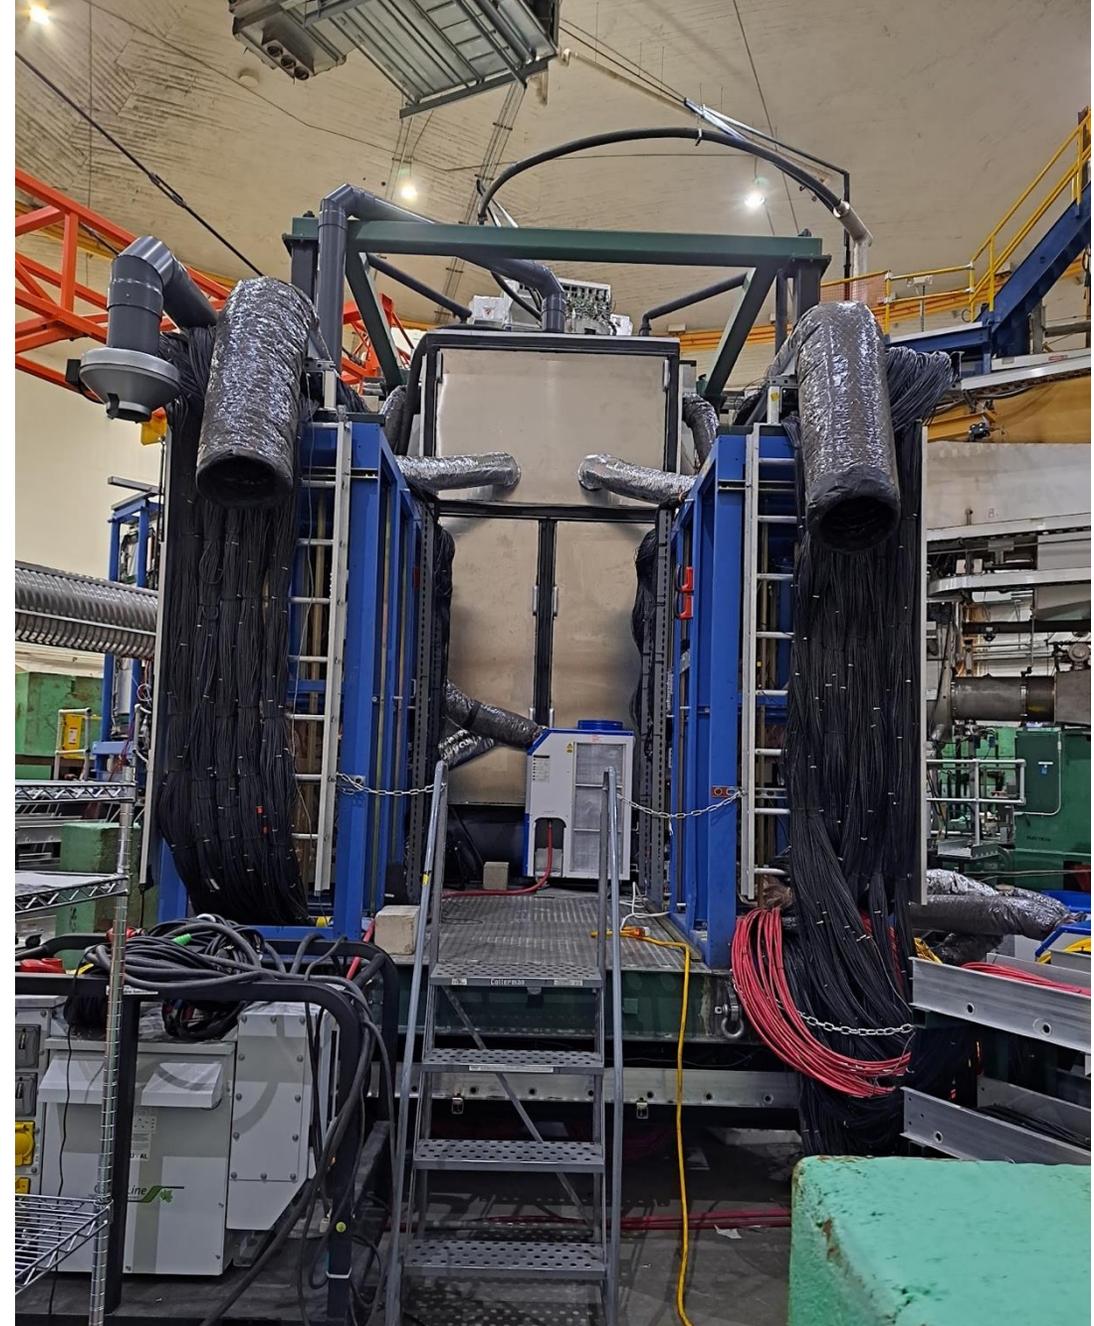
What didn't work so well

- Software controls set to wrong thermocouple type on first heating test.
 - Resulted in overheating detector by tens of degrees
- Glue joints between crystals and light guides darkened and many failed.
 - May have been due to overheating incident
- Controls hardware should have been better shielded to prevent faults
- Cooling system inadequate
 - Rear enclosure had large temperature gradient
 - 20°C on bottom, > 50°C on top

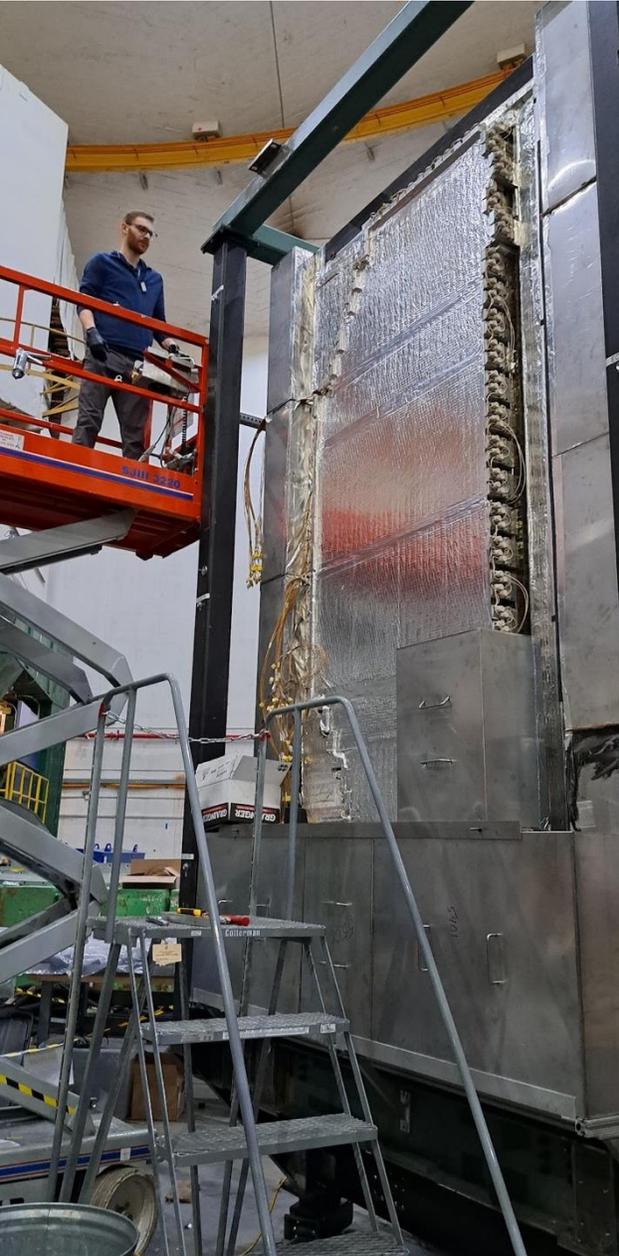
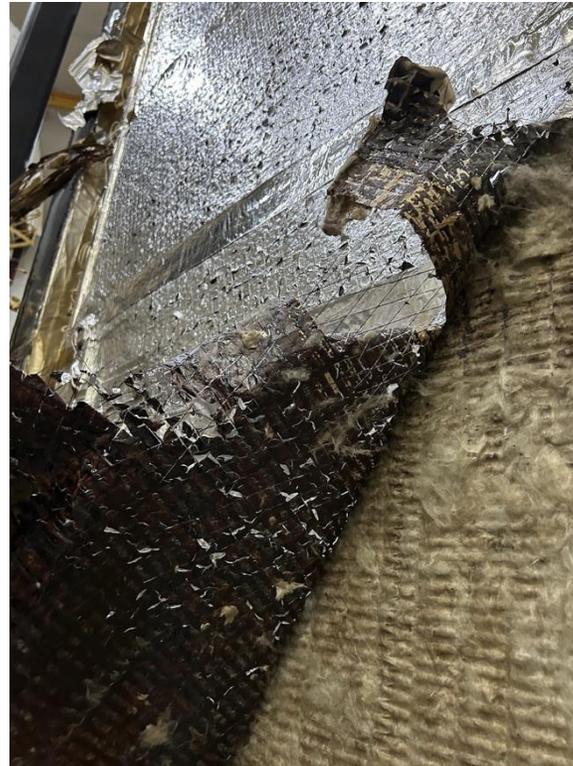
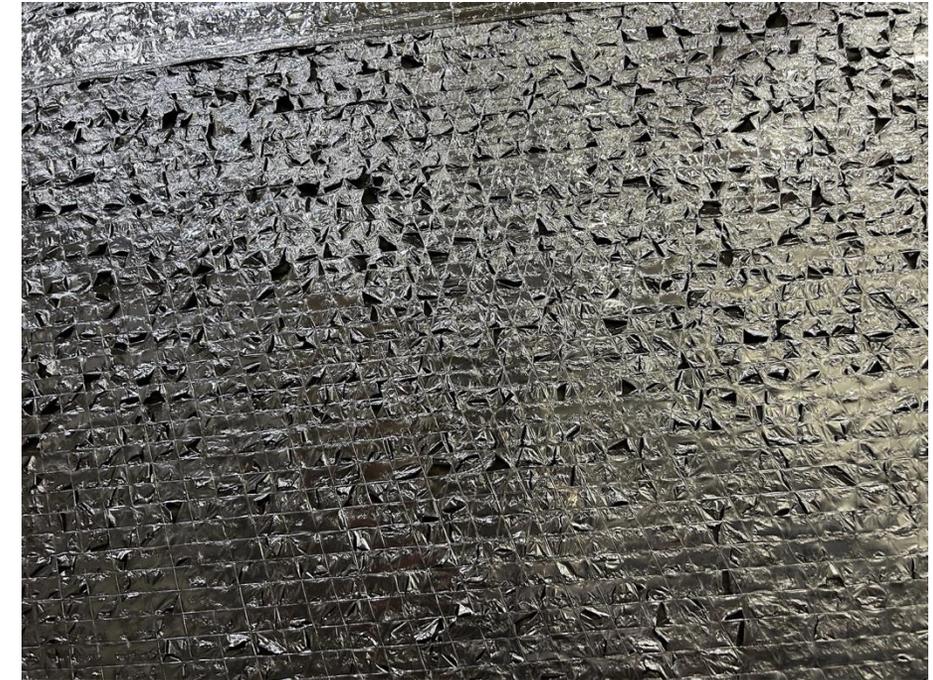
High temperature insulation failure

McMaster Carr claimed insulation rated to 650°C but post-mortem showed foil failed well below 300°C

They admitted their mistake on follow up and told me the insulation was rated at 650°C but the foil only to 150°C

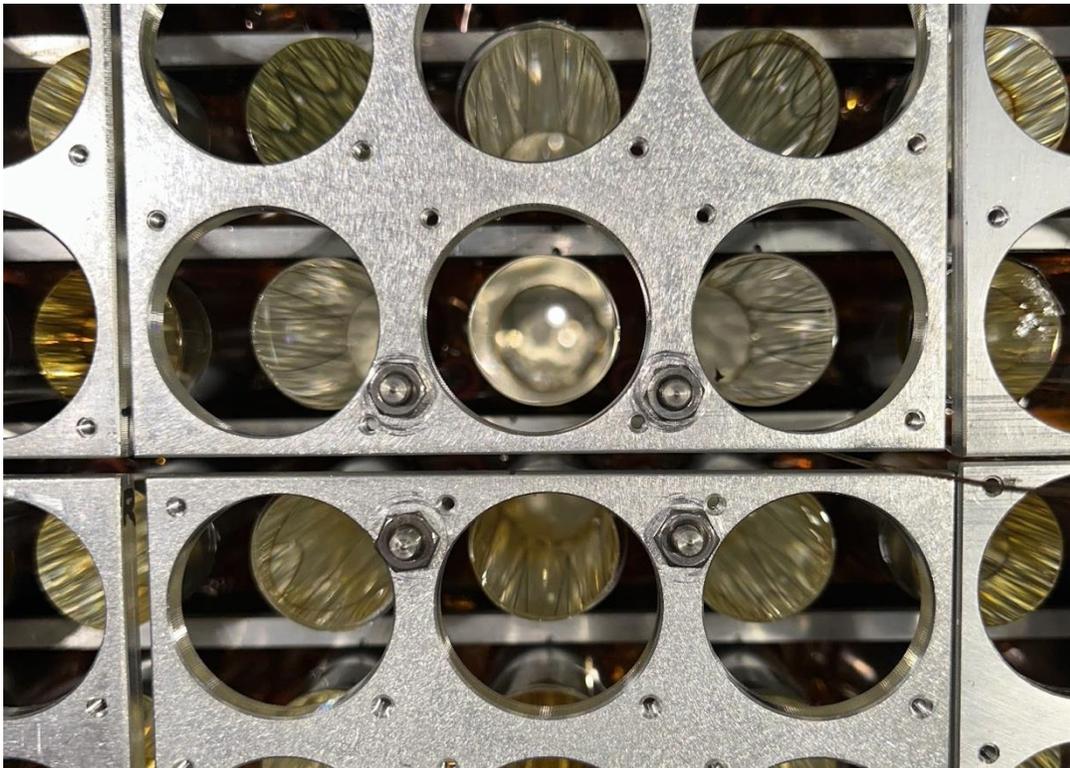
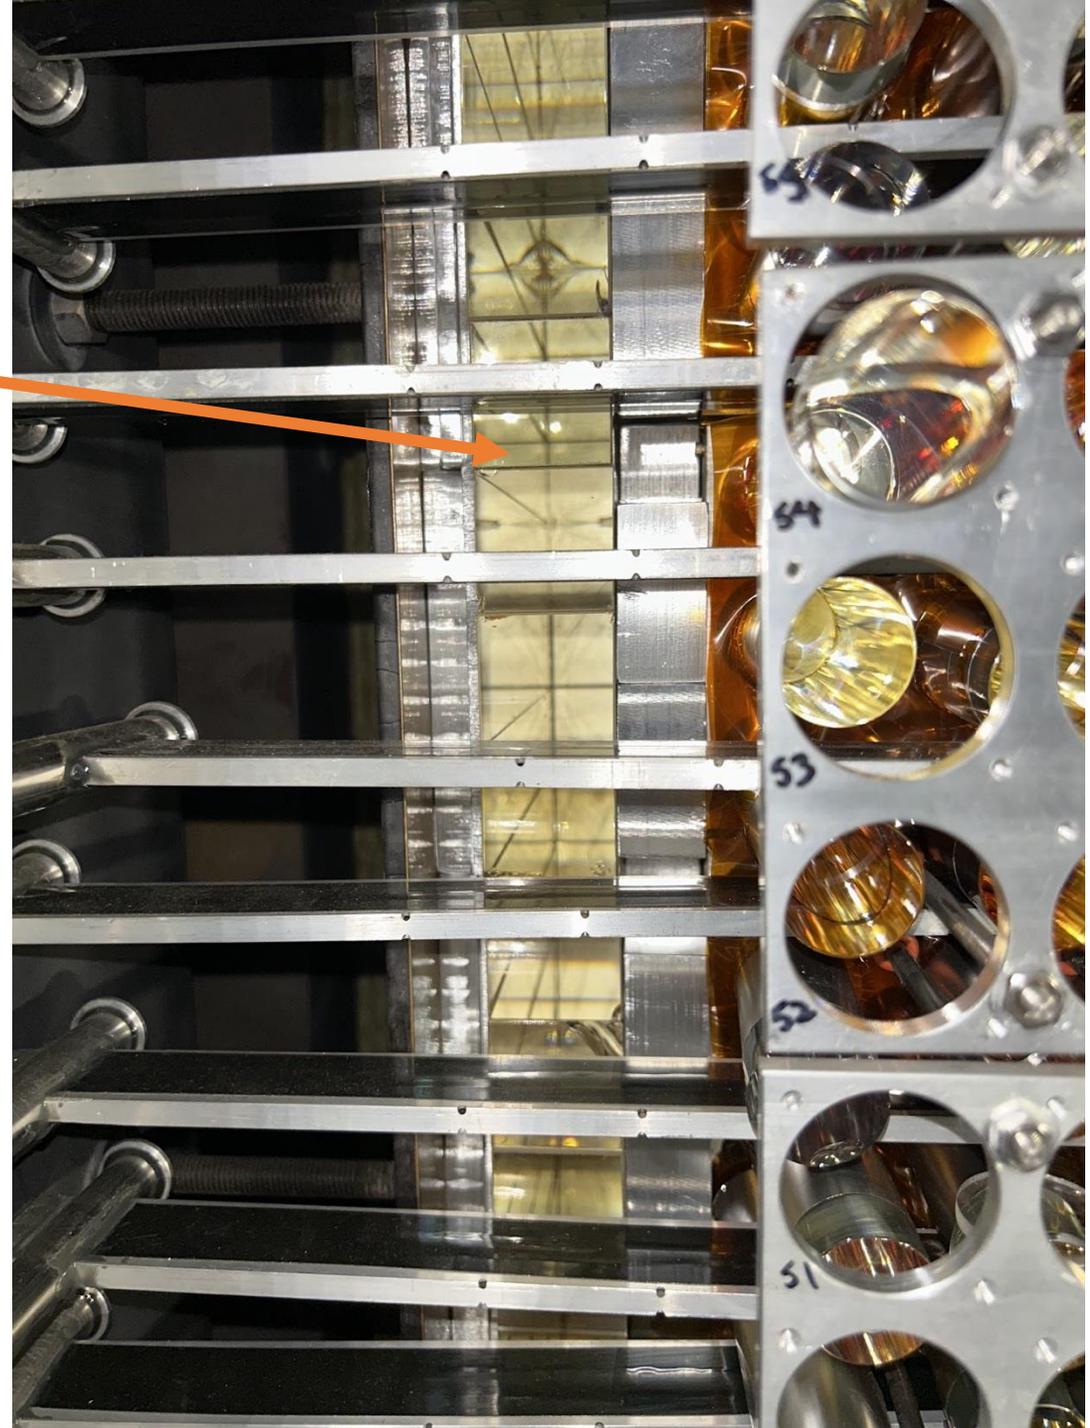
ECal crystals retained clarity

- The heated ECal crystals are still clear
- It is easiest to see in the bare crystals used for spacing
- It is also visible looking down some of the light guides

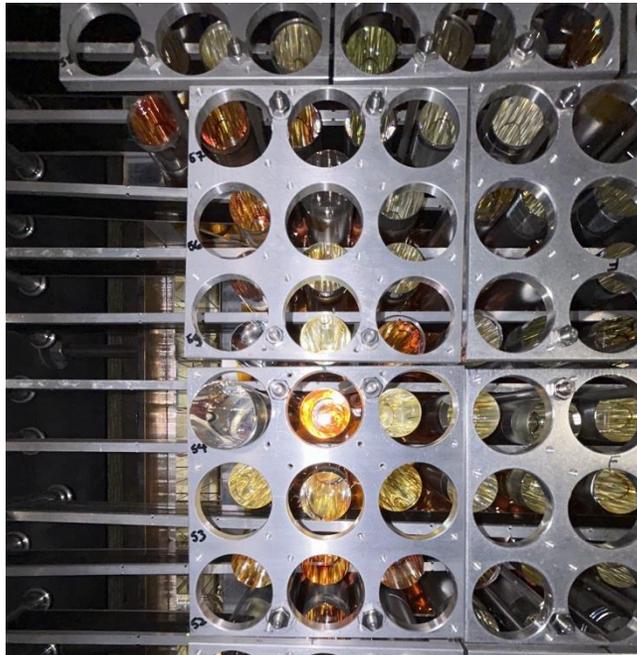
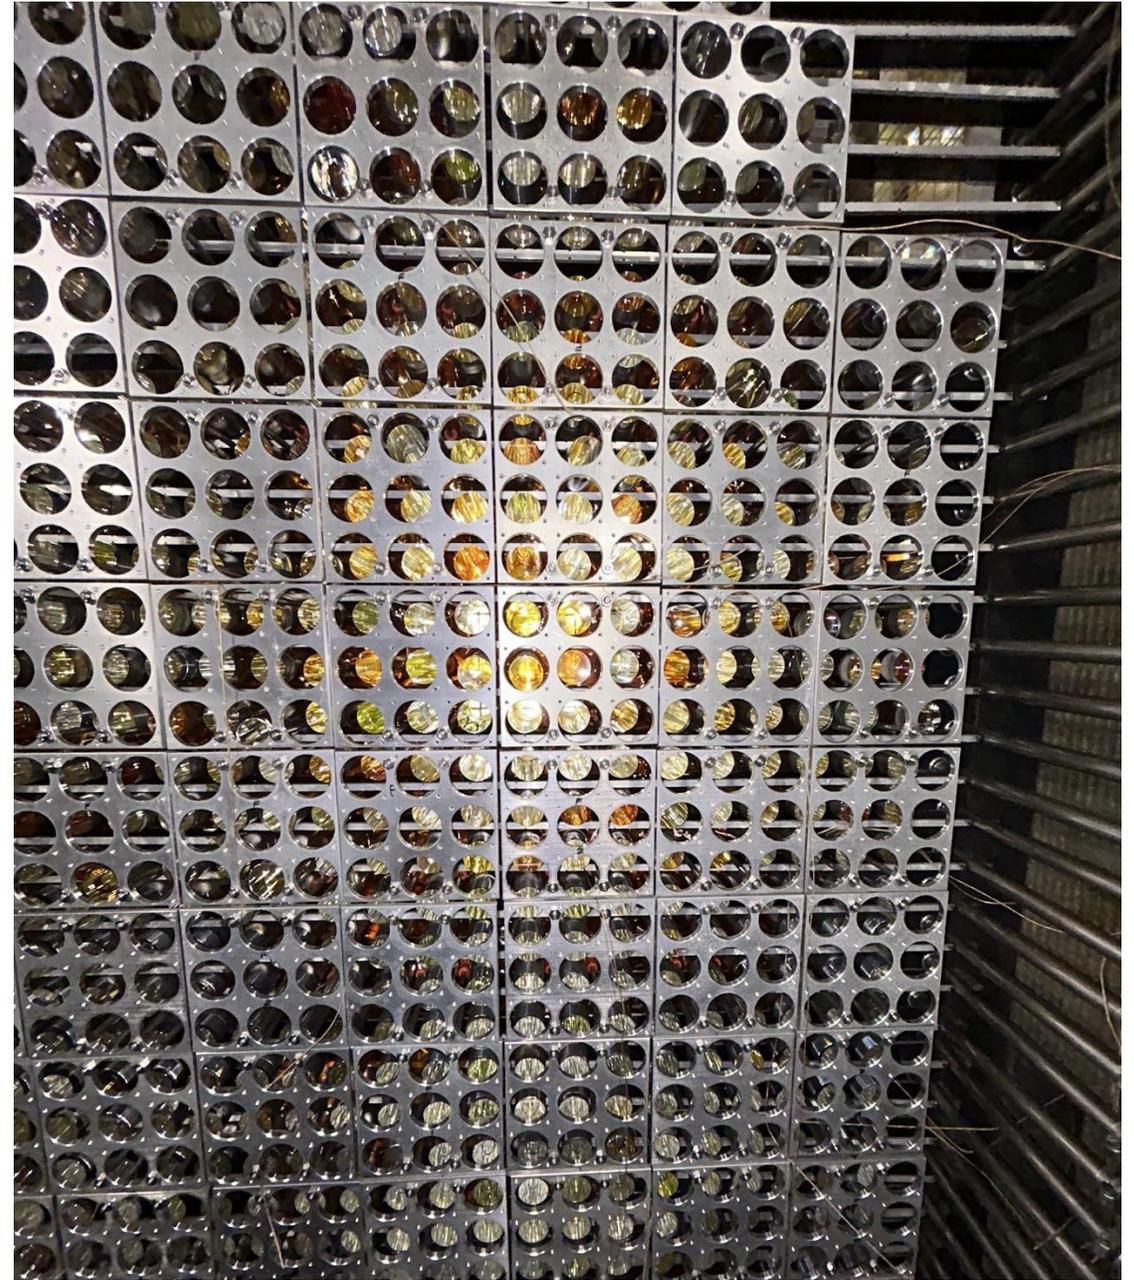
Many look darkened

- A big picture of ECal shows a great deal of apparently darkened crystals
- Closer examination shows this darkening is the glue joining the light guide to the crystals
- Poorer quality joints especially those in the hotter regions show darkening
- Cookies retained full clarity!

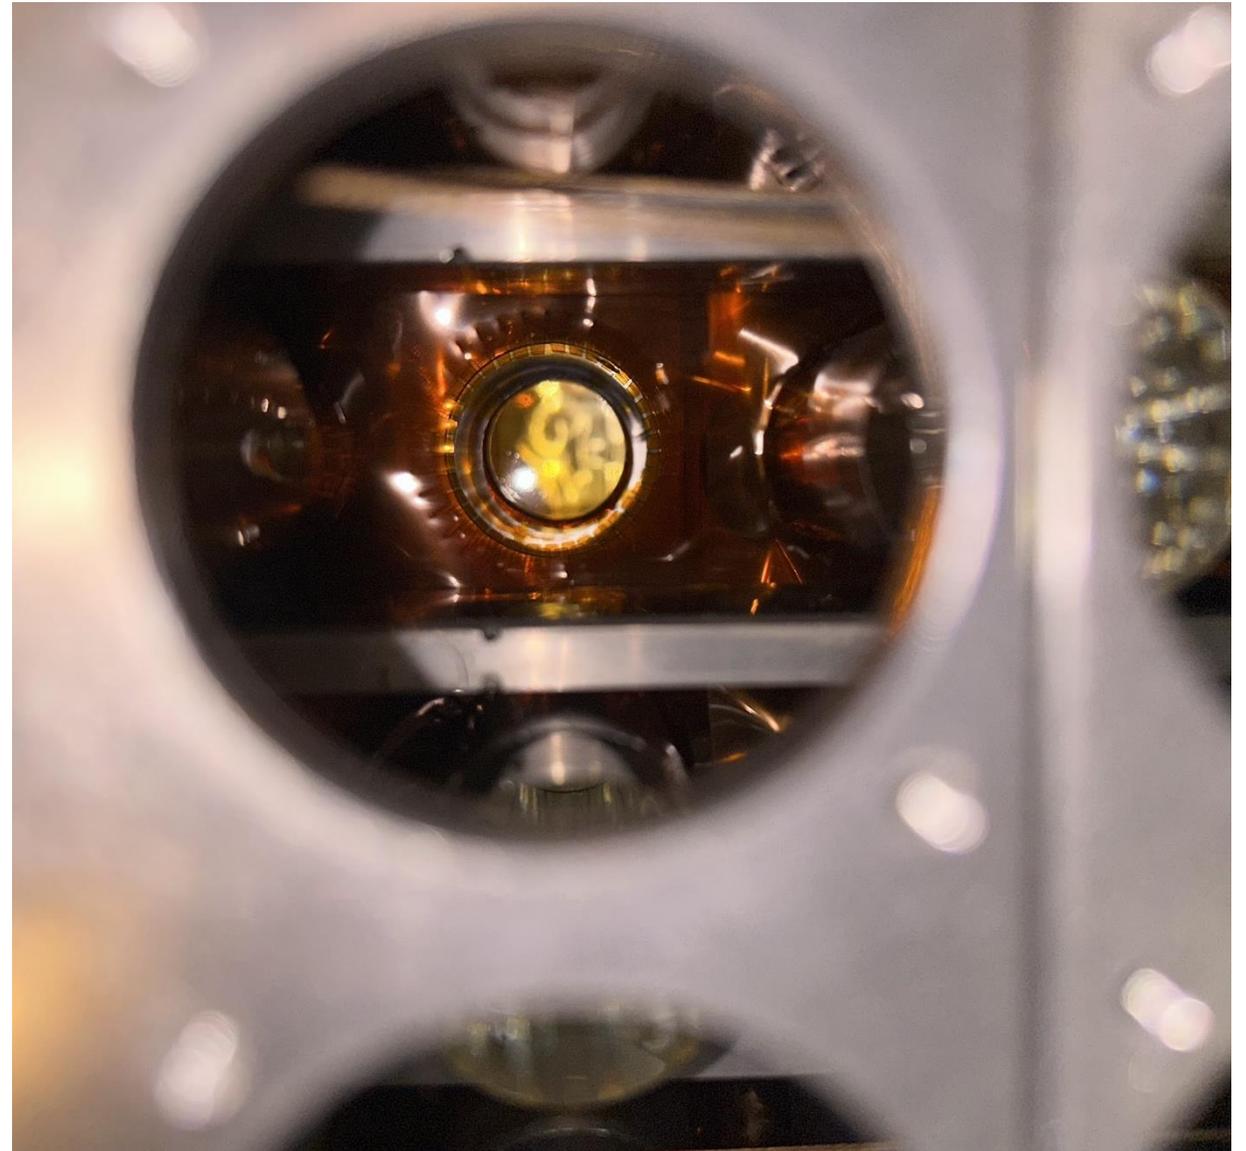
Many loose light guides

- After removing the PMTs we found many loose light guides
- Even though the glue joints in these cases had at least partially failed, the light guides were still held firmly in place and in contact with the crystals by the screw plates holding the PMTs
- Failed glue joints usually are accompanied by darkening suggesting it is a combination of air and heat that creates the darkening.
- The picture shows a crystal with the loose light guide removed and a yellowed glue film partially covering the crystal where the guide was

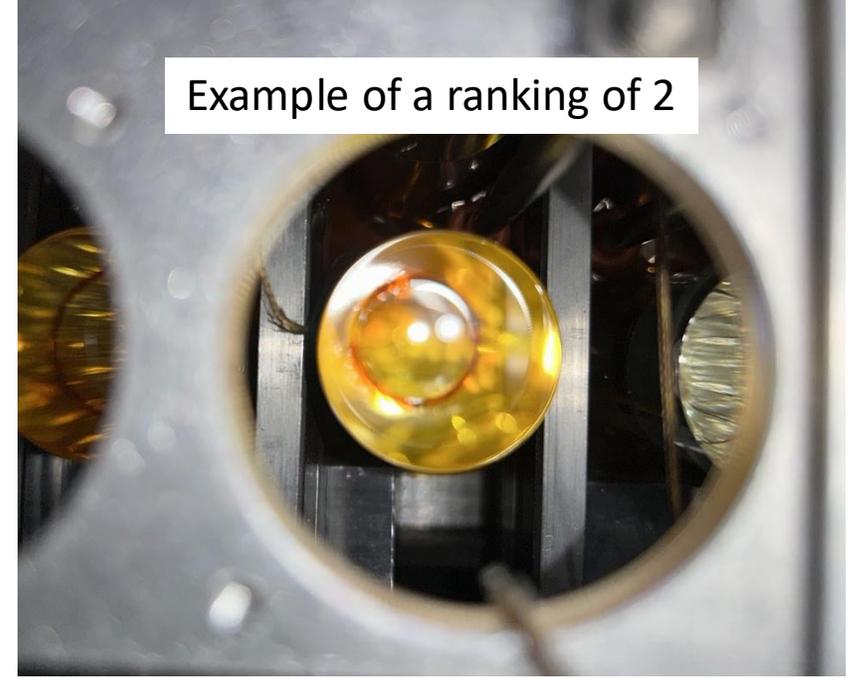
Example of a ranking of 2

- The top 1/3 of the detector (rows 43-69) showed much more darkening and many more loose light guides suggesting that the temperature in the upper region was too hot at least for a time
- The lower 2/3 (rows 1-42) had very few failures
- I went through and ranked the clarity of the glue joints qualitatively giving a ranking of 1,2,3,4 where 1 was mostly clear, 2 darkened to gold, 3 darkened to dark orange, 4 darkened to brown.
- Caveat: this was my qualitative judgment ranking
- There were only 2 ranked at 4

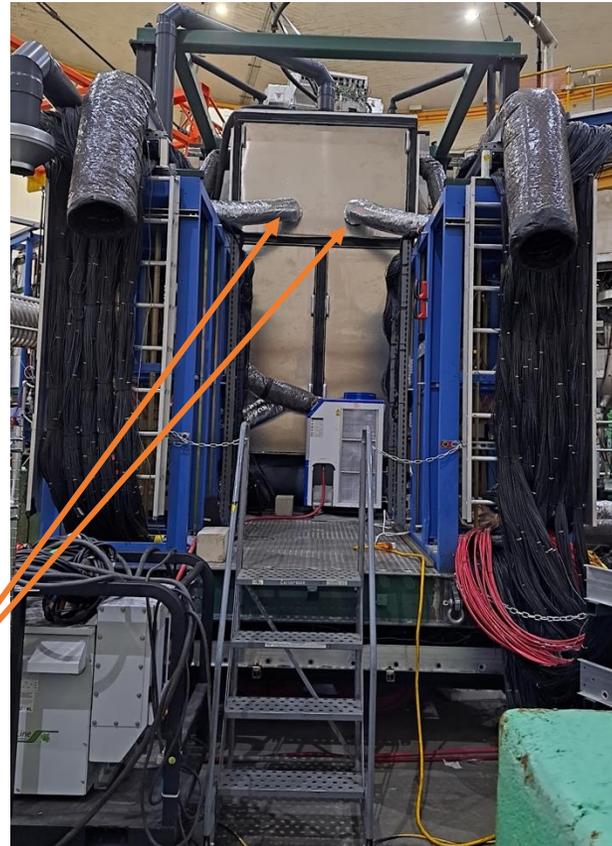
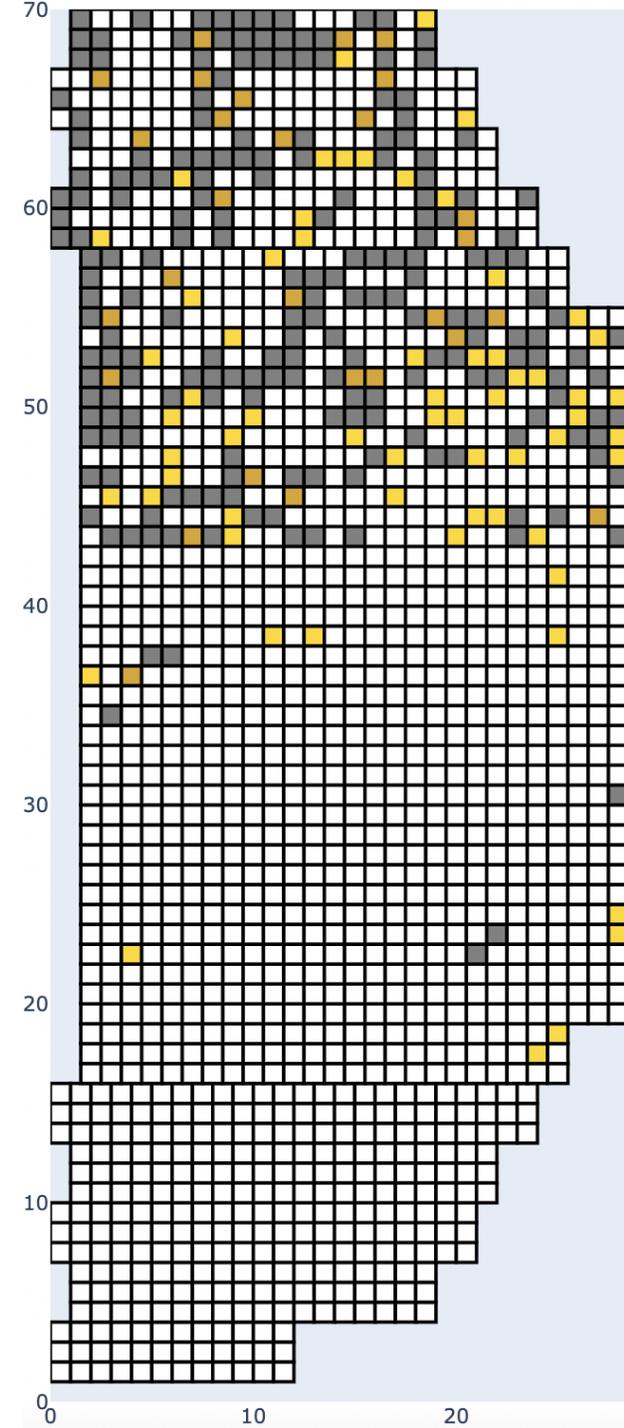
Visualization of light guide performance

- Yellow and dark orange in diagram to left signify levels of crystal darkening.
- Gray signifies a loose light guide.
- Although the transmission of the loose light guides is not specified, they are generally associated with darkened glue in addition to being loose

- This helps explain why we had a lot of difficulty calibrating the top of ECal
- It is not clear if this was a slow process over time or if it was due to a single event

- The most severe overheating happened during a test Mar 11-12, before the beginning of the experiment when the controls program underreported the thermocouple temperatures (interpreting them as j-type instead of k-type)

- During this test I ran much of the detector at full power and could not reach the crystal target temperatures of 220degC and only later found out I was well above that.

- During this test only one air conditioner was active and it was blowing into the bottom half of the enclosure and exiting the top.
- After this test, I added two more air conditioners.

- It is likely that this event was partially to blame along with an underperforming cooling system.
- At end of 3-pass running more cooling exhaust vents added

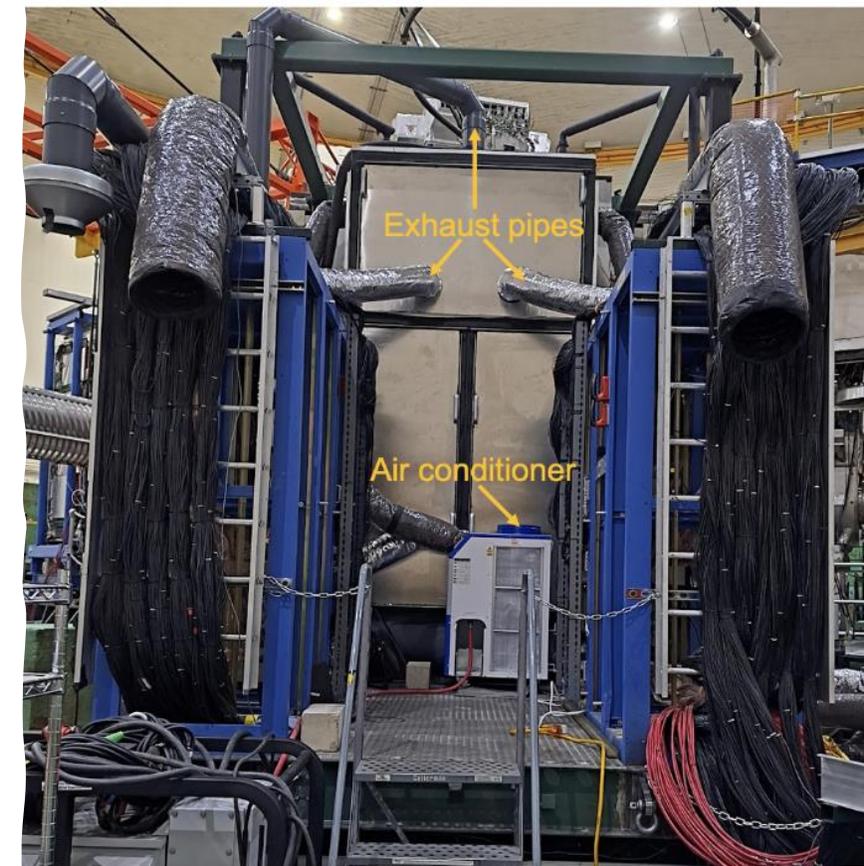
Cooling system

- A few weeks before GEP was starting I realized that the cooling system as designed would not accommodate both the heat generated by the hot crystals and the PMT bases.
- Retrofitted the rear enclosure to include pipes connected to an industrial air conditioner... then two air conditioners blowing air in the 1-5°C range
- Turned on detector and found dark current rate still extremely high with heater system on
- Biggest decrease in dark current happened when we added a 3rd air conditioner to feed cold air to pumps that shot jets of air at each PMT/light guide.
- Finally modification was adding more vents since inlets outnumbered outlets by a fair margin

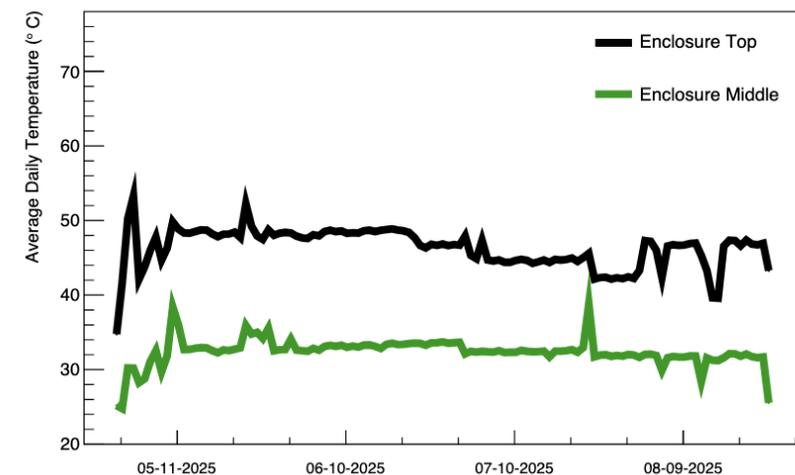
Rear Enclosure Ambient Temperatures

- Put the controls and monitoring hardware in a better shielded area and add independent monitor of temperature in heated region
- Cooling system subject to large gradient which is nearly impossible to remove
 - Couldn't seem to get rid of hot air pocket at the top even with cold air input near the top. Surprise--cold air falls.
 - Biggest gains were using cooled air directly as input to the cooling jet system
 - Recommend to introduce all cool air through the jet that are 2x radius (4x flow) so that the cool air is where you need it and you aren't relying on difficult to predict flow patterns inside the enclosure.
