# The surface impedance of Nb/Cu coated QWR cavities for HIE-ISOLDE project

**Silvia Teixeira**

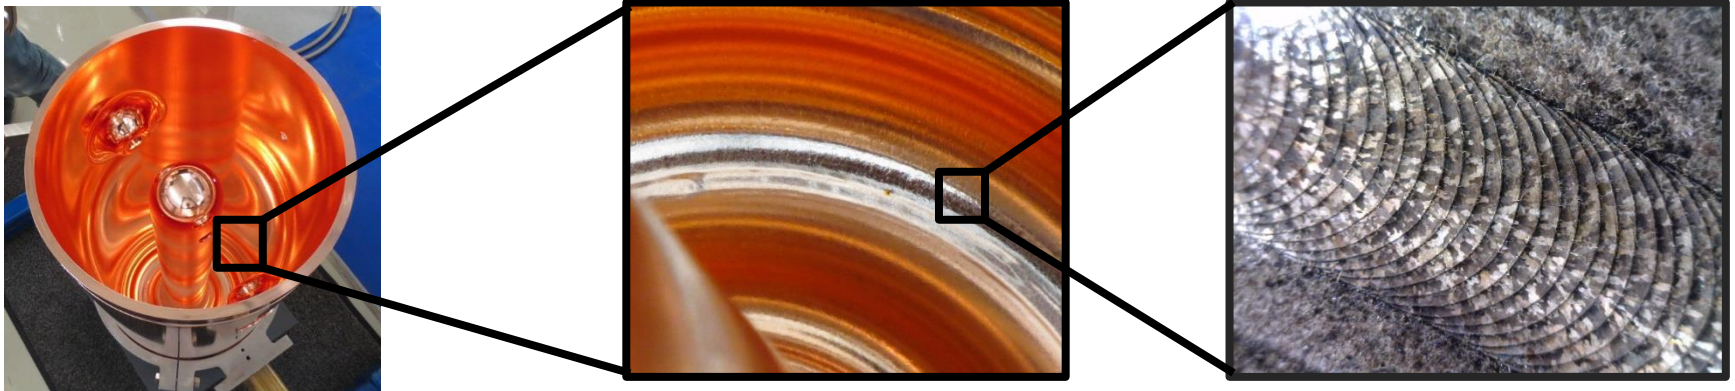
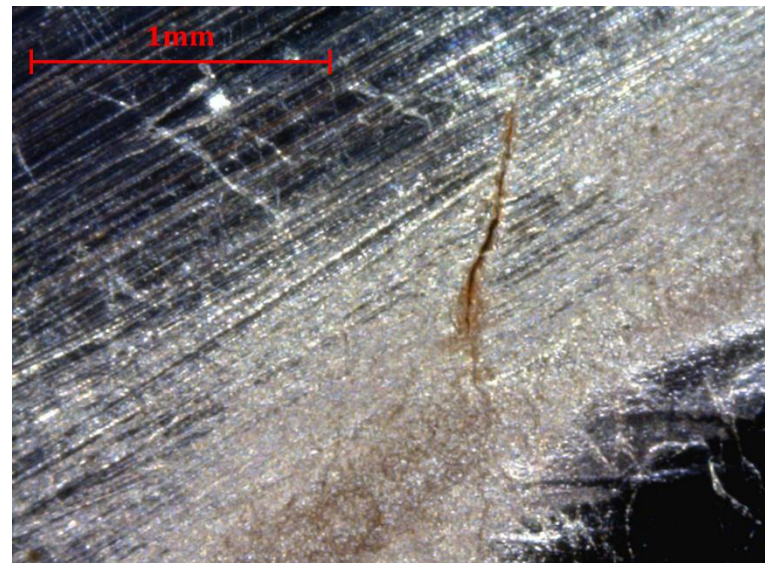
- In most of the substrates of the series production, cracks were observed mainly **near the weld area** (in the outer conductor)
- In most cases they are **identified when revealed by the SUBU** (chemical treatment)

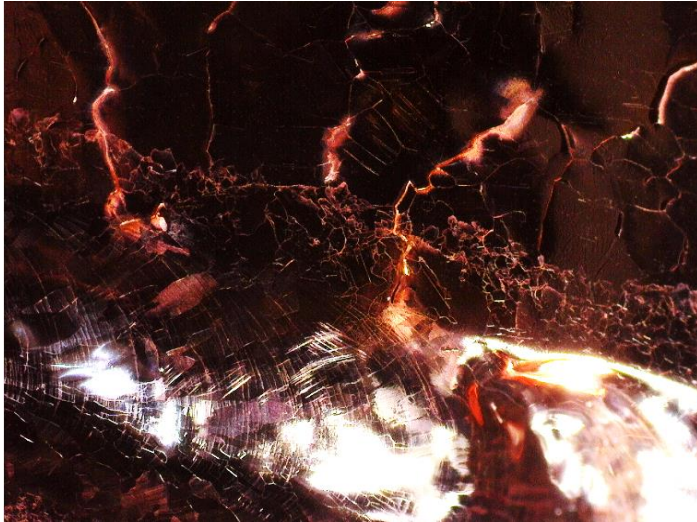
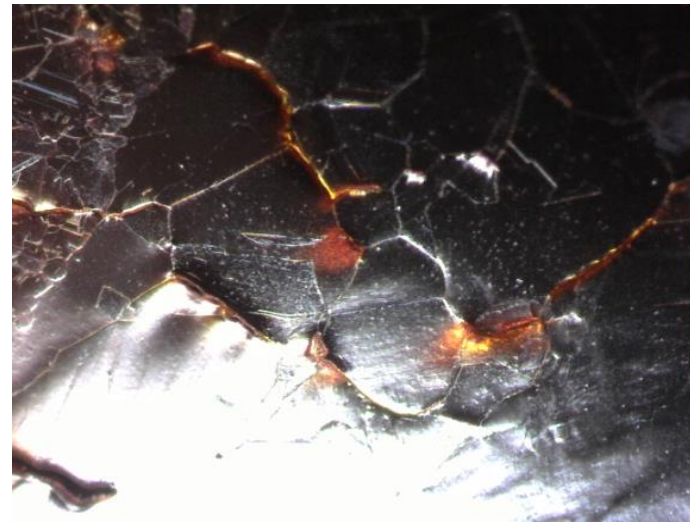
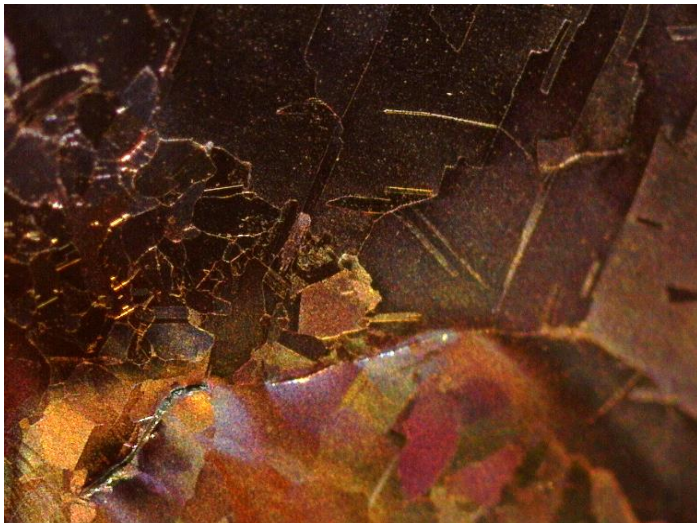
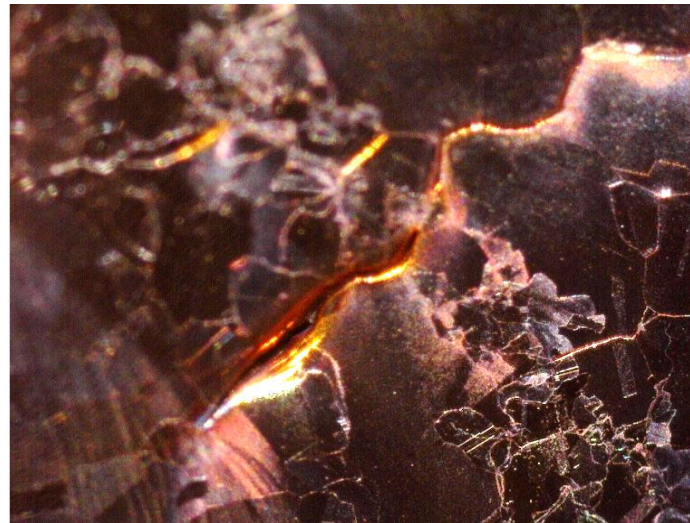
- Linear indications (appearing as cracks and voids) at surface were observed after SUBU etching on QS9, **especially around the EB weld zone.**
- Cracks are not only present in the surface, but in **the bulk material** (OFE copper).
- SUBU doesn't generate the imperfections, but **reveals** them.
- **Hydrogen embrittlement** was discarded as a possible culprit.
- We tried to reproduce the same effect on several kinds of OFE compliant material **without succeeding.**
- **Residual stresses and heat** have probably contributed to the apparition of these imperfections.

- Cavity machined from a **bulk Cu cylinder**.
- **Antenna length** shorter for frequency tuning
- **Thinner inner conductor** to recover R/Q
- **Cone insertion** to avoid leakage through the beam ports

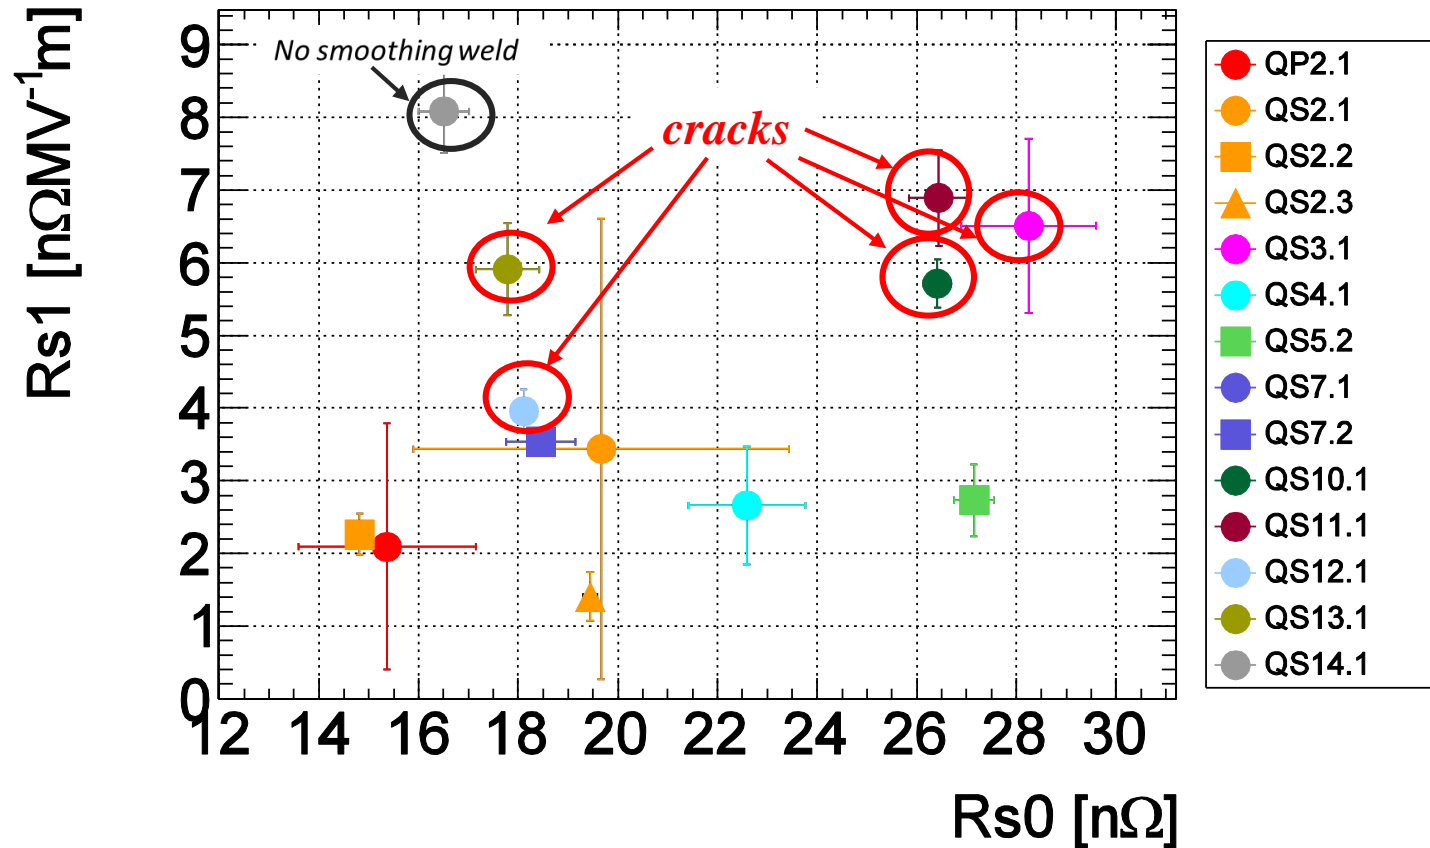
- Rs0 and Rs1 are weakly but **positively correlated** (correlation factor 0.3)
- The substrate with the **cracks tends to have higher Rs1** (Q-slope)
- Removal of the smoothing weld for material investigations
