Strategy and Status of Reference Cavities for European XFEL

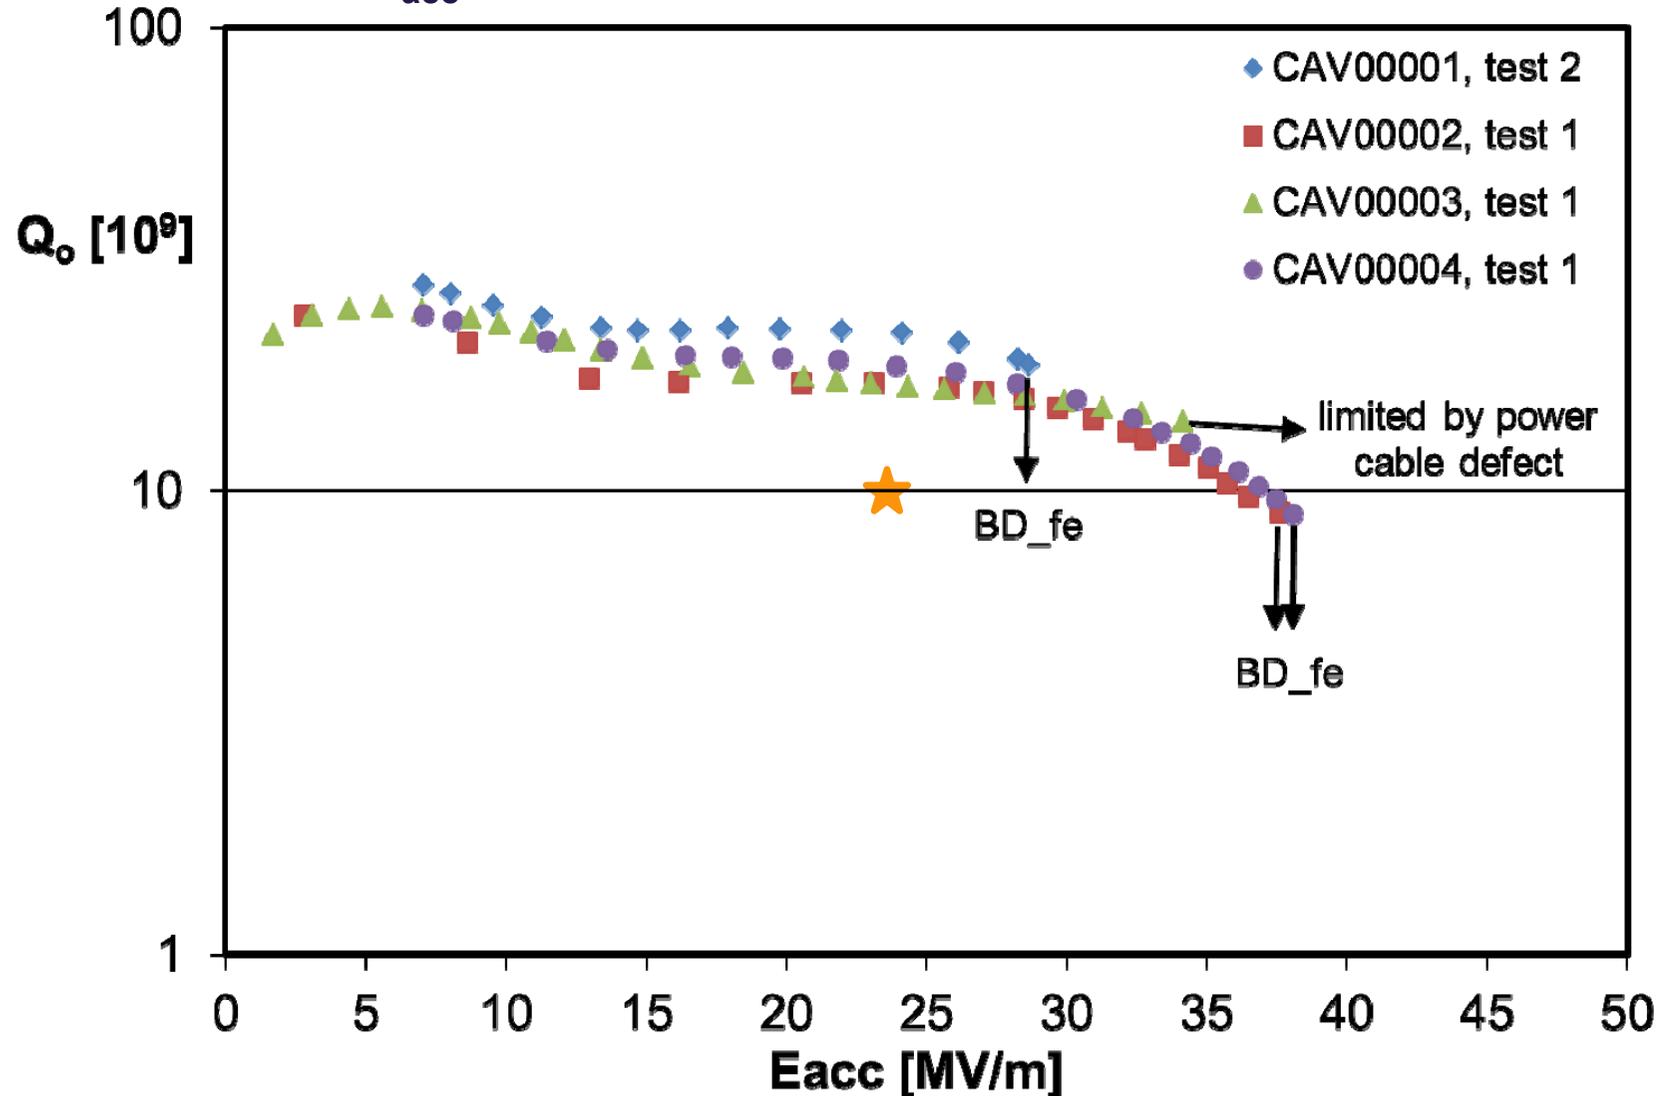
Starting Performance of Reference Cavities: RI (after surface preparation at DESY)

- Acceptance test of four RI reference cavities successful:
All cavities with $E_{acc} > 28$ MV/m!

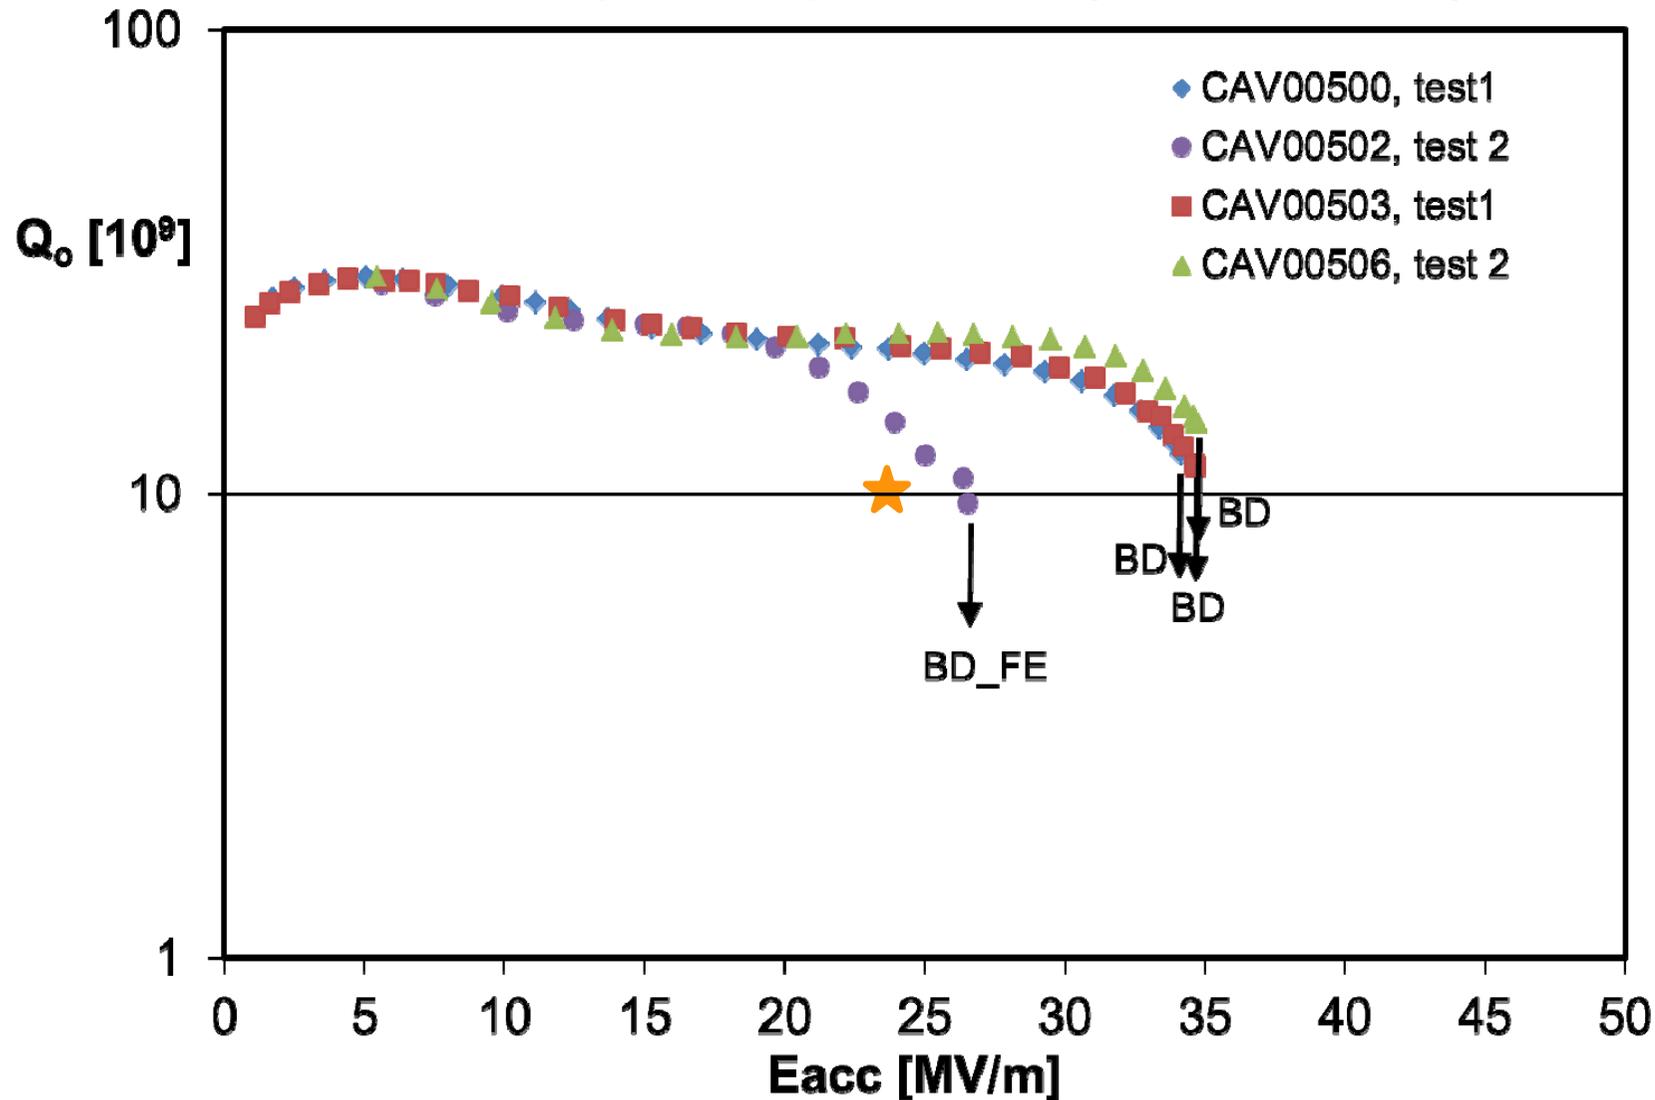
Starting Performance of Reference Cavities: EZ (after surface preparation at DESY)

- Three cavities vertical acceptance test successful (no FE)
- CAV00502 accepted though strong radiation (field emission)

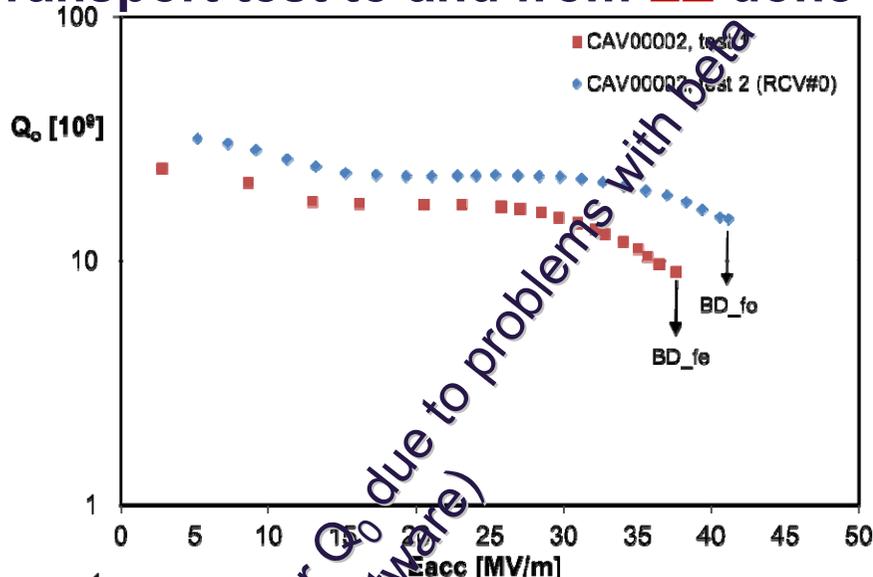
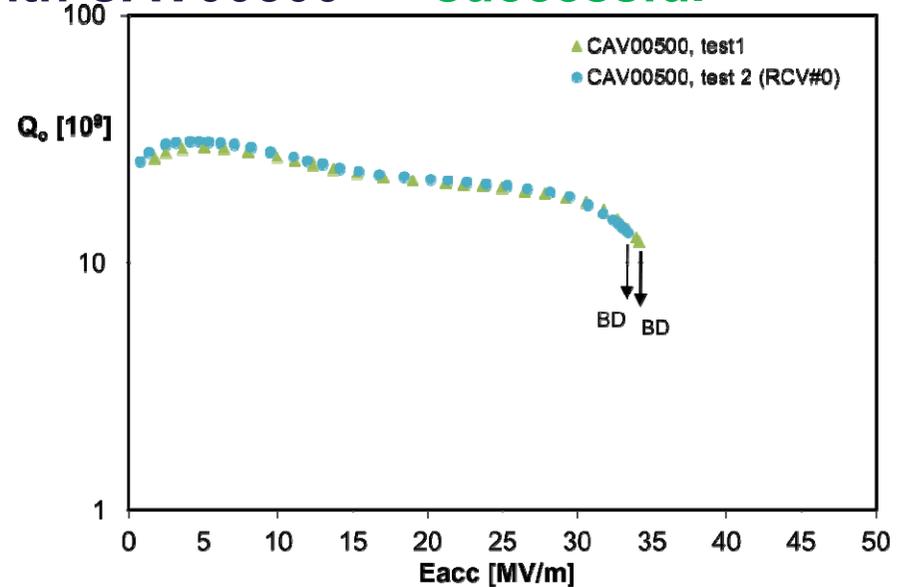
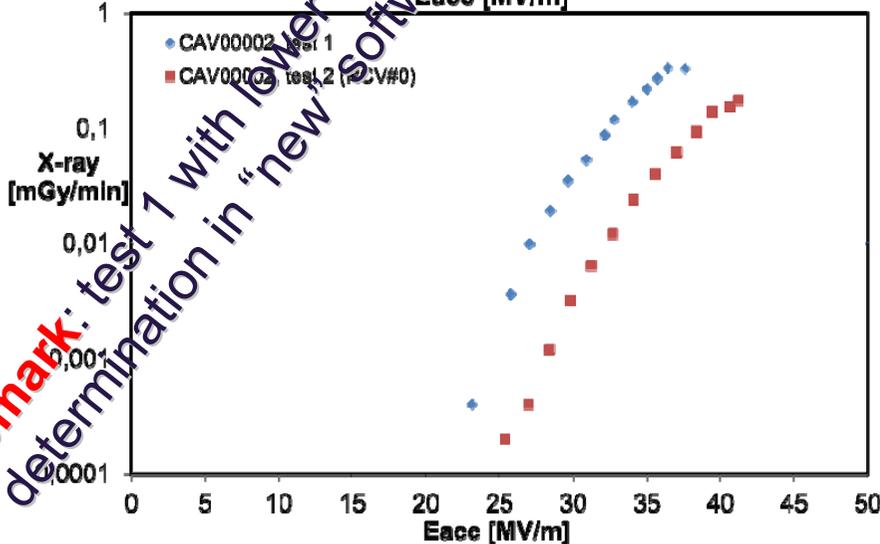
Transport tests: RCV#0 (0. step of RCV qualification)

- Transport test to and from **RI** done with CAV00002 => **successful**
- Transport test to and from **EZ** done with CAV00500 => **successful**

no radiation

remark: test 1 with lower Q₀ due to problems with beta determination in "new" software)

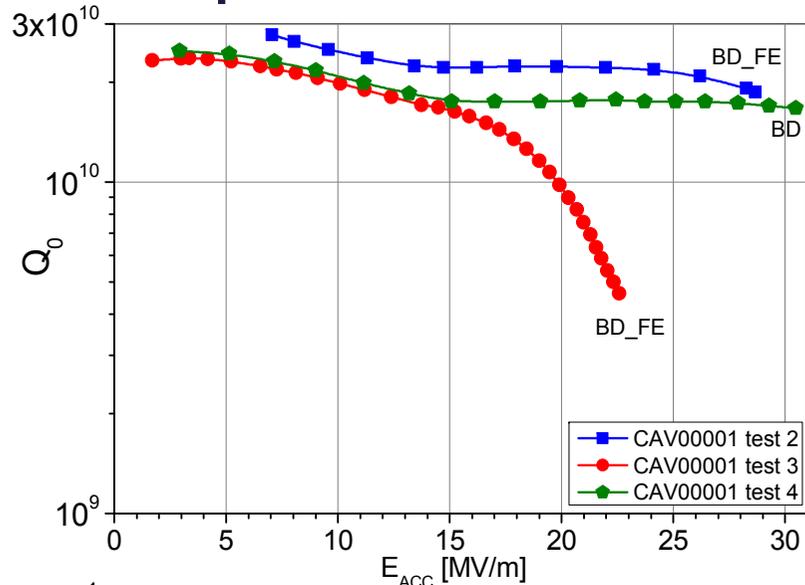
- Test of Slow Pumping / Slow venting at **RI** done with CAV00001 (left) => **failed**
- 2. attempt of SPSV at **RI** done with CAV00004 (right) => **failed**

test 4 → cavity retreated by DESY (HPR)

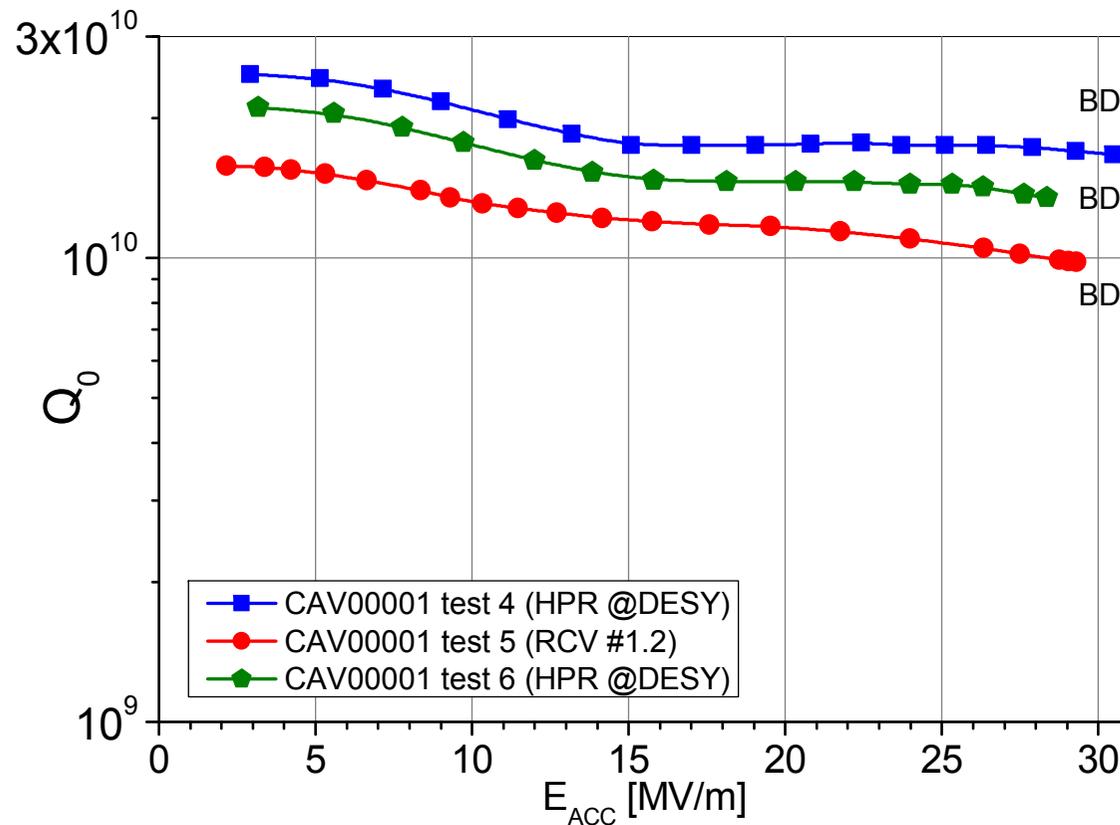
■ 3. attempt of SPSV at RI done with CAV00001 (left) => preliminary ok

no radiation

Small leak at 2K appeared during test => Re-tightening of screws for re-test

Re-test of CAV00001 ongoing in order to find reason for Q-degradation (RF-procedure checked and ok).

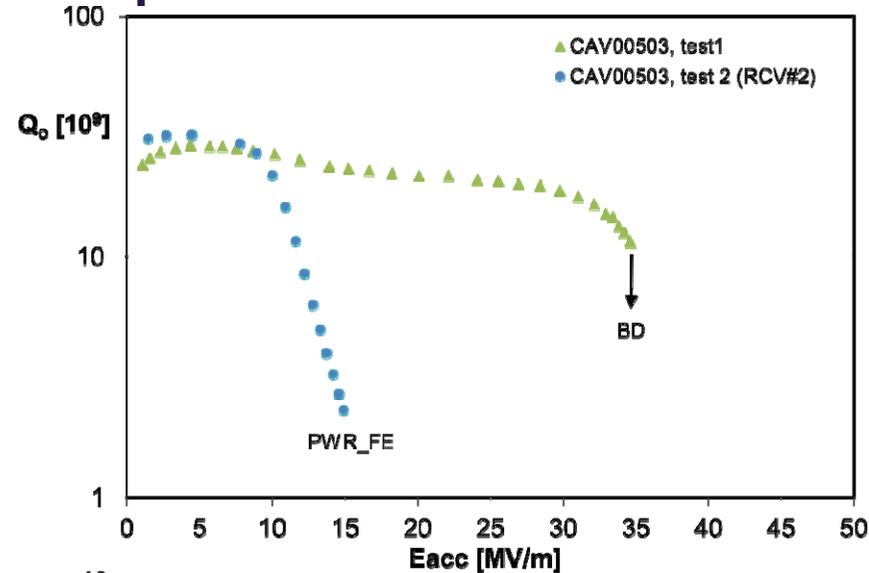
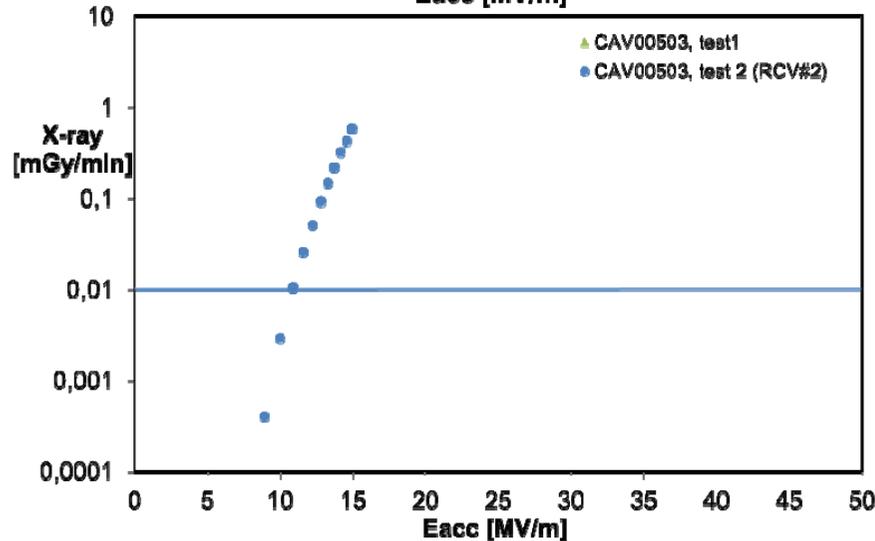
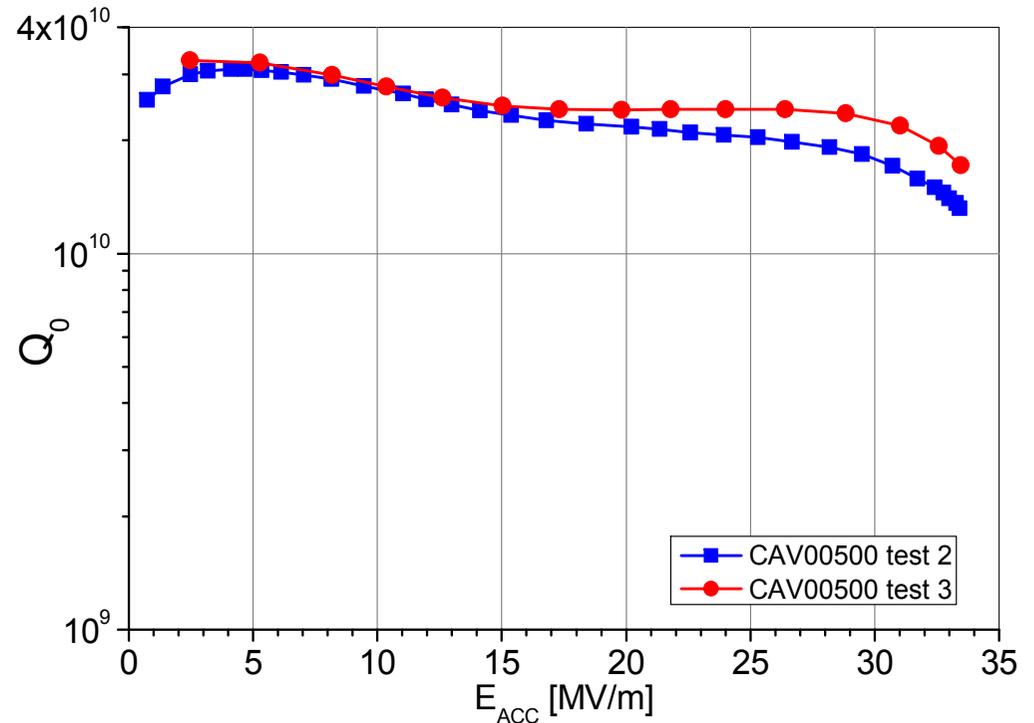
- 1. attempt of HPR qualification done at **EZ** with CAV00503 (left) => **failed**
- HPR qualification at **EZ** with CAV00500 (right) => **successful**

no radiation

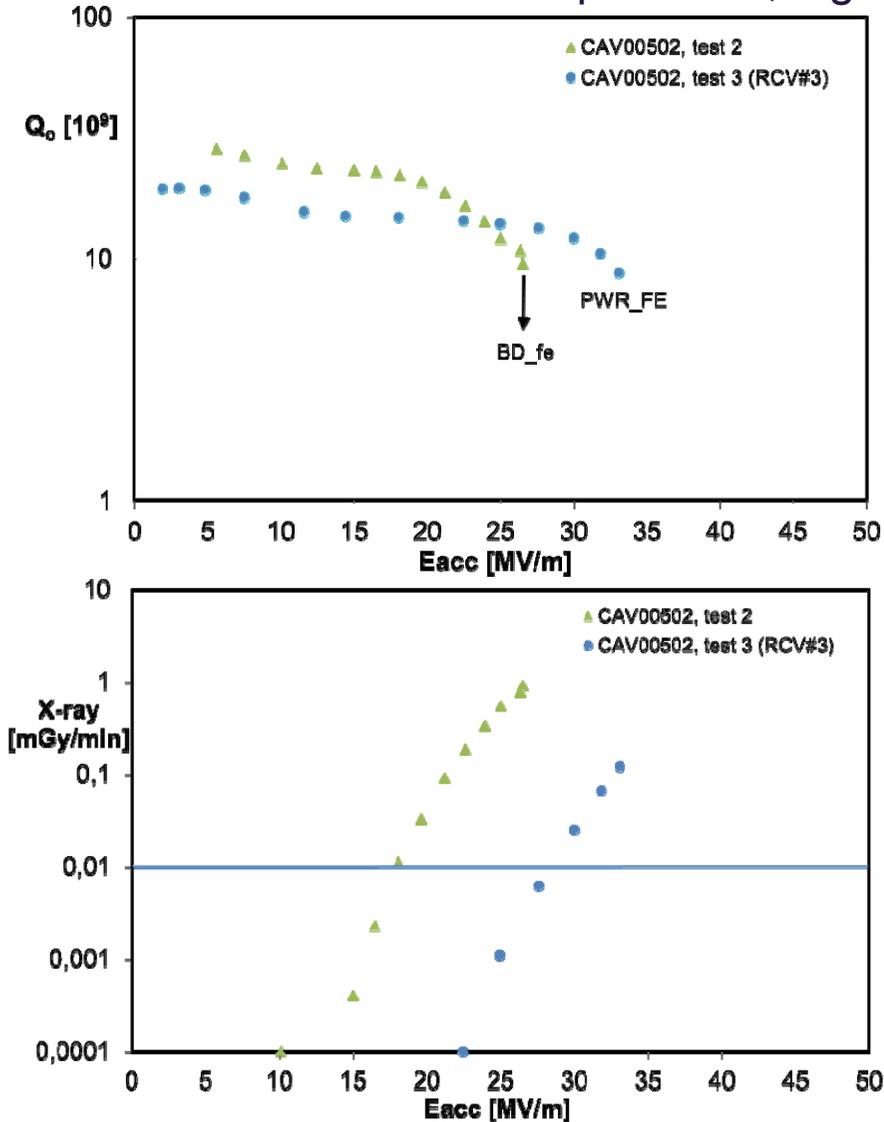
Qualification of full assembly (incl. antenna preparation) @ EZ: RCV#3

- Qualification of full assembly at **EZ** with CAV00502 => **successful**
(lower Q-value w/o obvious explanation; higher Q_{trans} than usual)

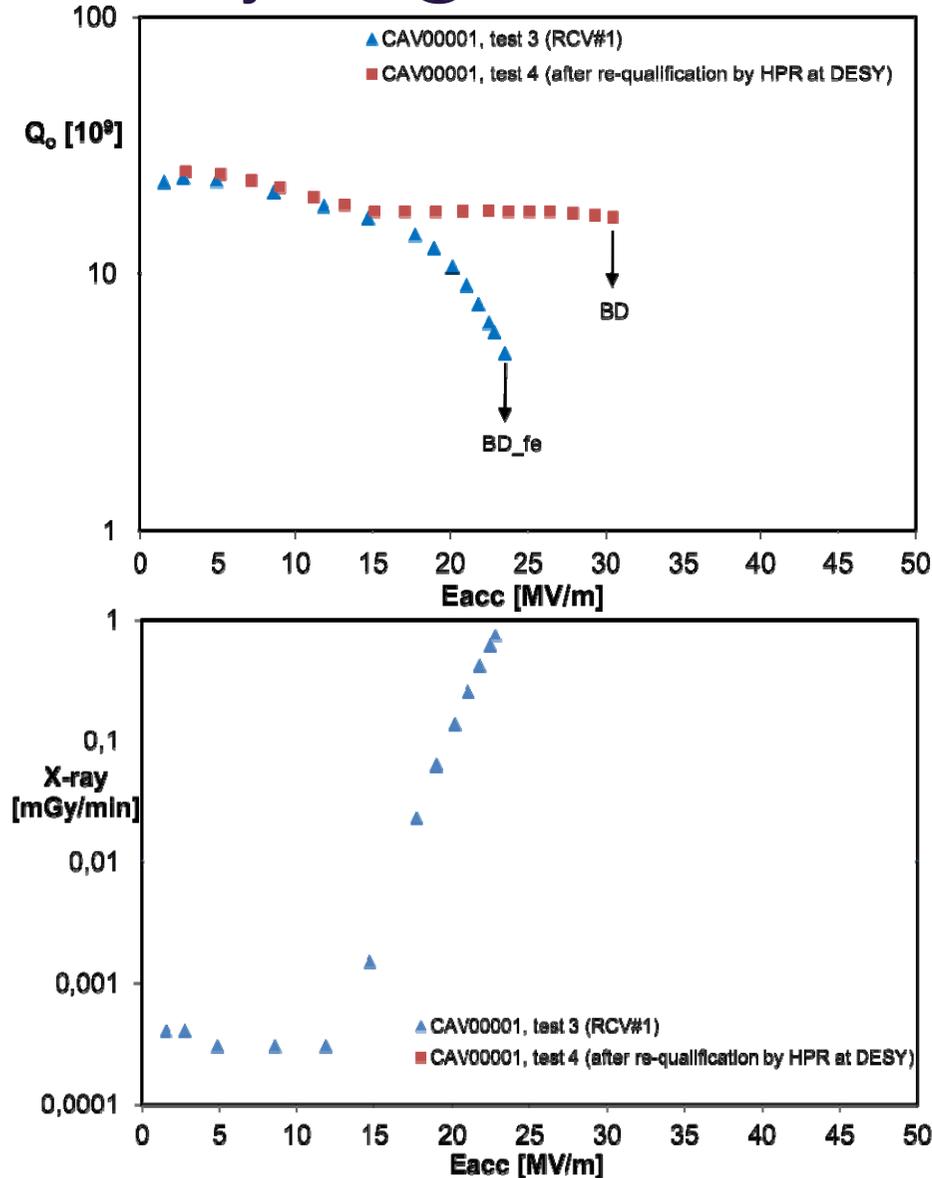
■ CAV00001 by HPR @ DESY after RCV#1 failed at RI => **successful**

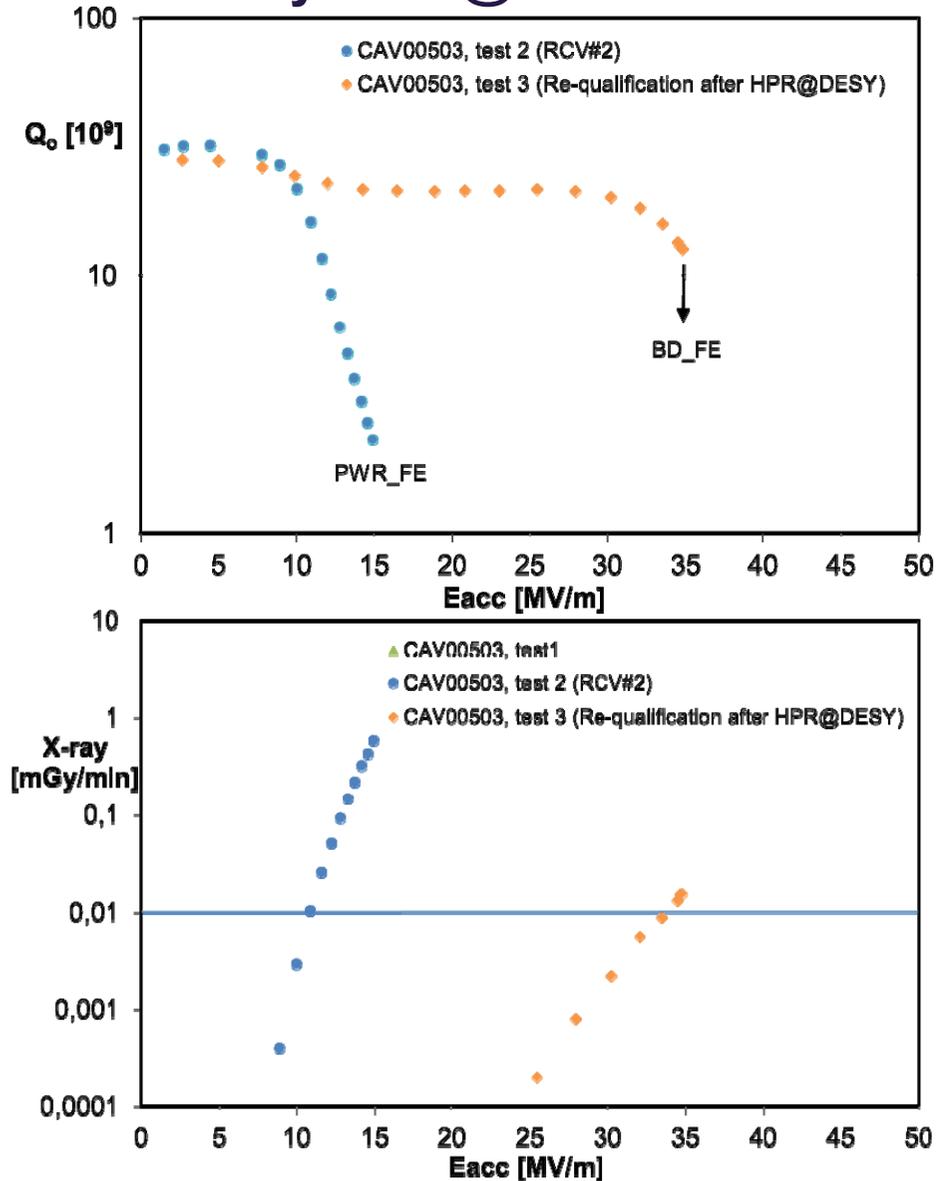
■ CAV00503 by HPR @ DESY after RCV#2 failed at **EZ** => **successful**

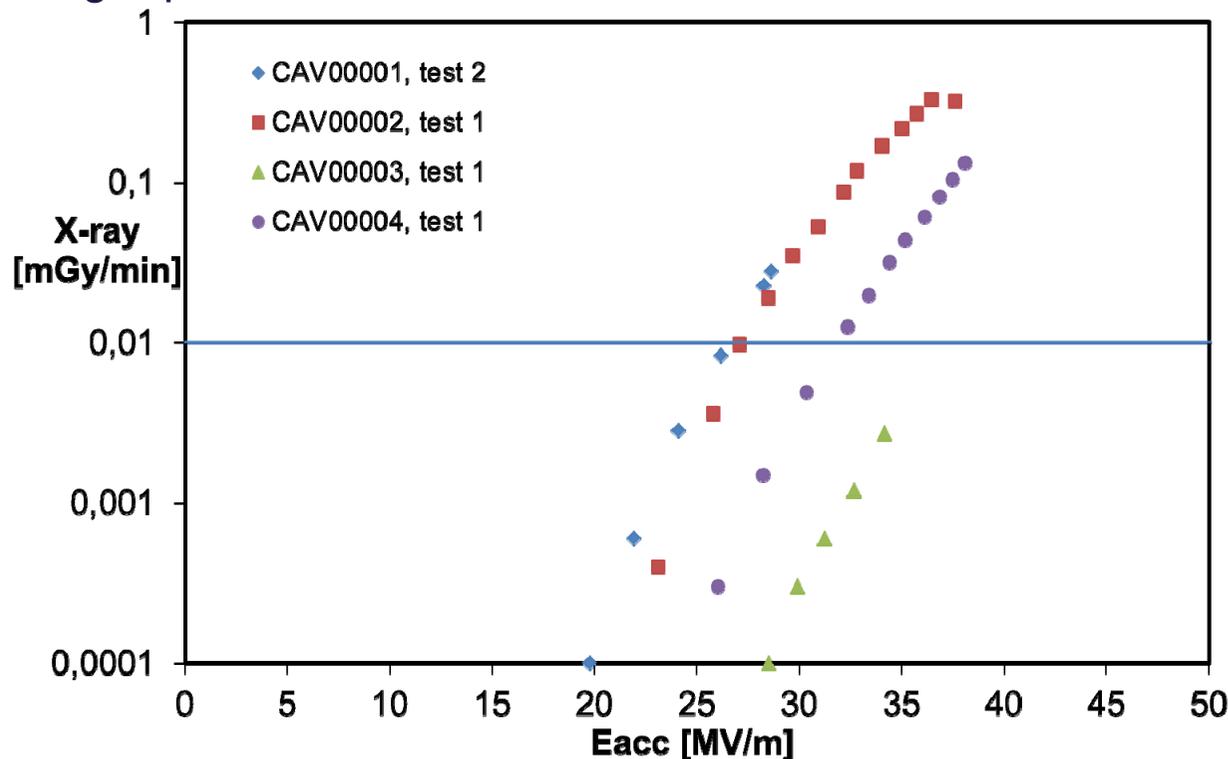
- Usable gradient for RI cavities:
 - CAV00001, test 2: 26.4 MV/m (radiation > 10^{-2} mGy/min)
 - CAV00002, test 1: 27.1 MV/m (radiation > 10^{-2} mGy/min)
 - CAV00003, test 1: >34.2 MV/m (limited by power cable defect)
 - CAV00004, test 1: 31.7 MV/m (radiation > 10^{-2} mGy/min)
- Remark 1:** CAV00001 needed additional test due to wrong assembly of valve in test 1 (cavity did not fit in transport box) => HPR + correct valve assembly before test 2
- Remark 2:** Though qualified the radiation in CAV00001 + CAV00002 are close to acceptable limit!

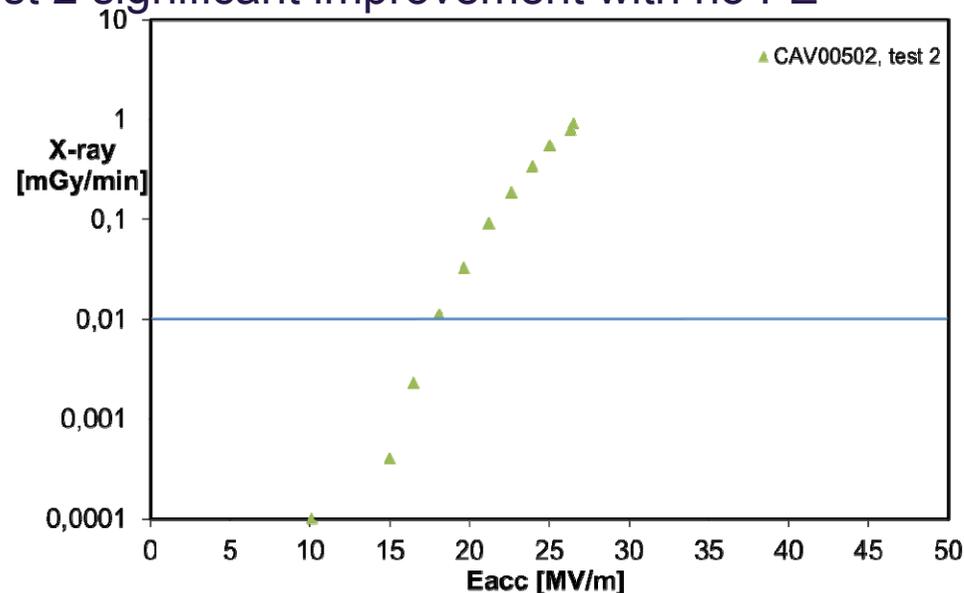
- Usable gradient for EZ cavities:
 - CAV00500, test 1: 34.2 MV/m (Quench, no FE)
 - CAV00502, test 2: 17.9 MV/m (radiation > 10^{-2} mGy/min)
 - CAV00503, test 1: 34.6 MV/m (Quench, no FE)
 - CAV00506, test 2: 34.7 MV/m (Quench, no FE)
- **Remark 1:** CAV00502 + CAV00506 showed activation of strong FE in first Q(E) of test 1
- **Remark 2:** CAV00502 after test 1 => OBACHT inspection and HPR
=> OBACHT shows scratches at Iris 9
=> in test 2 again degradation in first Q(E) due to FE and more x-rays than test 1
- **Remark 3:** CAV00506 after test 1 => OBACHT inspection and HPR
=> in test 2 significant improvement with no FE
