Condition of electron beam welding toward a high gradient application

**TESLA Technology Collaboration (TTC) Meeting
November 6, 2012, Thomas Jefferson National Accelerator Facility**

KEK

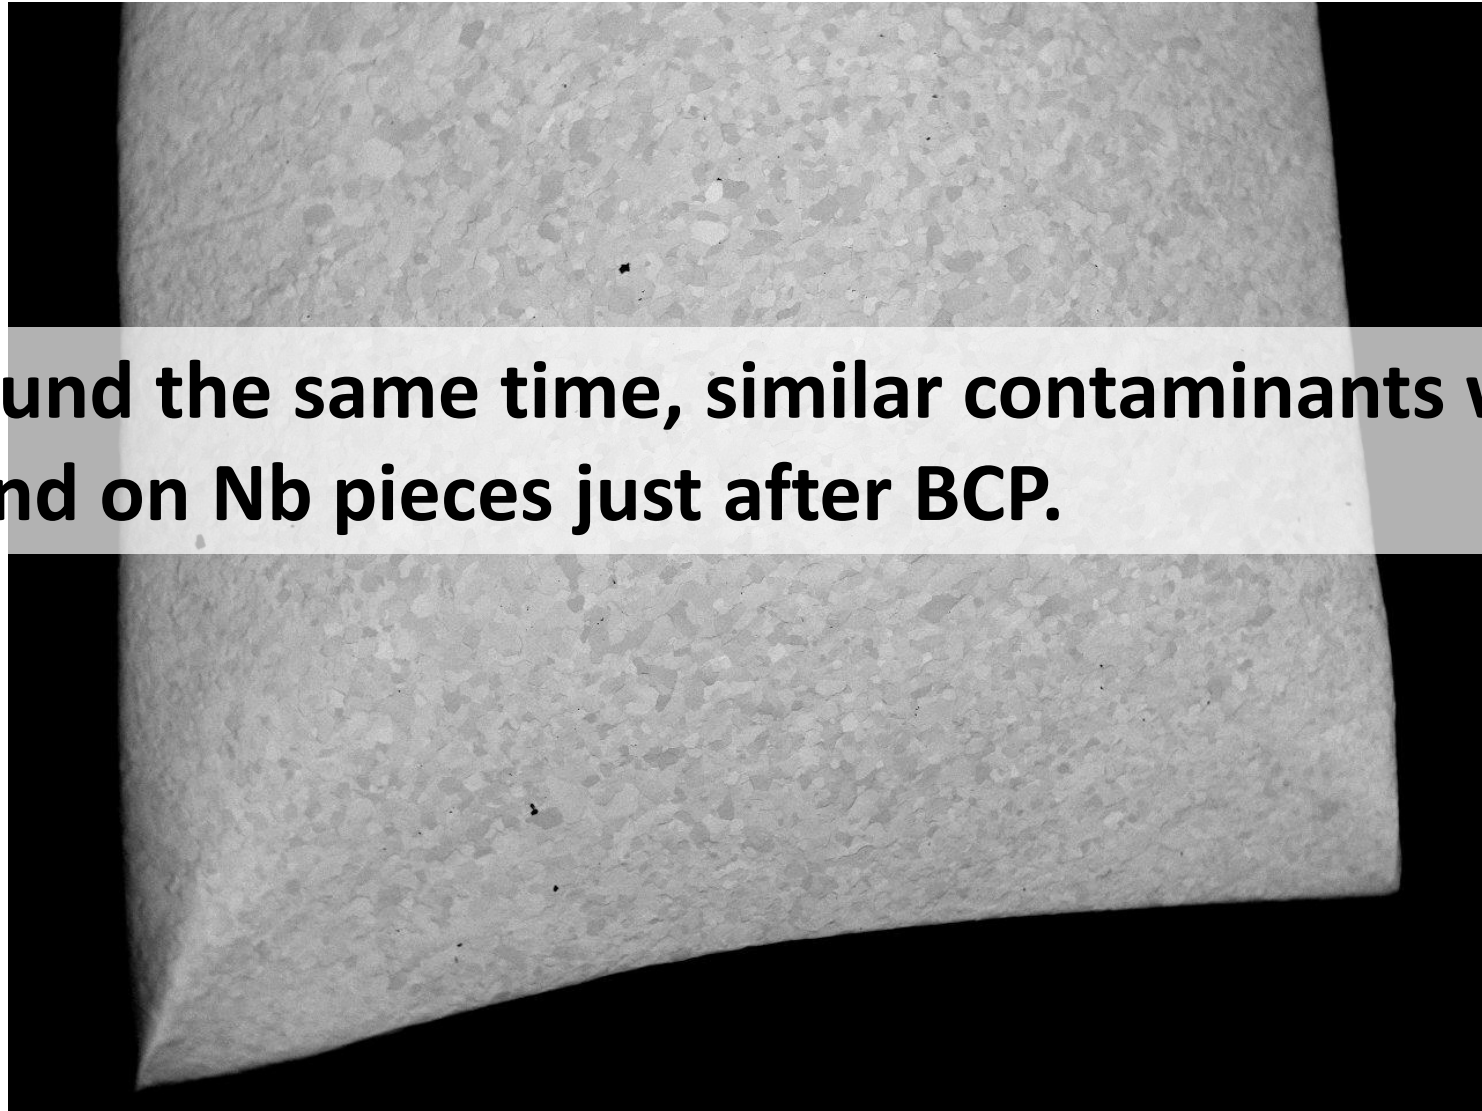
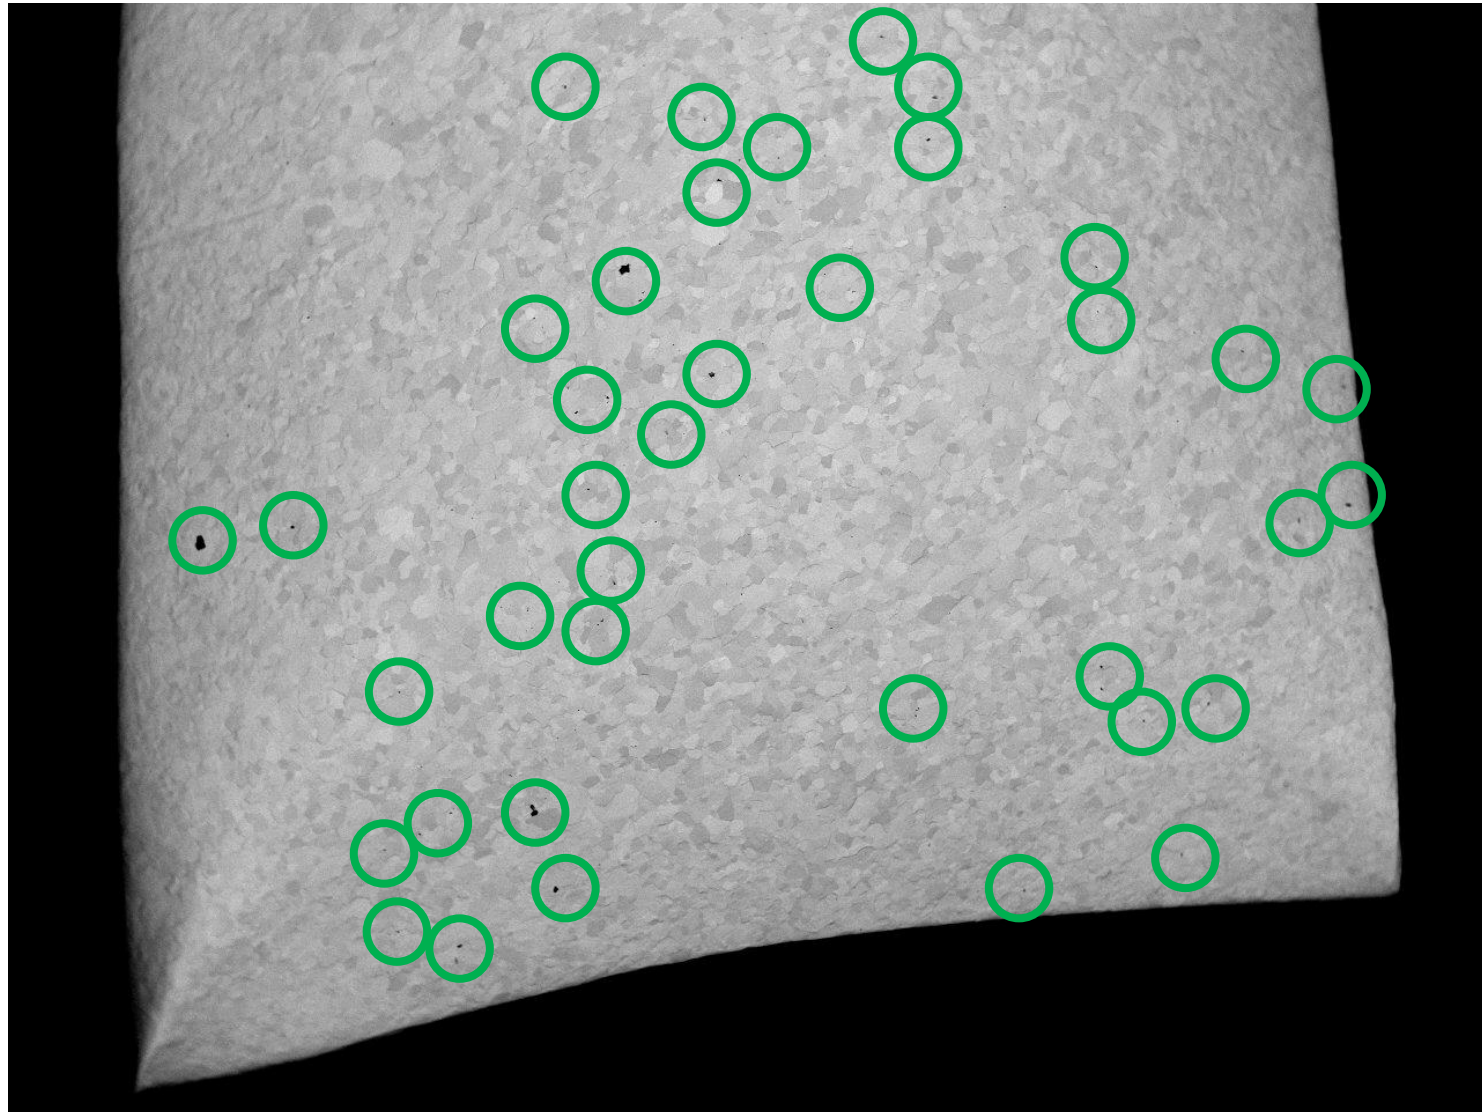
Example of a surface condition just after
BCP + pure water rinsing

Around the same time, similar contaminants were found on Nb pieces just after BCP.

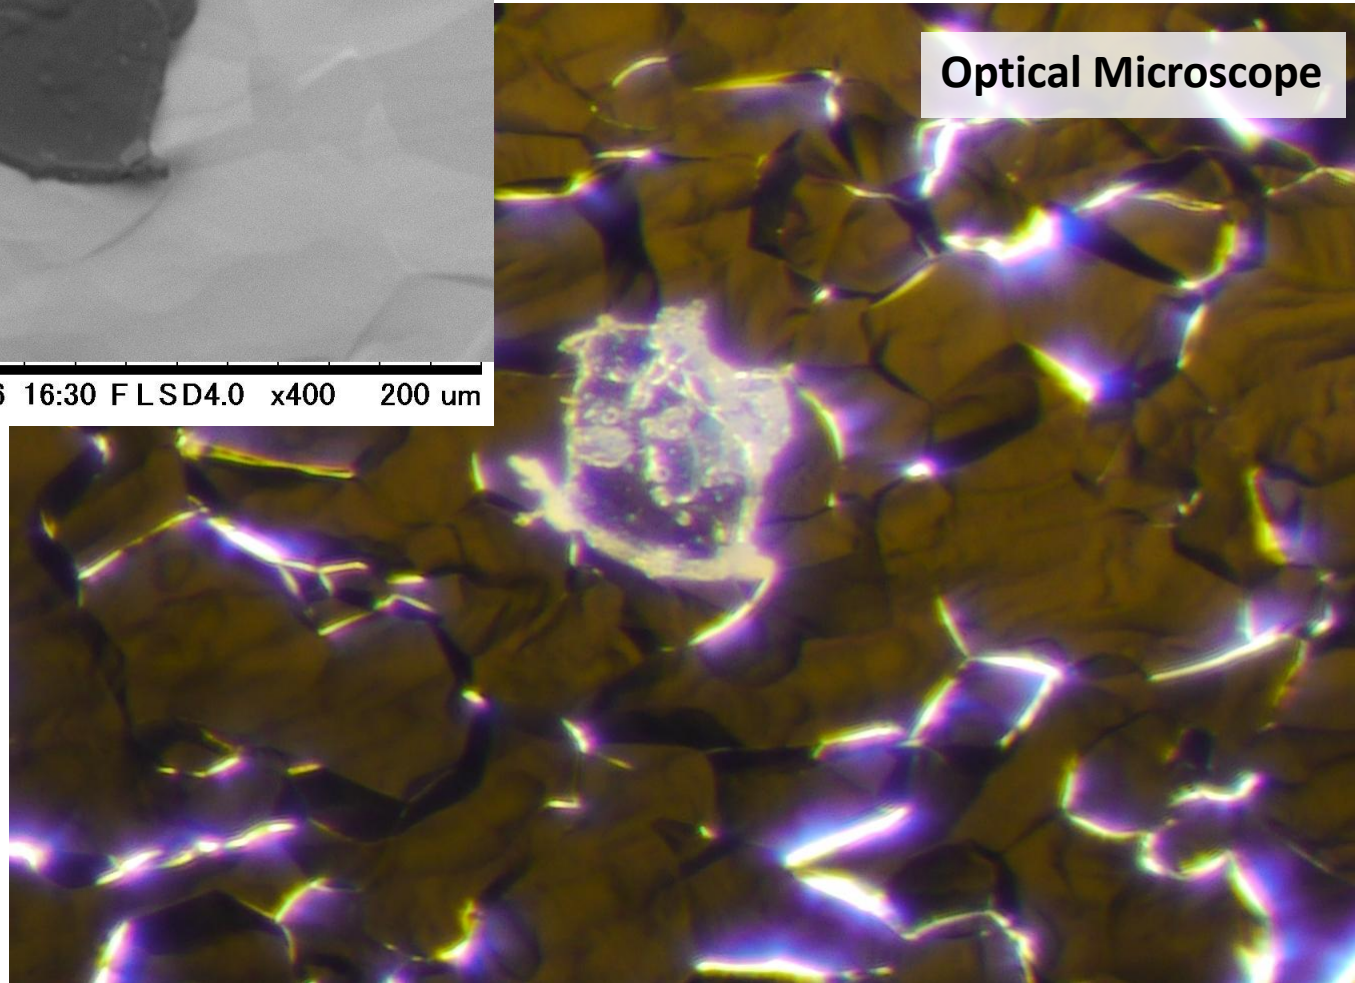
A contaminant is transparent and like a membrane.

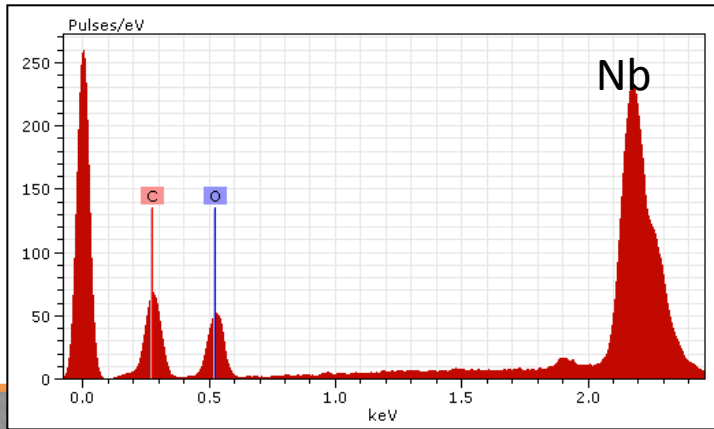
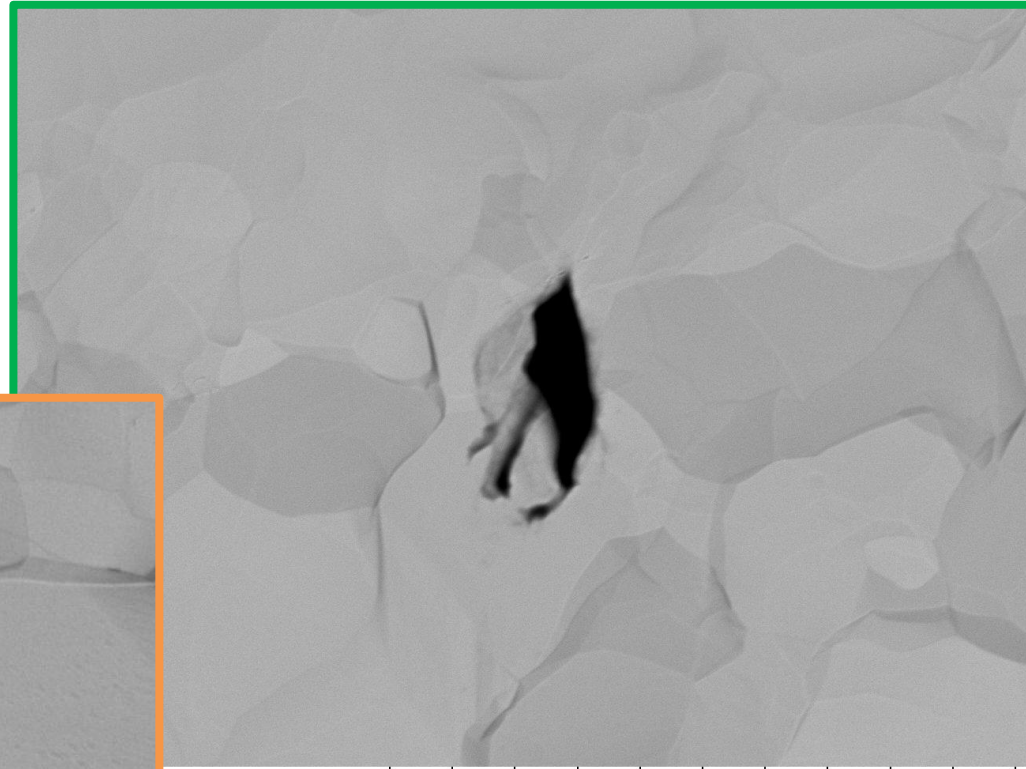
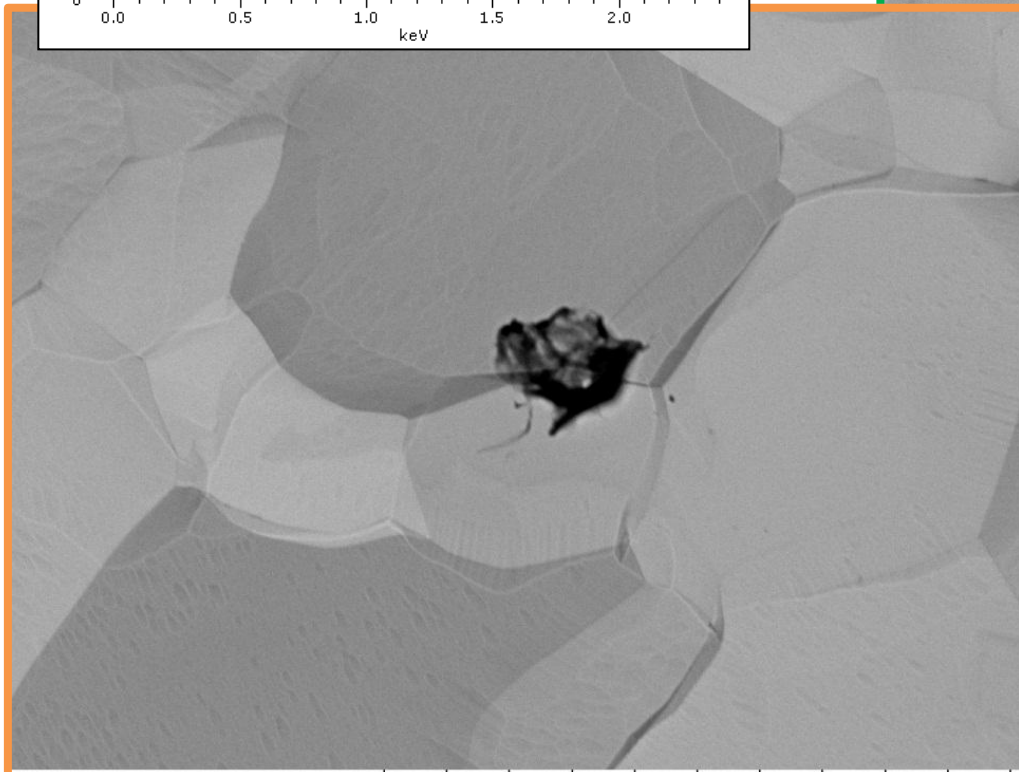
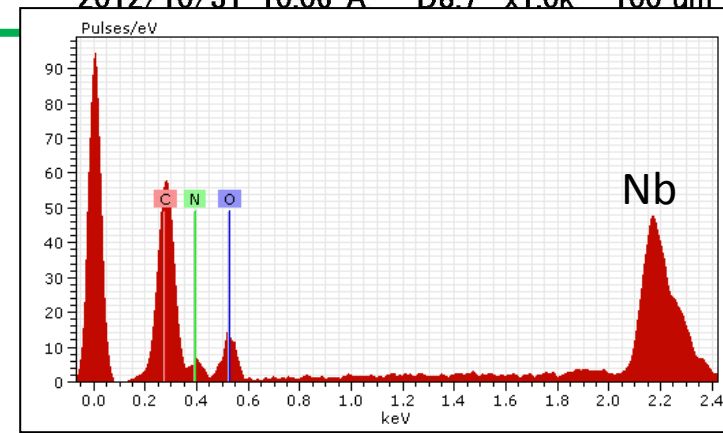
**EDX analysis indicates the contaminants contain “carbon”,
“oxygen” and sometimes “nitrogen”.**

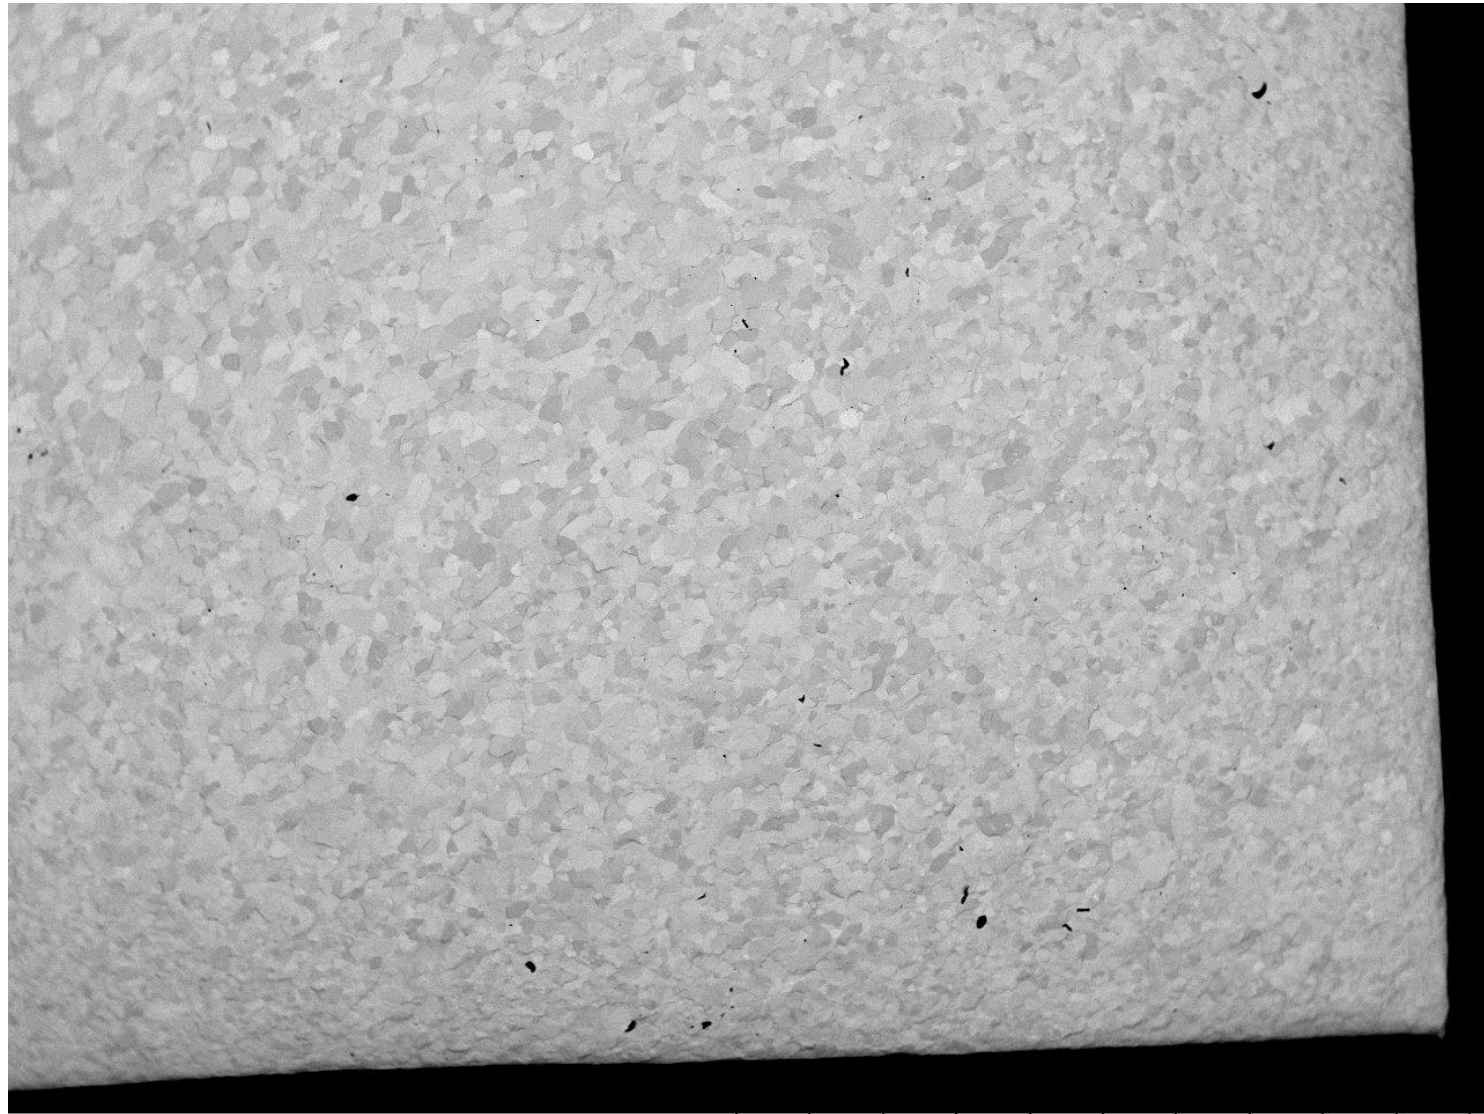
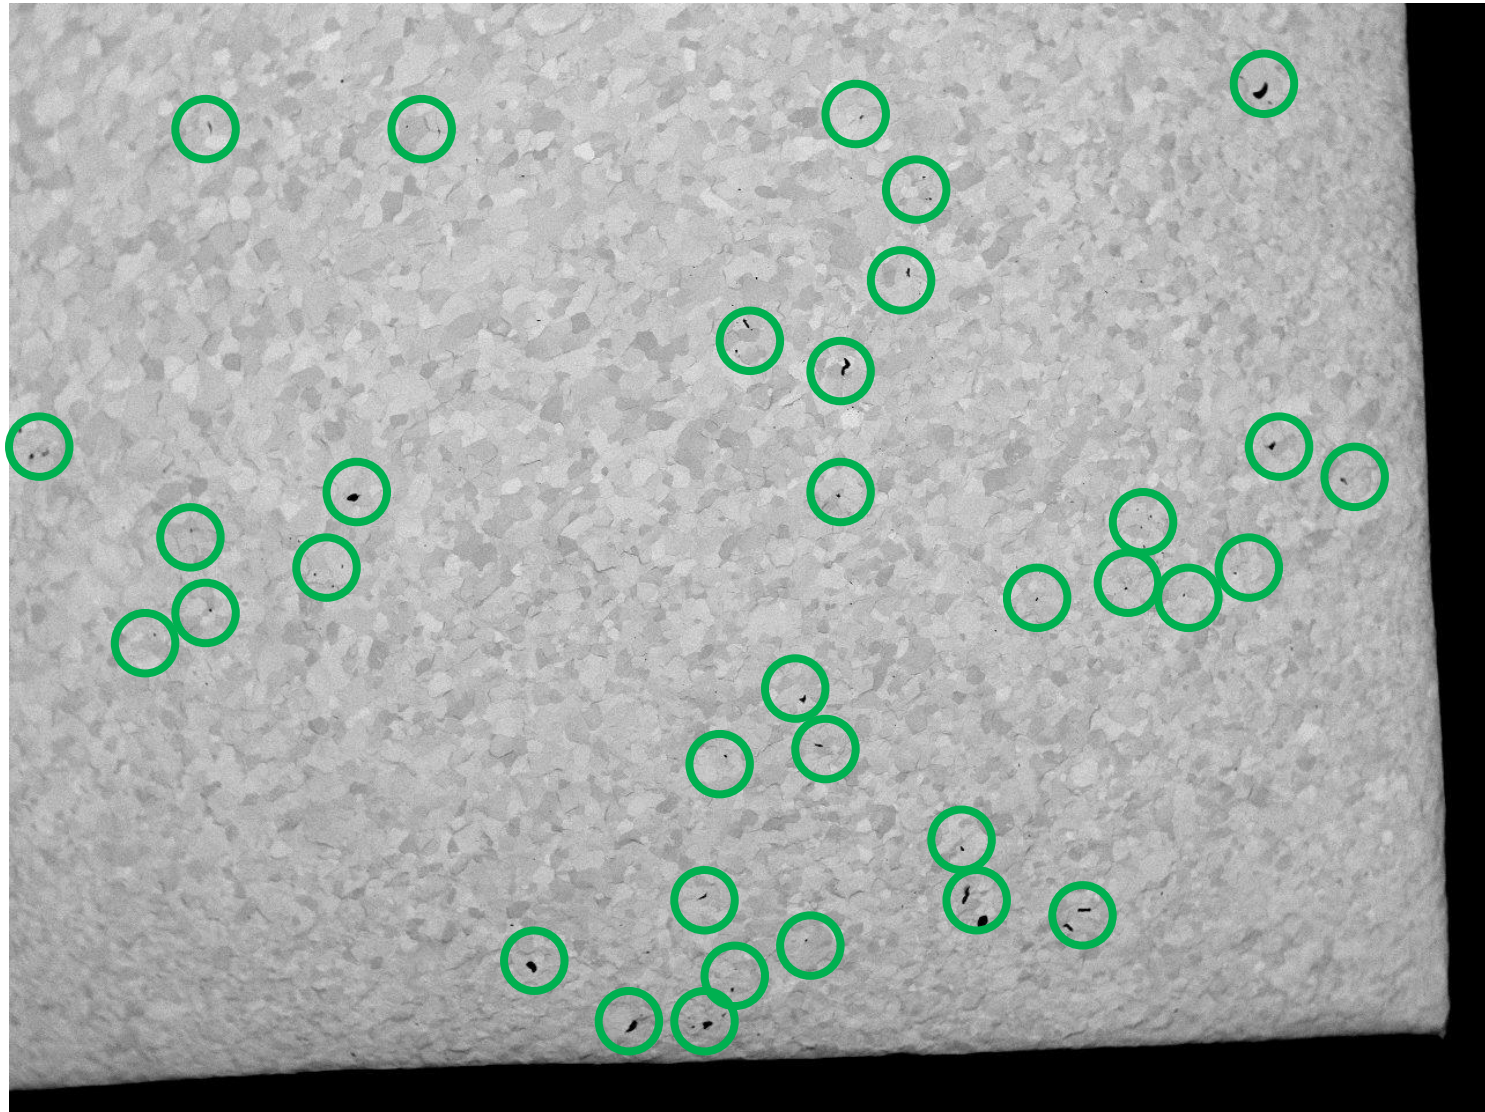
Example of a surface condition just after
BCP + pure water rinsing

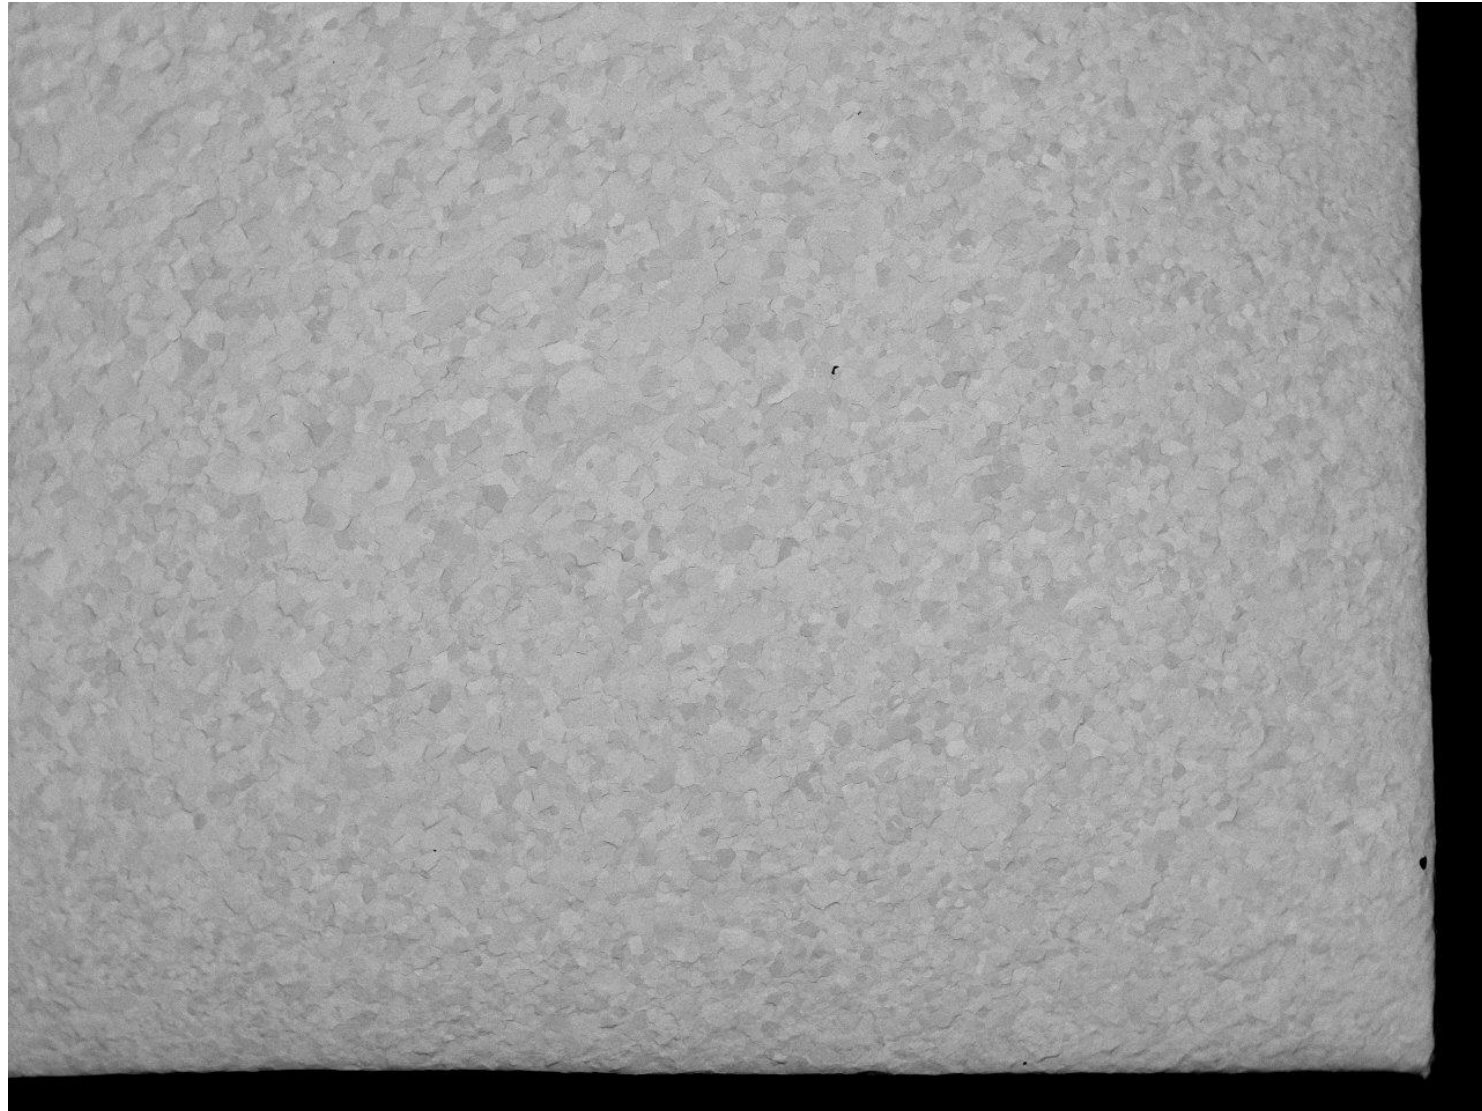
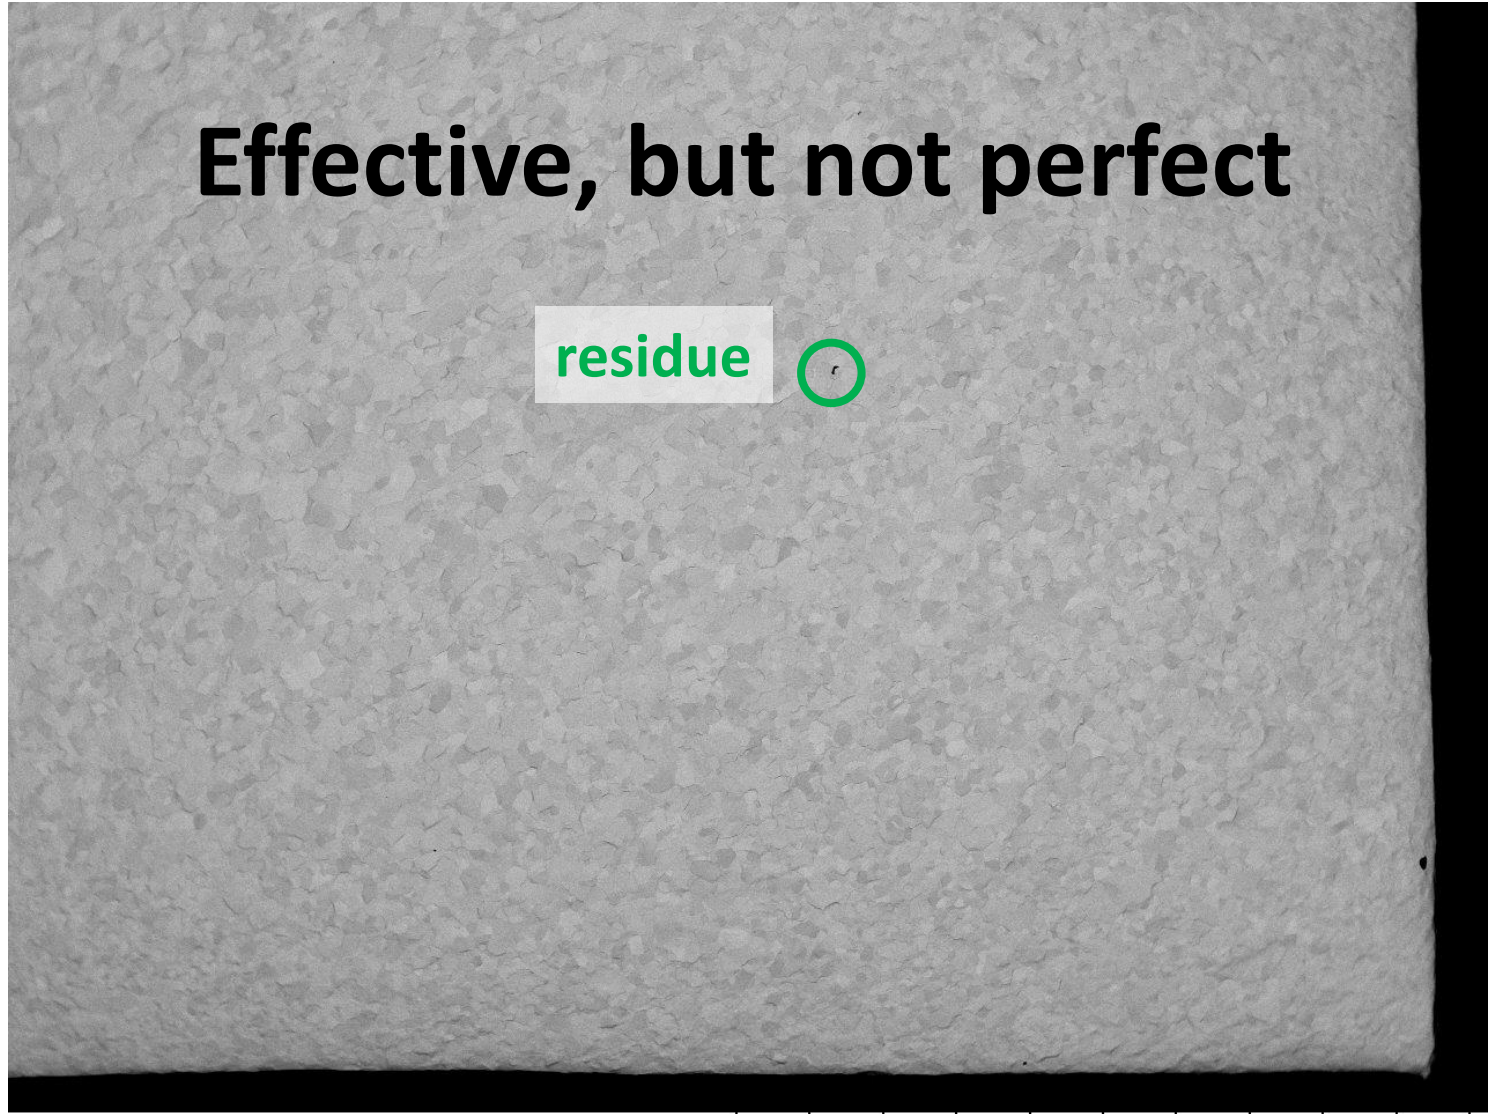
A surface condition just after

Ultrasonic cleansing with FM20 (60min)

Effective, but not perfect

residue

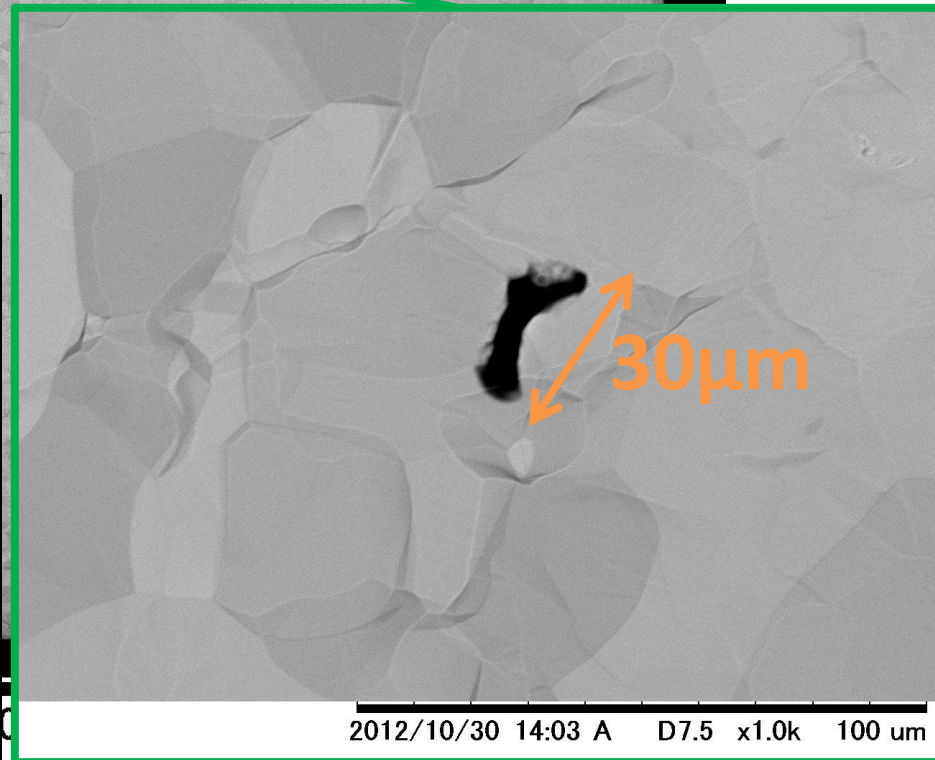
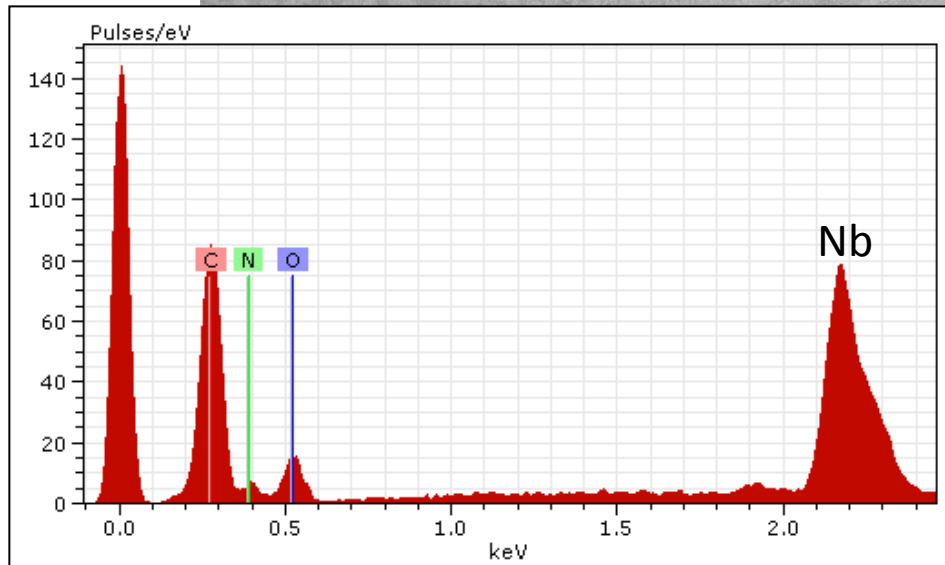
A surface condition just after Ultrasonic cleansing with FM20 (60min)

Effective, but not perfect

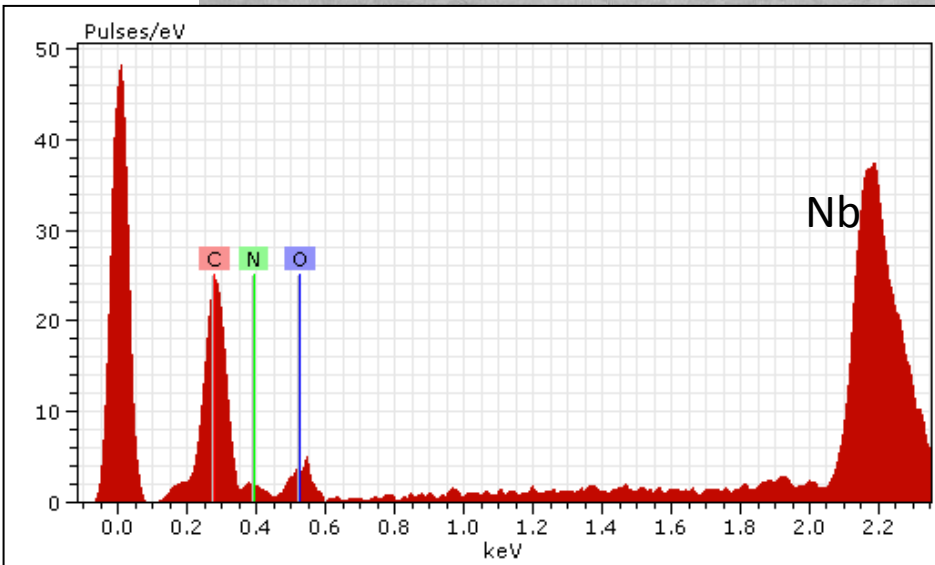
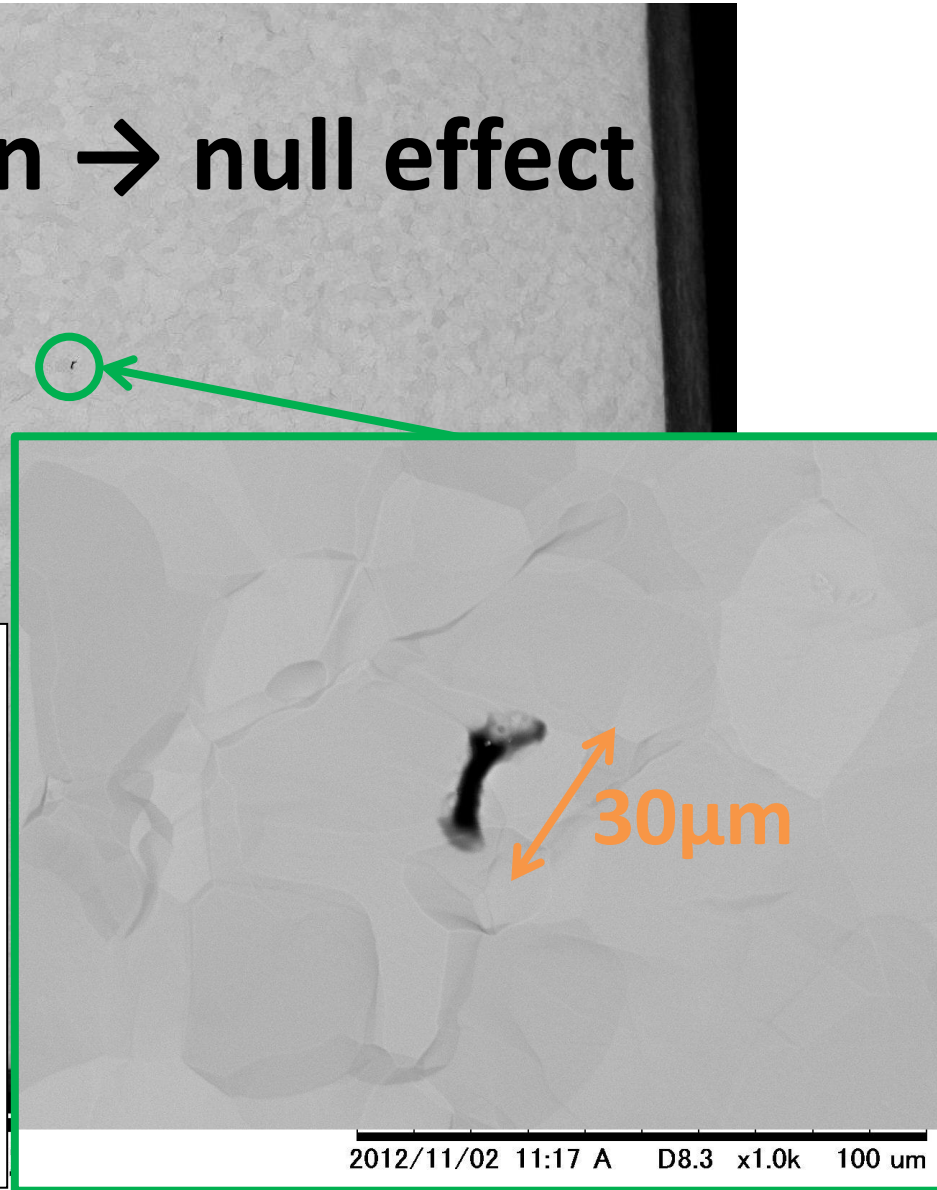
A surface condition just after
Ultrasonic cleansing with FM20 (165min)

Additional 105 min → null effect

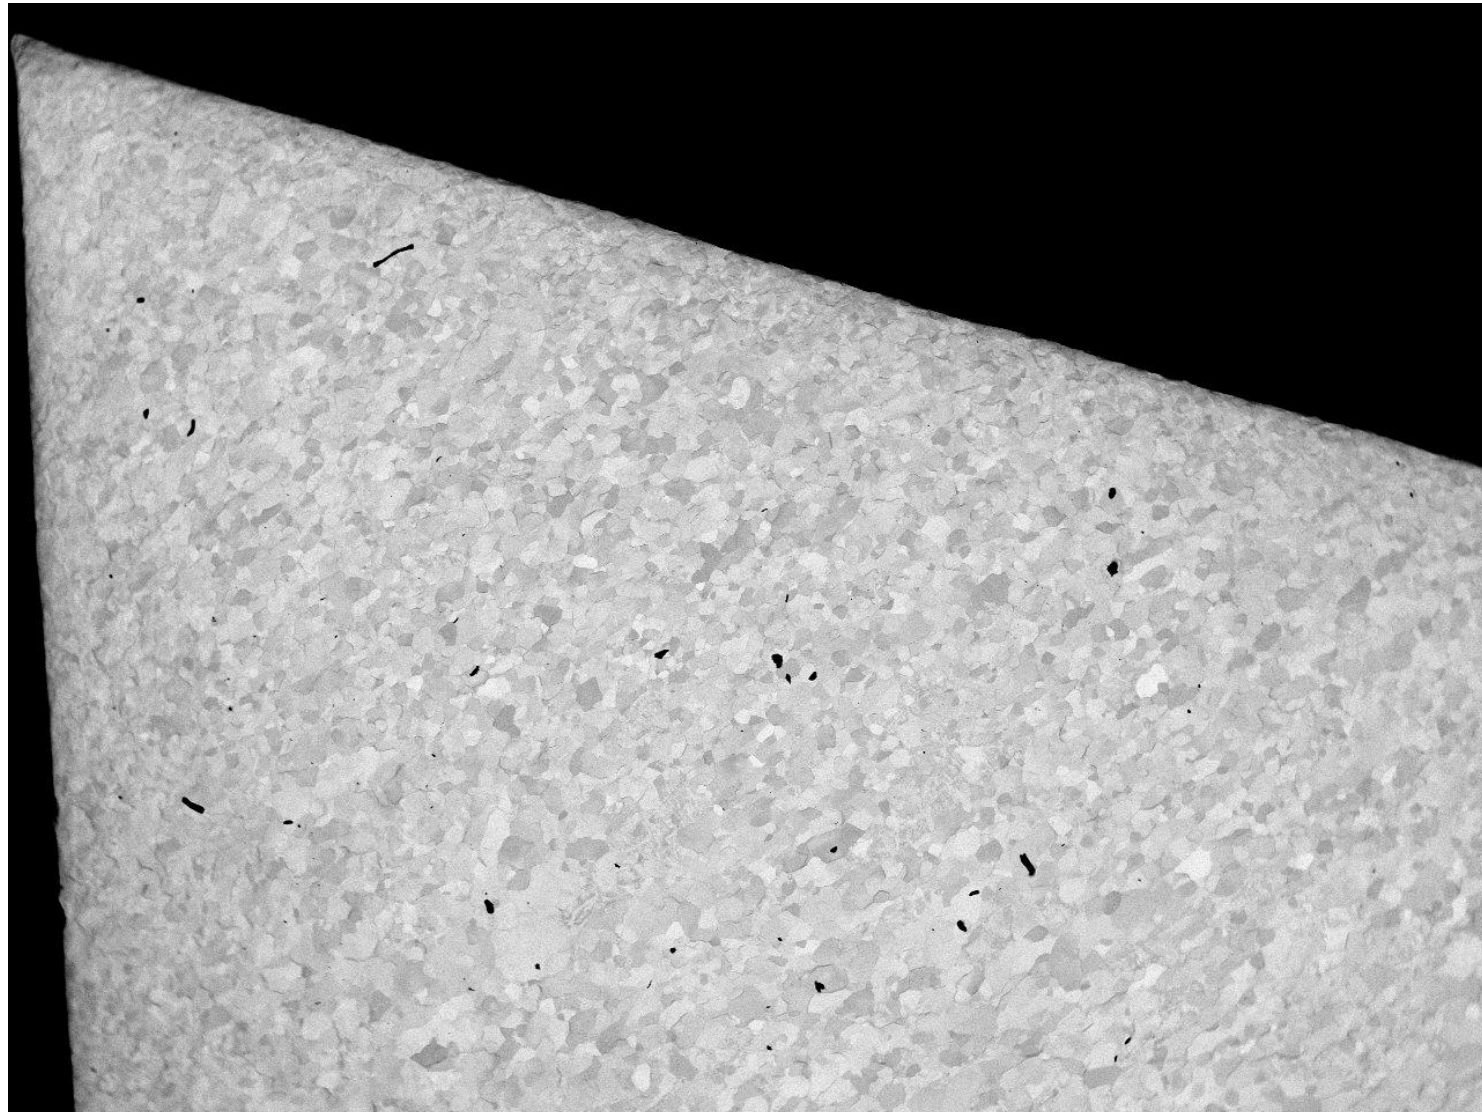
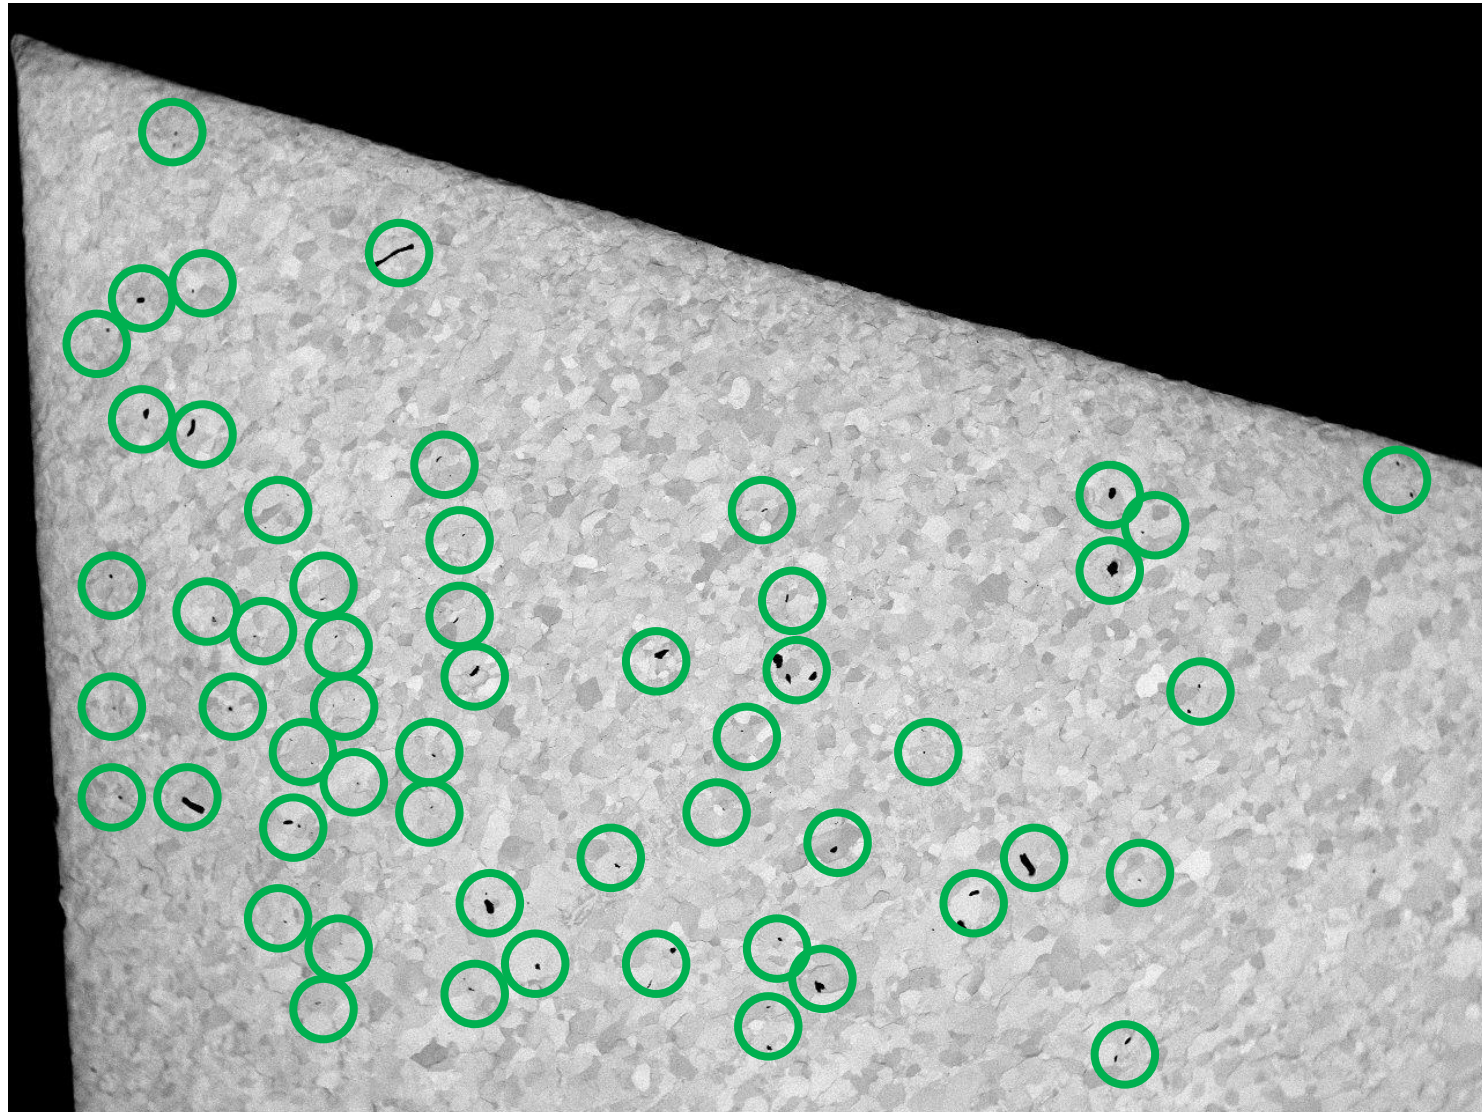
Example of a surface condition just after
BCP + pure water rinsing (Before H_2O_2 with UV)

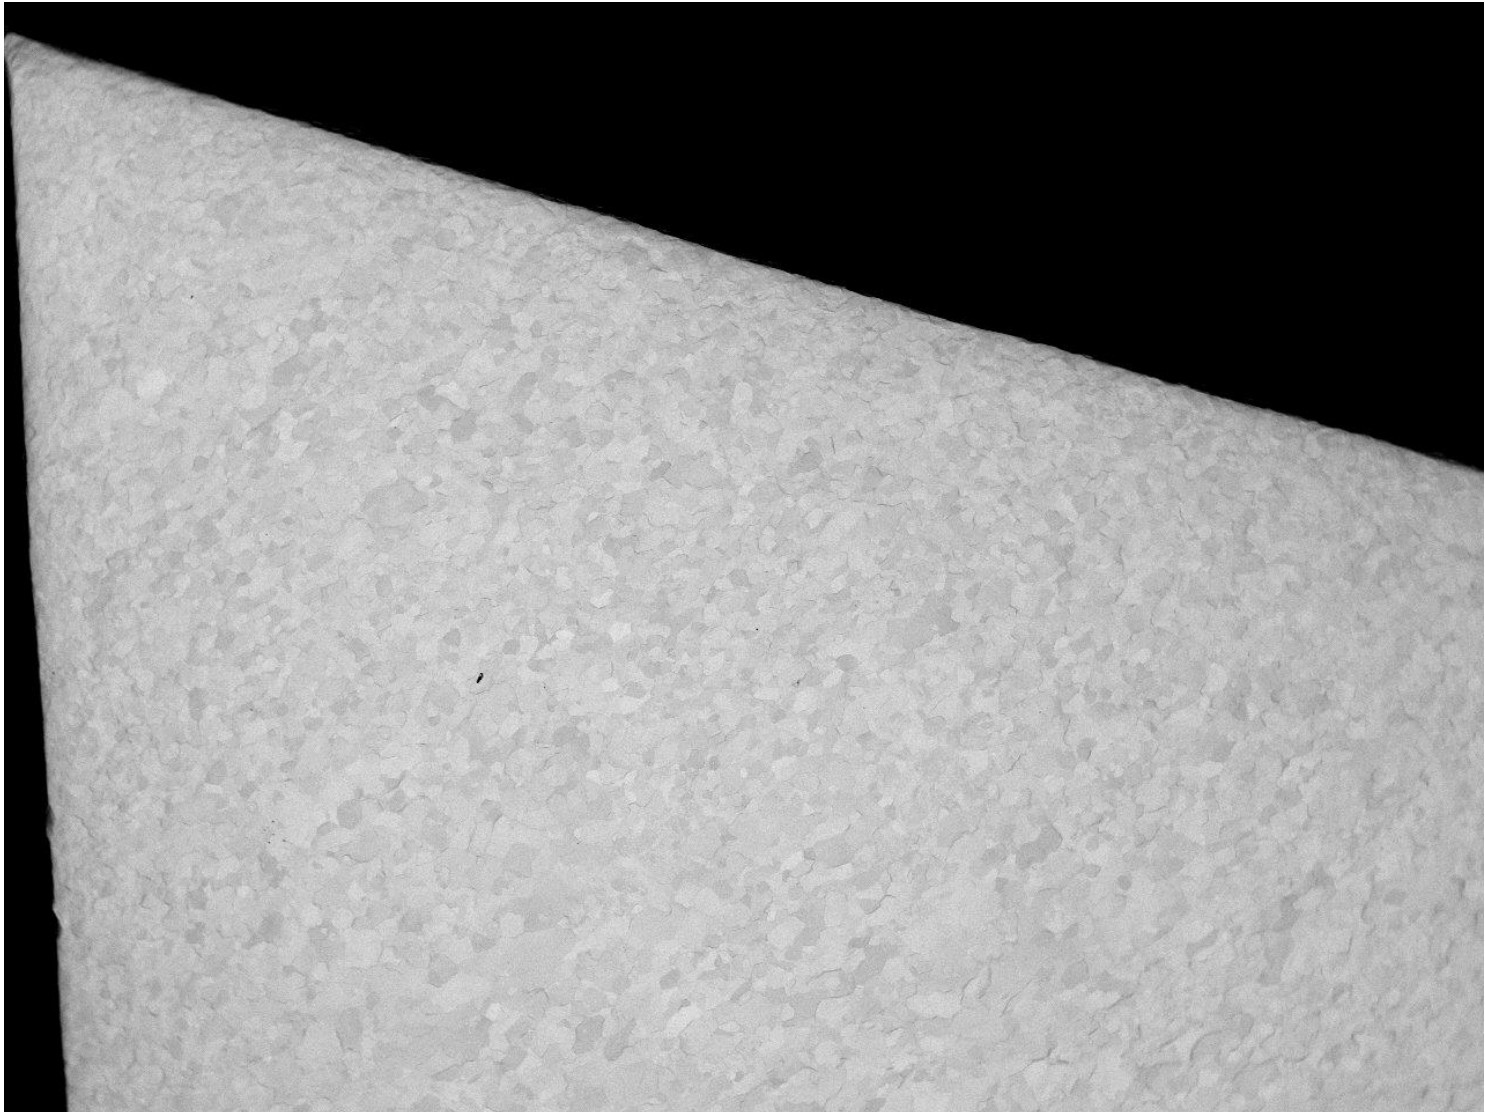
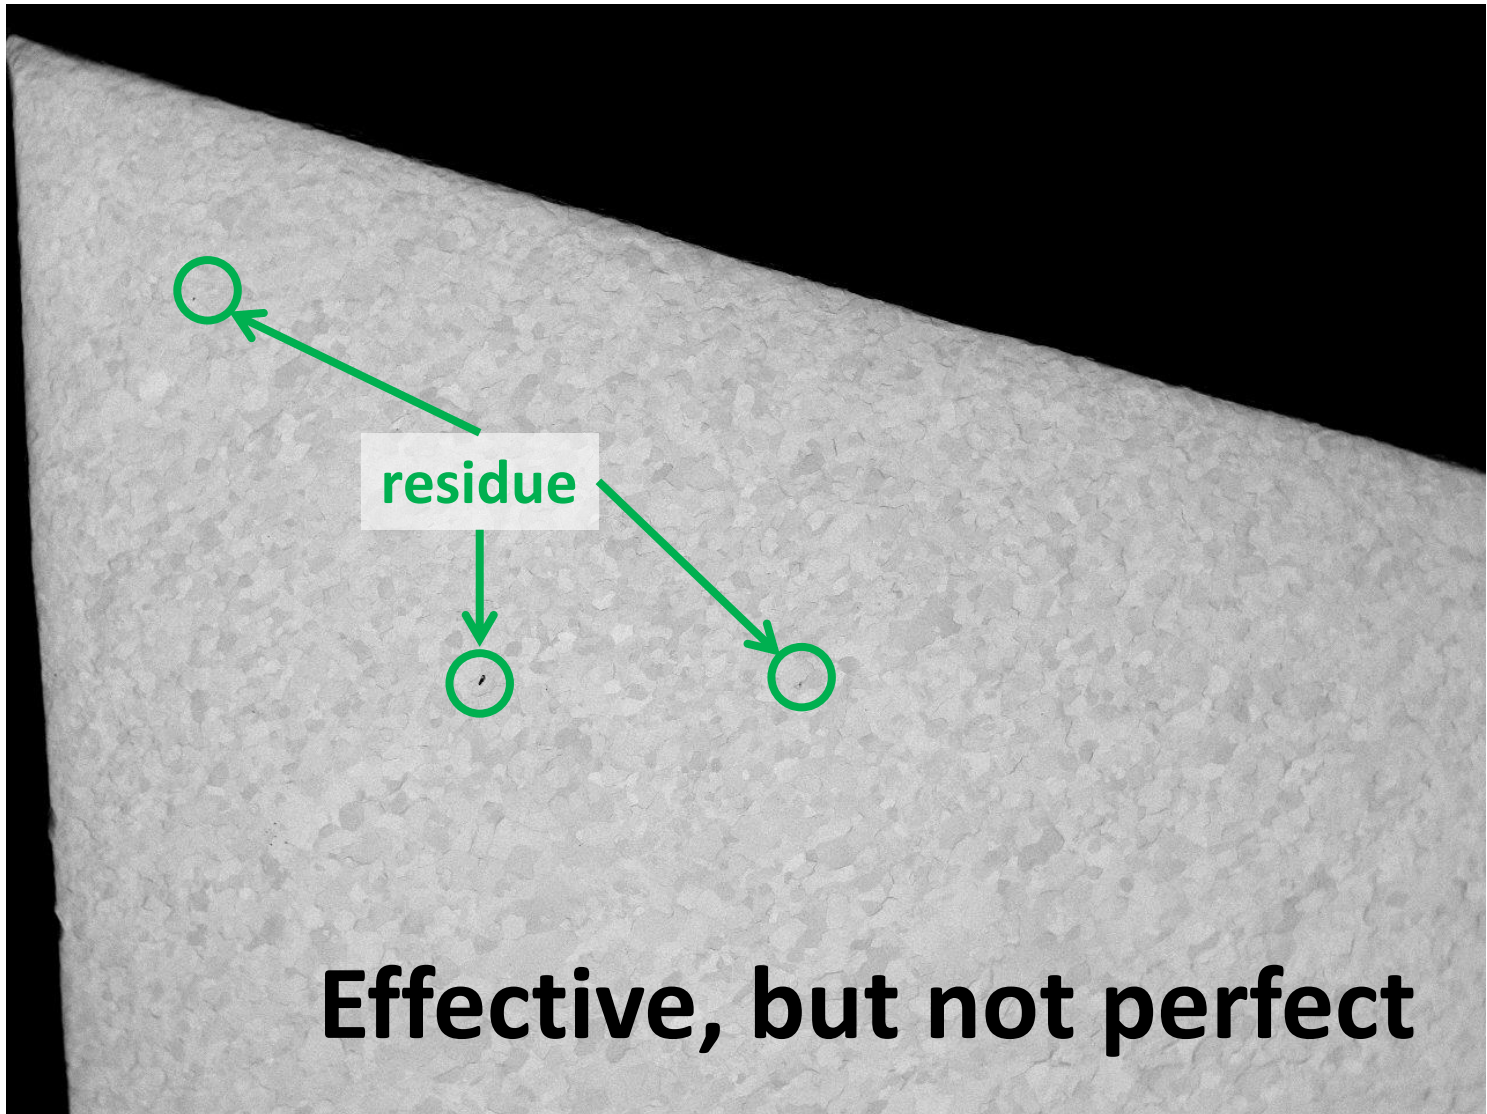
Example of a surface condition just after
decomposition by H_2O_2 with UV irradiation (50min)

Effective, but not perfect
