Condition of electron beam welding toward a high gradient application

**TESLA Technology Collaboration (TTC) Meeting
November 6, 2012, Thomas Jefferson National Accelerator Facility**

KEK

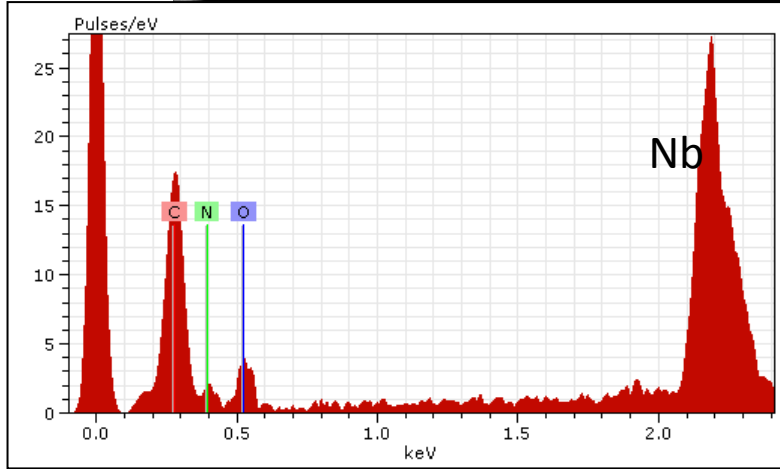
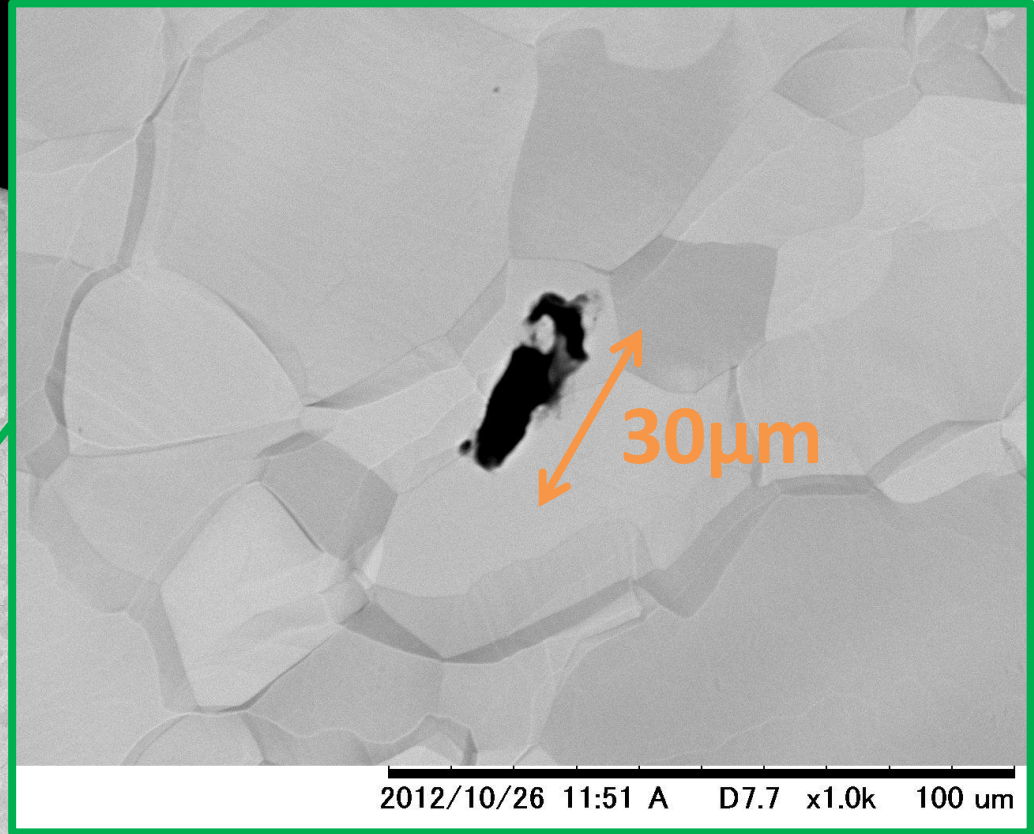
Example of a surface condition just after decomposition by H_2O_2 with UV irradiation (50min)

Effective, but not perfect

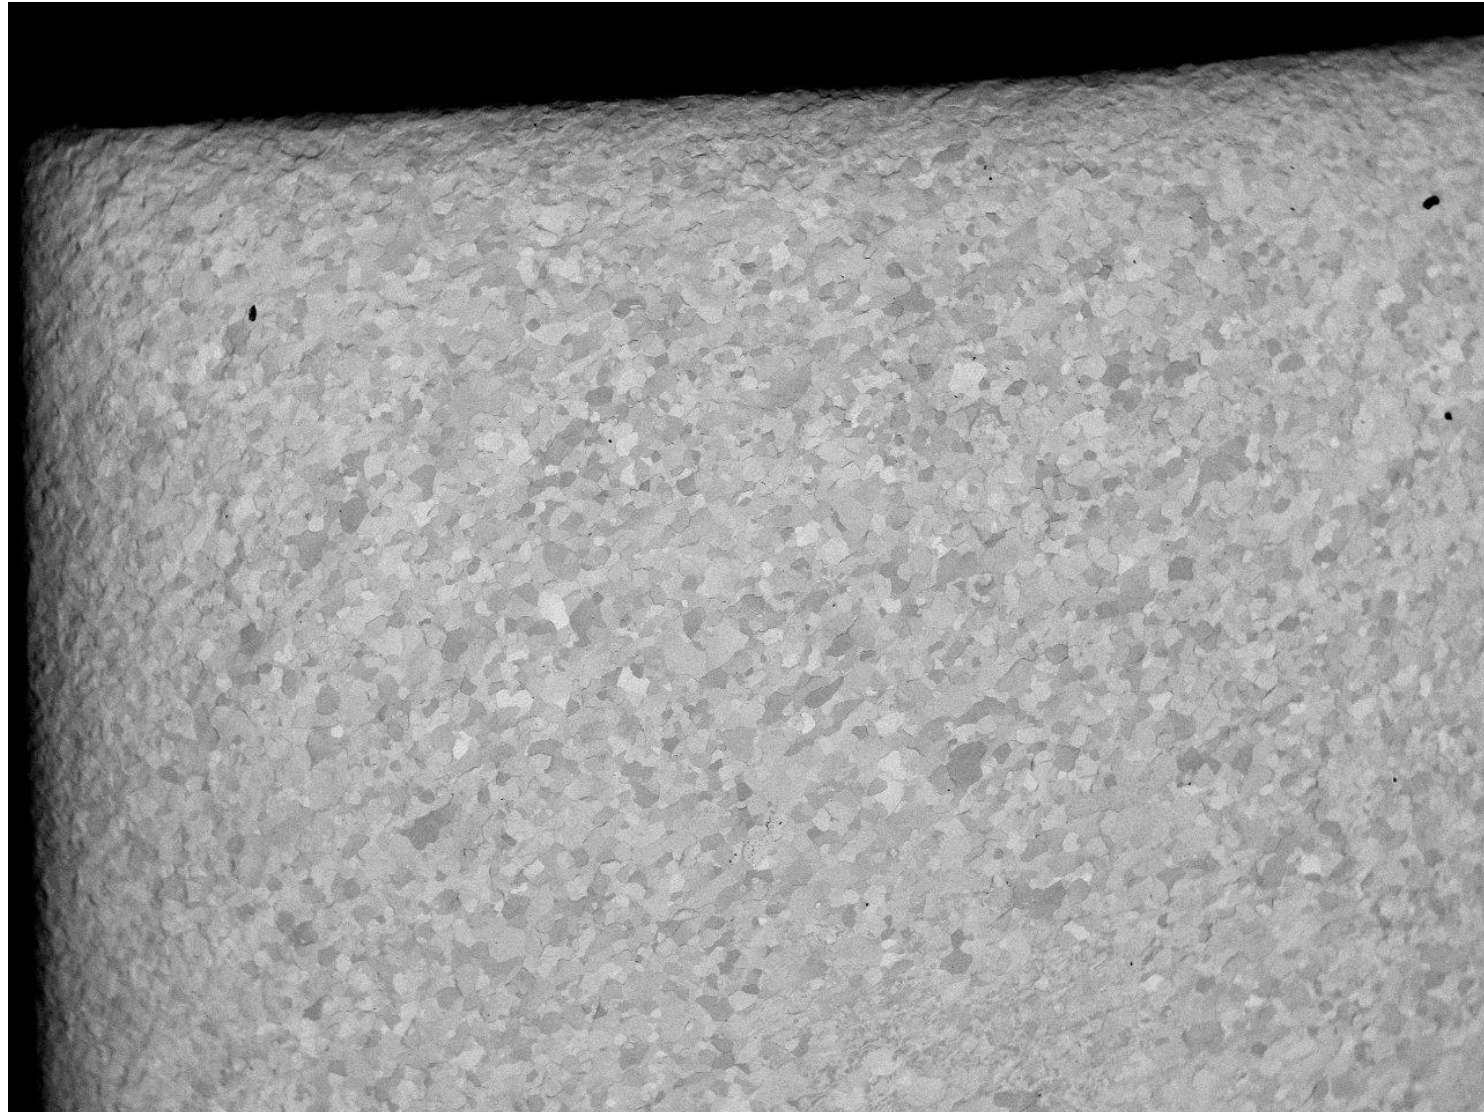
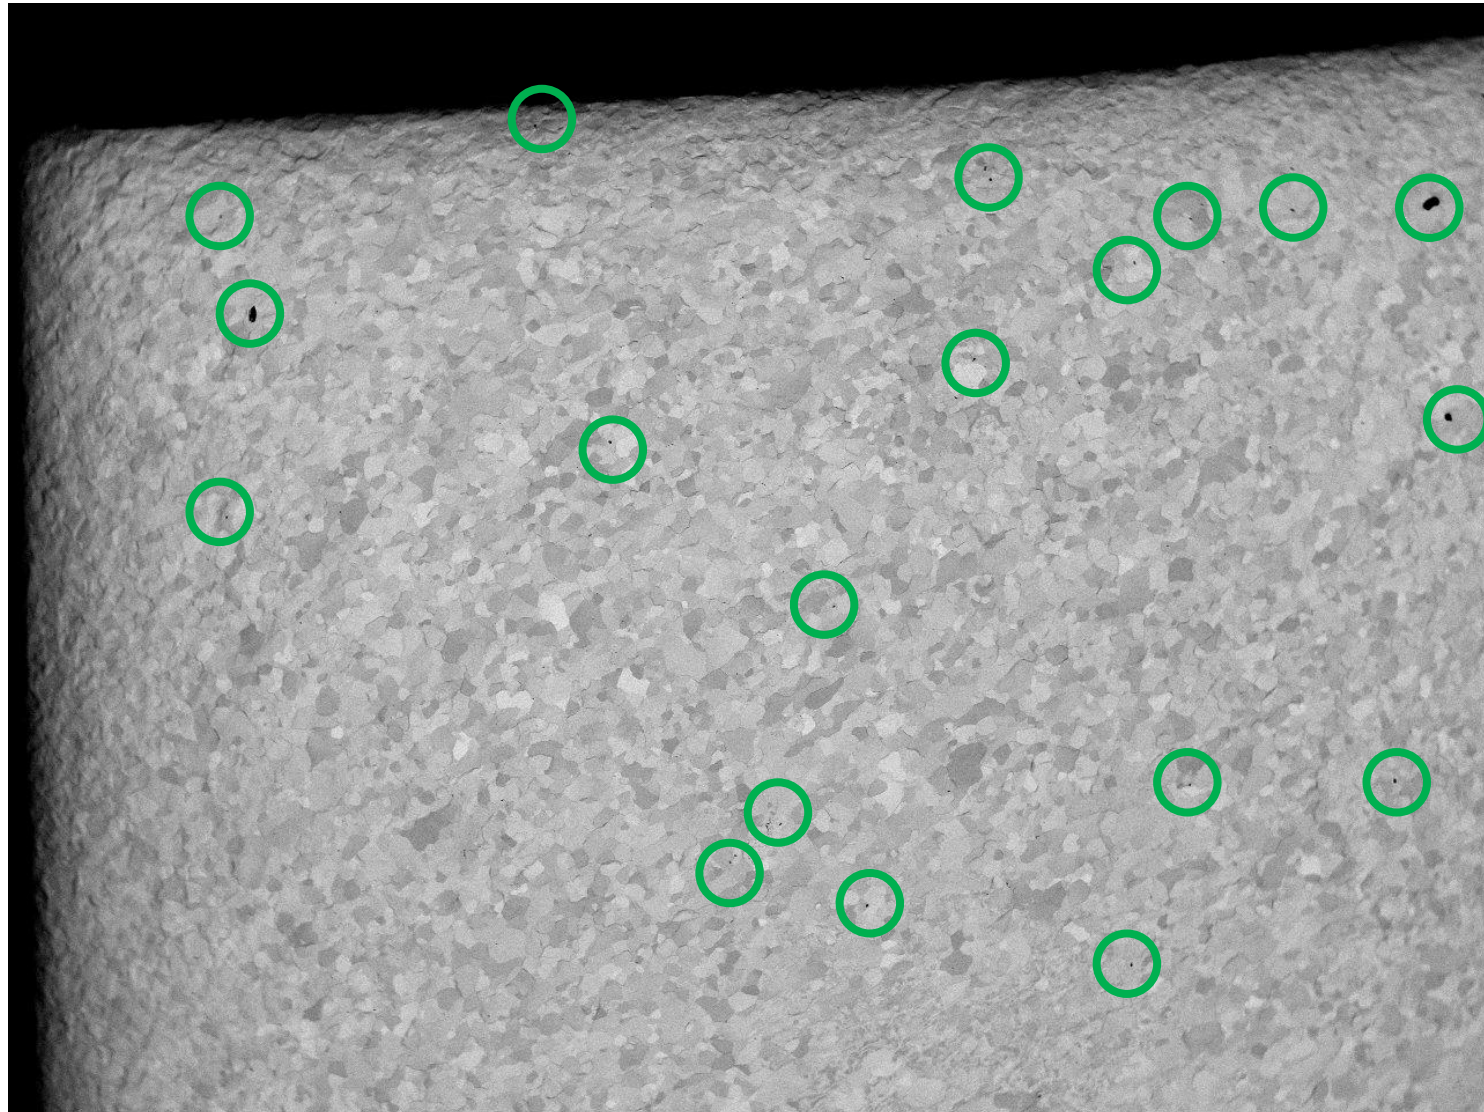
Example of a surface condition just after
BCP + pure water rinsing

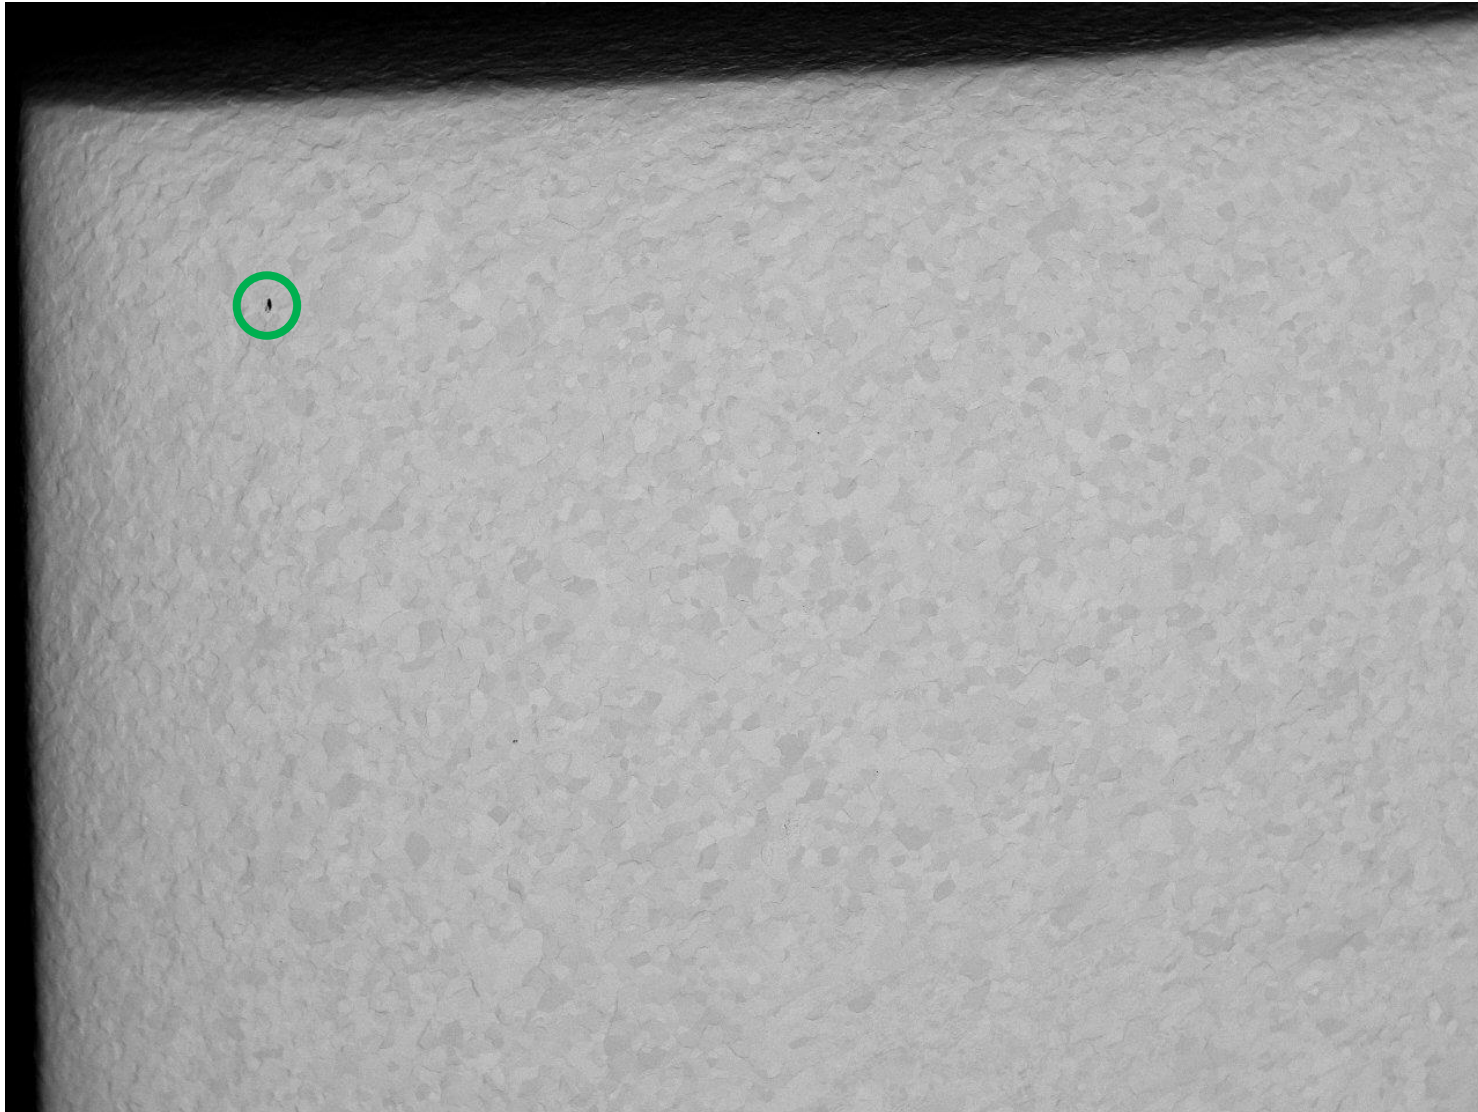
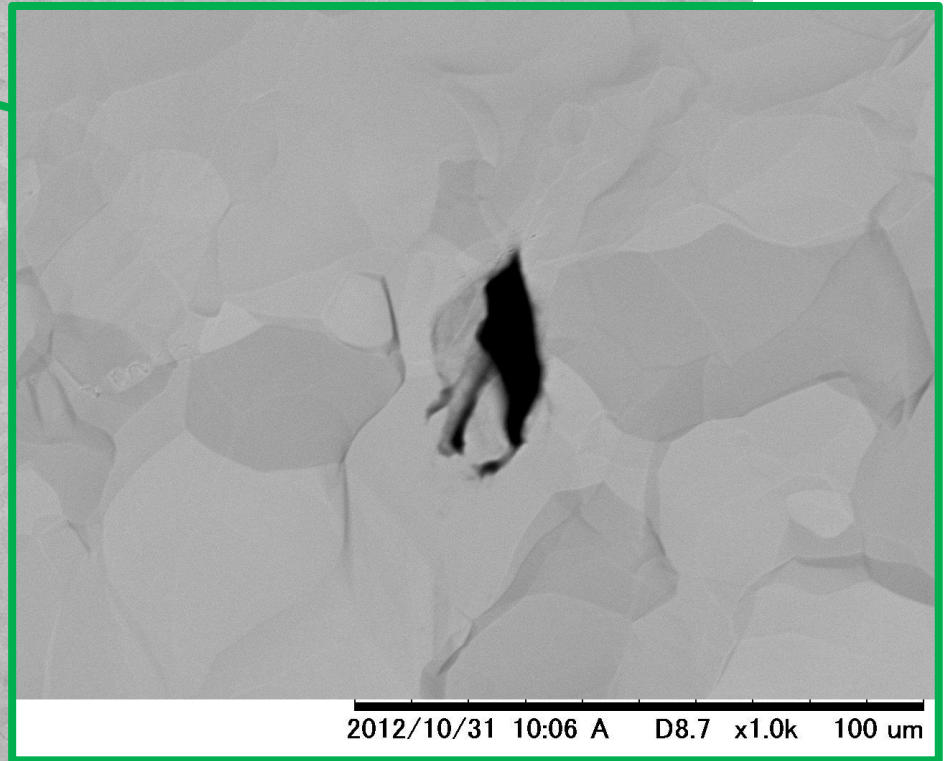
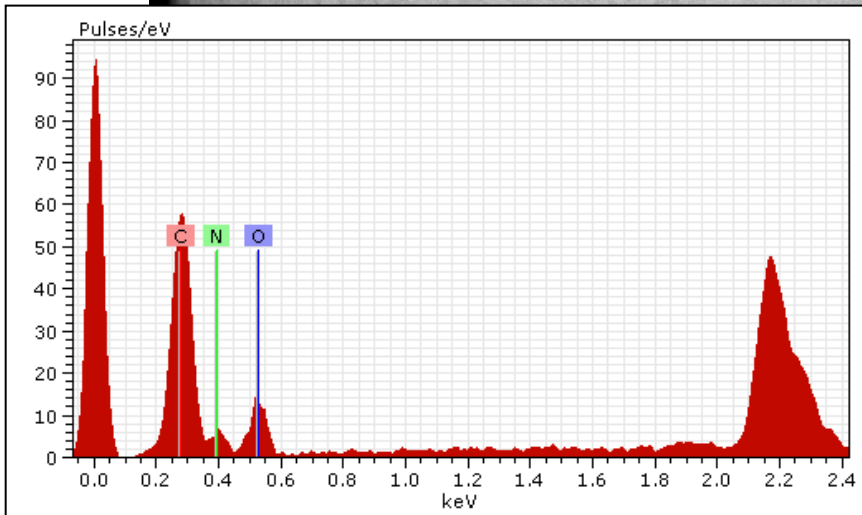
A surface condition just after
Ultrasonic cleansing with FM20 (60min)

A surface condition just after Ultrasonic cleansing with FM20 (60min)

Effective, but not perfect

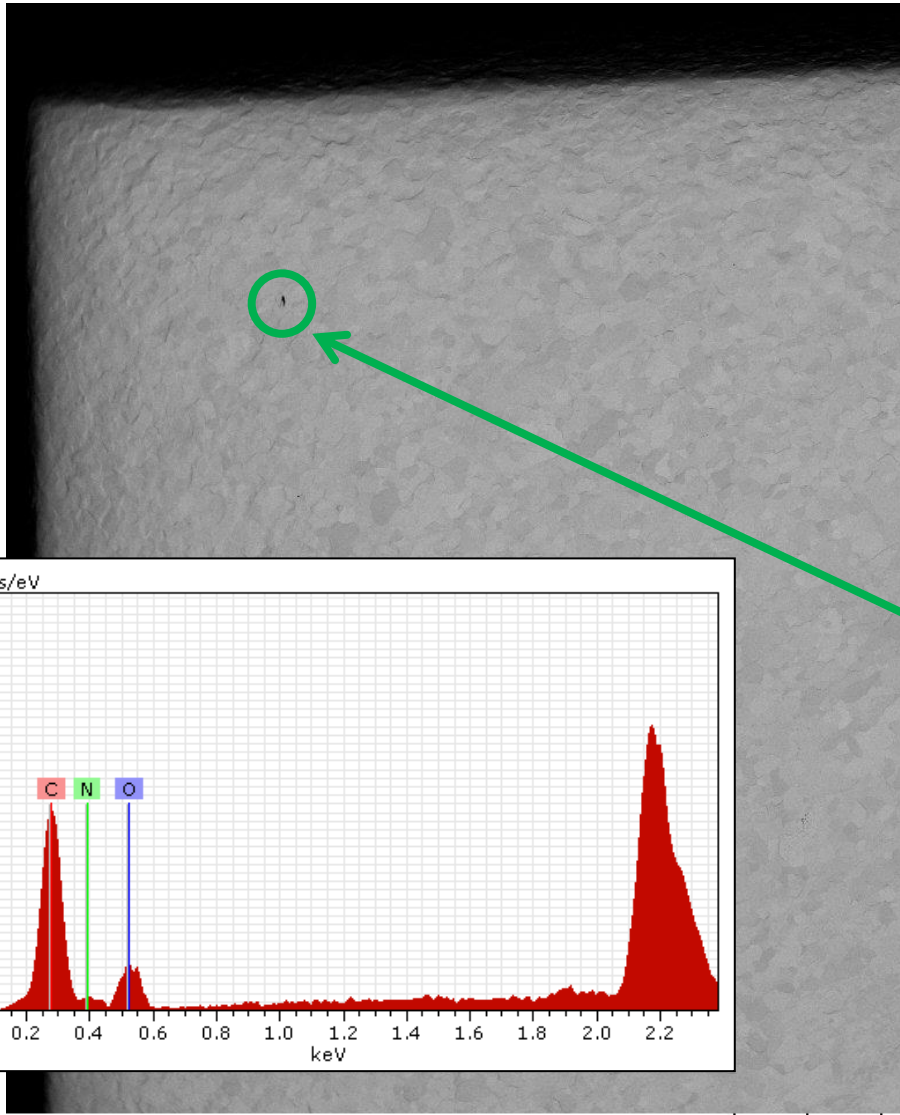
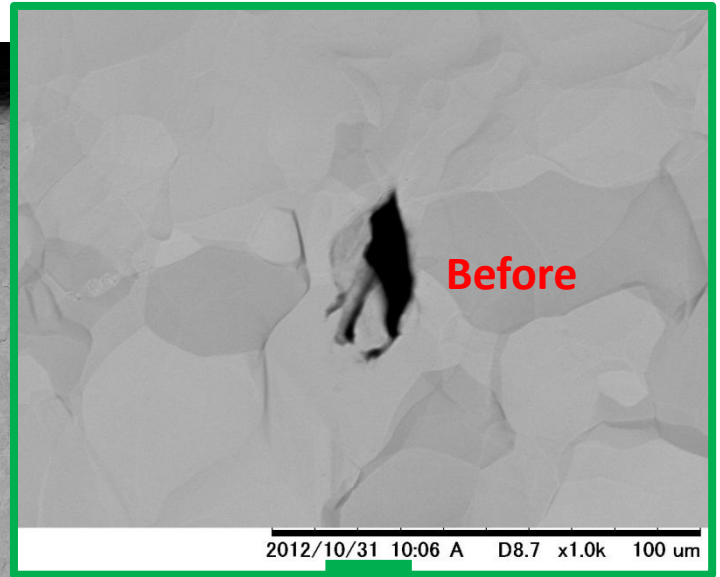
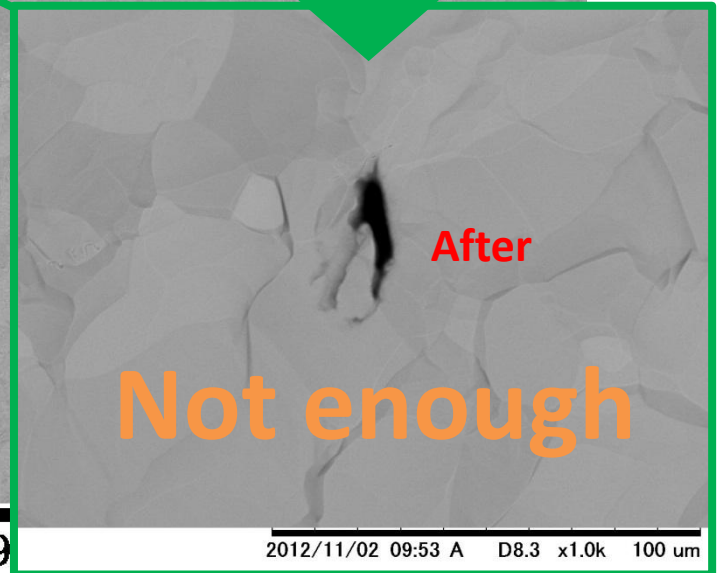
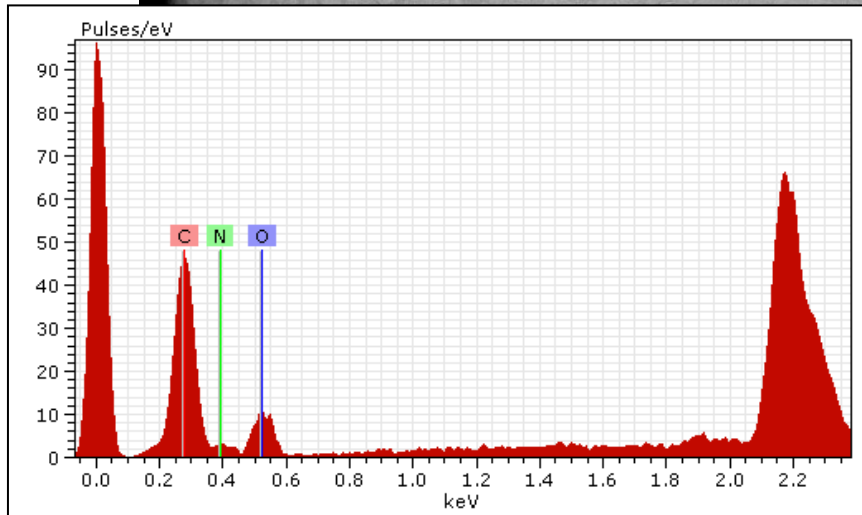
A surface condition just after

H₂O₂ with UV (60min) in addition to Ultrasonic cleansing with FM20 (60min)

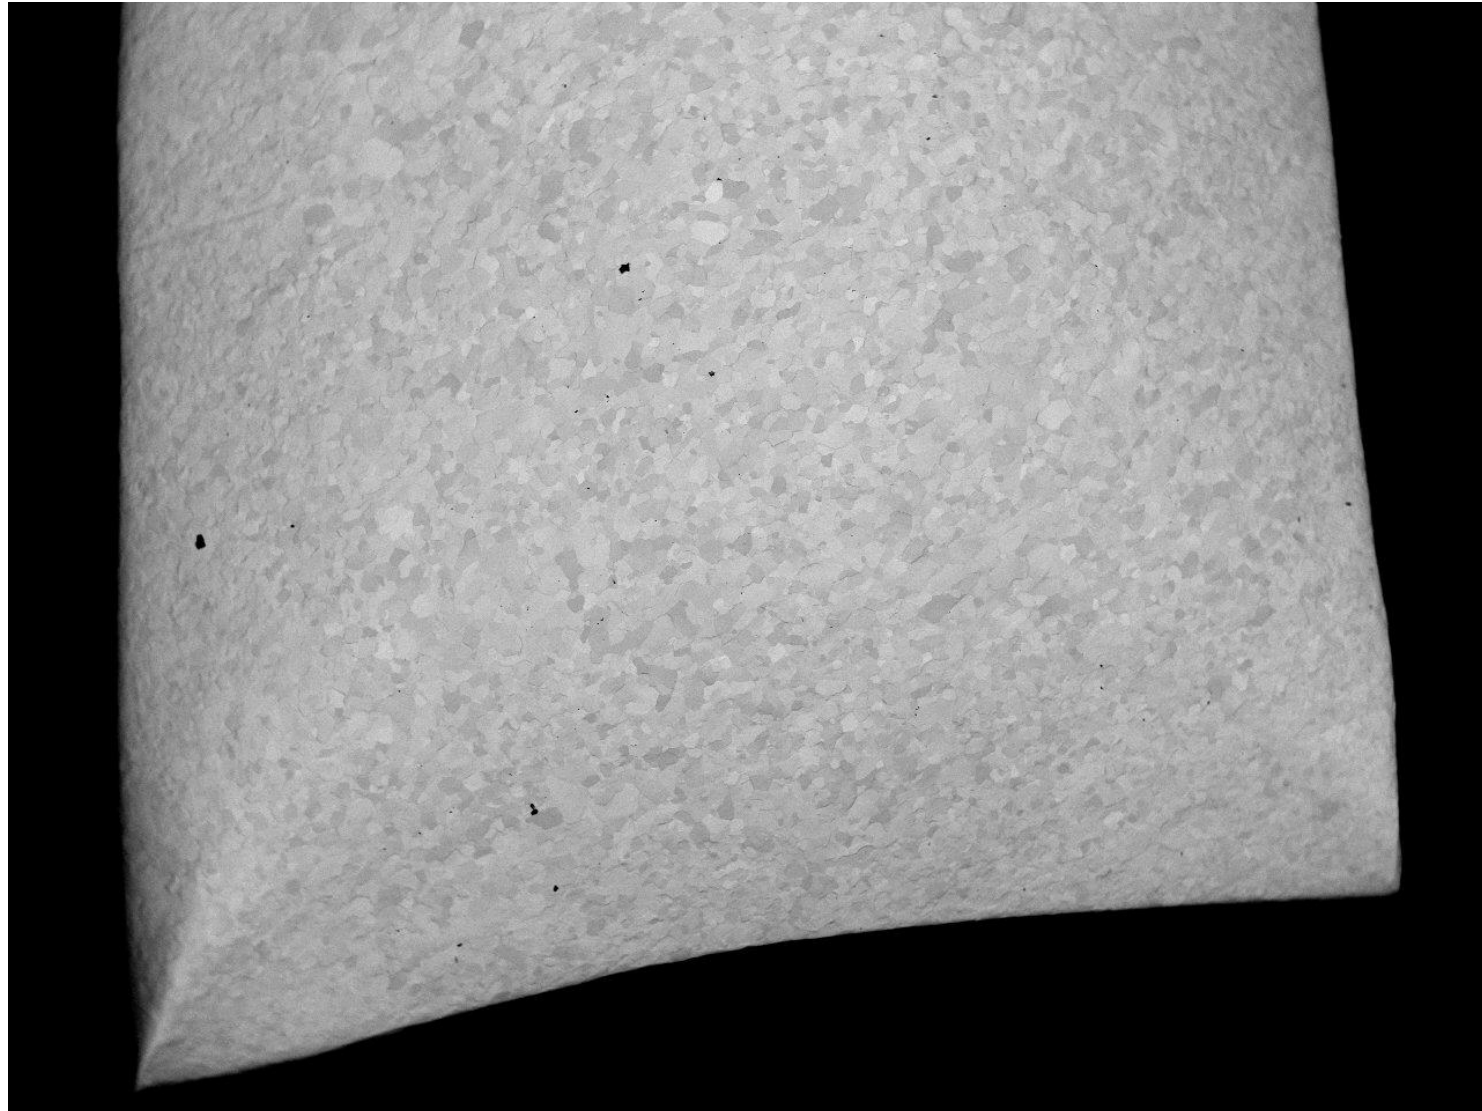
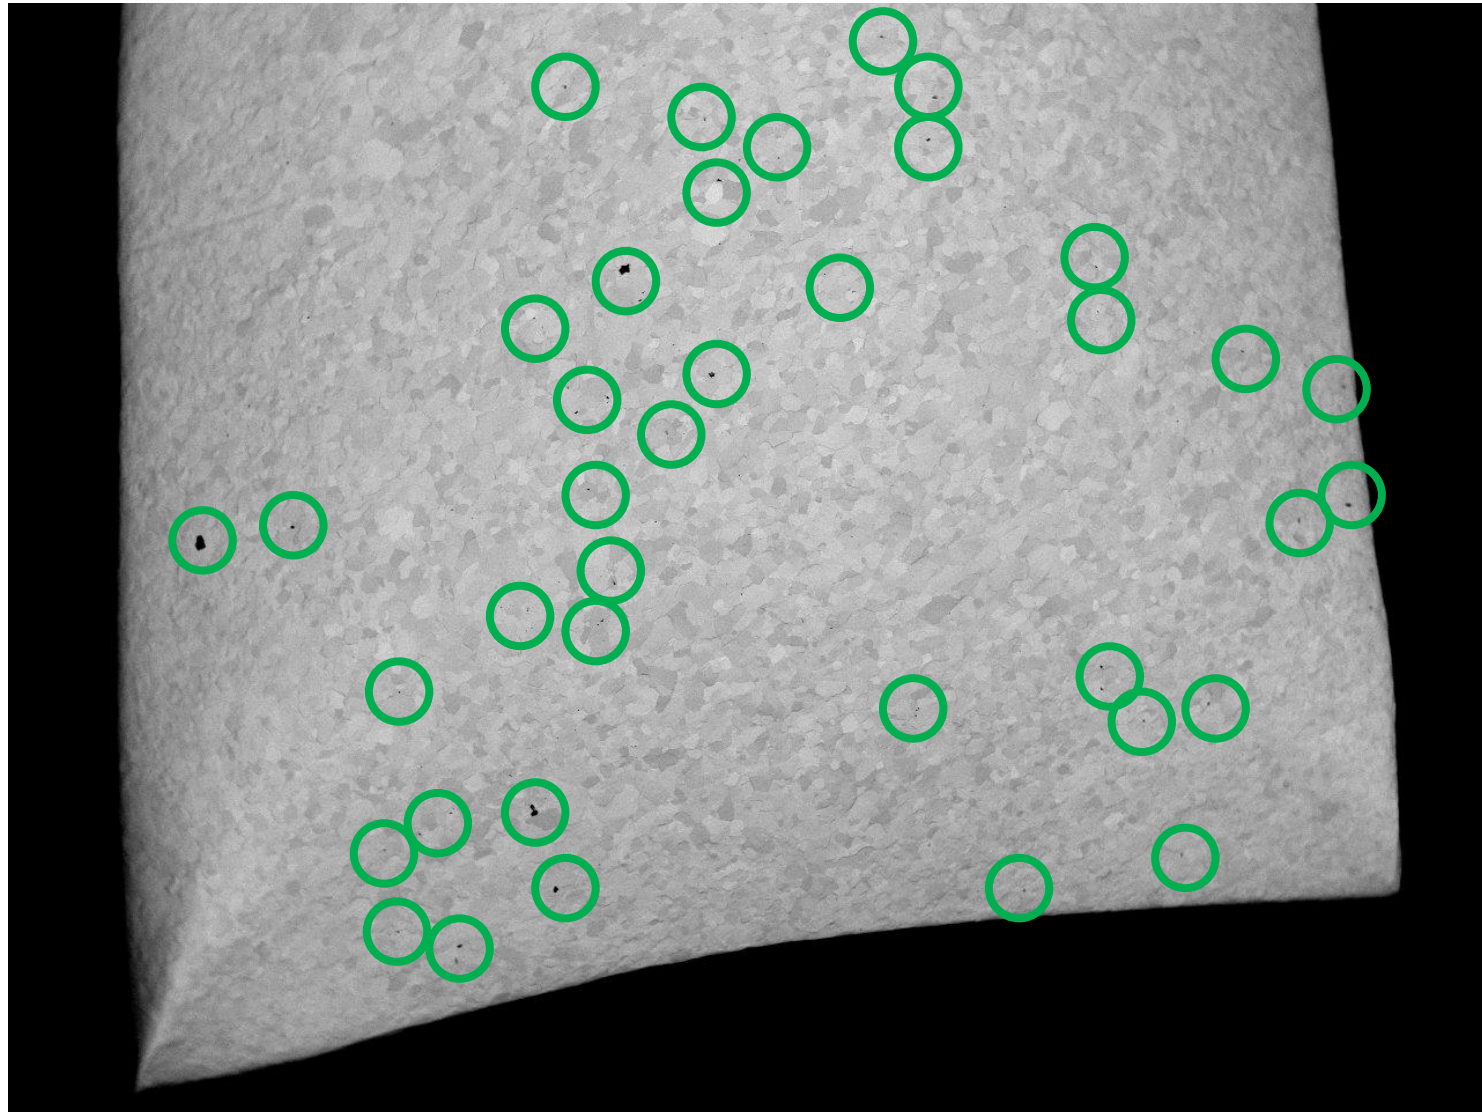
A surface condition just after
BCP + pure water rinsing

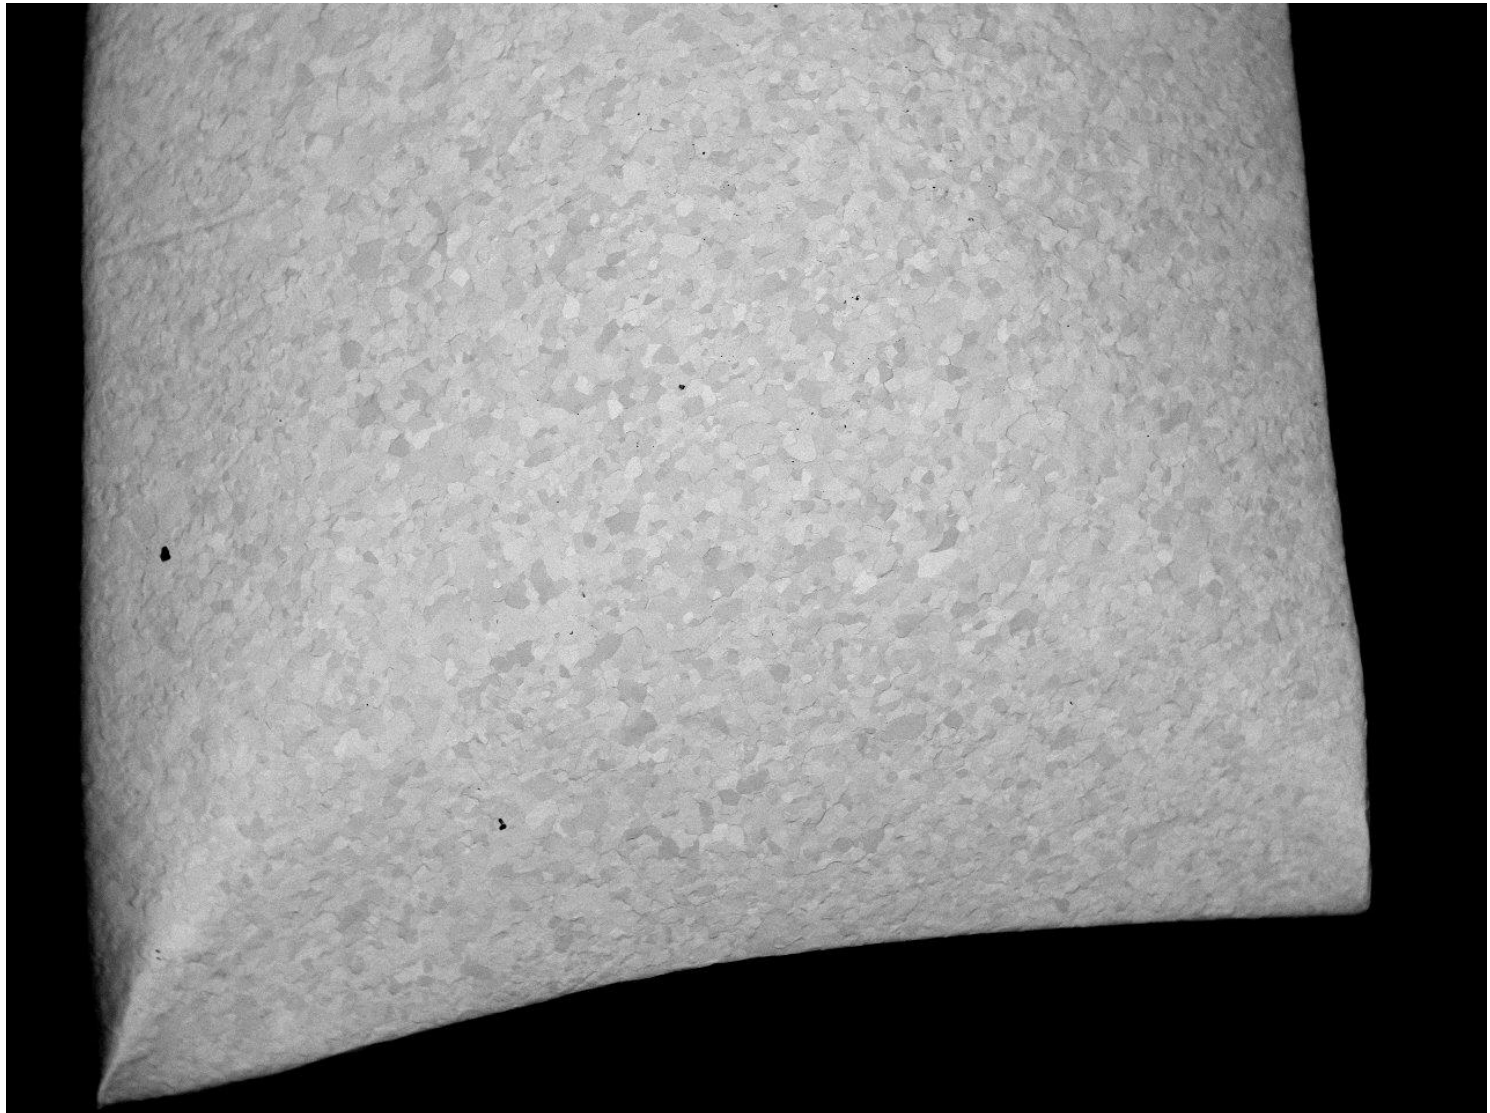
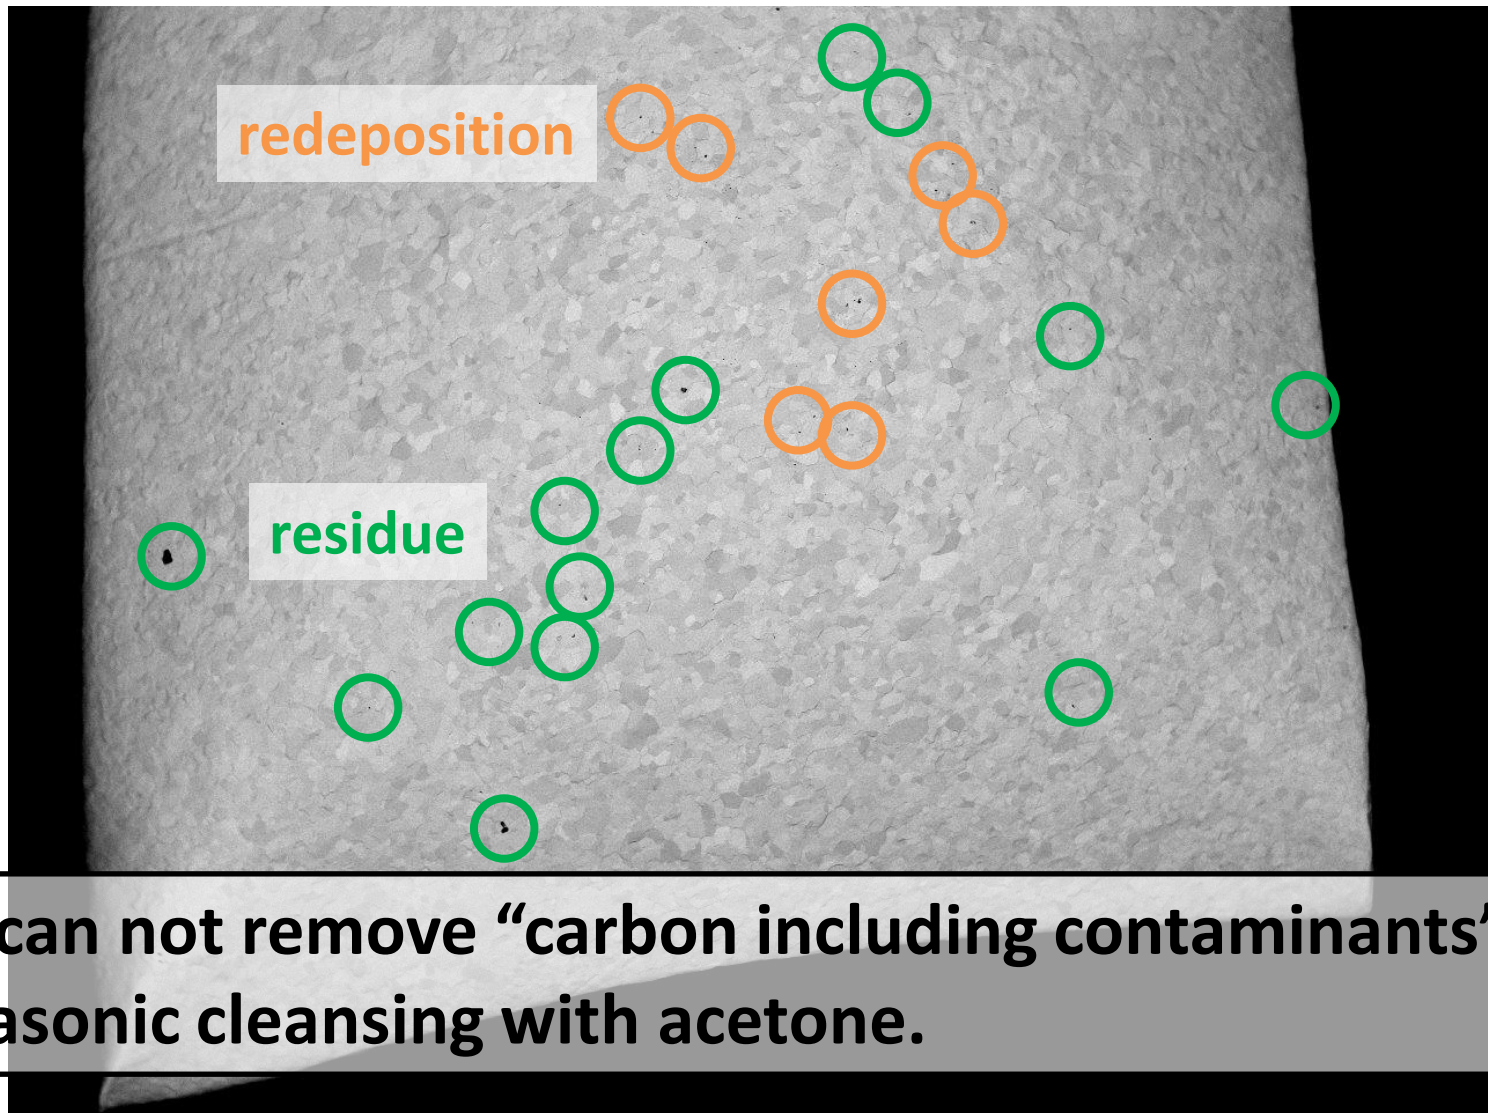
A surface condition just after

Ultrasonic cleansing with Acetone (35min)

We can not remove “carbon including contaminants” by ultrasonic cleansing with acetone.

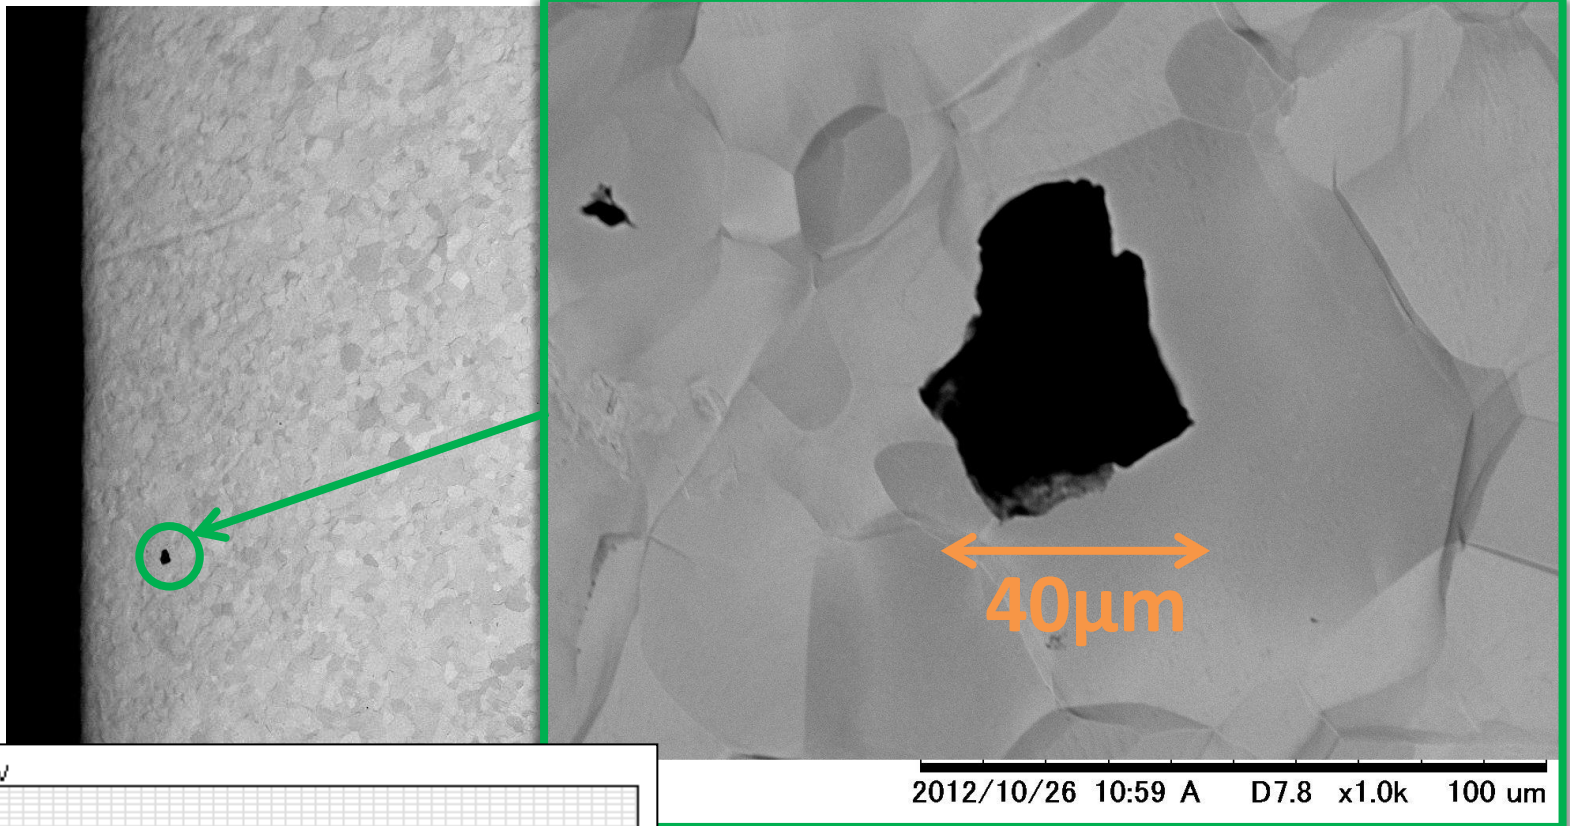
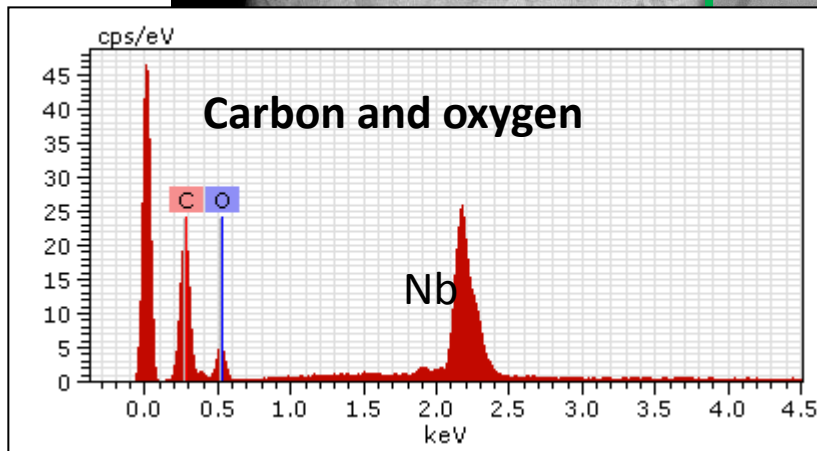
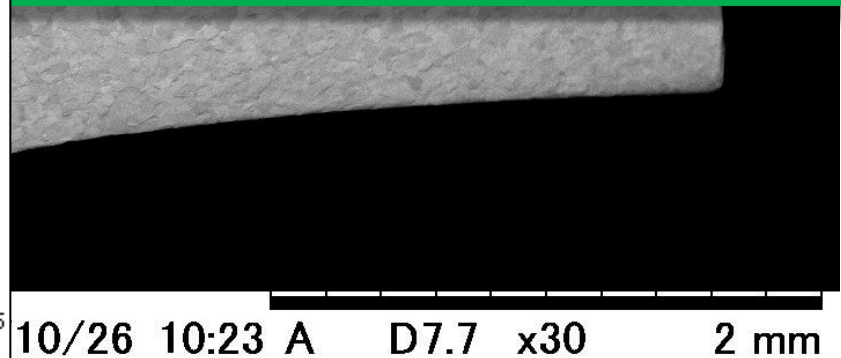
A surface condition just after Ultrasonic cleansing with Acetone (35min)

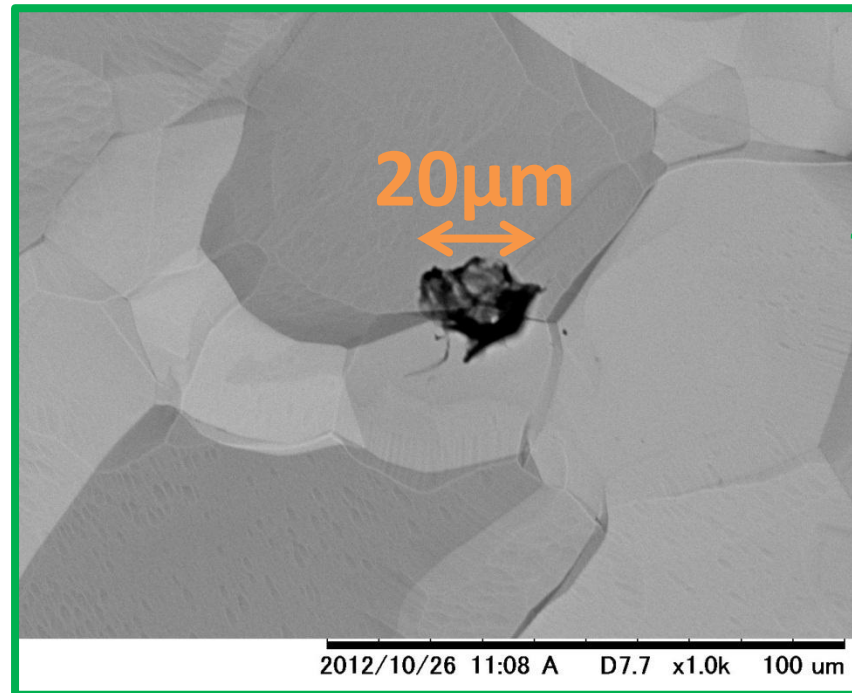
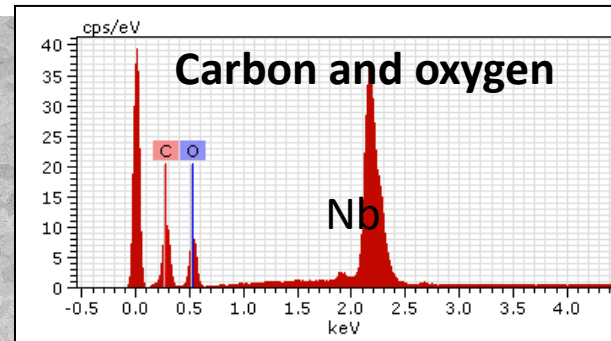
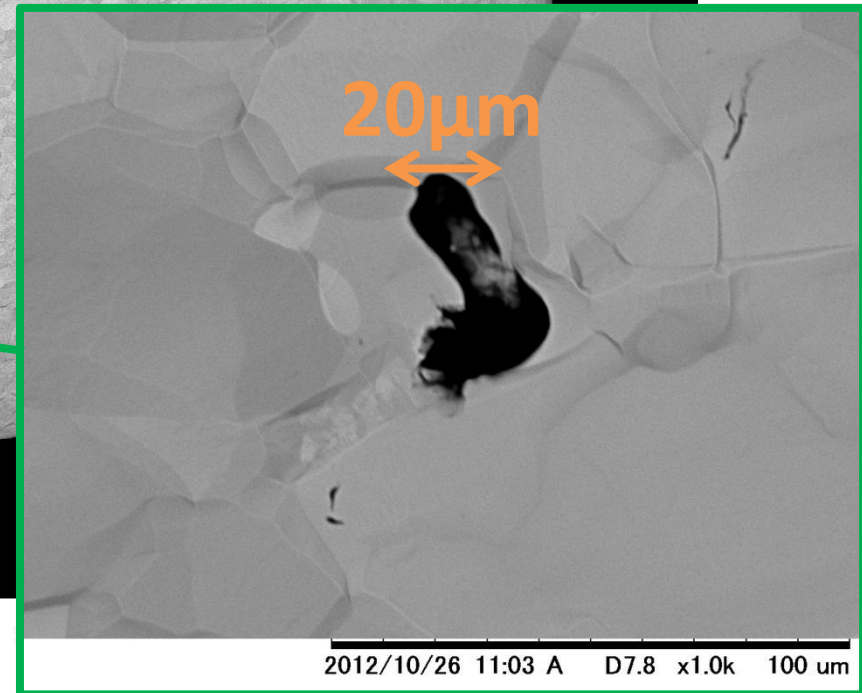
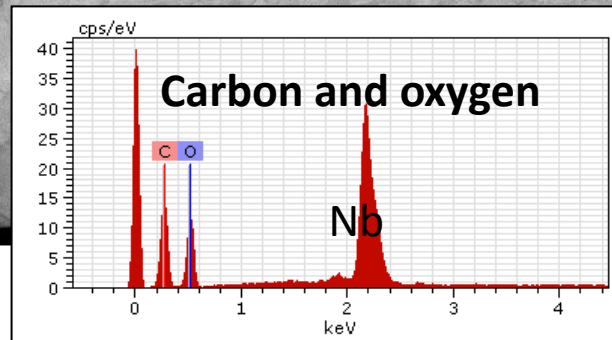
A surface condition just after Ultrasonic cleansing with Acetone (35min)
