Preparing the SVT for Operations in 2021

Tim Nelson - **SLAC**

HPS Collaboration Meeting

JLab - November 20, 2020

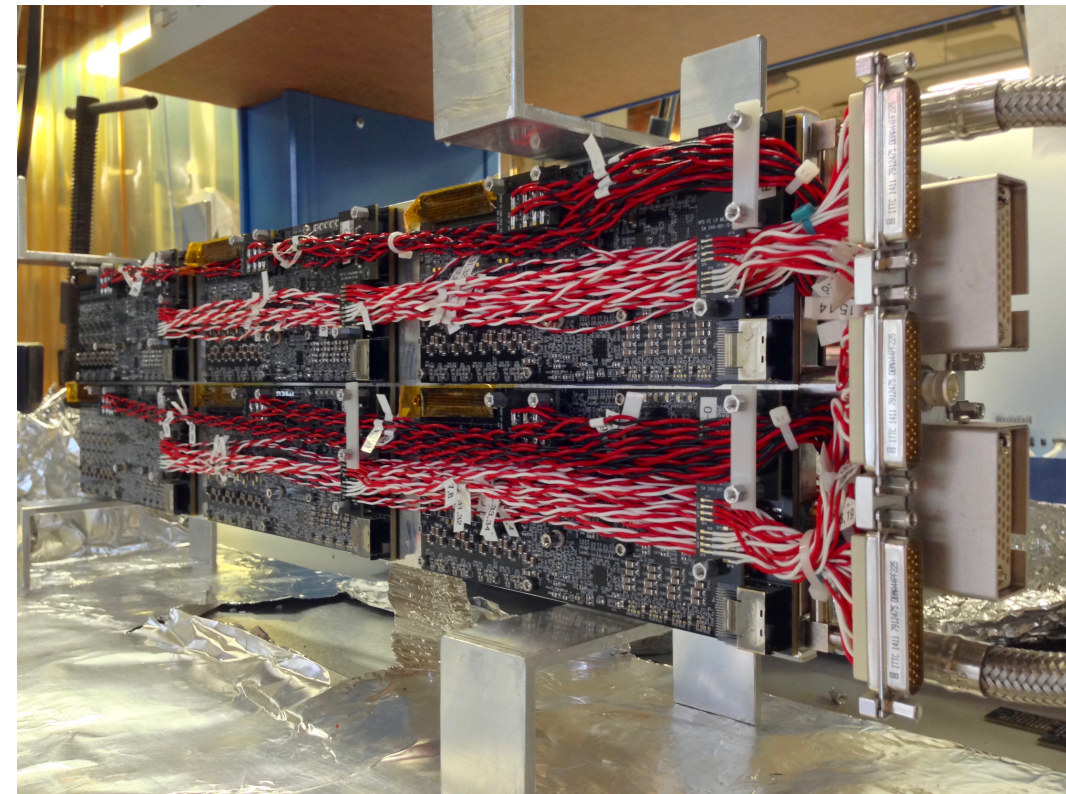
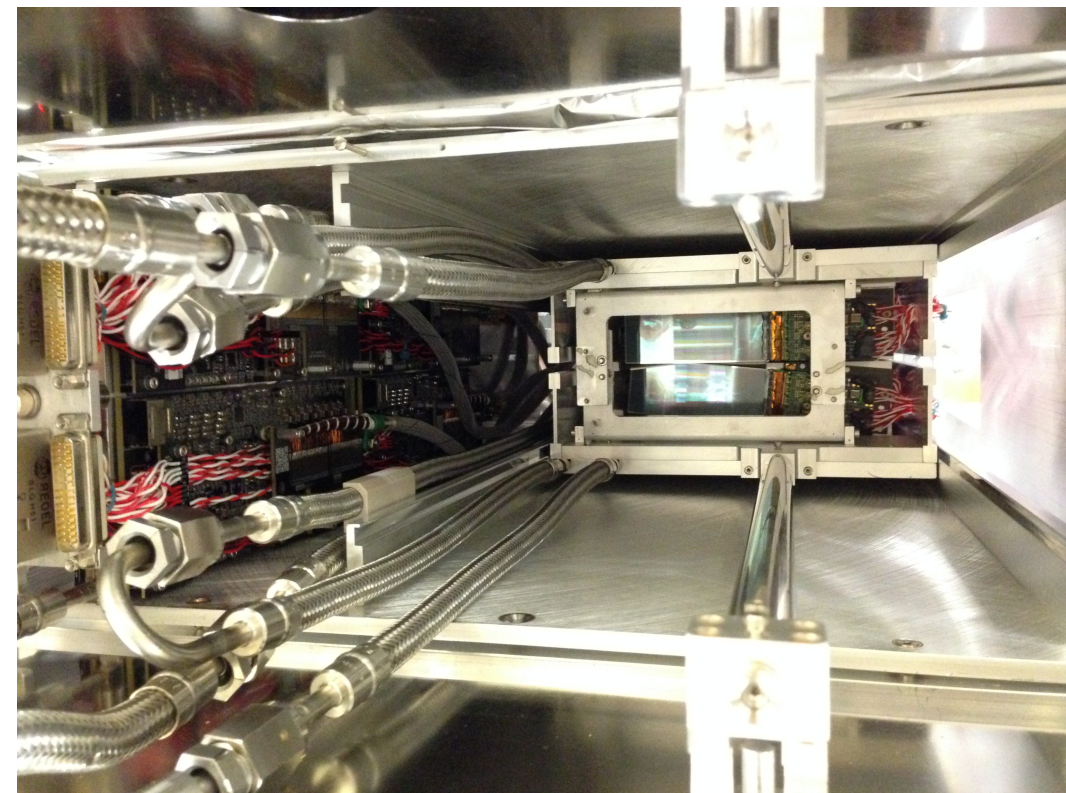
FEB degradation manifests as drooping 5V / 500 mA regulator designed to supply ~300 mA total:

No current monitoring, so mechanism has been unclear, but lowering temperatures improved overhead.

Damage meant loss of data from L7T, one of four hybrids in L5B for most of the run.

Once recognized, we improved monitoring and were more careful with the beam to limit further damage.

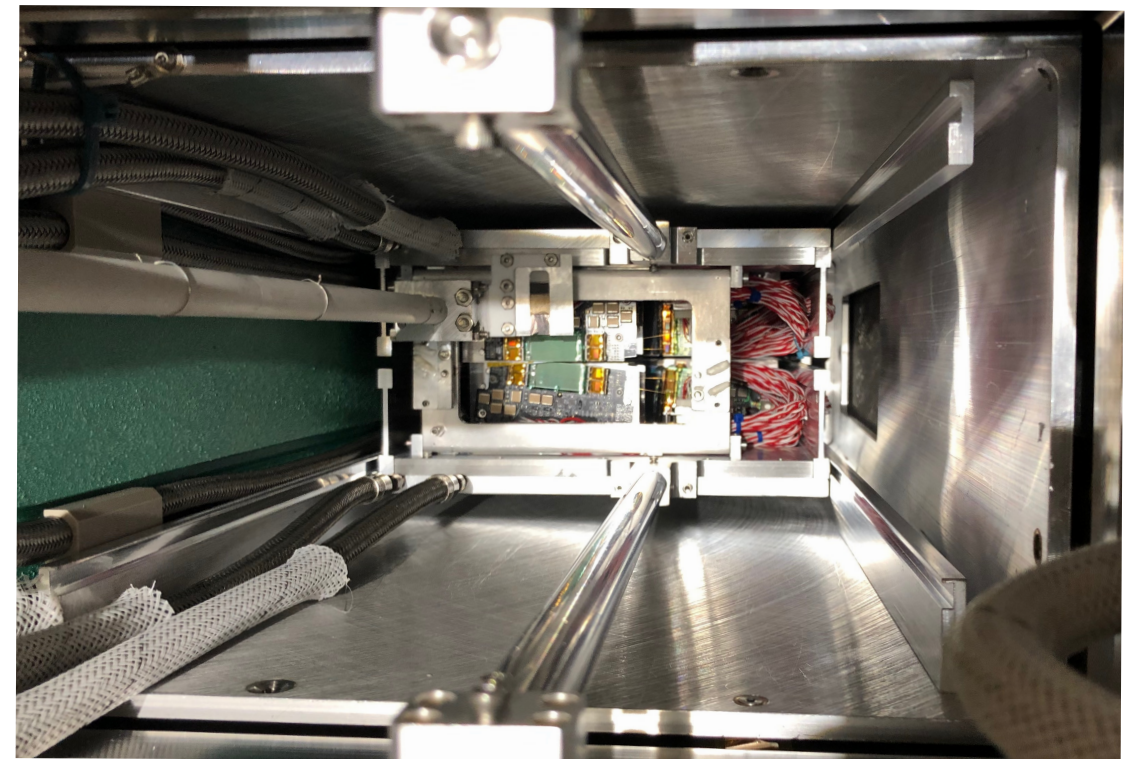
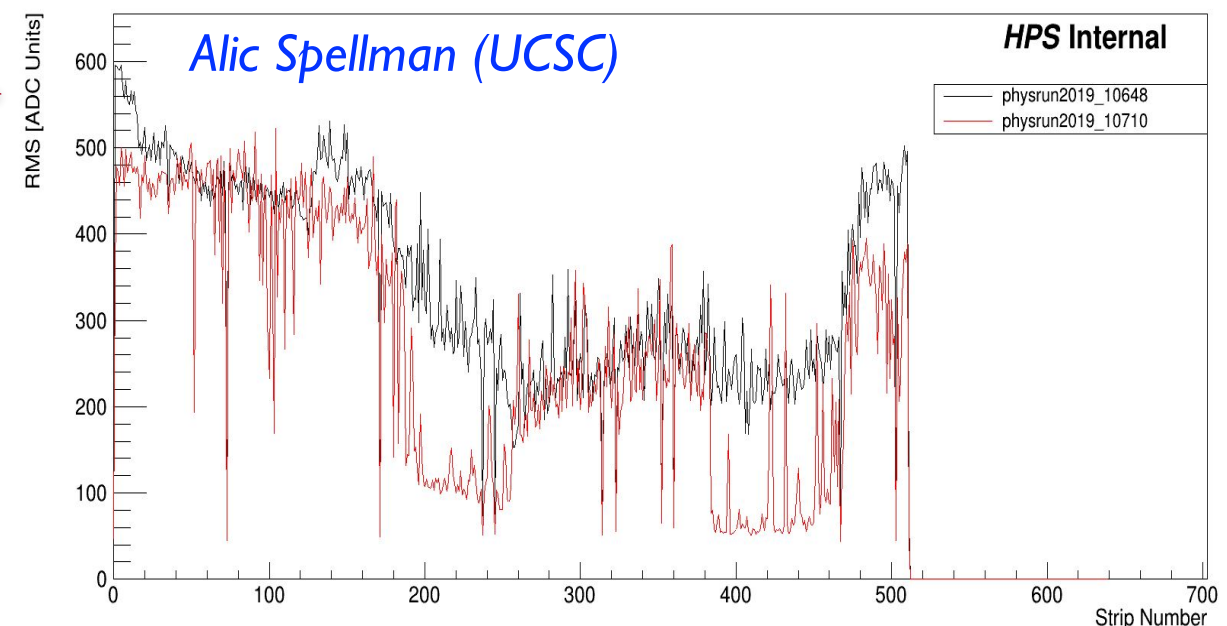
raw_hits_L1T_axial_timesample_0_physrun2019_10648

HV trips in the SVT were rare in previous runs, but much more common in 2019.

- On a few specific days, experienced a large number of HV trips in new Layers 1/2.
- No obvious problems with beam, but there was unusual activity /tuning for other halls
- On one occasion, a section of channels damaged in Layer 1, mostly outside acceptance.
- Late in the run (during field-off run), a Layer 2 sensor severely damaged.

Layer 1/2 sensors no longer hold bias voltages required for operation to much higher doses.

Will need access to modules to study these issues further and explore mitigations.

More modules will be needed to run again.
