Analysis of BLM System Performance

Kitty Price

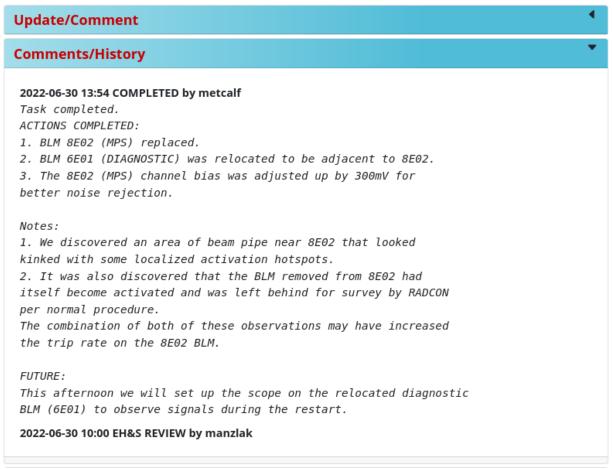
ATLis comment: Replace 8E02 BLM, Move Diagnostic BLM to 8E02 Region

- I could not find any surveys to correlate with this claim
 - Though it is possible I simply missed it

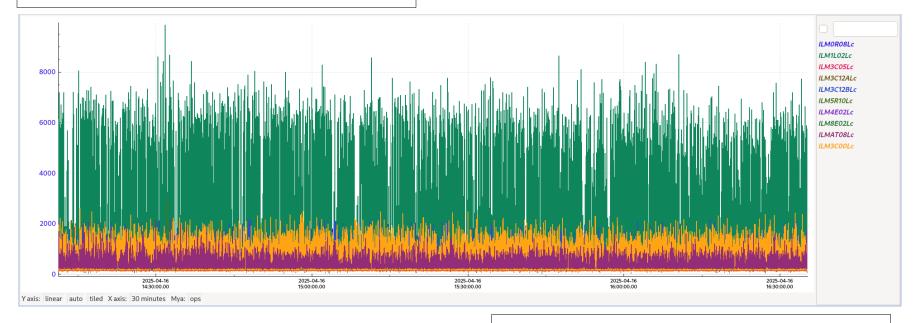
A sampling of BLM signals during a period with no beam in the machine

Note the large disparity in noise levels, especially between ILM1L02 and ILM3C05 (which displays no noise)

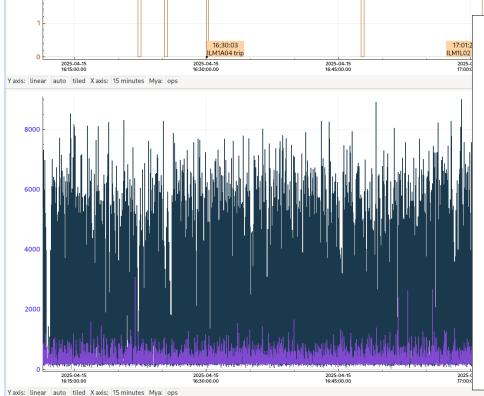
Another selection of BLM signals during a period of occasional BLM trips that have no apparent correlation with loss

These trips don't tell us anything about the location or nature of the loss – only that a trip has occurred.

Troubleshooting a spate of BLM trips like this means the control room has to start from square one: there might be loss somewhere, and not necessarily near the location of the BLM(s) that caused the trips
