CEBAF Particulate Field-Emitter Control

Rongli Geng July 15, 2015

C50-12 Rework Cryomodule Cavities

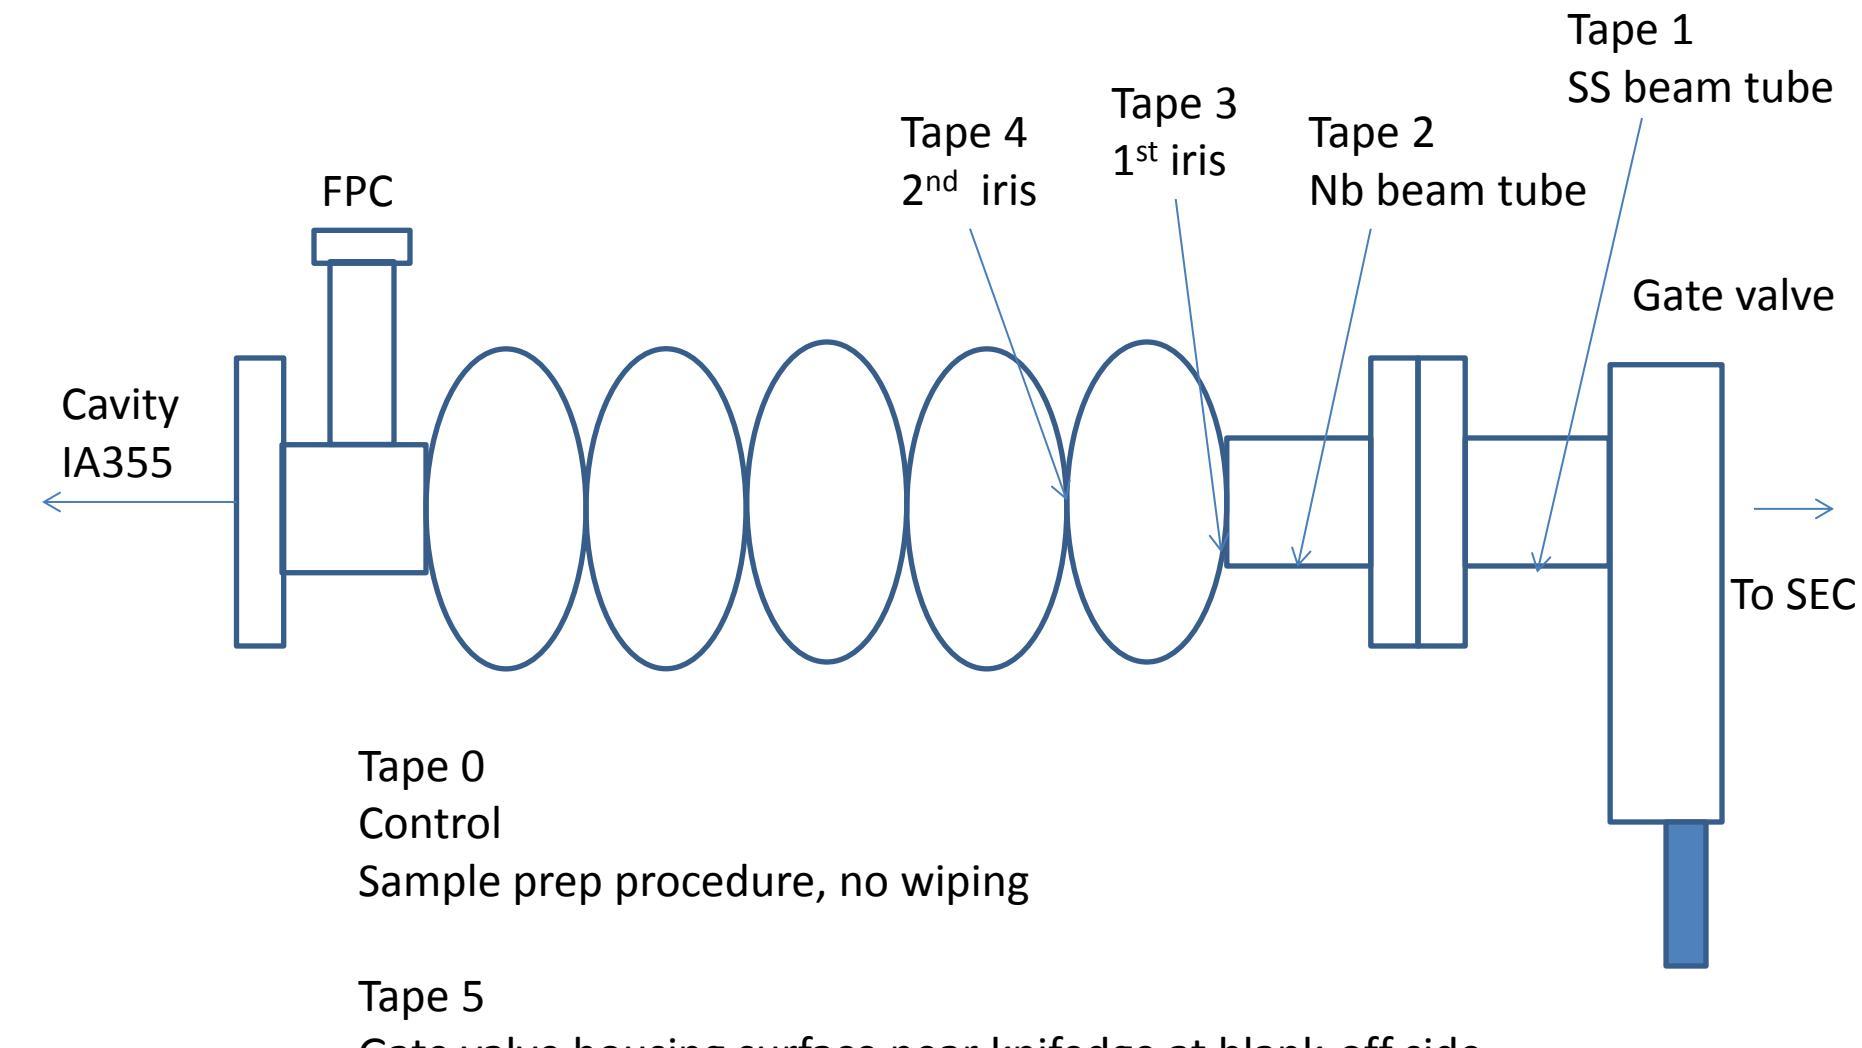
IA080 Collection Areas – Sample Batch 1

Gate valve housing surface near knifedge at blank-off side (two big Cu particles were noticed by unaided eyes)

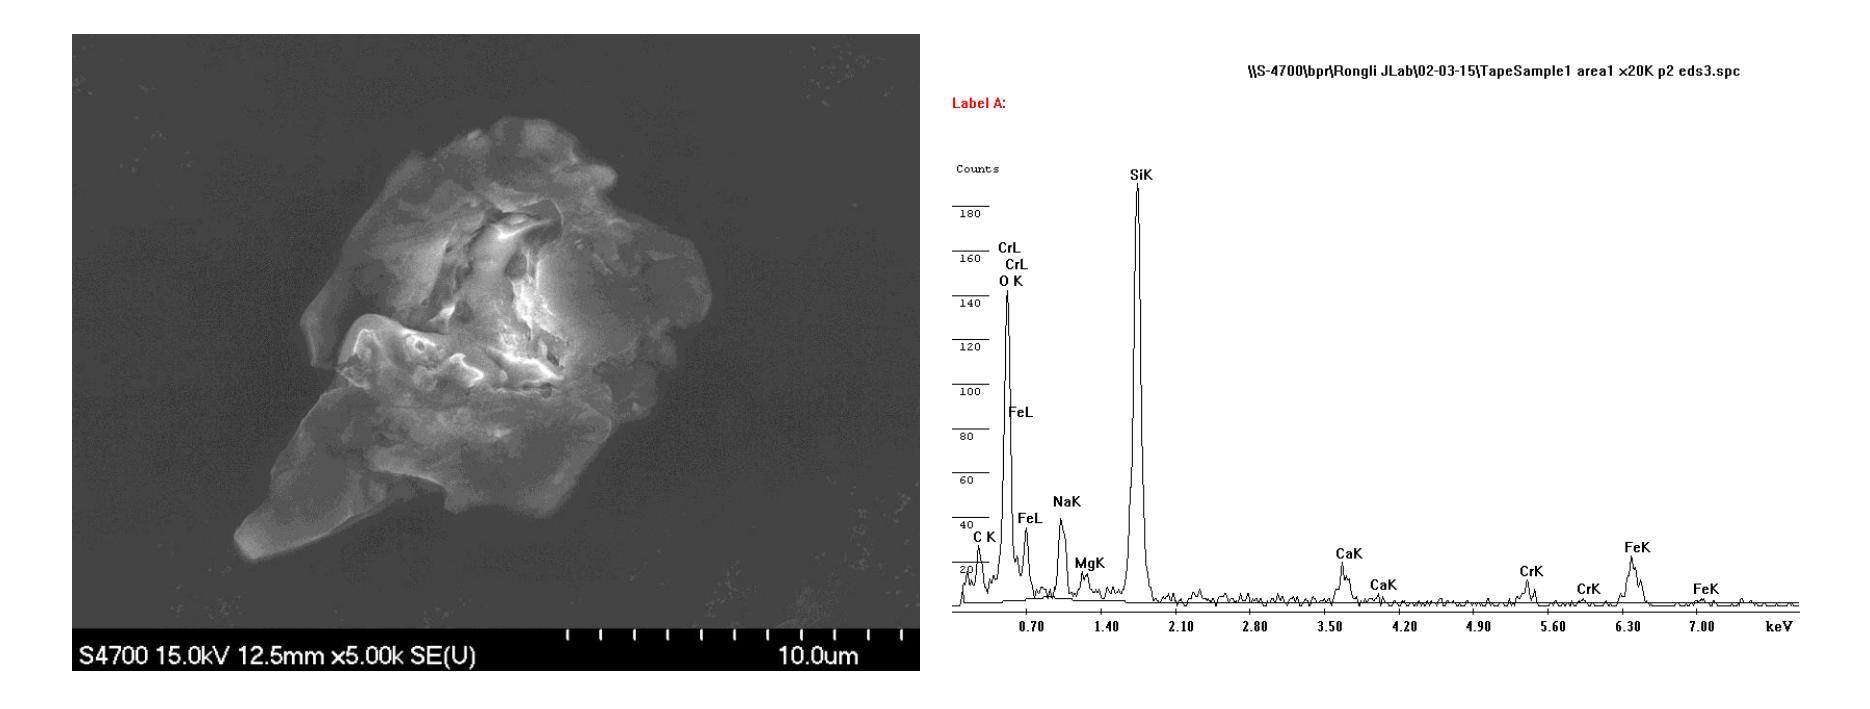
IA080 Inner Surface SS Beam Tube Fe, Cr, Ca, Na, Mg, Si

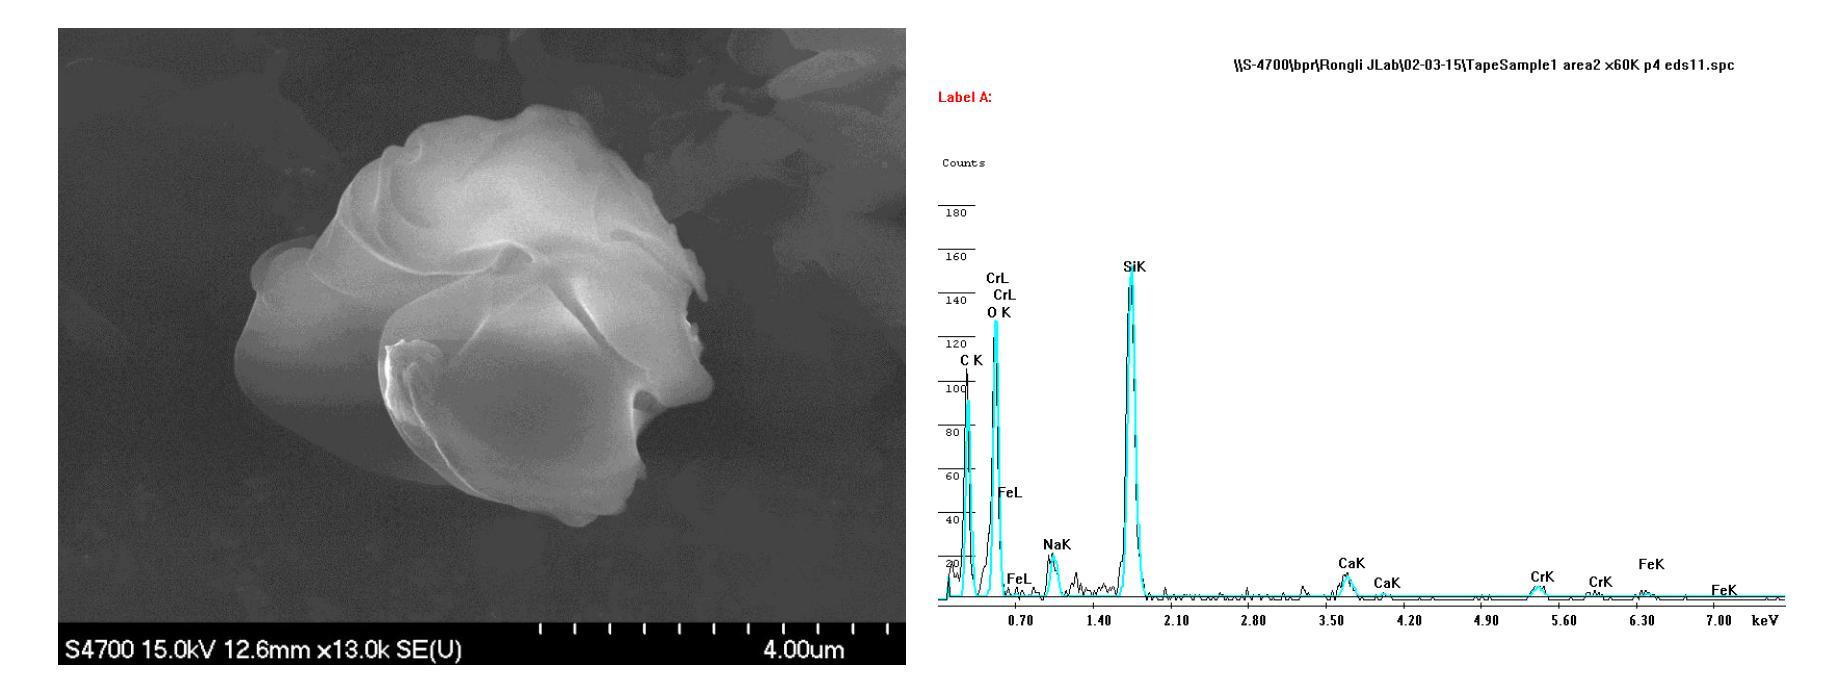
Cr, Fe, Ca, Na, Si

Dirty stainless steel particle

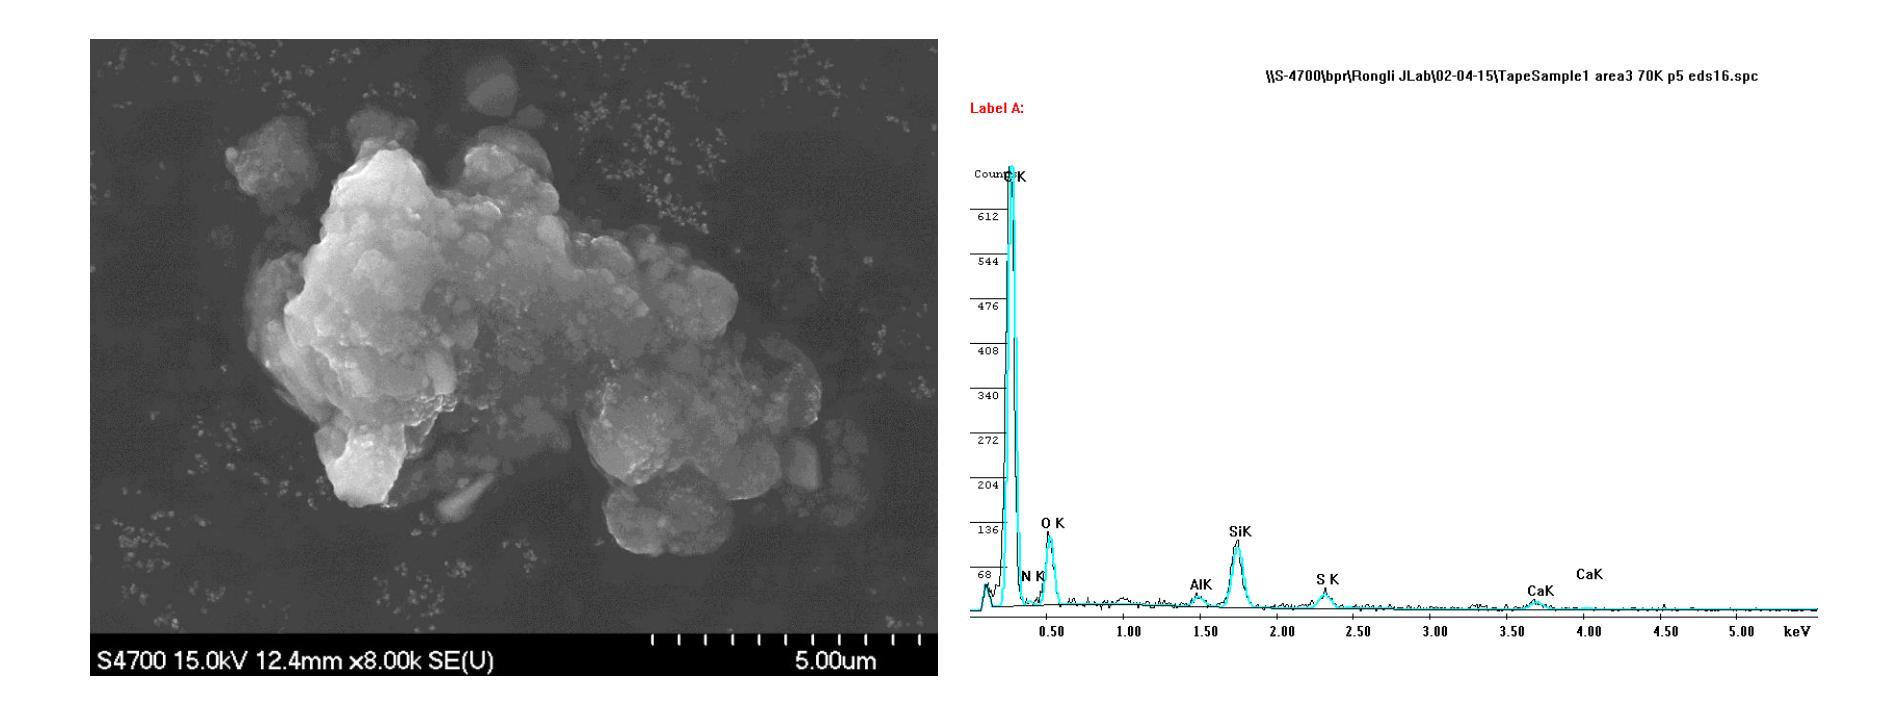
IA080 Inner Surface SS Beam Tube Ca, Al, Si, S

dust

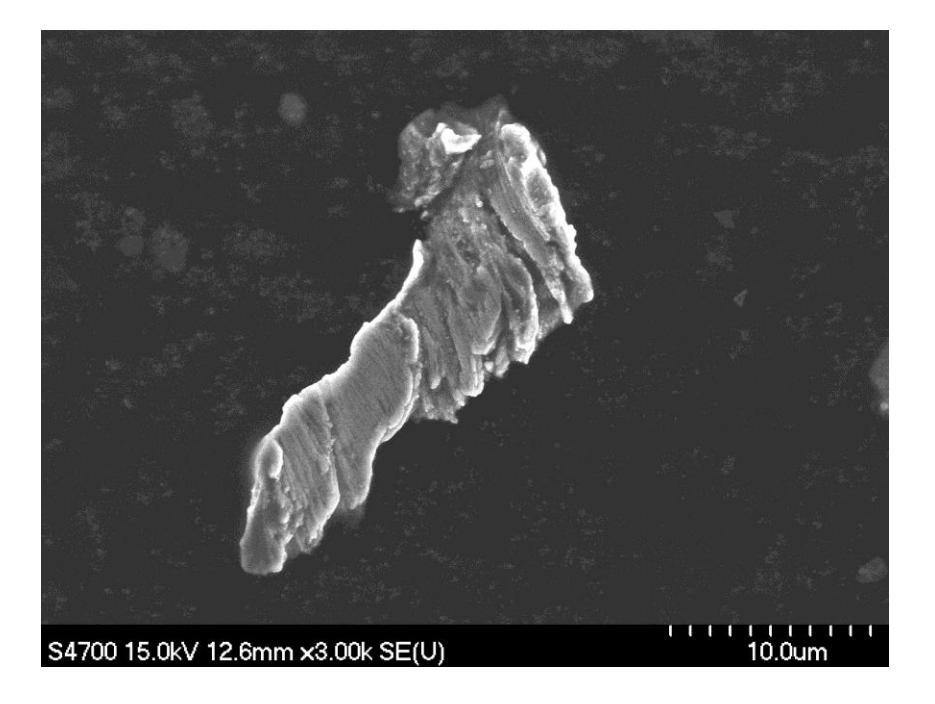
TapeSample1 area2 x3K1a_q00

Typical of stainless steel

Quick EDS analysis showed typical fingerprint of stainless steel: Fe, Ni and Cr peaks (and C due to the carbon tape substrate).

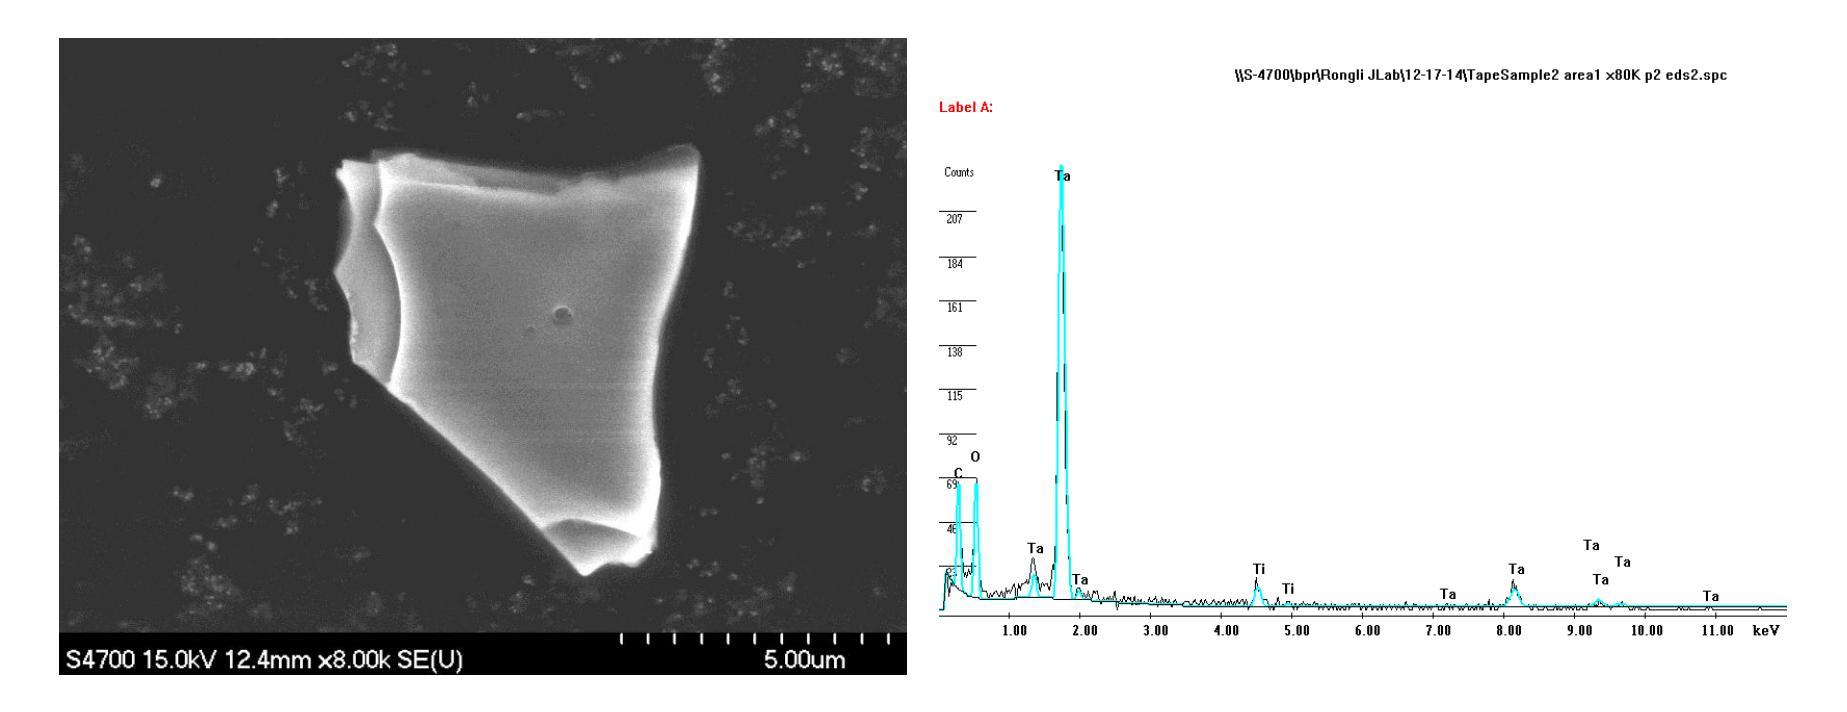
IAO80 Inner Surface Nb Beam Tube Ta, Ti

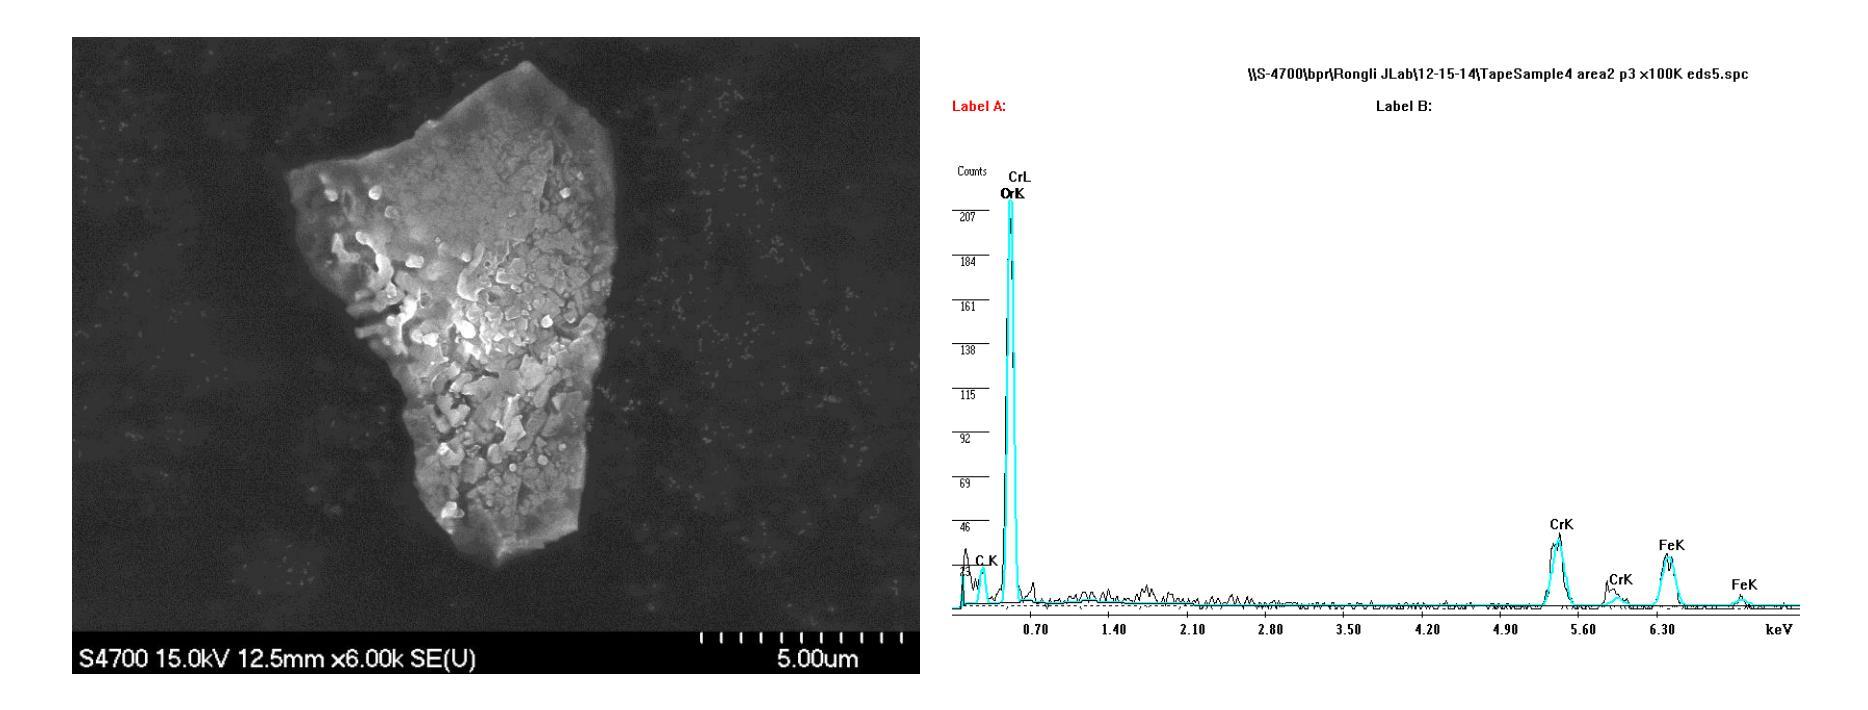
IA080 2nd Iris from Gate Valve Cr, Fe

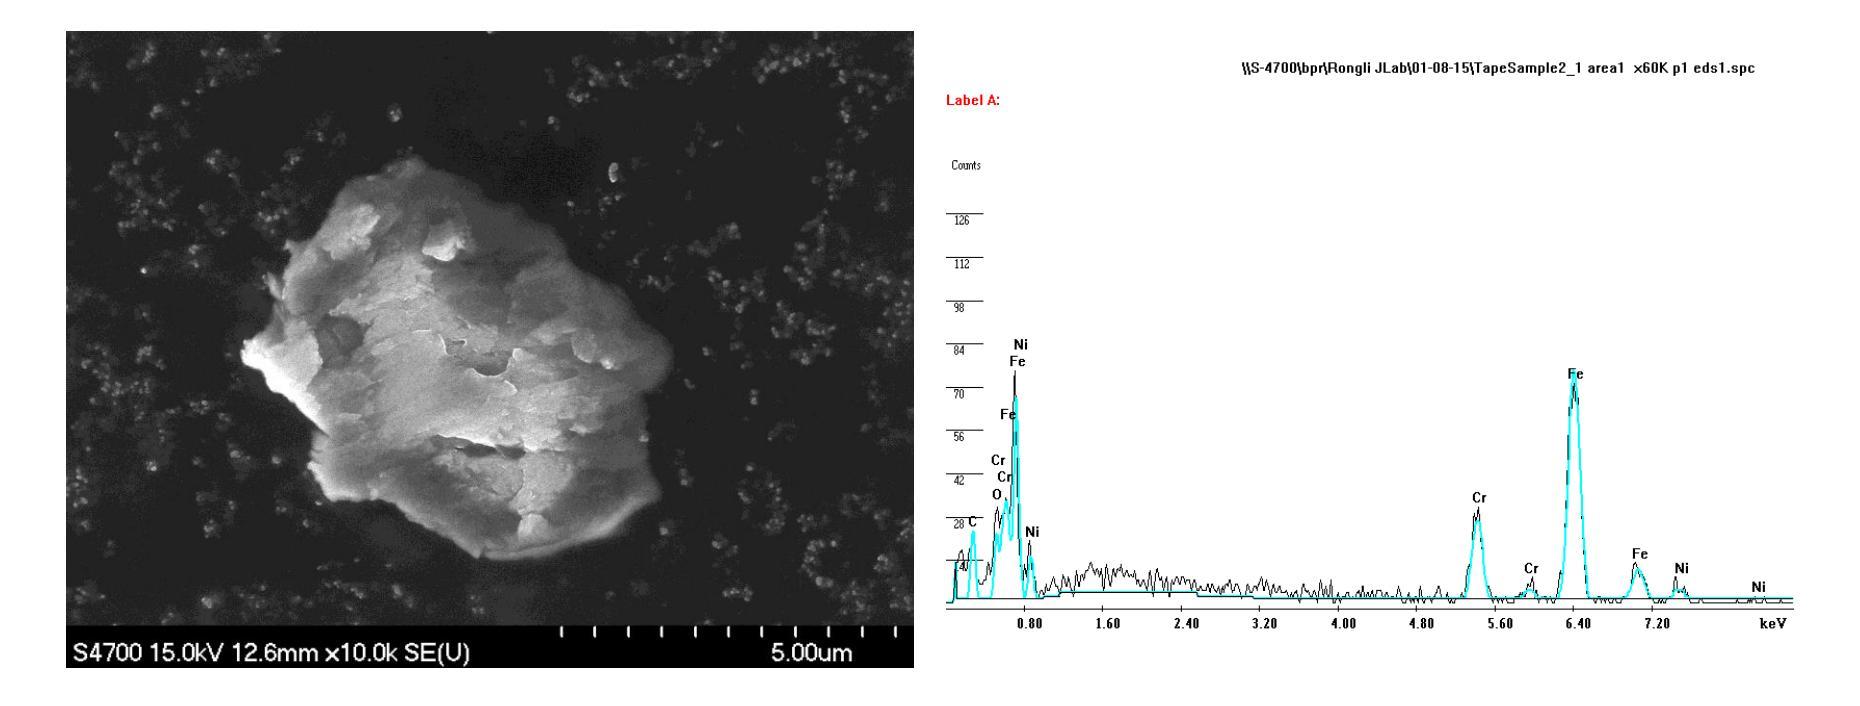
IA355 SS beam pipe 6 o'clock, 1 Fe, Ni, Cr

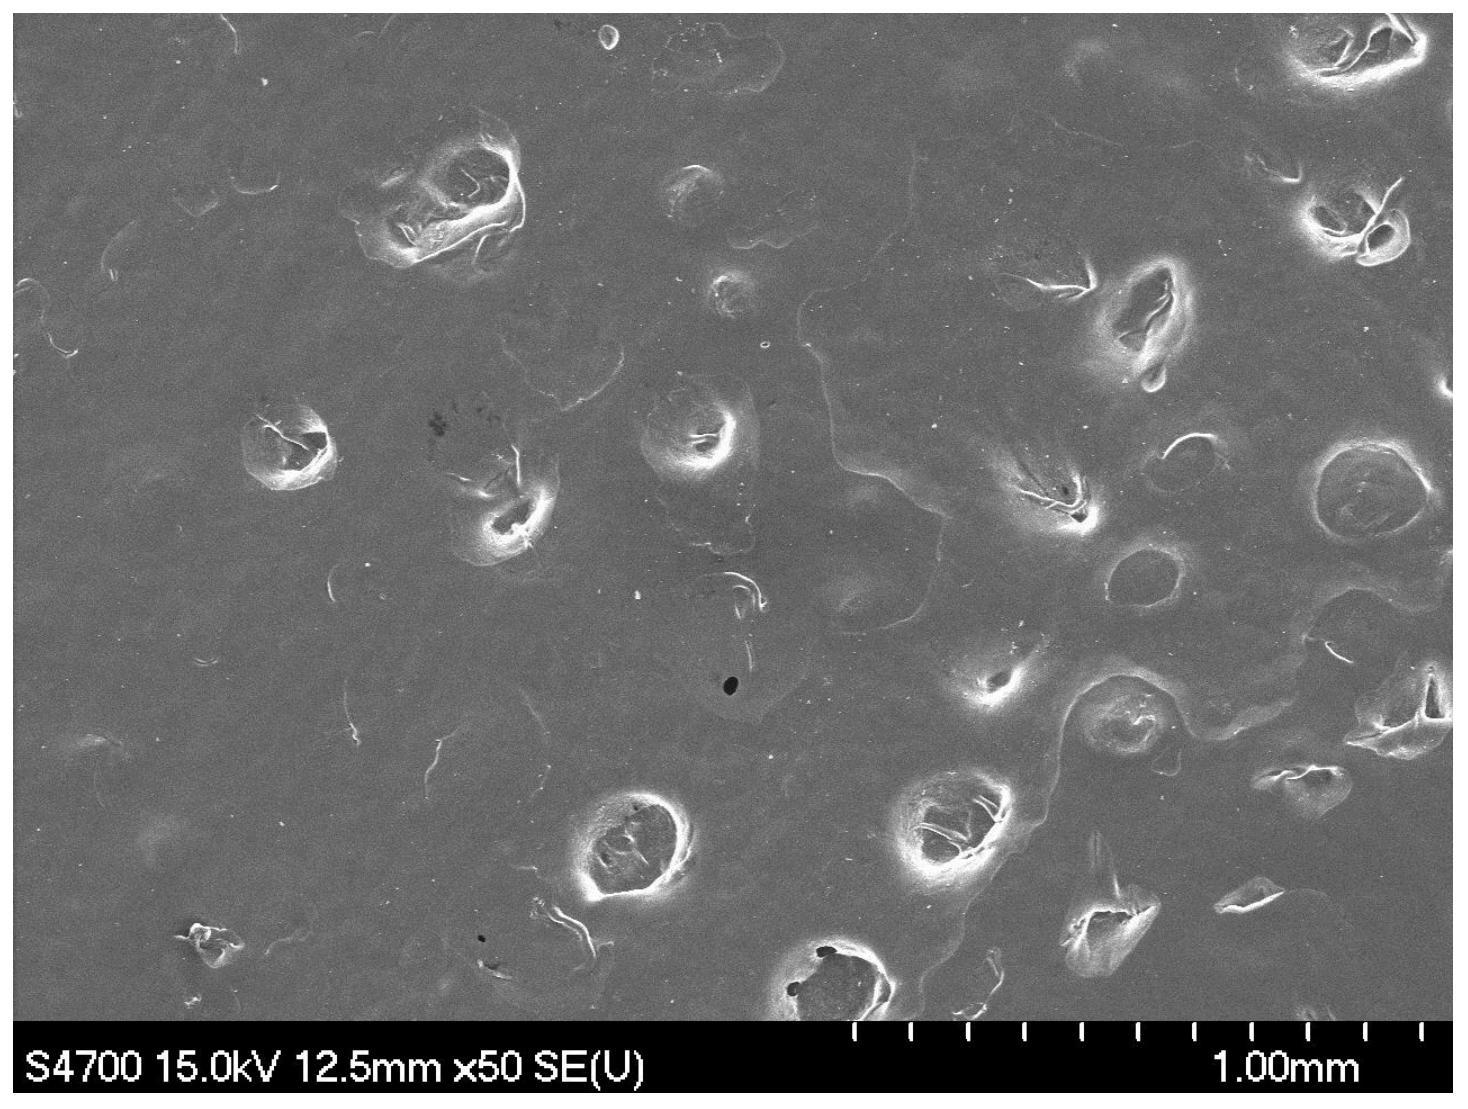
IA255 SS beam pipe 6 o'clock, 4

C, O peaks (high level of O), traces of Al and Si. Sample charges heavily.

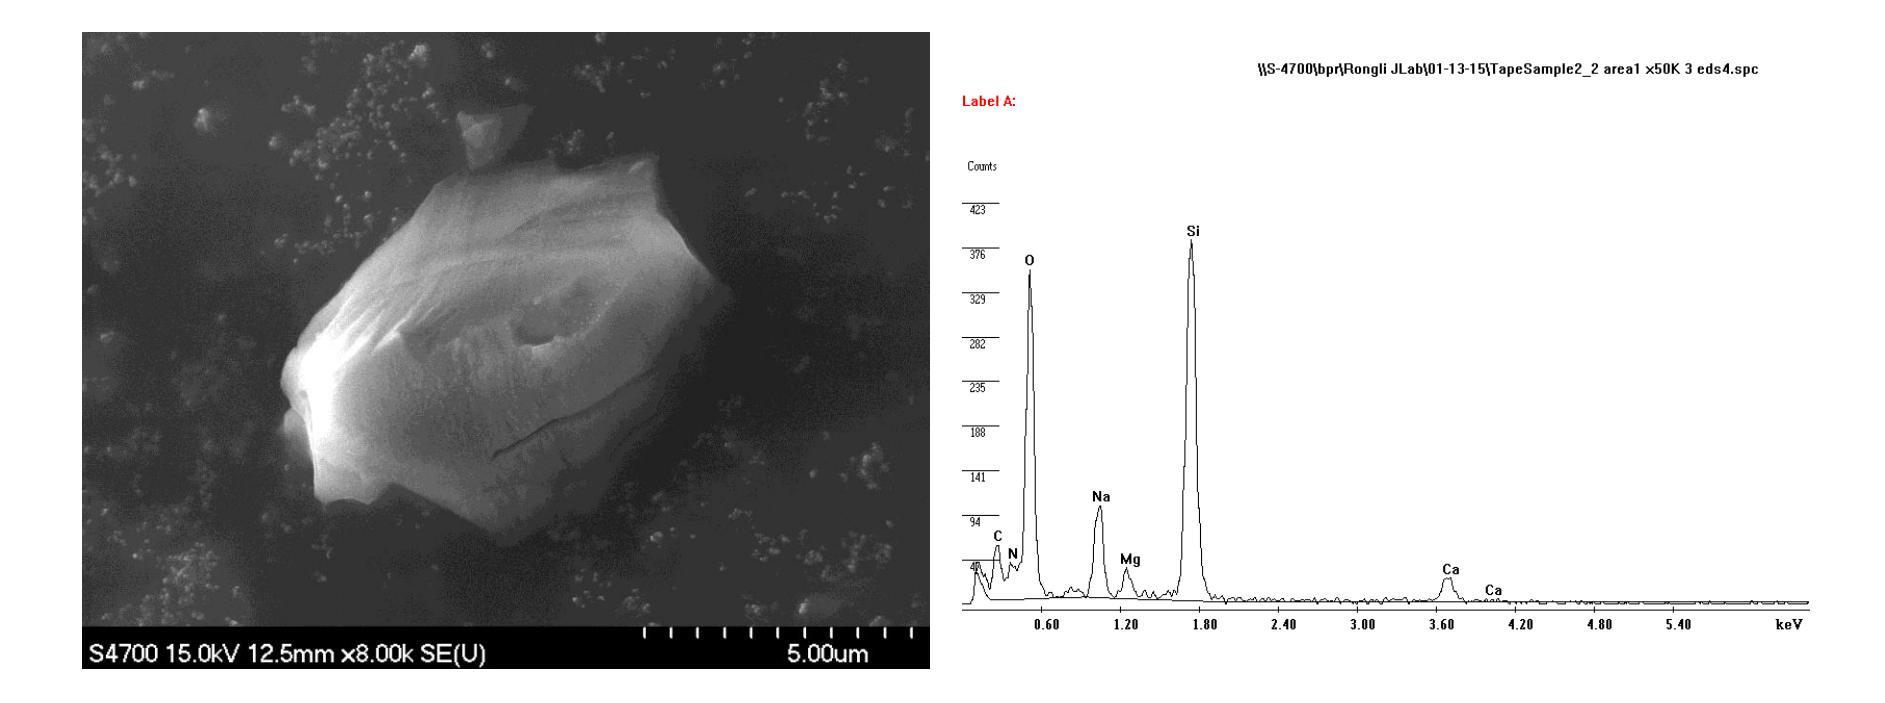
TapeSample2_2 area1 x13K 4_q00

IA355 SS beam pipe 3 o'clock Si, Ca, Na, Mg

EDS results are similar to the previous sample: Si, Ca, Na, Mg peaks.

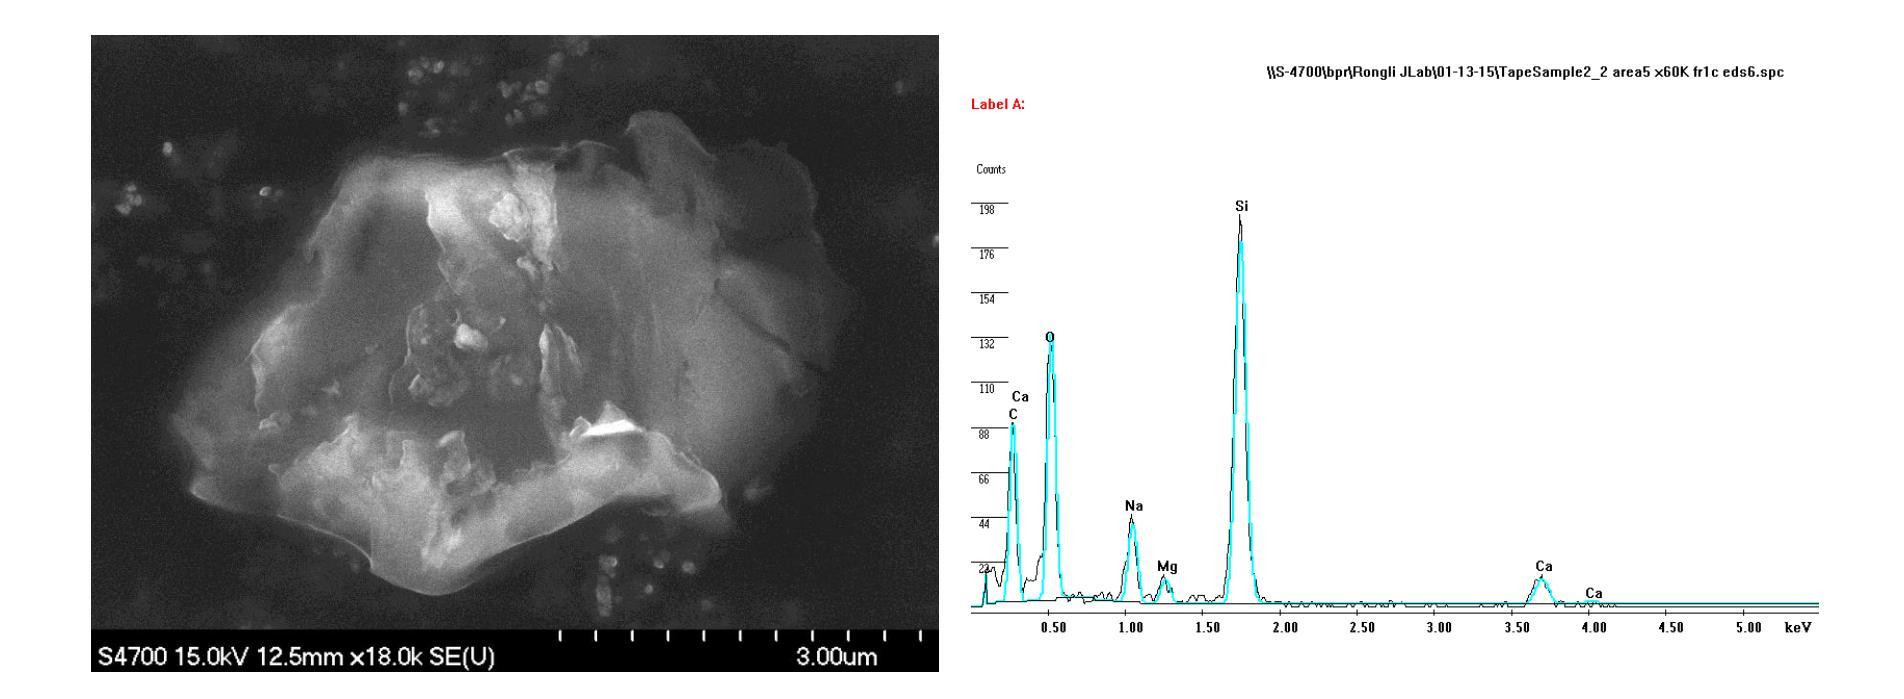
TapeSample2_2 area4 x5K 3_q00

IA355 SS beam pipe 3 o'clock Si, Ca, Na, Mg

Quick EDS analysis showed Si and O peaks (C peak is always present due to the carbon tape substrate).
 Silicon oxide particle.

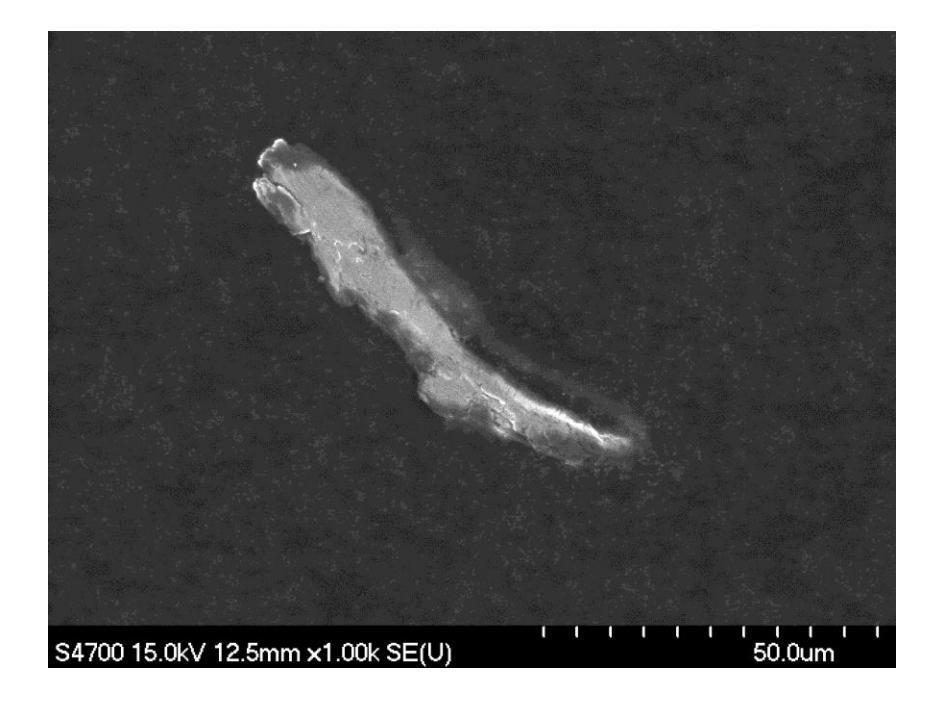
TapeSample2_3 area2 x1K p2_q00

Fe, Ni, Cr

Quick EDS analysis showed typical fingerprint of stainless steel: Fe, Ni and Cr peaks (and C due to the carbon tape substrate).

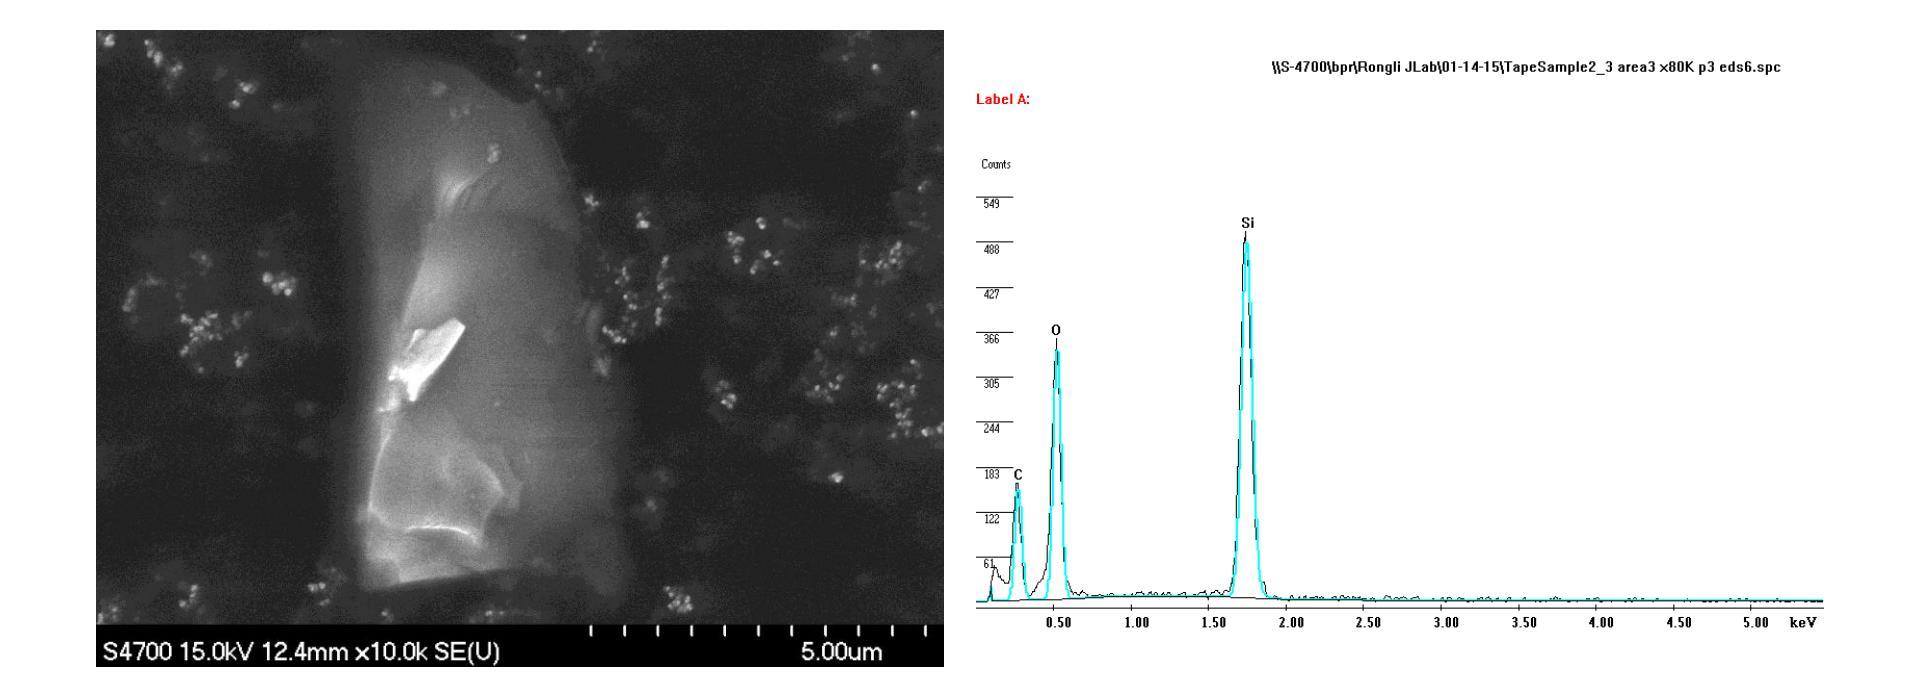
Si oxide (a grain of sand?)

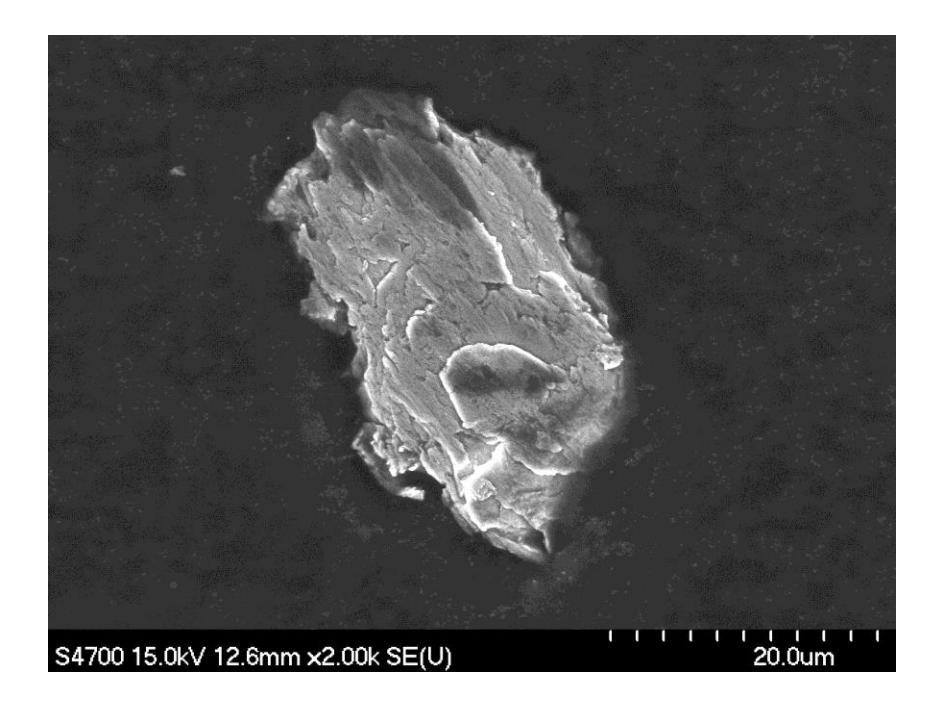
TapeSample3_1 area3 x2K p5_q00

Quick EDS analysis showed typical stainless steel signature of Fe, Cr and Ni peaks.

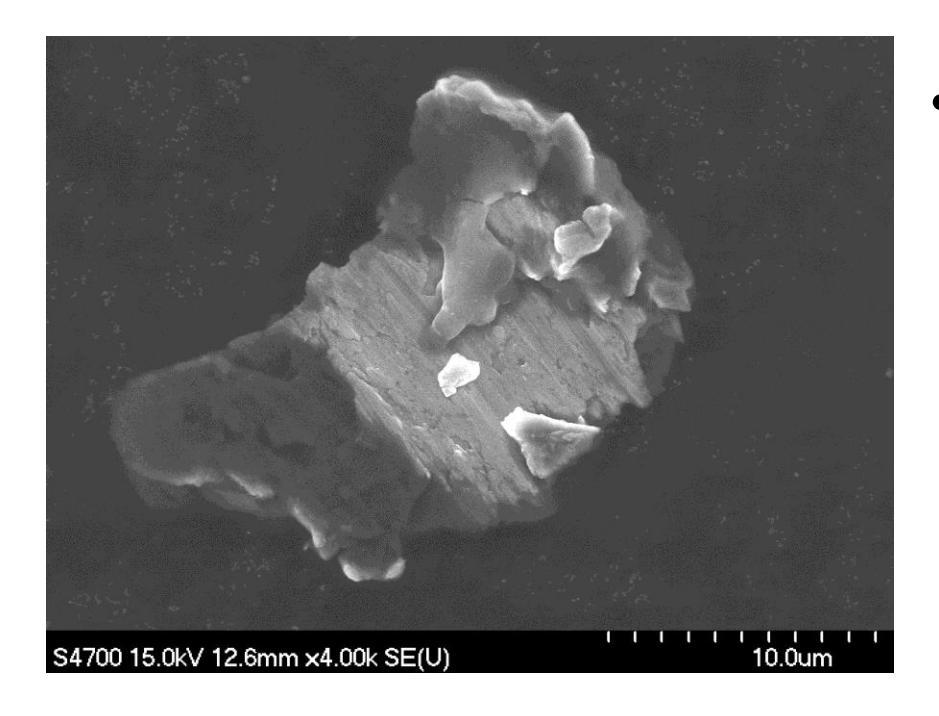
TapeSample3_1 area3 x4K p6_q00

Quick EDS analysis showed typical stainless steel signature of Fe, Cr and Ni peaks.

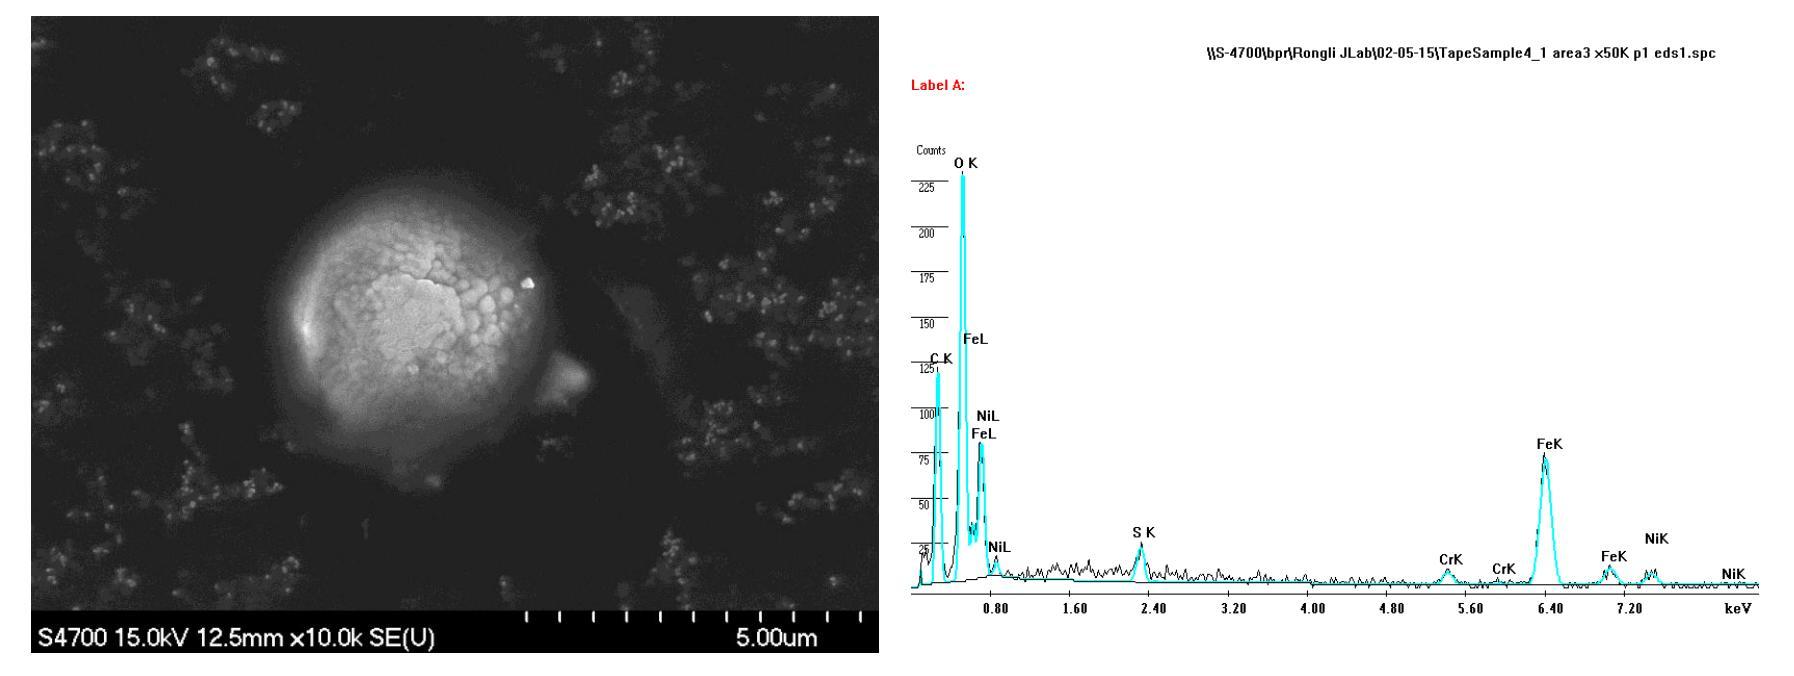
Fe, Cr, Ni, S

Post emission "melted" stainless steel ball?

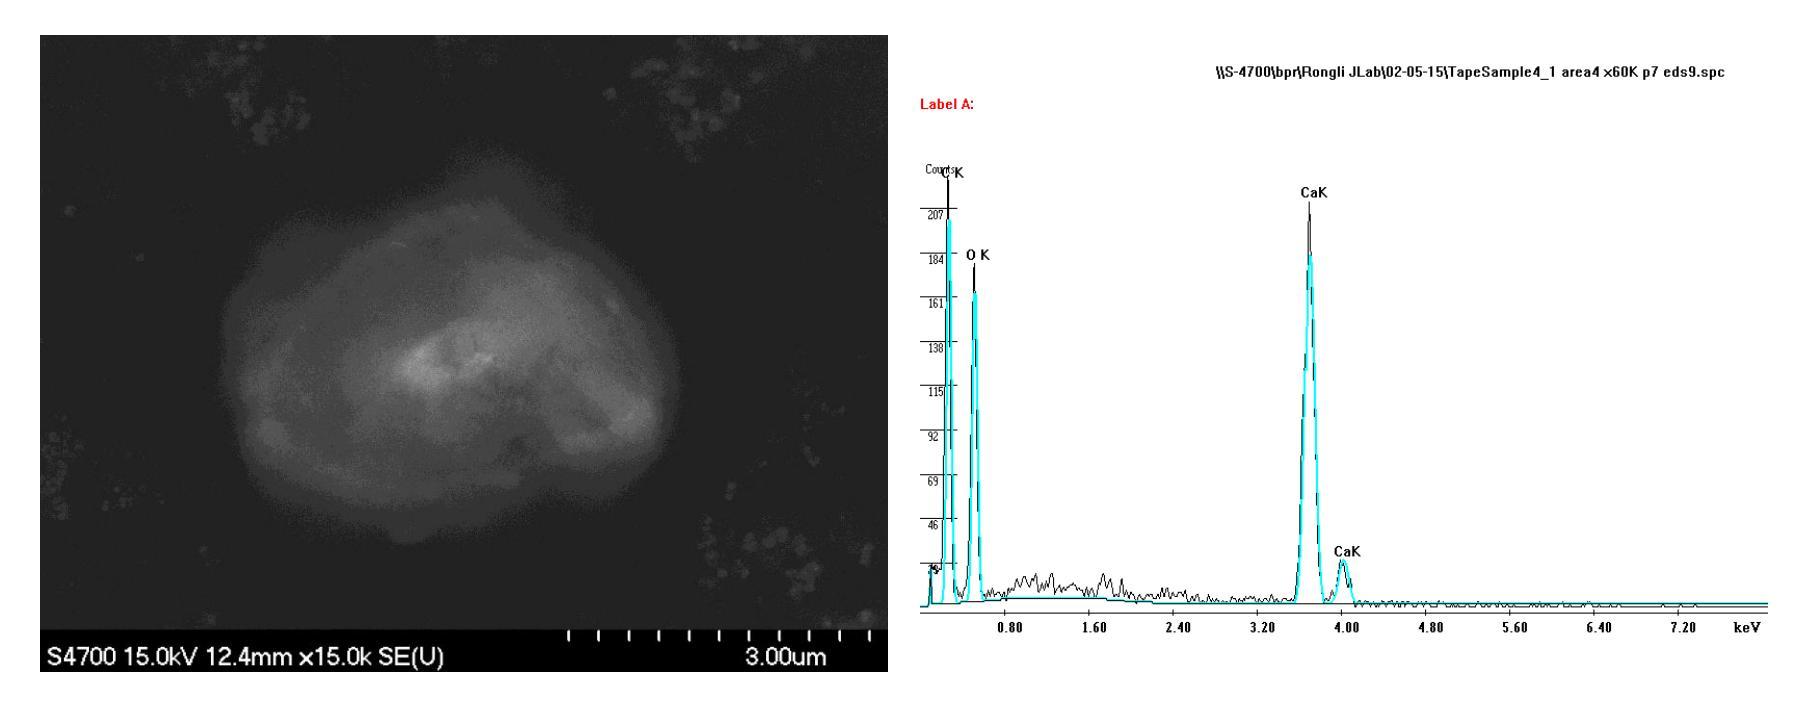
Ca

Post emission "melted" Ca stain?

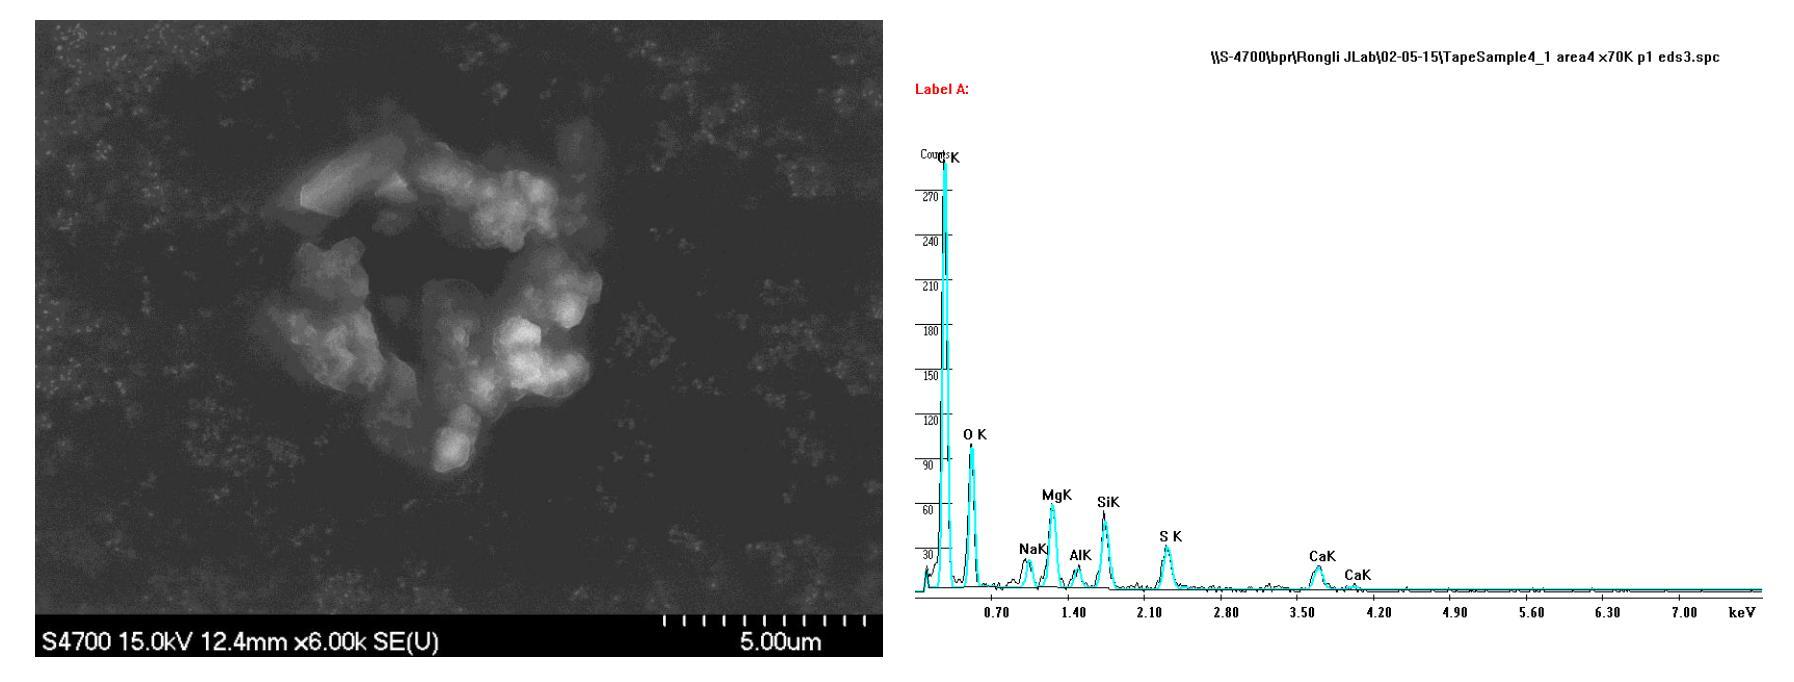
Ca, Na, Mg, Si, S

Post emission "partial melted" crystal?
