CEBAF Particulate Field-Emitter Control

Rongli Geng July 15, 2015

C50-12 Rework Cryomodule Cavities

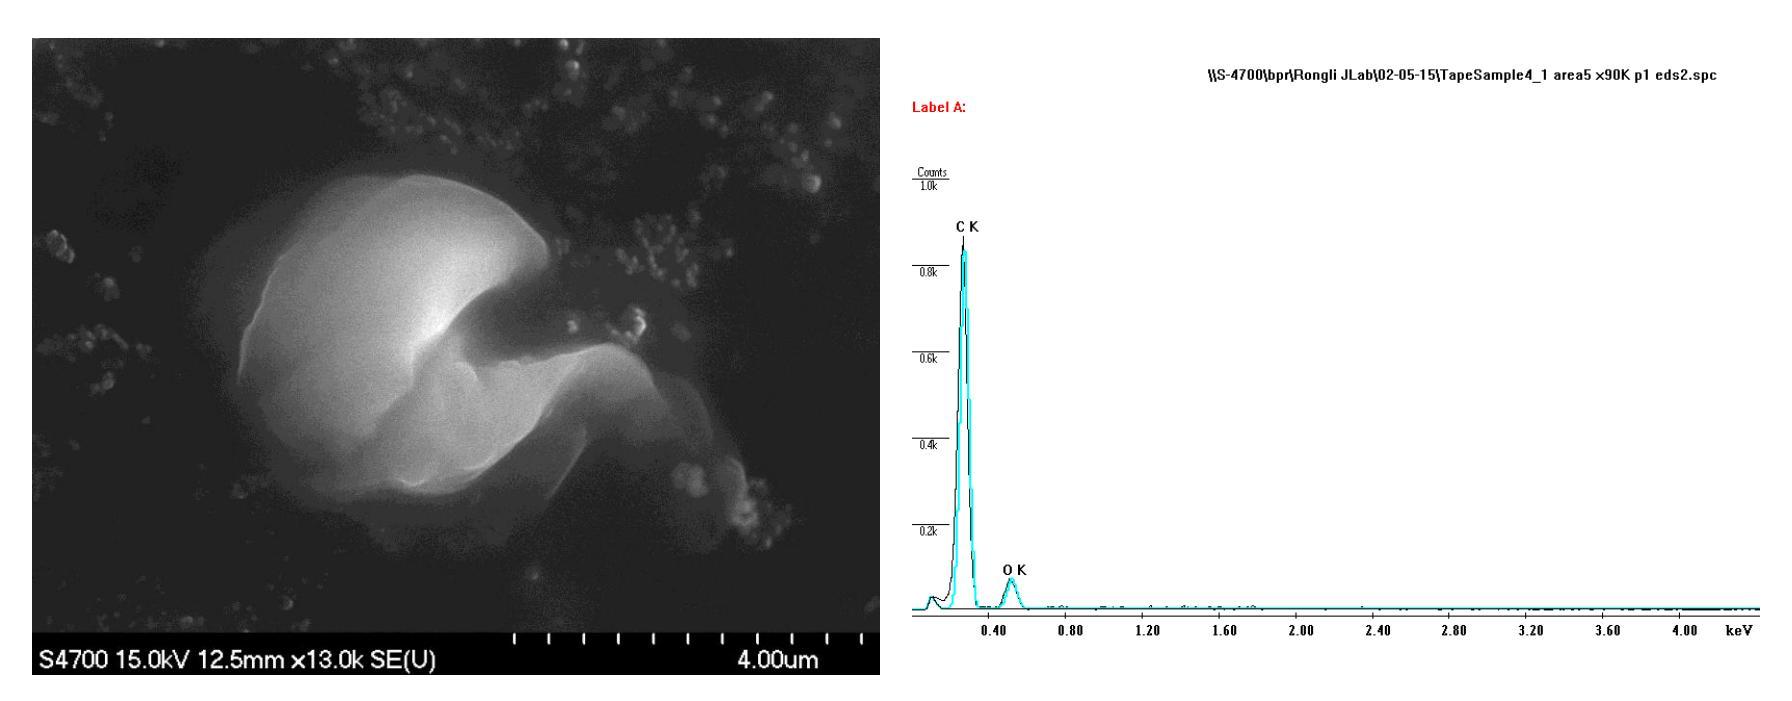
High C and low O contents and low charging could indicate that this is a carbon tape defect (carbon tape artifact).

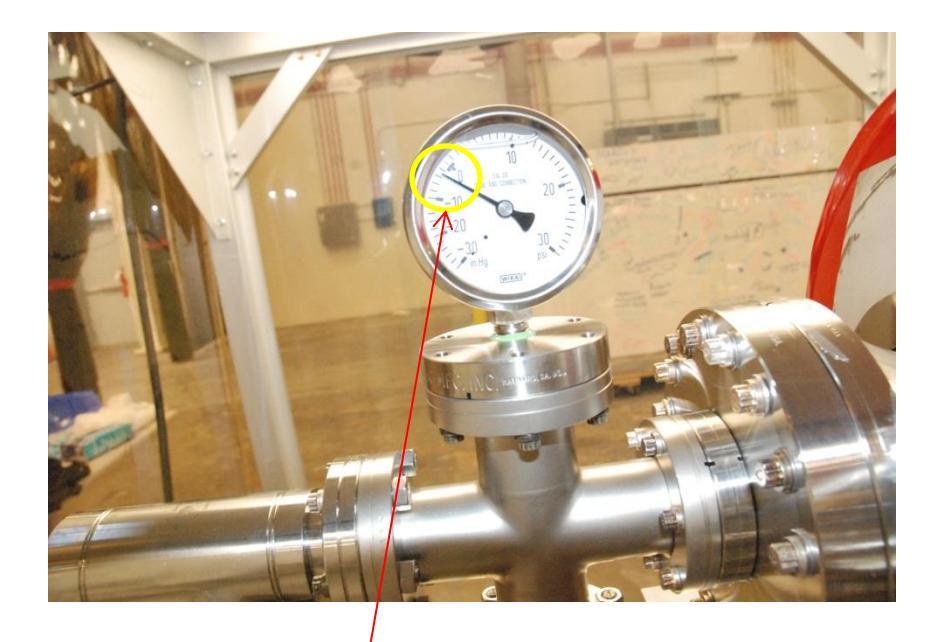
Pressure quickly rose to -3 in Hg after gate valve was opened – indicating cavity pair was already vented to near atmospheric 7/15/15, 2015 OPS \$P\$(CESSURE) prior to gate valve was opened \$6

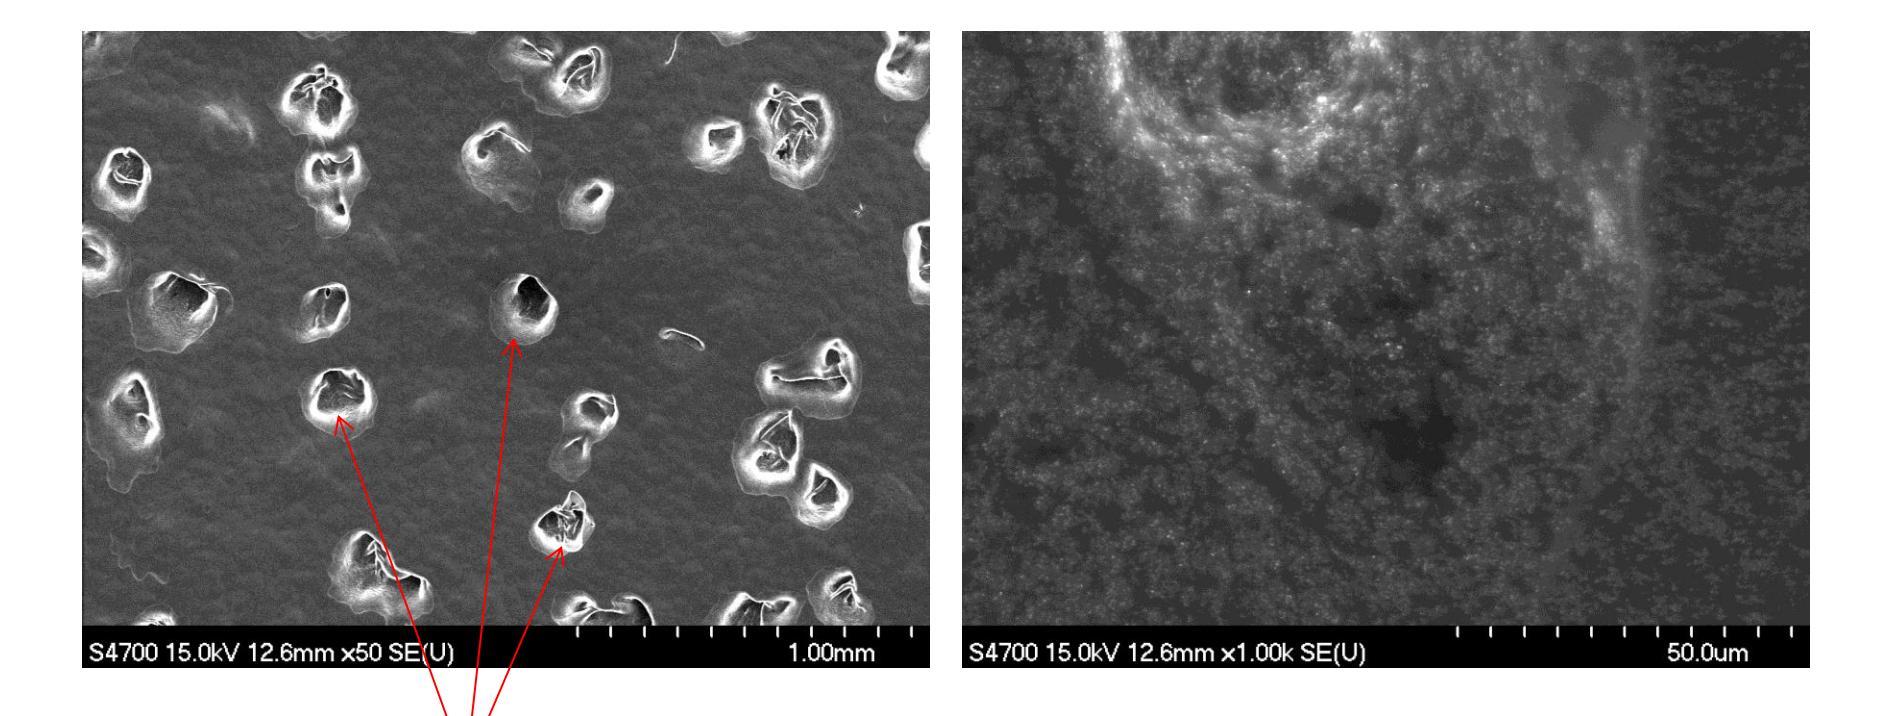
View at low magnification "bubbles in tape" visible View at high magnification EDS shows C and O only
