# HEAVY PHOTON SEARCH AT JEFFERSON LAB

# Overview of the first physics run

HPS Collaboration Meeting, JLab Nov 18, 2019

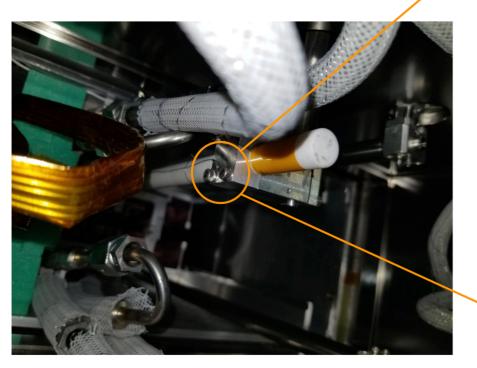
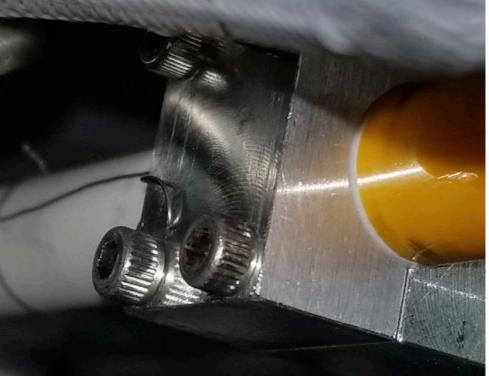
- RC: Rafo
- Good beam to the hall.
- DAQ became very unstable and would crash at random times, but frequency would scale with luminosity.
- It was found the grounding wire to the target was broken.

It was noticed immediately upon opening the upstream flange of the vacuum box, that the grounding wire of the target was broken!

Fix was relatively easy, even target was not removed

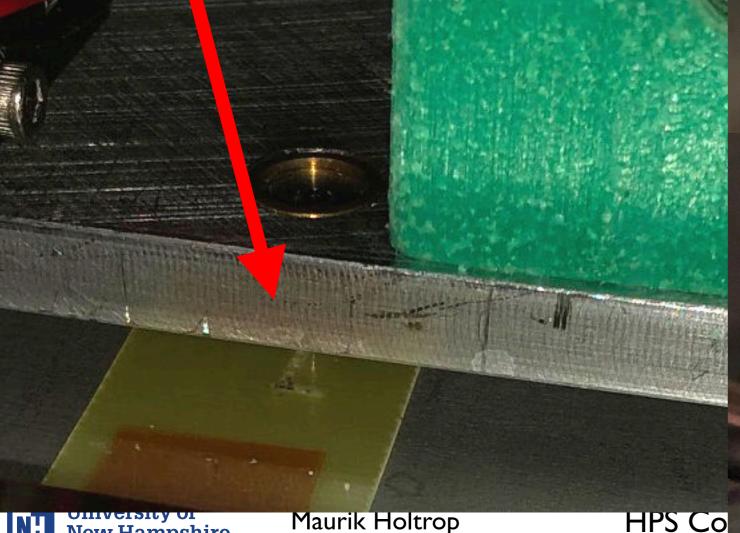
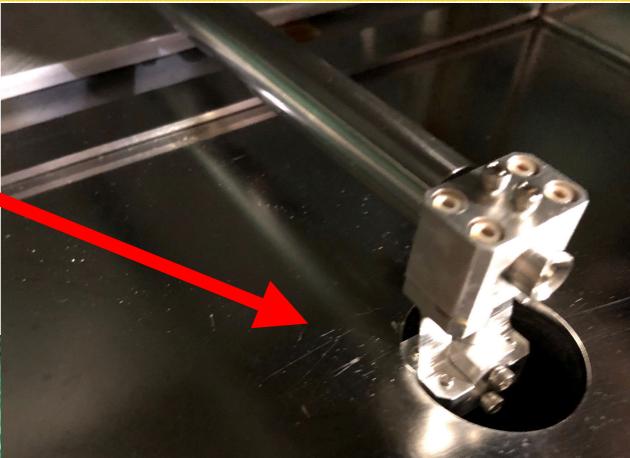
- RC: Maurik
- 7/23 After LCW water leak fixed, HPS running again.
  - Tuning beam, but SVT wire scans don't make sense. Top and Bottom scan disagree by > 200µm and are inconsistent.
  - Taking some data to diagnose issue using tracks. Results don't make sense either.
  - Hypothesis: The top SVT is not sitting properly in the groove that forms the downstream hinge of the first 4 sensor layers.
- 7/24 3pm We decide the only thing to do is open the detector, again.
  - Detector was found to have moved ~ Icm downstream.
  - This must have happened when the magnet crashed when power was lost.

Motor control rods are bent against the side of the hole. Flex joints are stressed. Scrapings found on plate.

Scrape mark on the GI0 board below the set screw.

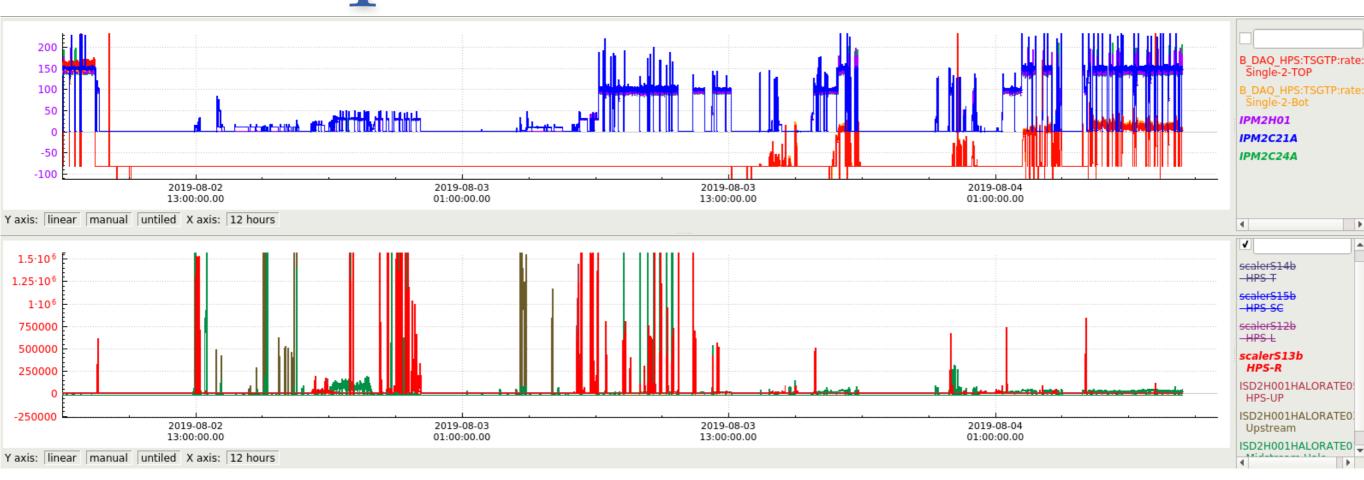
During the beam tune, very high rates are seen on the HPS-R halo counter (red), and the upstream (brown) and midstream (green) FSD counters.

This wasn't brought under control until Saturday midday.

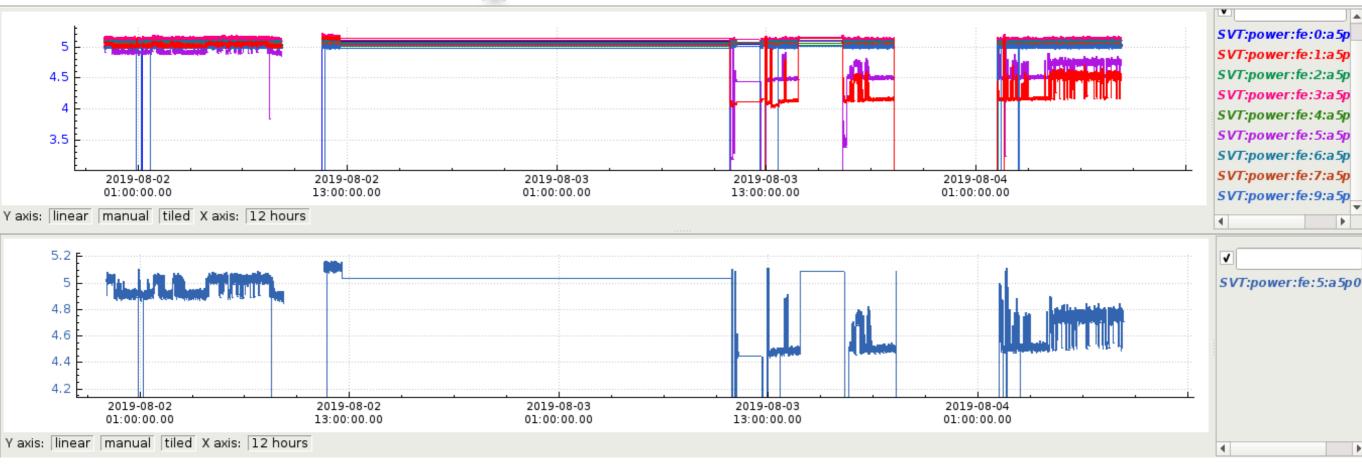
The Front End Boards (FEBs) of the SVT show a clear degradation in the 5V power to the analog section of the board, which powers the amplifiers.

When the 5V power drops to 3.8, one or more of the 4 hybrids on that FEB need to be turned off, causing us to loose one SVT.
