HPS SVT: 2019 Run and beyond

Tim Nelson - **SLAC** HPS Collaboration Meeting JLab - November 18, 2019

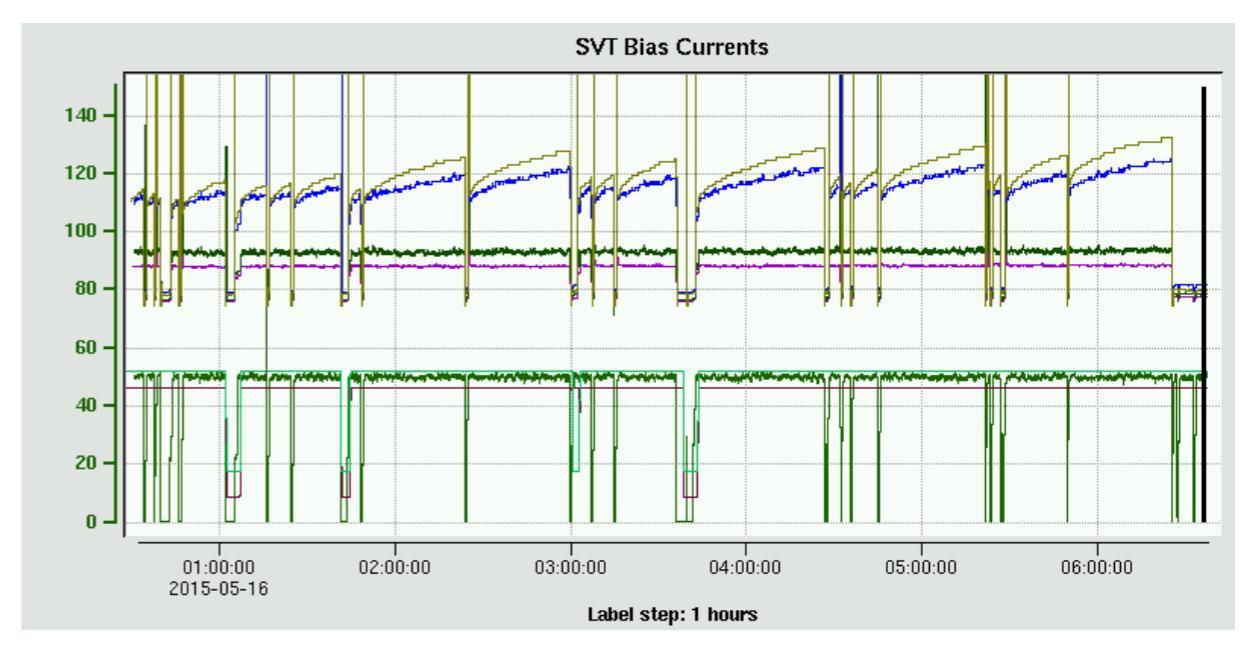
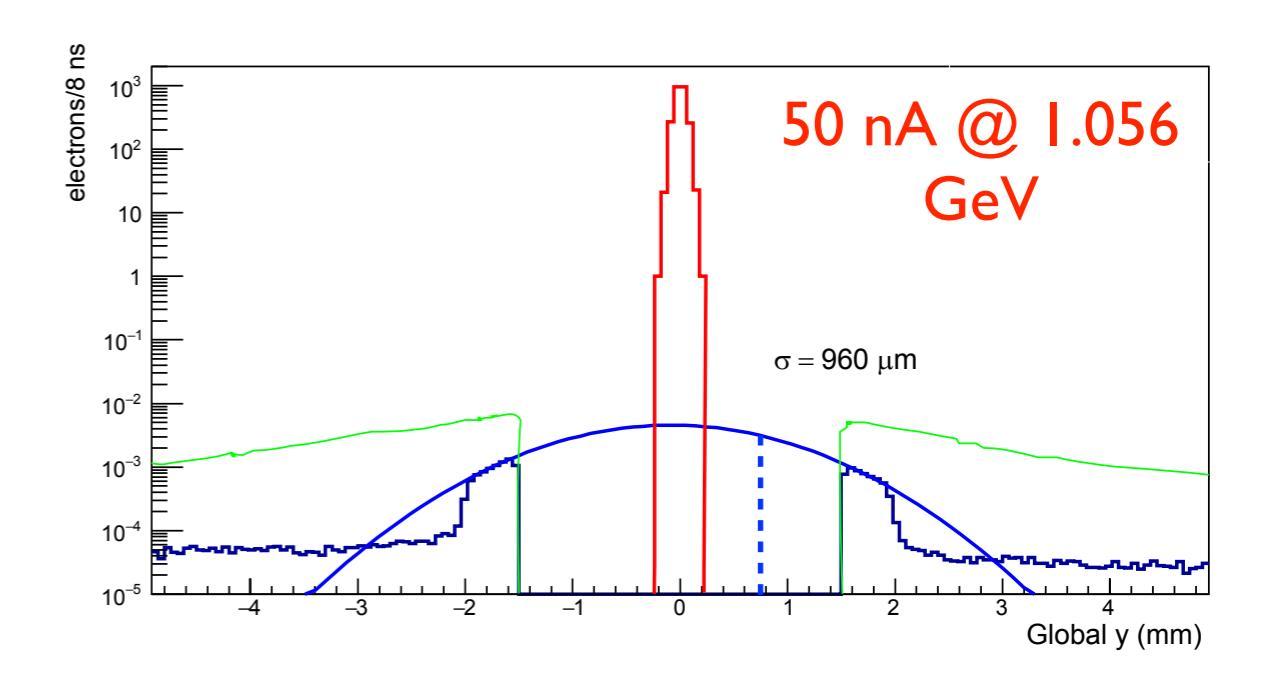
Expected observations

- increases in bias currents from bulk damage
- SEU counts in FEB FPGA monitors, but no clear instances of data corruption

Unexpected observations

- surface currents from x-rays in L1 front side.
- beam tails
- low-charge hits (from high noise) in samples acquired during readout of header (observed at CMS also)
- Problems w/ corruption of SD cards in RCE.
 Mitigated by DAQ updates.

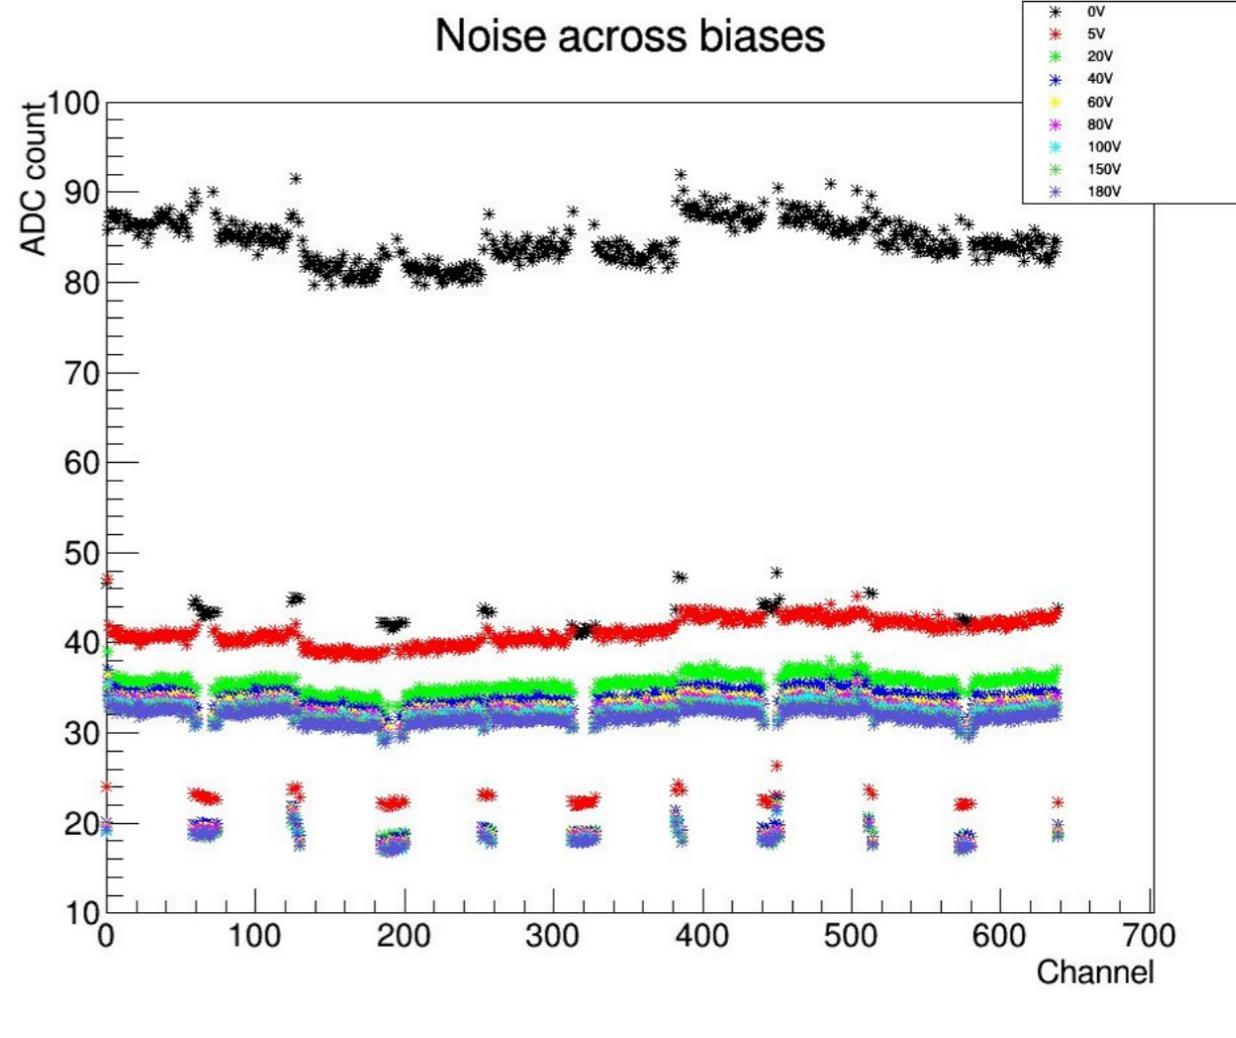
Some sections of low-noise channels observed, only on back side of Layer 6 (facing ECal), in the middle of each APV and between APVs.

Those remained stable during/after 2016 run, but some additional similar channels in L1-3, away from beam, again after 2016 run.

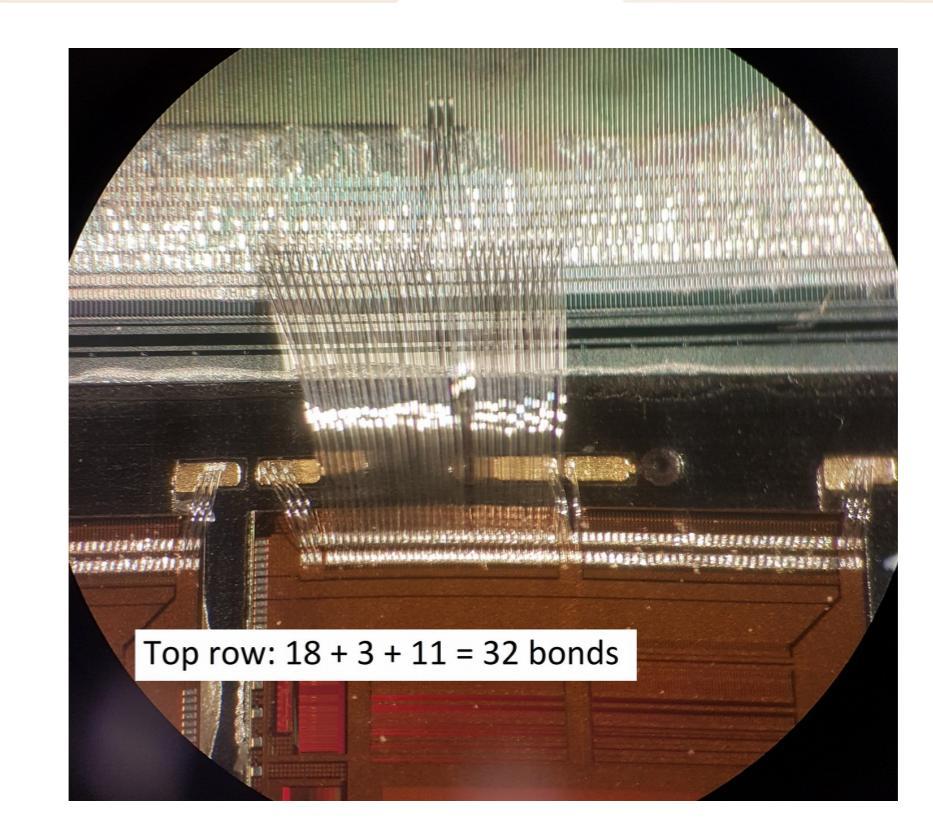
Wirebond Damage

Cameron's investigations indicate wire bond damage

Less clear exactly what caused this

- Sylgard (esp. 186) is tried-and-true material for >30 years. Problems have been rare and involved unusual geometries (not like ours)
- CMS and ATLAS *had* recently decided that Sylgard was 100% trusted solution for upgrades.
- Everyone now looking at this more carefully
- CMS starts to see problems with 80C swings.

Localization suggests more than one causative agent

- Entire back of L6 pump oil contamination? (crude test show ~1% swelling)
- Occasional outer edges of L1-3 CTE stress (40 C swing gives ~1% differential)

Al-1%Si bond wire breaks at about 1% elongation...

- Removed Sylgard and wire bonds from one sensor and re-bonded.
- Channels are recovered.
