# TTC High Q WG meeting -

### Quench studies 9 cell cavities for LCLS-II prototype – Preliminary as of Feb 25<sup>th</sup> 2015

Ari D. Palczewski, SRF Scientists Jefferson Lab, USA 02/26/2014

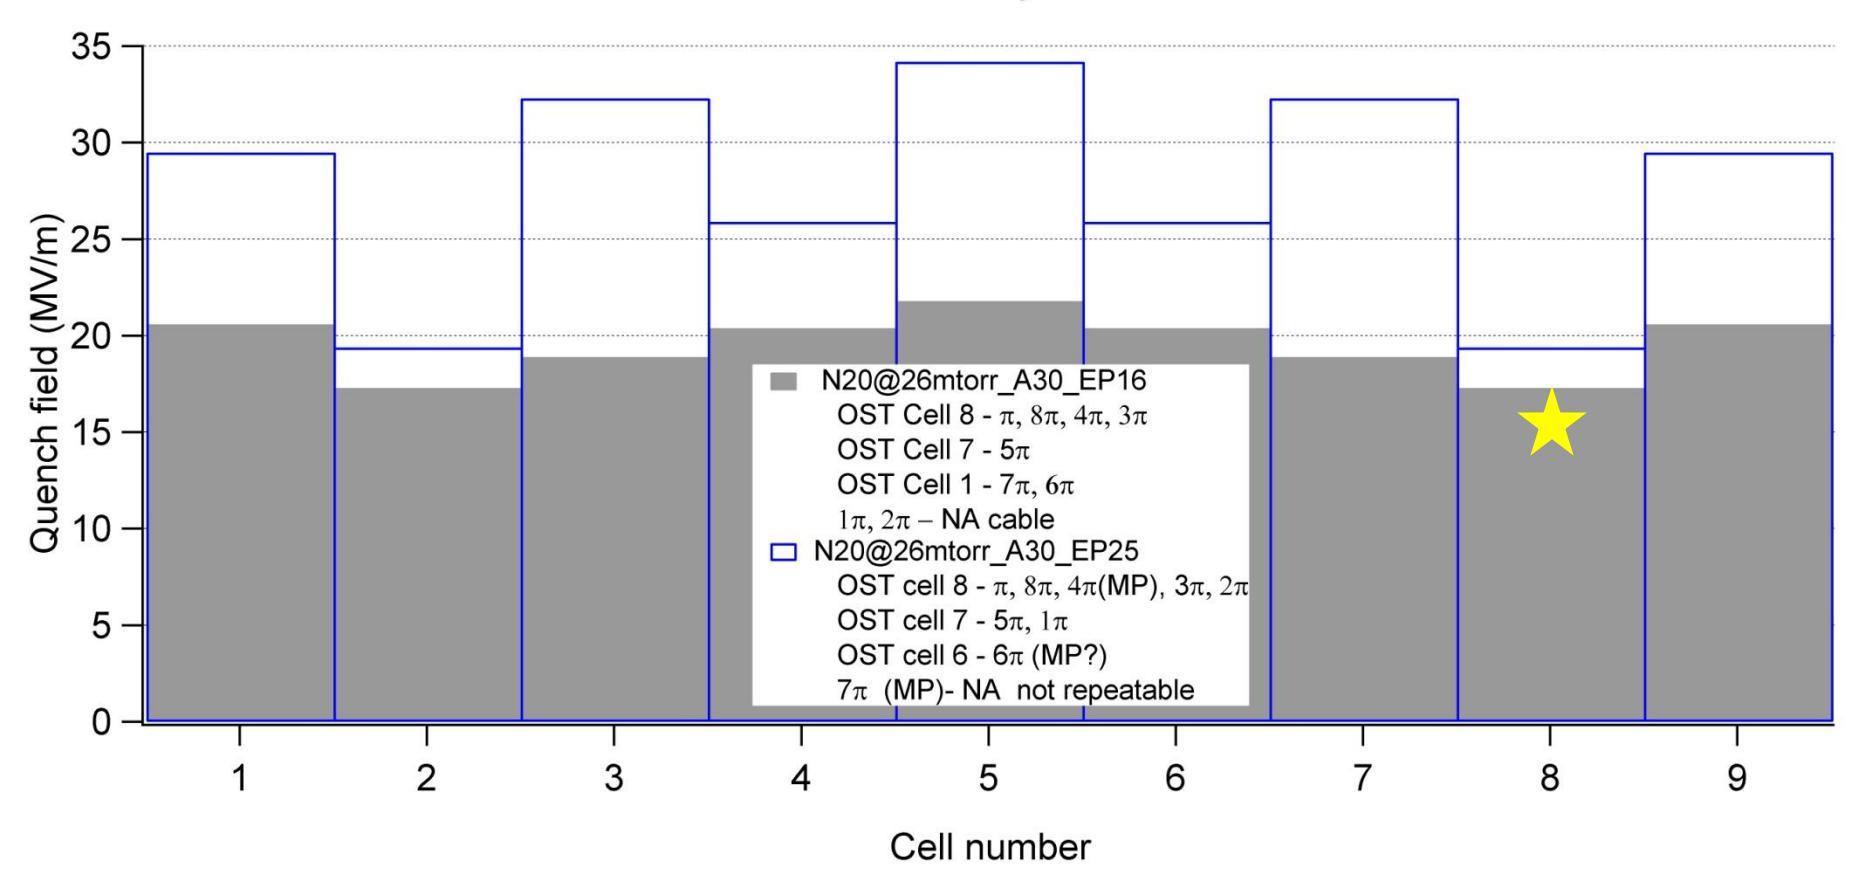
#### Quench Mode Analysis TB9AES031

Same quench location in Pi mode for both tests

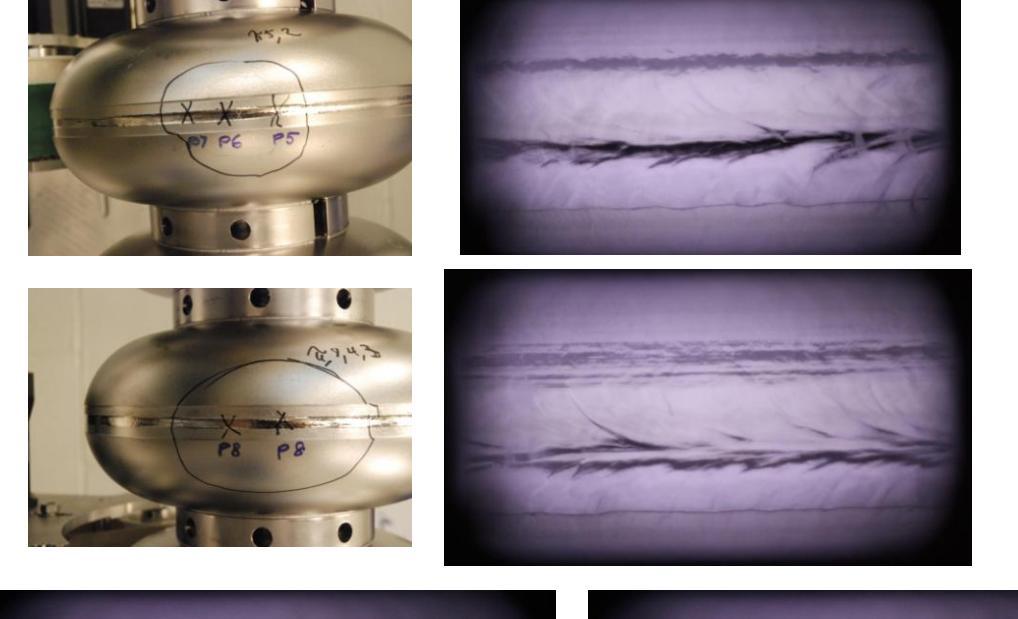
Cell 7

Cell 8

No defect found

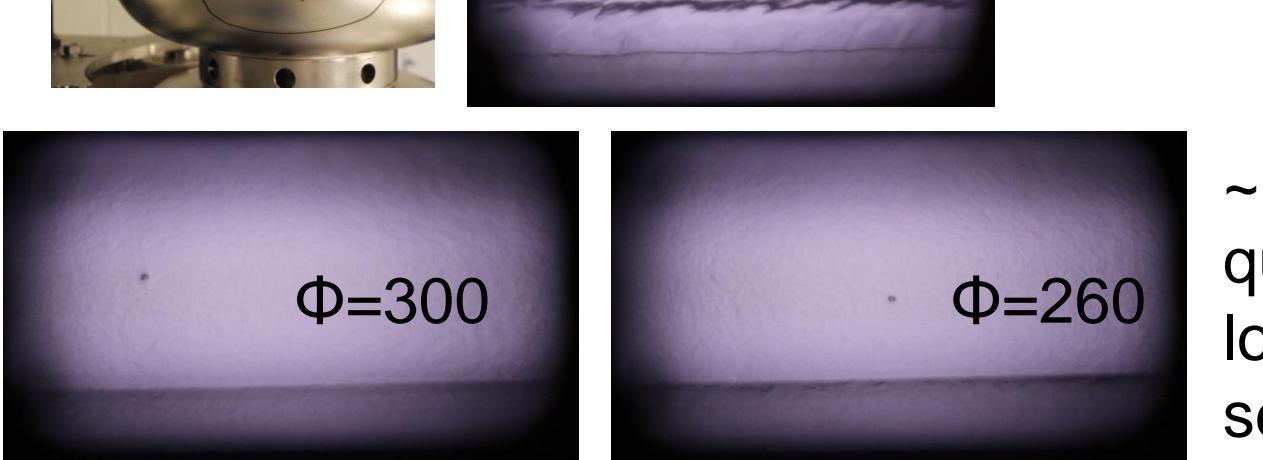
Cell 6

### No defect found

~ cell 6 quench location after second EP

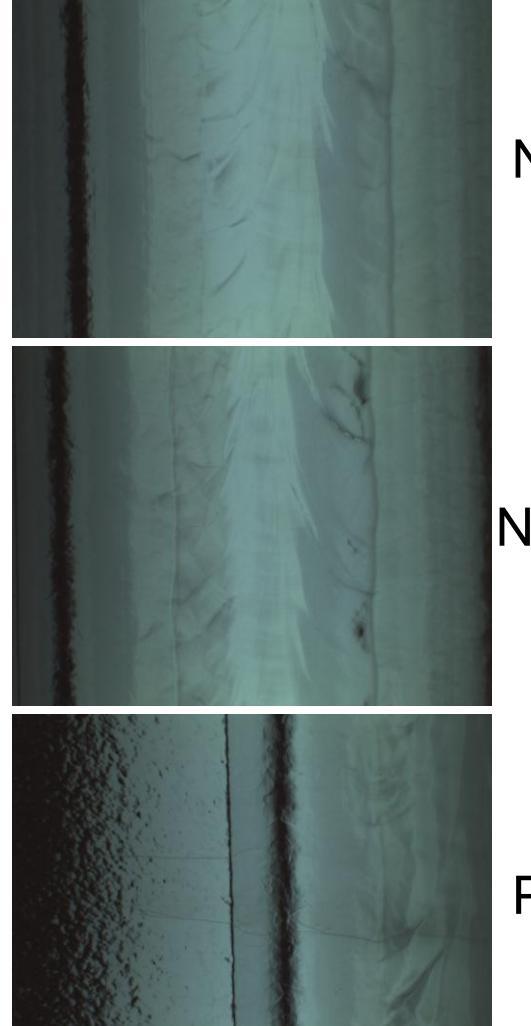
Cell#8, fusion zone, inside OST circle angle = 280 degree

Cell#6 quench site angle=190 degree

**Cell#9 quench site**, Machining line edge angle=170 degree

Cell#8, fusion zone angle=150 degree No defect found stain away from quench (benign)

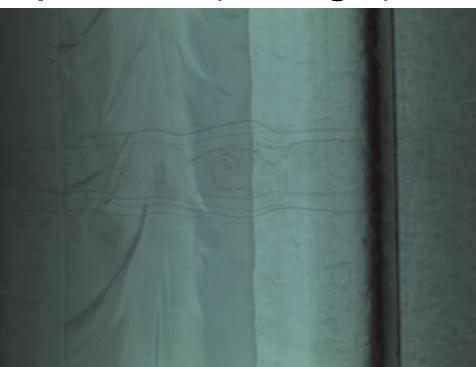
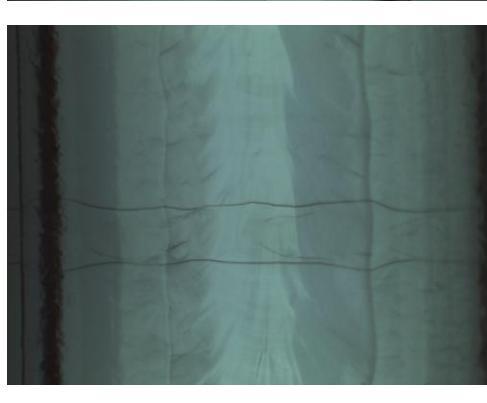
No defect found

Possible stain

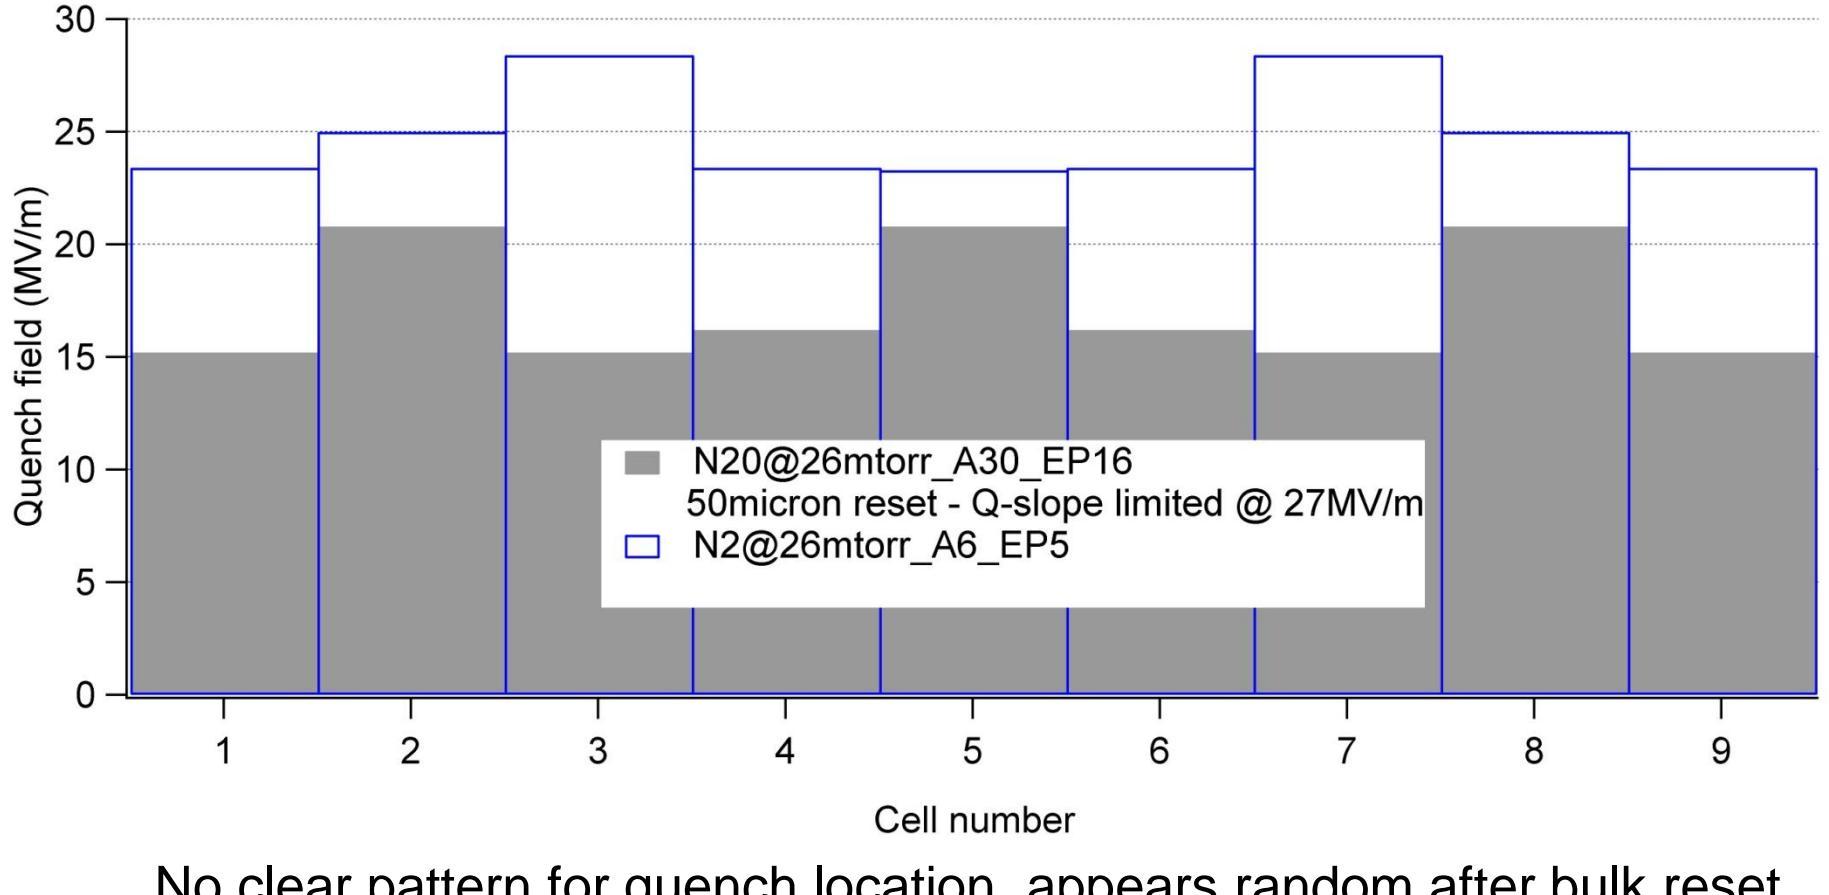
#### Quench Mode Analysis TB9AES035

No clear pattern for quench location, appears random after bulk reset and re-dope

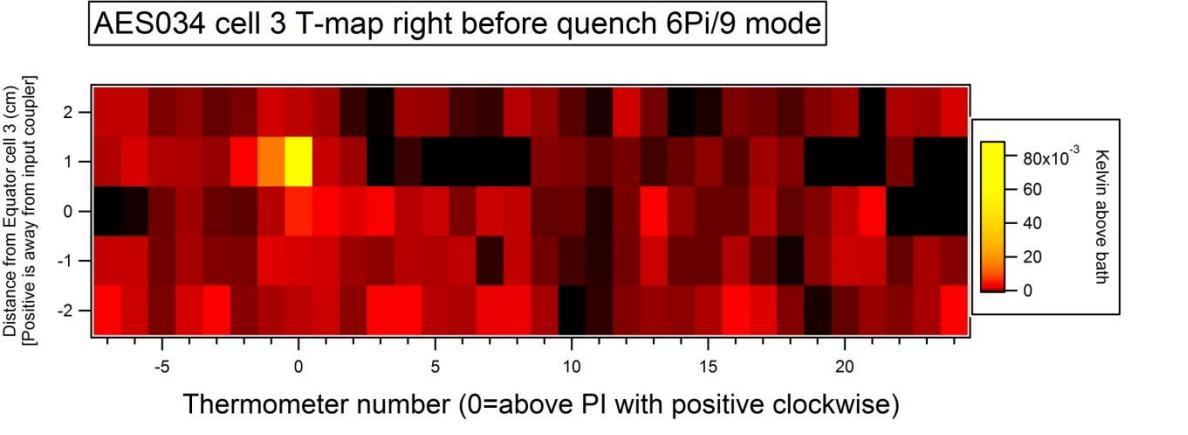
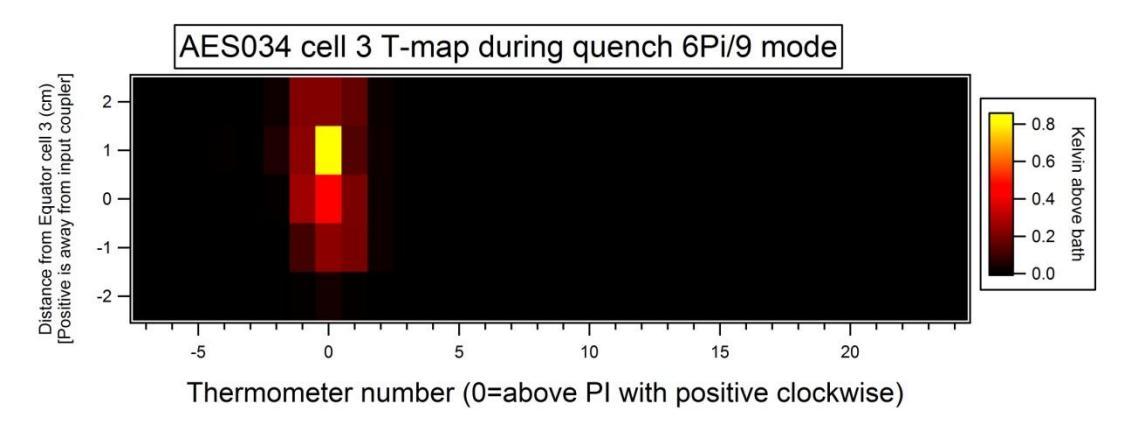
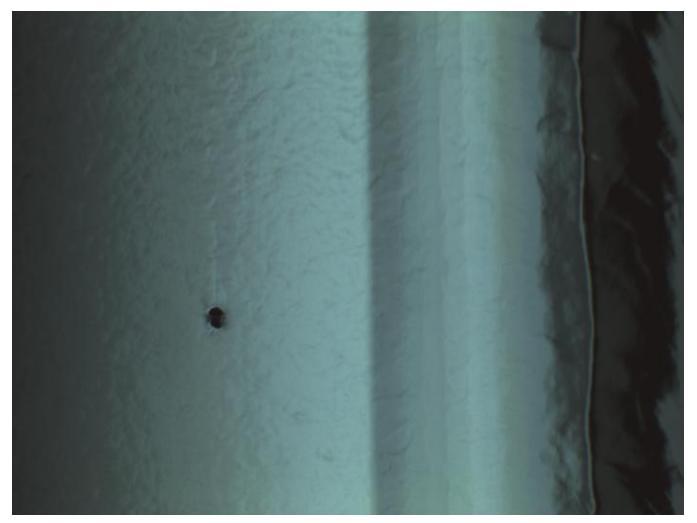
# **Optical inspection and T-map TB9AES034**

Most outstanding feature 200 micron dia. Deep pit Leading candidate defect for quench at 11 MV/m during vertical test

Multiple other defects found – sent for CBP  $\sim$  120micron

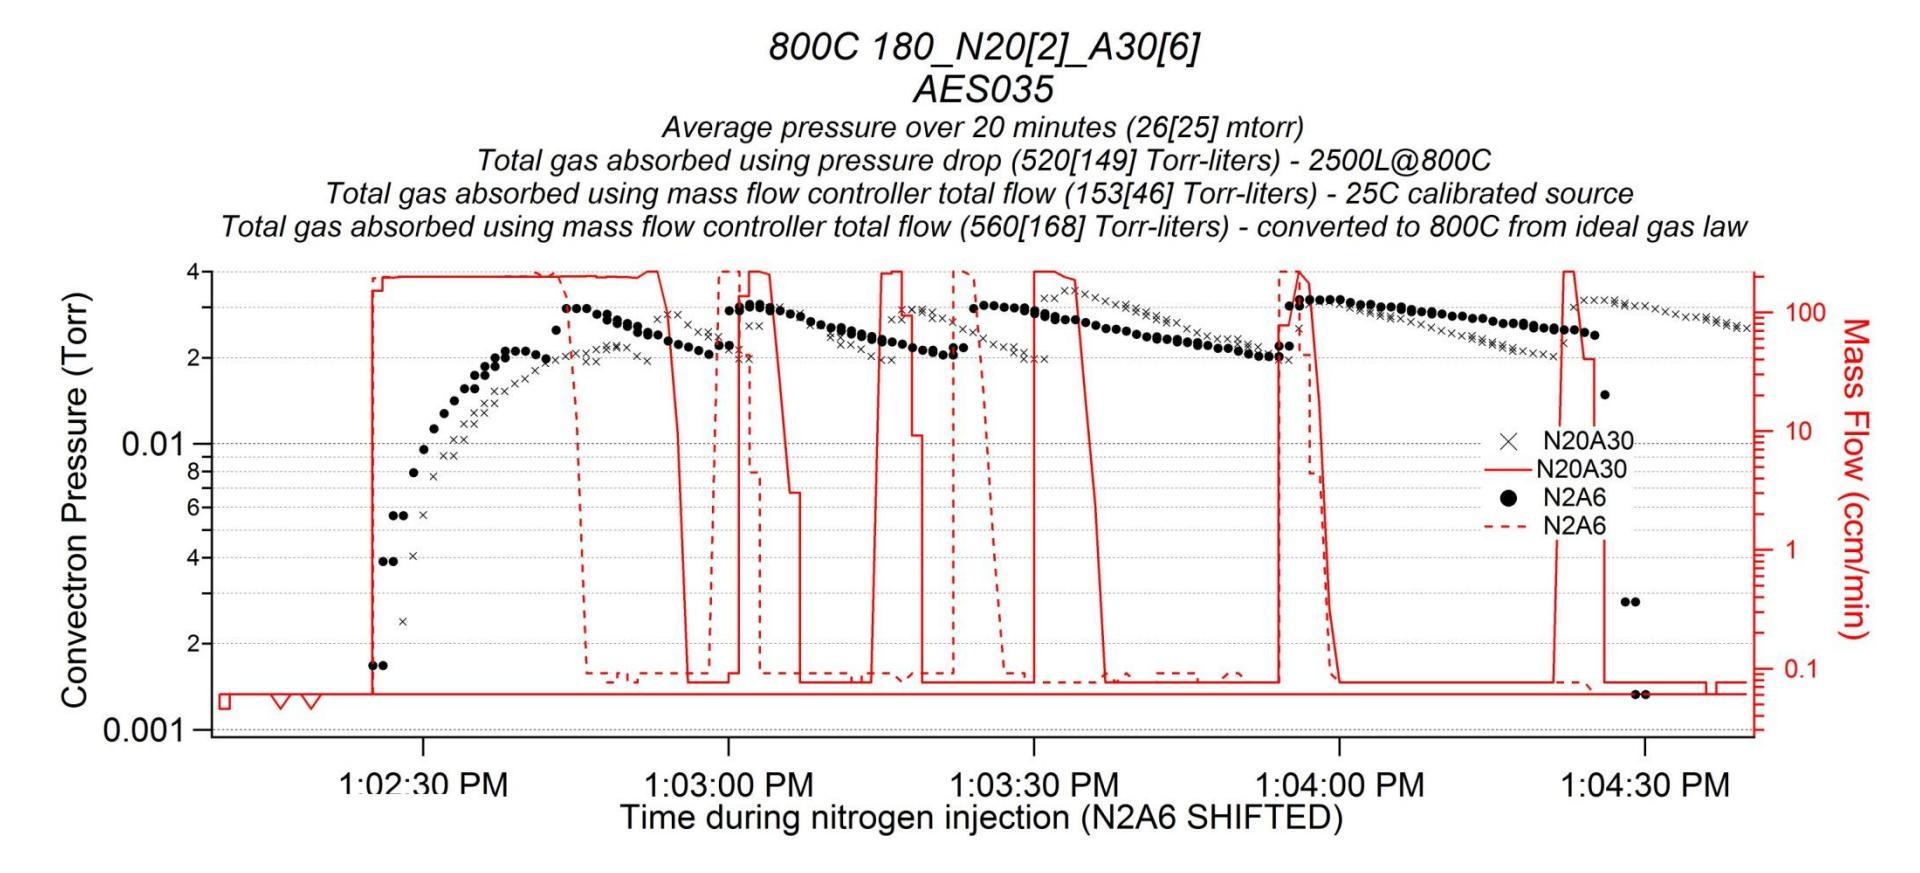
### Side note - Re-doping Furnace data

Outside of cavity already was heavily doped so absorption rate in second round is less (first two minutes)
