2015 Operations Stay Treat

- CHL2 4K Cold Box Modifications
- SC1 2K Cold Box CC4 Failure
- Helium and LN2 Losses
- Contamination

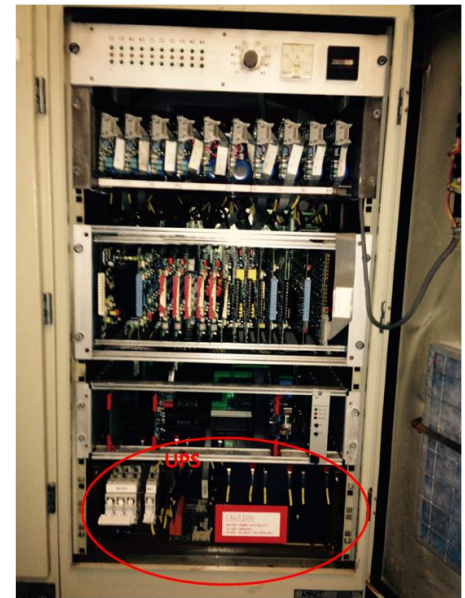
Cold Compressor Bearing Controls

- Cold compressors
 - Multi-axis magnetic bearing
 - Each cold compressor has a magnetic bearing control cabinet
 - Each cabinet has UPS for protection during power outages
 - Electronics monitors speed to determine when required
 - UPS holds bearings until speed ramps down then turns off
 - UPS has a test button which is used when system is prepared for operation at the end of an extended down

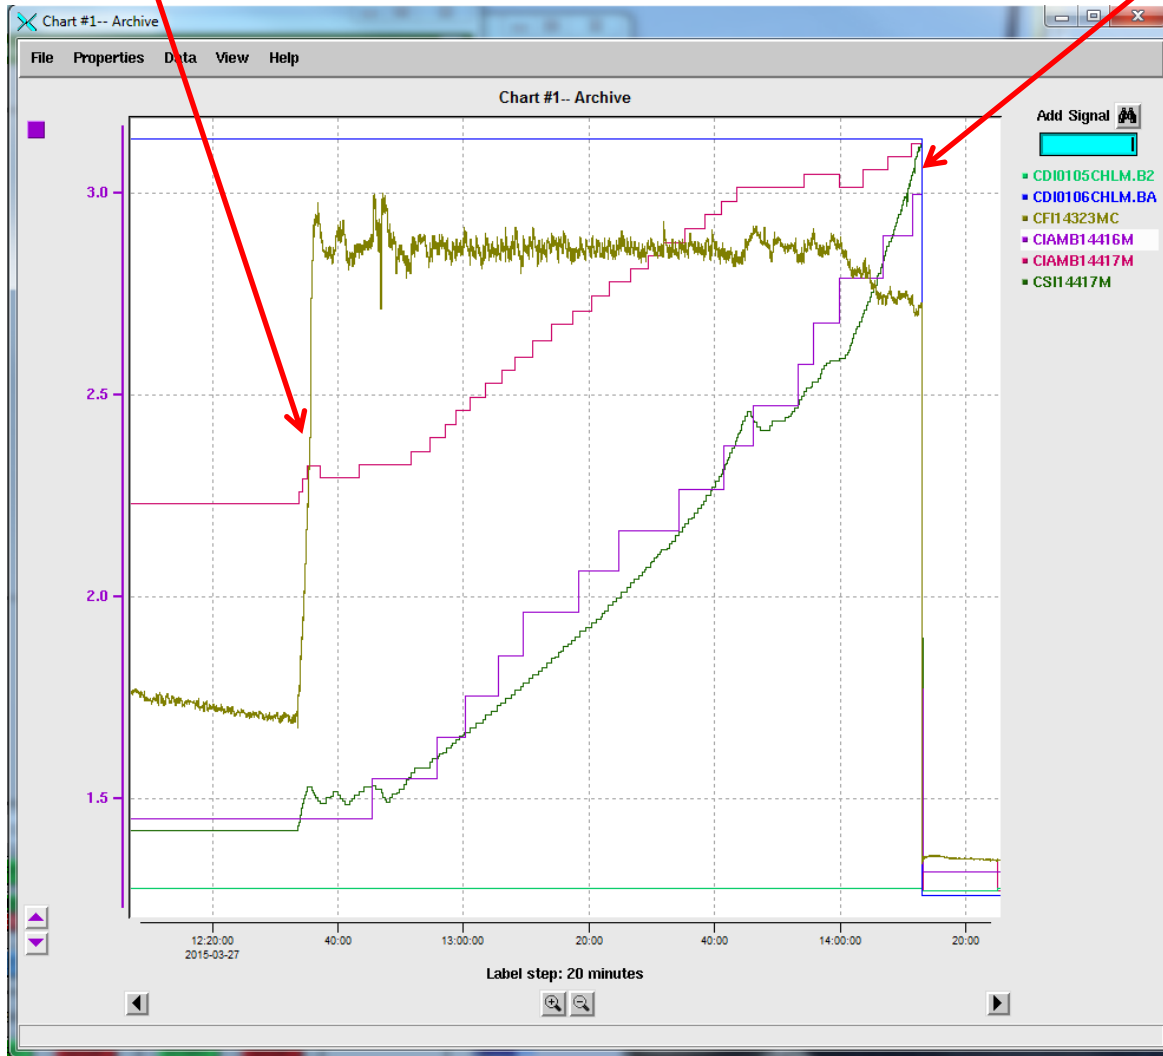
SC1 CC4 Failure

- Site wide power outage
 - CHL1, CHL2, ESR, and Hall D plants shutdown
 - Systems were secured and prepared for restart
 - SC2 brought online first
 - SC1 pumpdown started two days later
 - Magnetic bearing cabinet reported normal conditions
 - Two hours into pumpdown the compressor failed

Start of pumpdown

Mag Bearing Trip

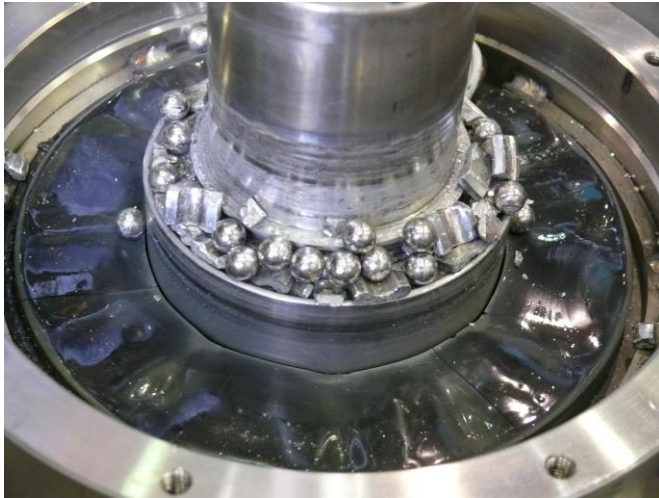
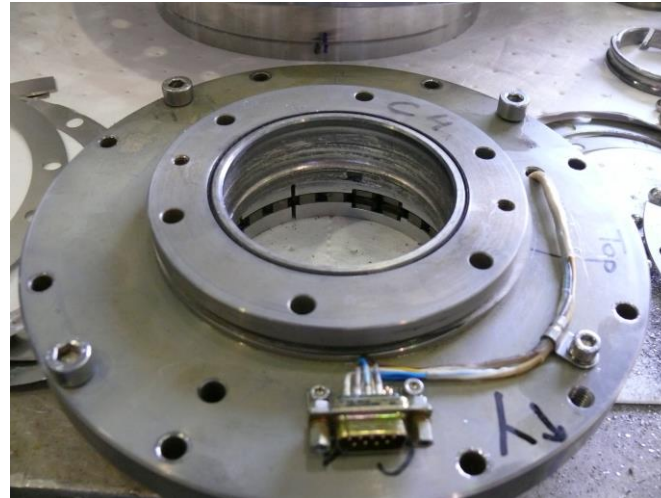
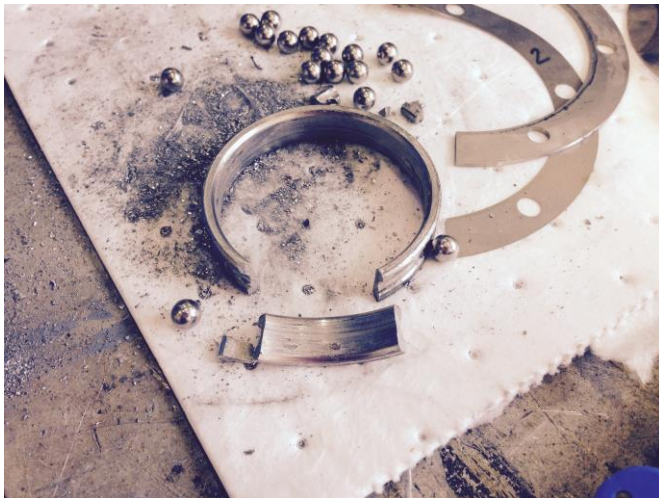
SC1 CC4 Findings

- Backup ball bearing failure
 - When rotor fell bearing 0 to 35,000 RPM instantly
 - Inner and outer races shattered
 - Balls damaged
 - Shaft scored
 - Position sensors damaged
 - Air Liquid and S2M working on estimates
 - CC4 repair
 - Balancing spare wheels
 - List of recommended future spare parts

- Investigation
 - UPS test function
 - Applies a high wattage resistor across batteries and measures voltage drop over time
 - Does not test actual detection and switching functionality
 - New UPS test designed by JLAB
 - With compressor at zero speed
 - Simulate speed input with function generator
 - Turn off circuit breaker
 - Time 5 minutes
 - Turn down speed until UPS turns off
 - Perform at start of operation and after any power outages

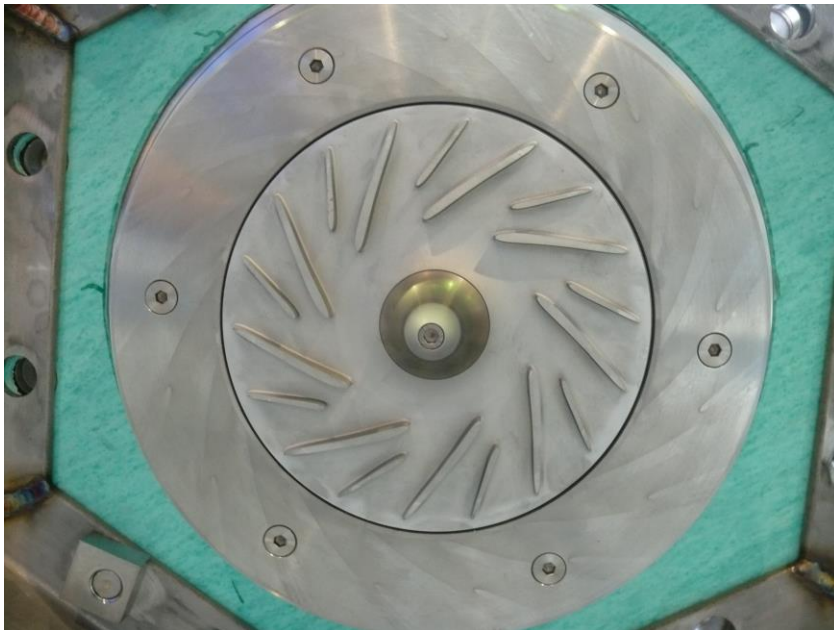
SC1 Repair Using SNS Compressor

- Moved our wheel and backplate to the SNS compressor
- JLAB modified SNS compressor
 - LN2 supply and LN2 return connections
 - Magnetic bearing power and controls feedthroughs (x4)

- Estimate about 1 months of work remaining
 - Pull a vacuum on process piping
 - Check bearing controls
 - Test run compressor (balance and bearing control)
 - Visit from AL/S2M to certify bearings ready
 - Install vacuum shell and establish vacuum
 - Clean up system
 - Utubes and cooldown
 - Test by pumping down

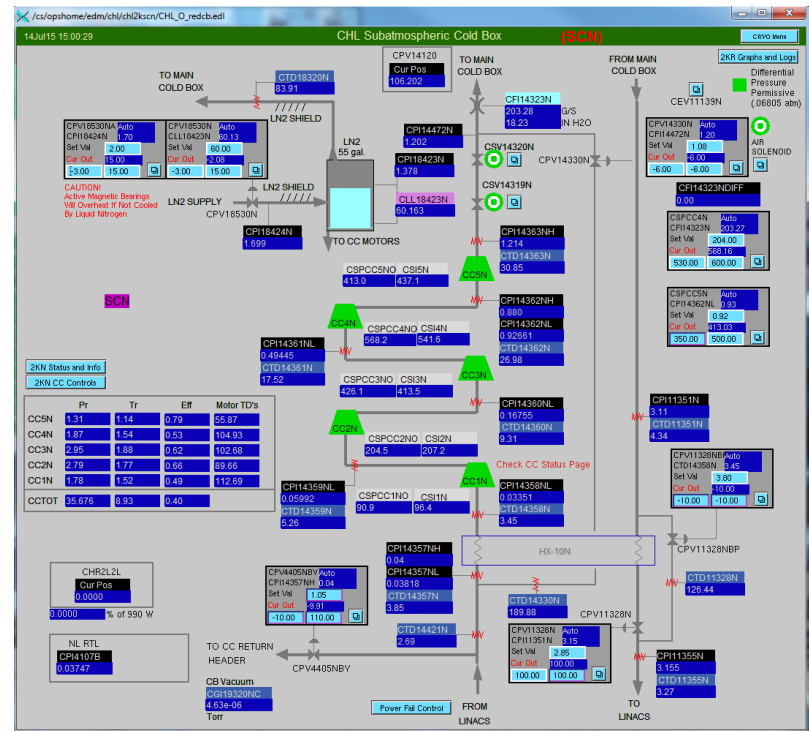
Contamination

- Following the power outage we had two episodes of contamination problems
 - SC1 CC2 froze in place
 - SC2 primary heat exchanger plugged
- Likely causes
 - Large number of utube operations performed during down
 - Subatmospheric relief valves leaking
