Status of DVCS Calorimeter

Kijun Park

Jan. 18, 2015

DVCS Collaboration meeting

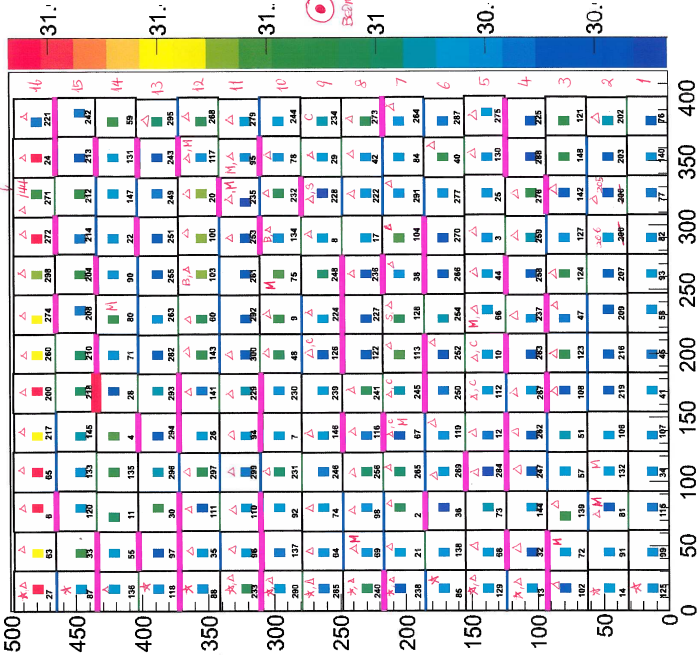
- Start de-stacking Nov.16 and completed Nov.18 (*Thanks to Tom*)
- *Many blocks were stuck together due the remnant of adhesive that used for shim*
→ *even worse during the experiment due to hot temperature inside of dark-box (talk about later)*
- *Take a note for any specific condition (broken brass/screw/optical glue/chip/...)*
- *Secure block in white box and store them into each container row-by-row*
- *Survey by RadCon group @ Nov.24*
- *Completed transporting all crystals to ODU @ Nov.25*

Plastic shim: ★
Metal shim: △
Broken Brass: D
Chip in face: C
Broken Screw: S

NOTE: option-2
shim: green: 0.005" (x38)
blue: 0.010" (x45) H1: 134
magnite: 0.015" (x55)
red: 0.025" (x11)

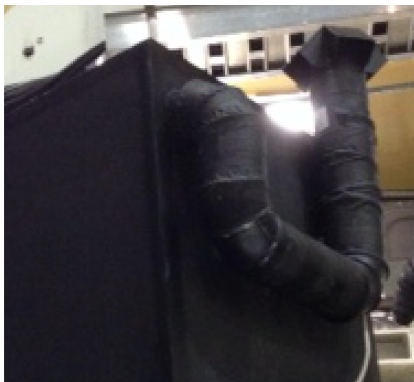
Active Air Cooling System

- New dark-box with active ventilation system (Thanks to Thomas Hartlove, ODU)
→ Two ventilate-fans (inhale/exhale),

- Sitting position: side & back of dark-box
 - Easy to attach/detach, polyken tape: light tight
 - Maze pipe: light tight
 - 4way-out of Dampered roof cap: light tight
-
- Model: DB204 (4x4-in duck fan)
 - 65 CFM free air (80 CFM as Max)
 - Thermally protected Class B motor
 - Weight: 1.5LBS

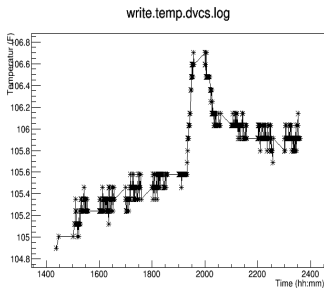
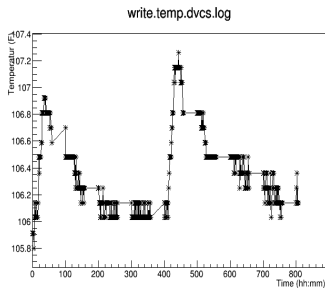
Temperature Monitoring with new dark-box @ Sep., 2015

- Starting Temp= 100°F (when LV/HV were off), see how much Temp. change
- Take a cosmic run (Run number= 11556)
 - Engaged LV/HV as cosmic mode
 - Temp. monitoring is running as cron job on dvcsdaq2
 - Run overnight (24hrs)
- Deviation of temp is about 7°F (4°C) as maximum between on and off the HV/LV
- Fan creates a little vibration (I can feel it by hand on the box), Check any impact on signal/pedestal

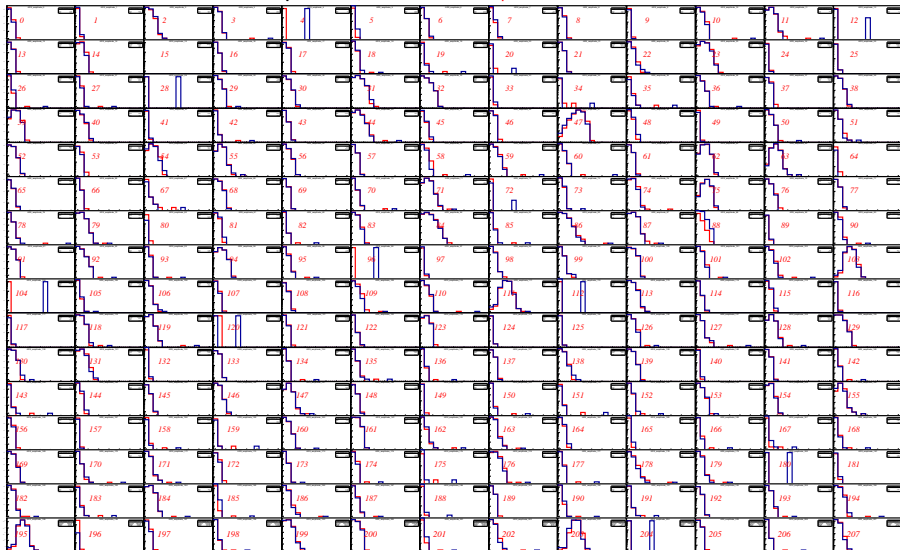
Pedestal Monitoring with new dark-box @ Sep.28, 2015

● Monitoring ARS after taking cosmic runs (Run 11573(fan-off;red) vs. 11584(fan-on;blue))

● Little electronic noise effect in pedestal 🔗 [Link in detail comparison](#)
