# The SVT for 2019: Status, Commissioning and Operations

HPS Collaboration Meeting @ JLab

May 29, 2019

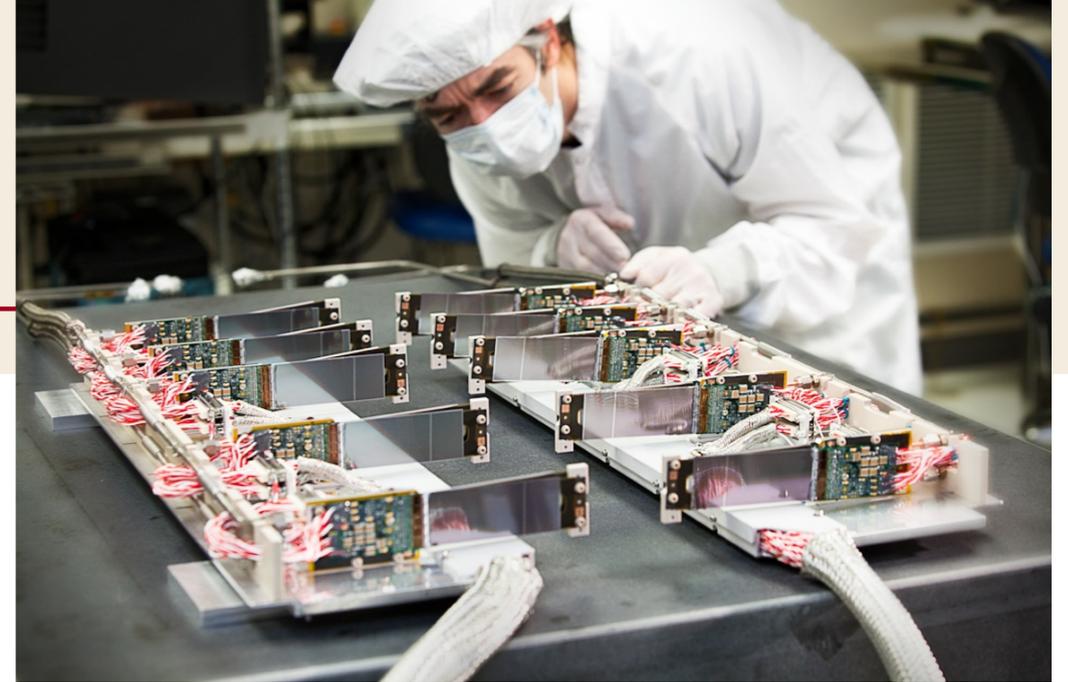
# SVT Test Run: Support, Cooling and DAQ

*Infrastructure was somewhat crude.*

- individually cooled modules:  
low flow, poor cooling for sensors
- skinny “support plates” and “C-support”:  
structures suffered significant static sag
- analog signals from APV25 driven out  
through flange to RCE DAQ ~3 m away
- reflections required FIR filter  
implemented in RCE DAQ (Sho!)
- RCE still too close for comfort -  
SEB of ATCA power supplies from beam
- CAEN supplies from CDF nearly unusable

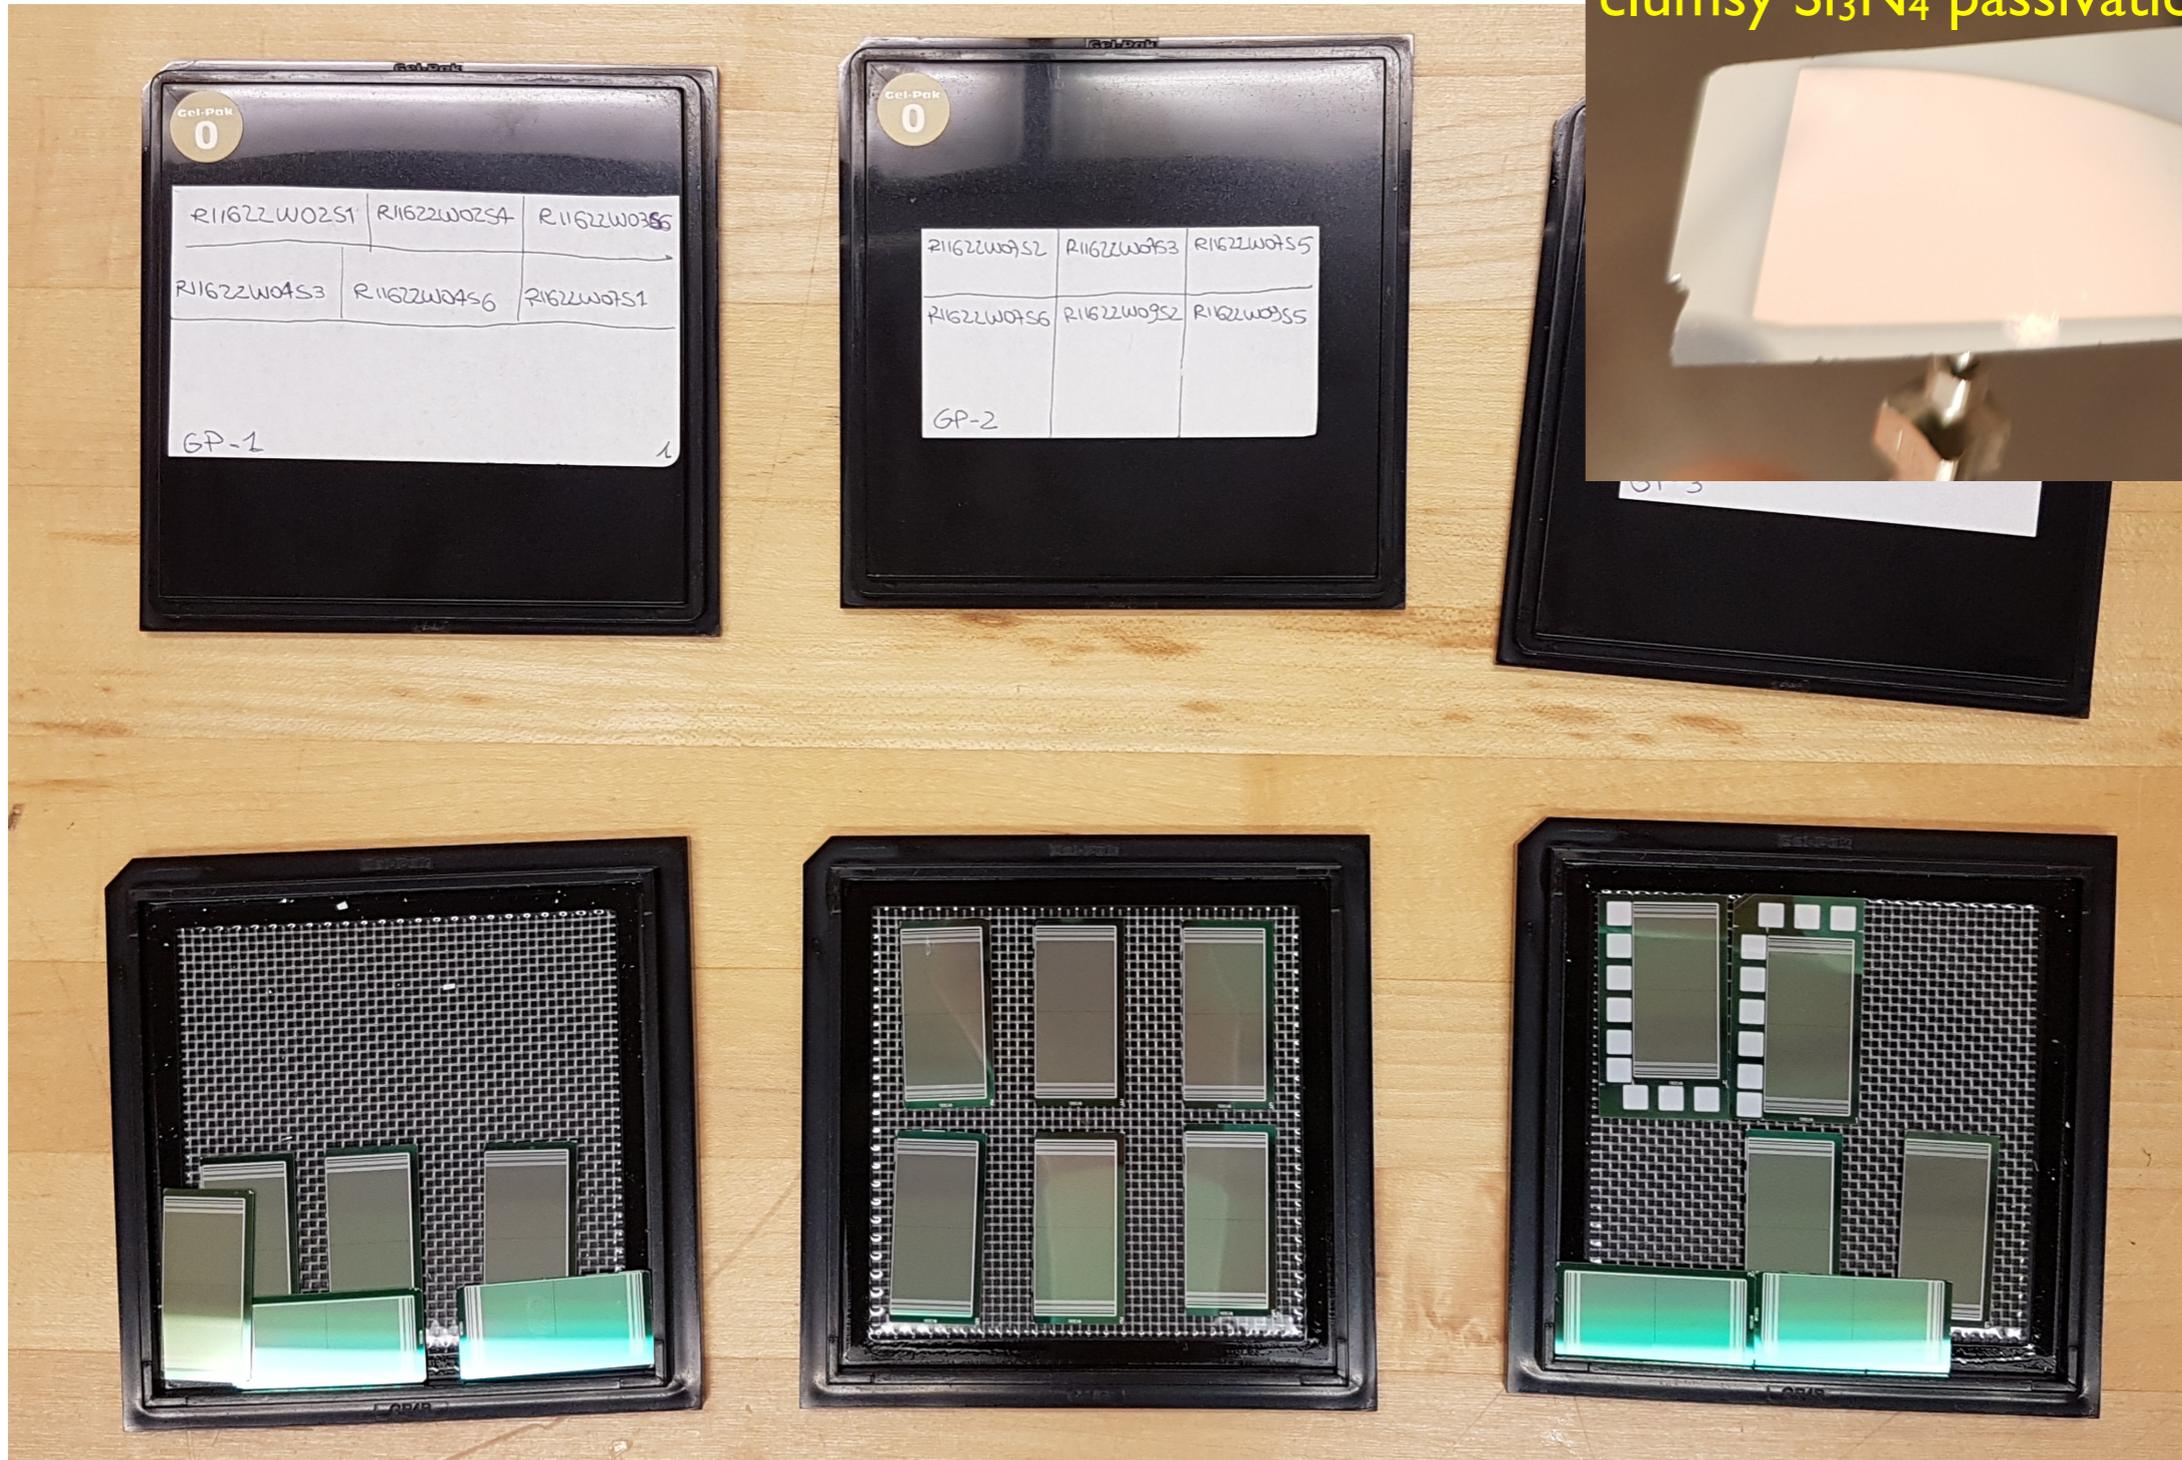
Packed for shipping in light-hold Gel-packs!

- First sensor shipment, poorly processed, some damaged due to improper packaging.
- Spent all time contingency understanding mitigations before instructing vendor on final processing and shipping remainder
  - ensuring our procedures not doing damage
  - baking sensors to grow oxide
  - investigate of alternate cleaving techniques
- Second shipment better. Of 20 modules built, 10 meet quality requirements, 8 of those use sensors from second shipment!
- Numbers allow L0 and replacement of L1, with bad channel rate of 1-2% (2015 detector was 1/10000) and *one* good spare stereo pair.
- Module production/testing completed 4/19, 1 month later than scheduled

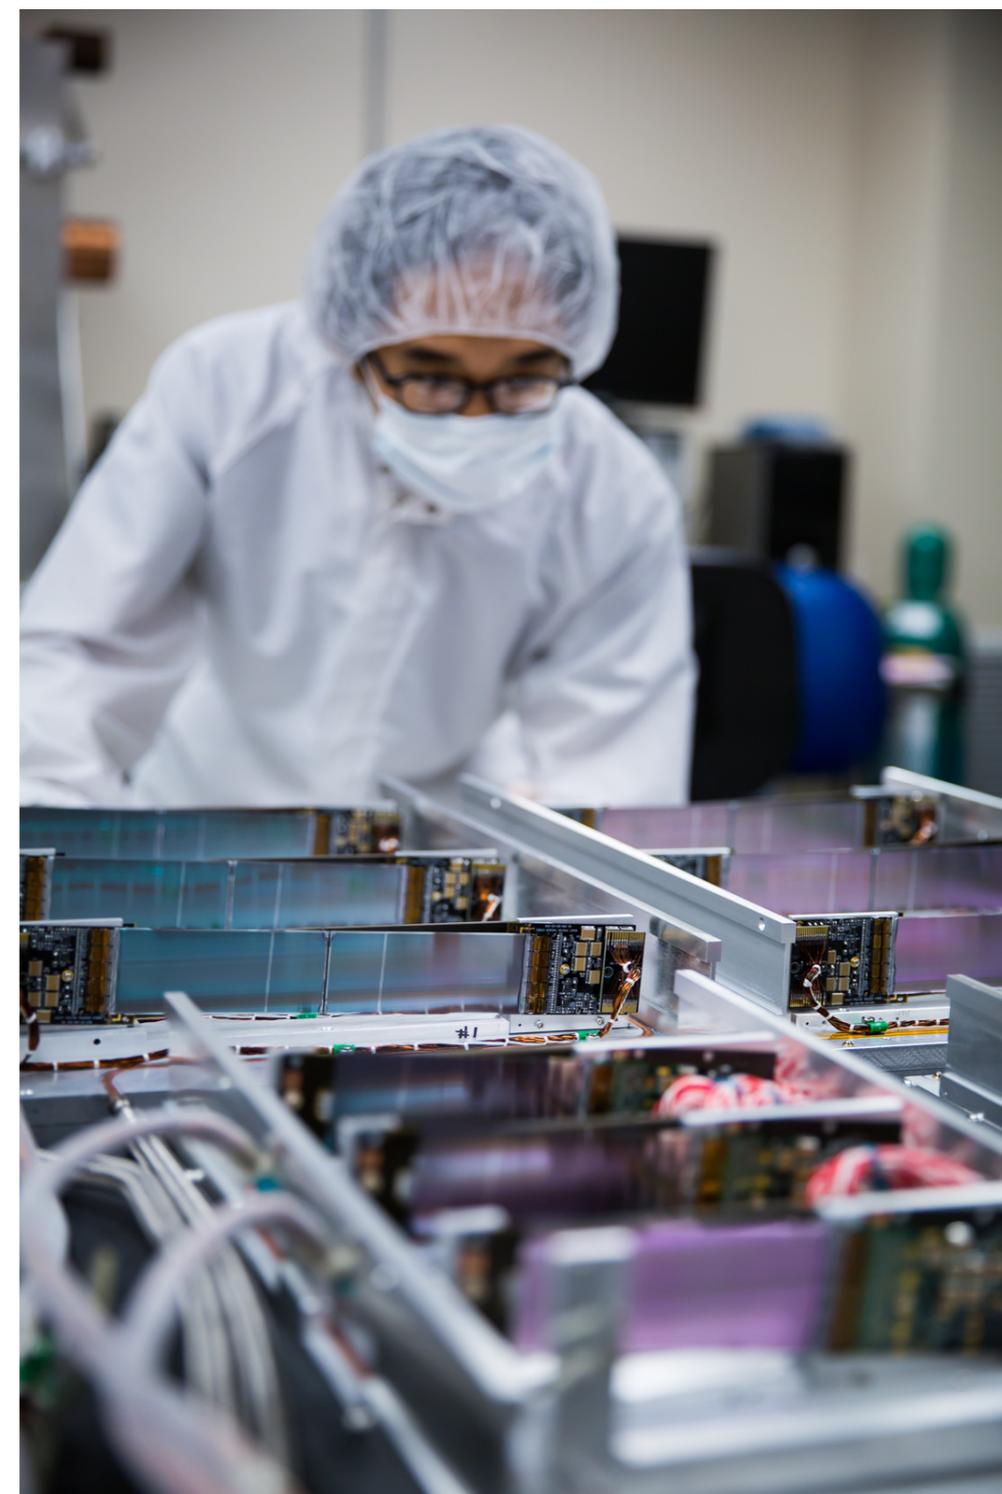
# SVT Survey and Testing

## Final testing in cold box at SLAC

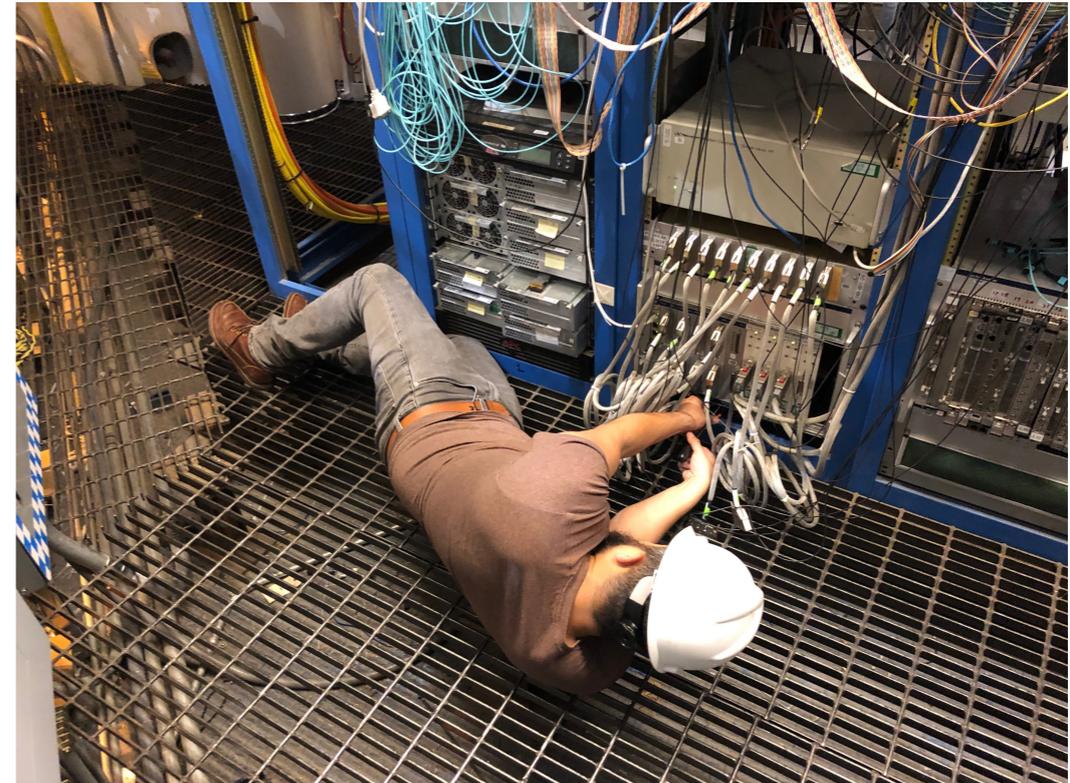
## Installation Plan Reality:

- FEB chiller contaminated with algae (limited testing until day 3)
- Not receiving data from **2** FEBs: L4b and L23t
- One of four Wiener MPOD LV supplies not working, and half of Wiener crate is blacked out.
- SVT chiller runs but won't cool, starts delivering errors.
- L4-6 looked as expected on arrival

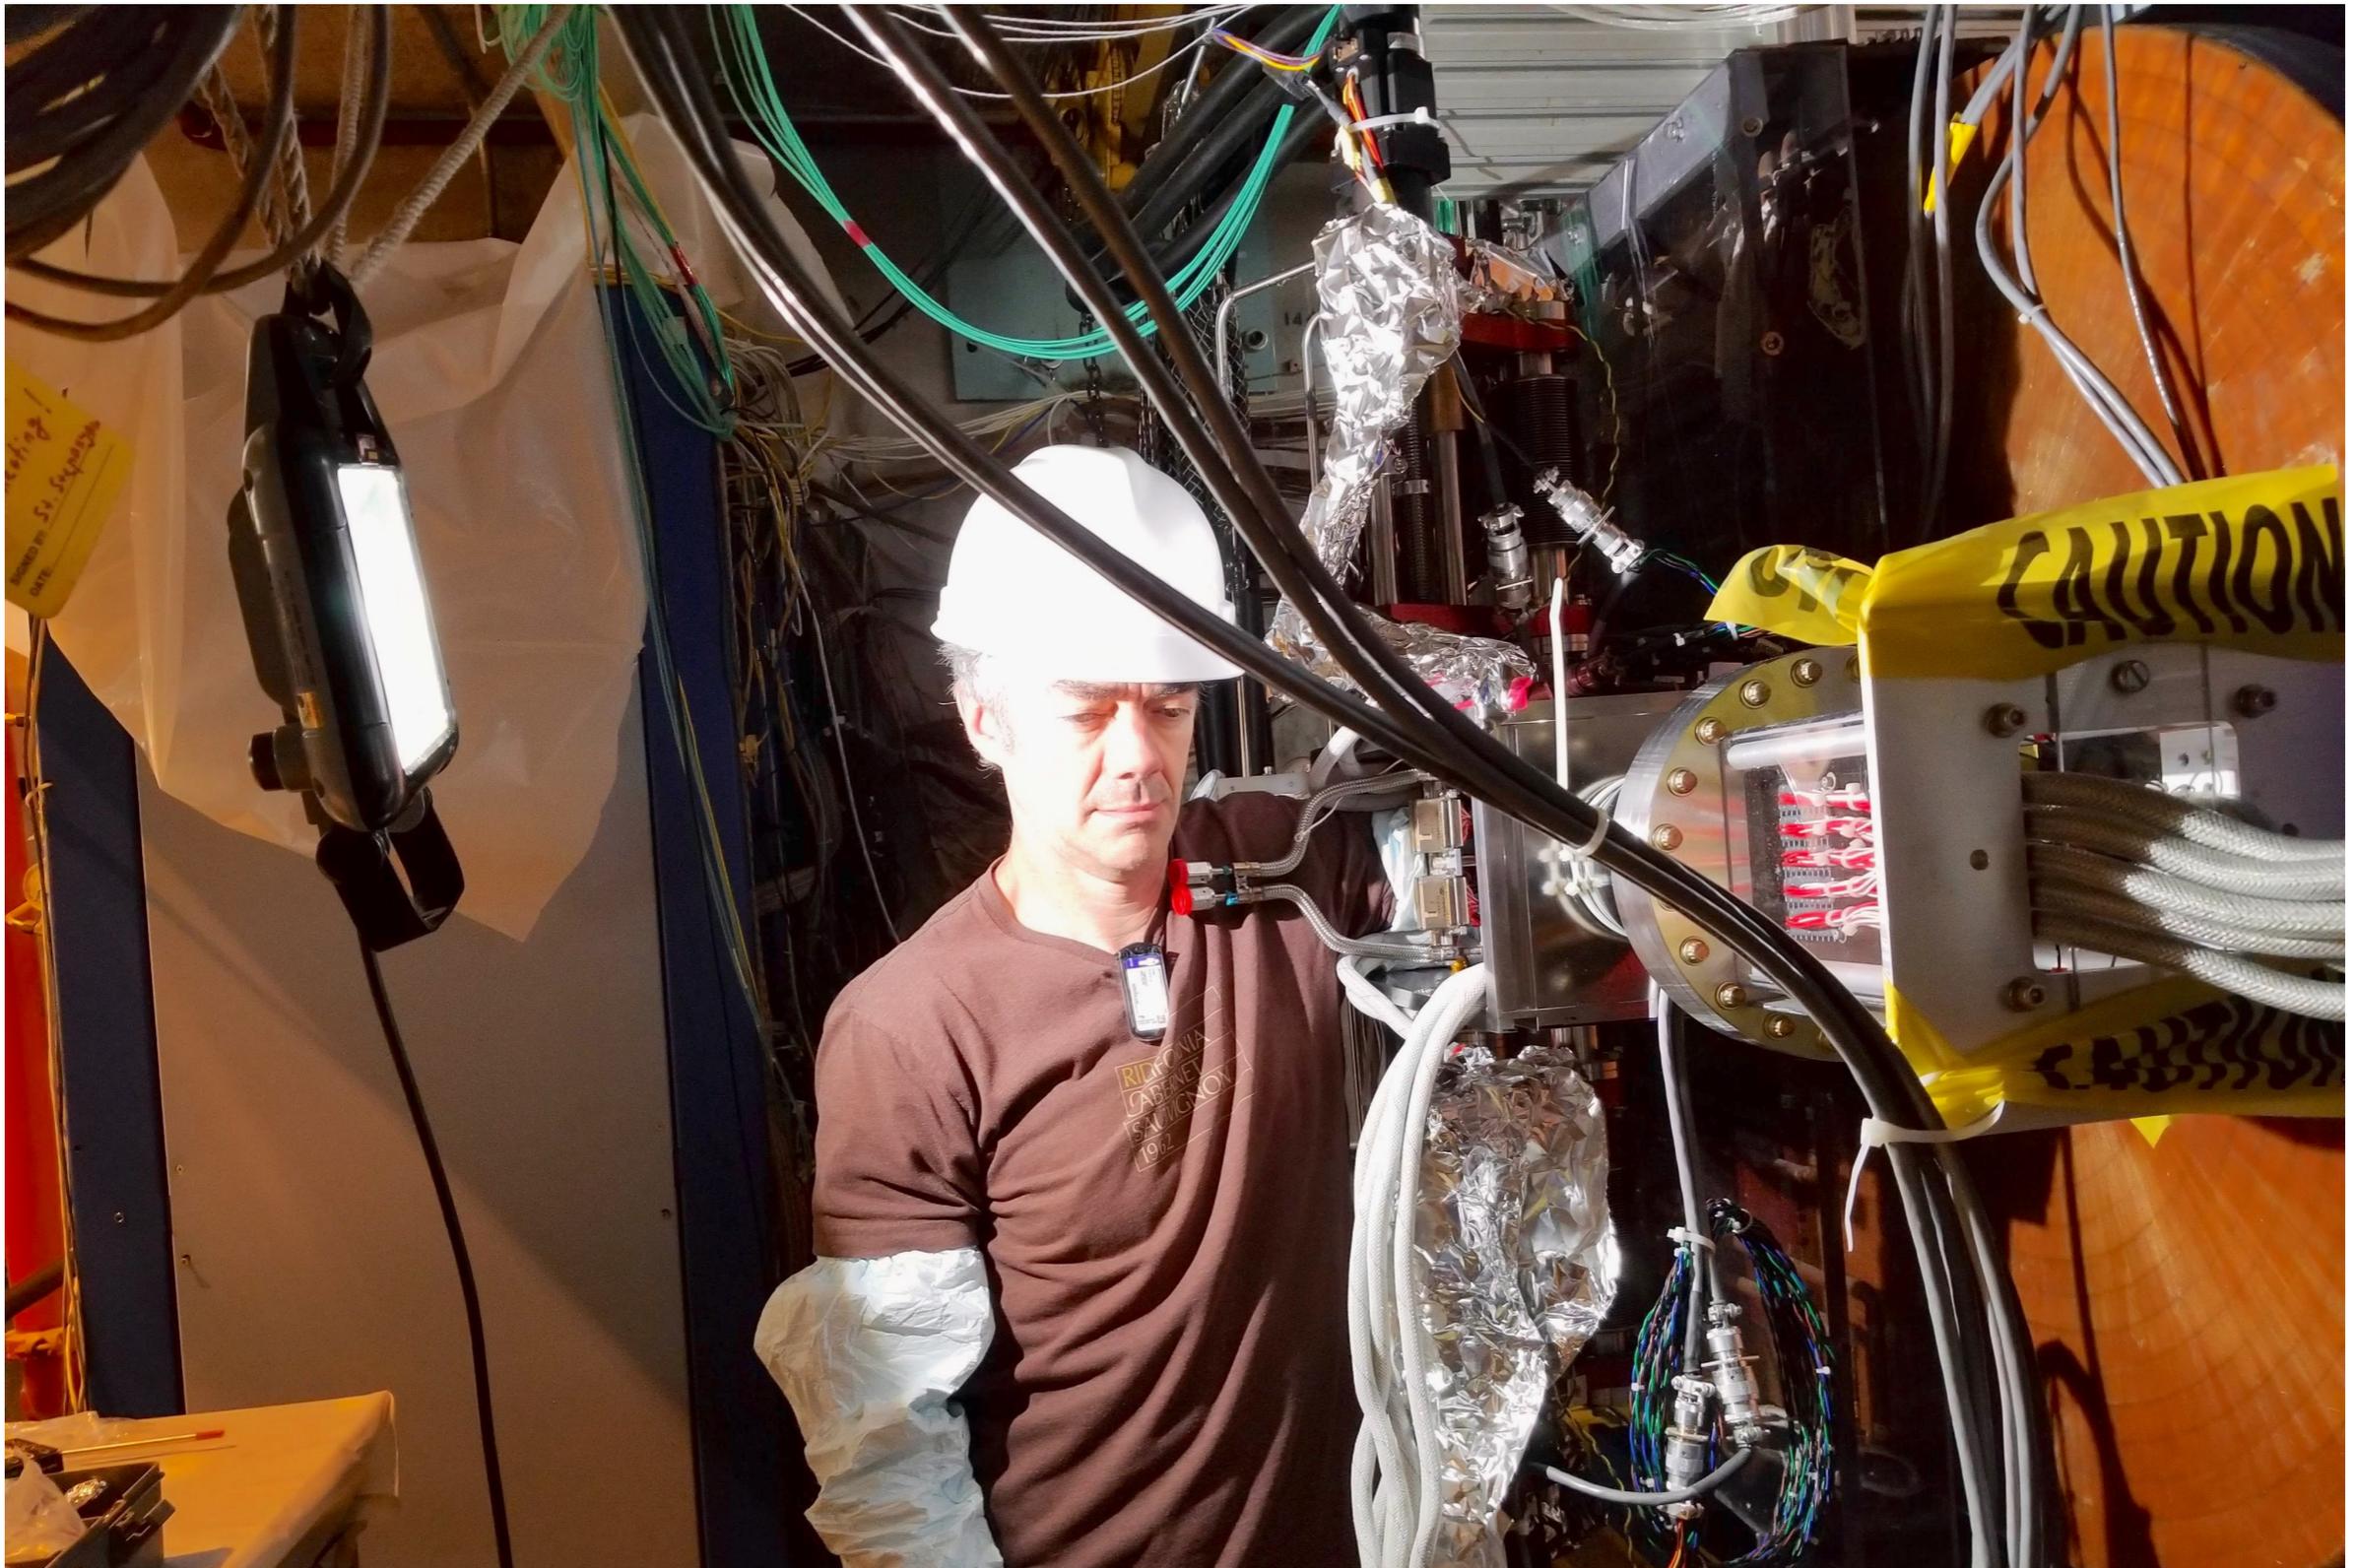
# Extraction and Installation of FEB Cooling Plate (Tim/Matt)

*Decided overall risk was lower removing the FEB cooling plate, so created an orderly work space in front of the alcove for L6 and FEB replacement work*

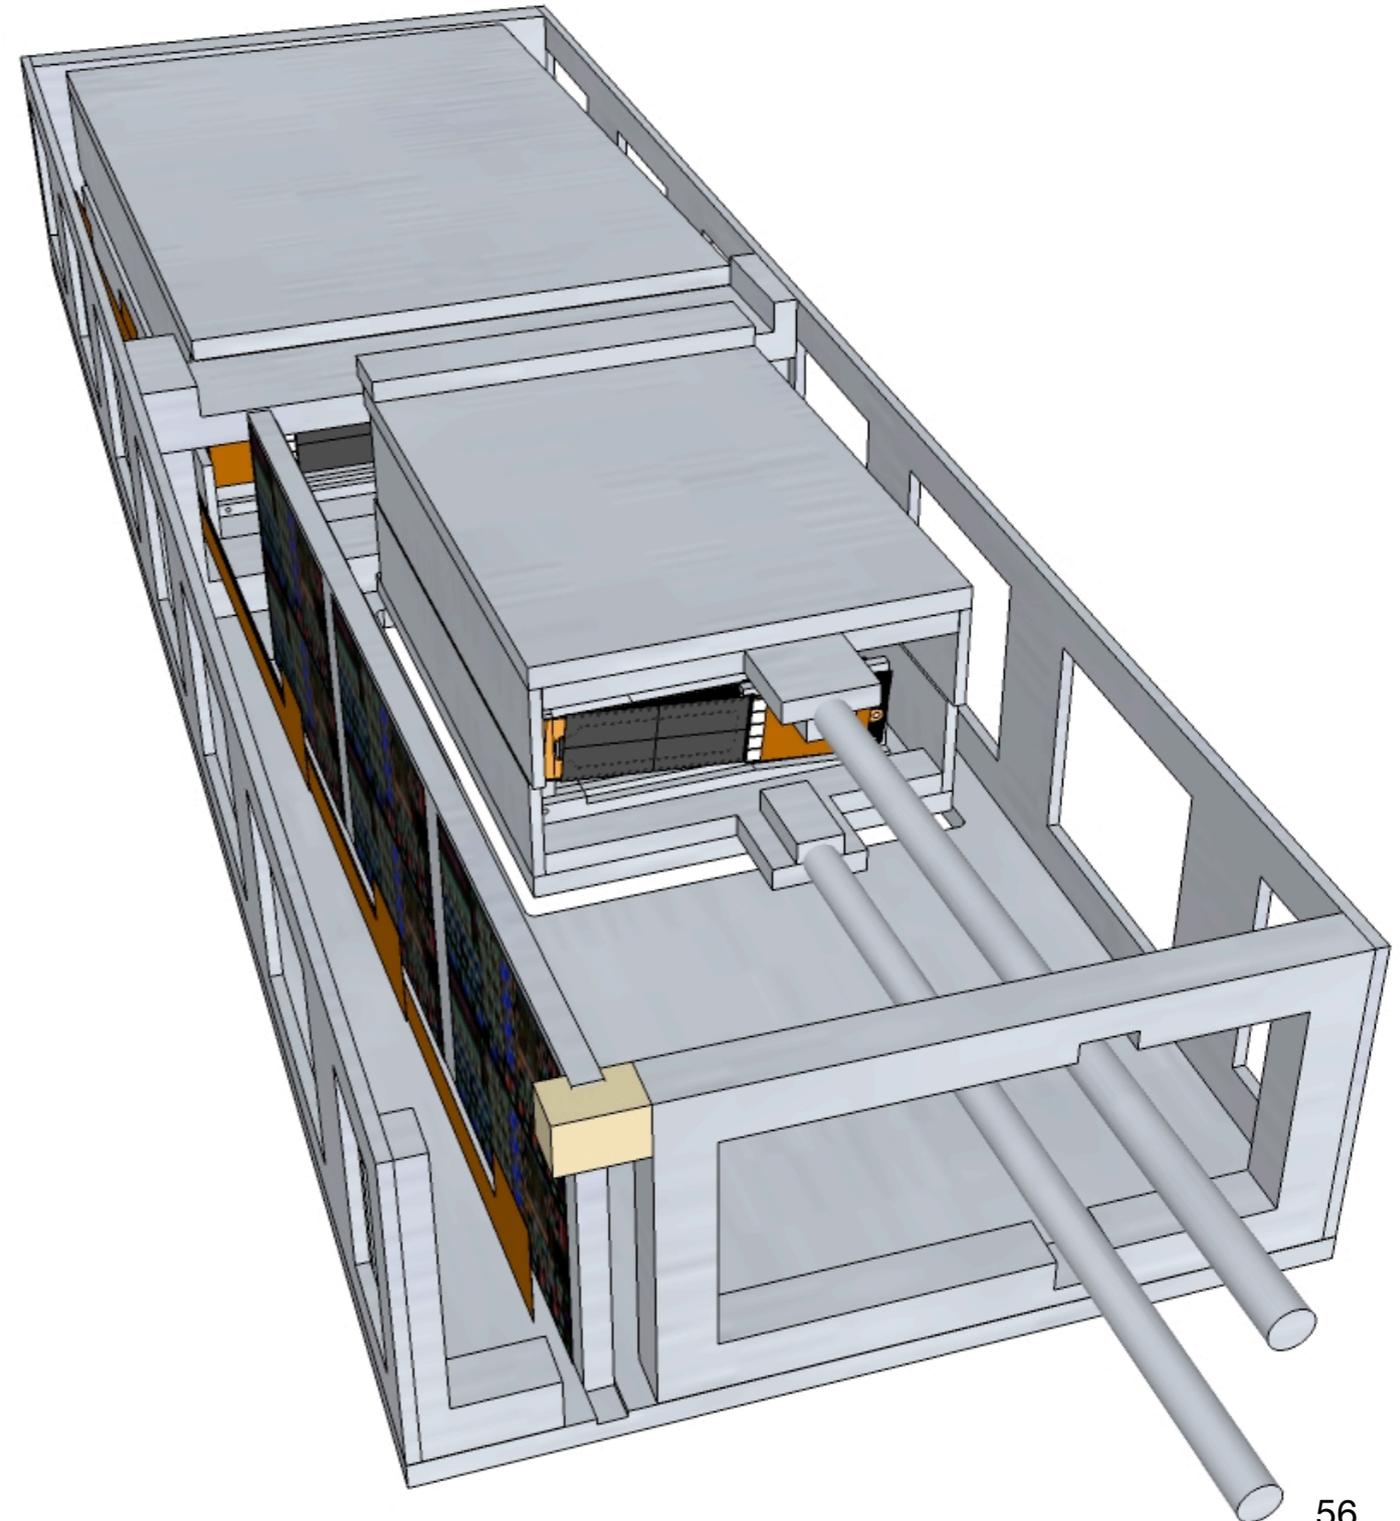
- Rigid SVT support box
- adjustable, 3-point, kinematically mounted u-channels slide in like drawers, are removable from ends
- Survey features on box and each channel at kinematic mount points
- FEB cooling plate slides out from upstream end
- polyimide flex cables for data and power  
(1 pigtail + 4 longer cable designs)
