High power operation of J-PARC 3 GeV Rapid Cycling Synchrotron under high temperature and humidity

ARW2022
18 Oct., 2022

Kazami Yamamoto
on behalf of J-PARC Center
Accelerator Division

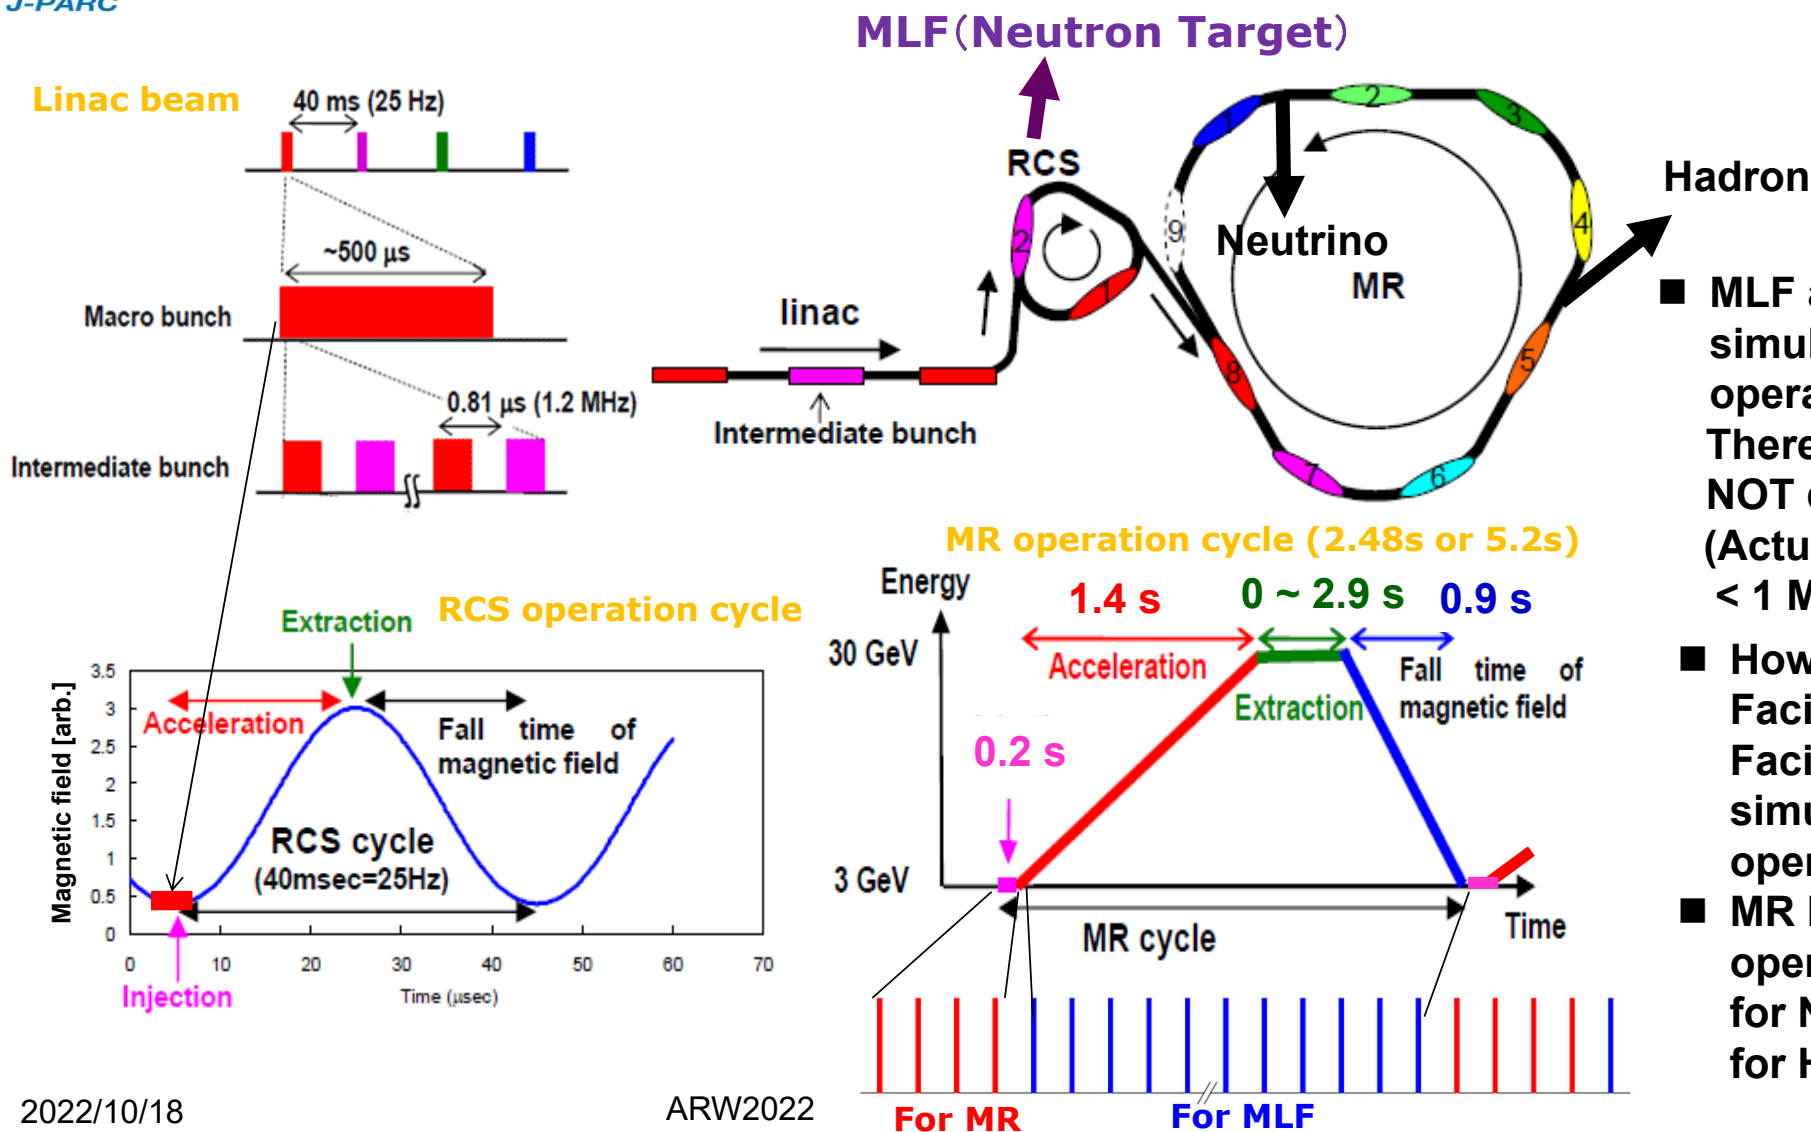
Time structure of accelerator operation

- MLF and MR can be simultaneously operated. Therefore, all pulses are NOT delivered to MLF! (Actual beam power is < 1 MW for MLF)
- However, Hadron Facility and Neutrino Facility **cannot** be simultaneously operated.
- MR has to select the operation mode (FX for Neutrino, or SX for Hadron)

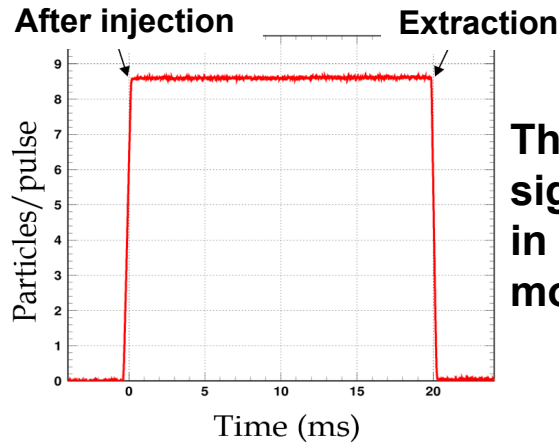
Beam current@1 MW

There is no significant loss in the current monitor signal.

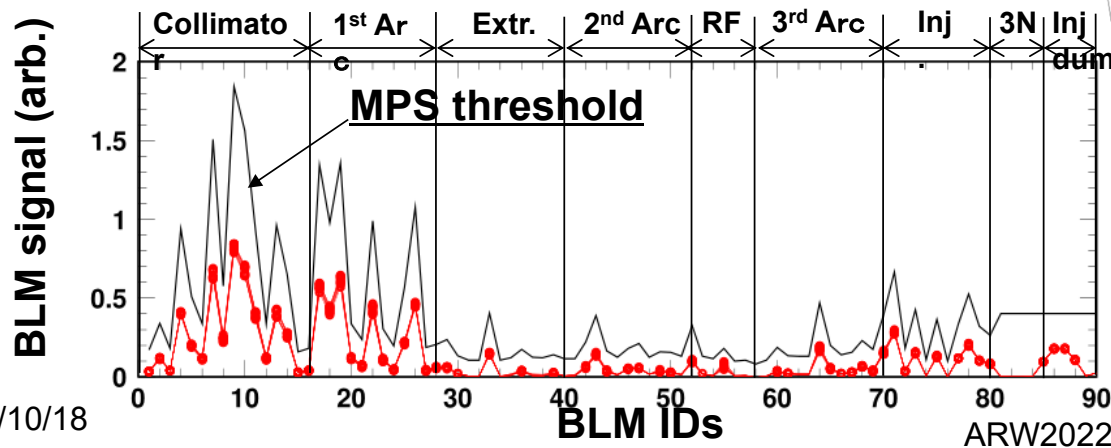
Beam loss monitor signals

After 1 MW, 40 hr trial for MLF (27th Jun. 2020), Measurement after 5 hours from beam stop
600 kW user operation (24th Jun. 2020) , Measurement after 4 hours from beam stop

Black : after 1 MW continuous trial
Blue : after 600 kW user operation

✓ **Enough small, acceptable beam loss**

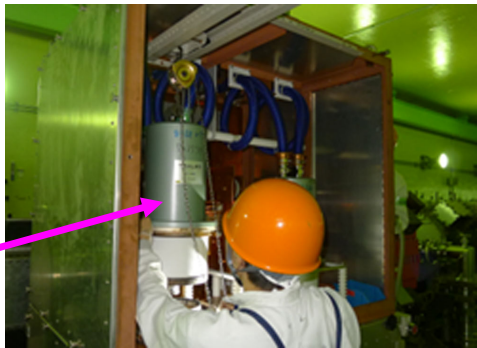
RCS RF system.

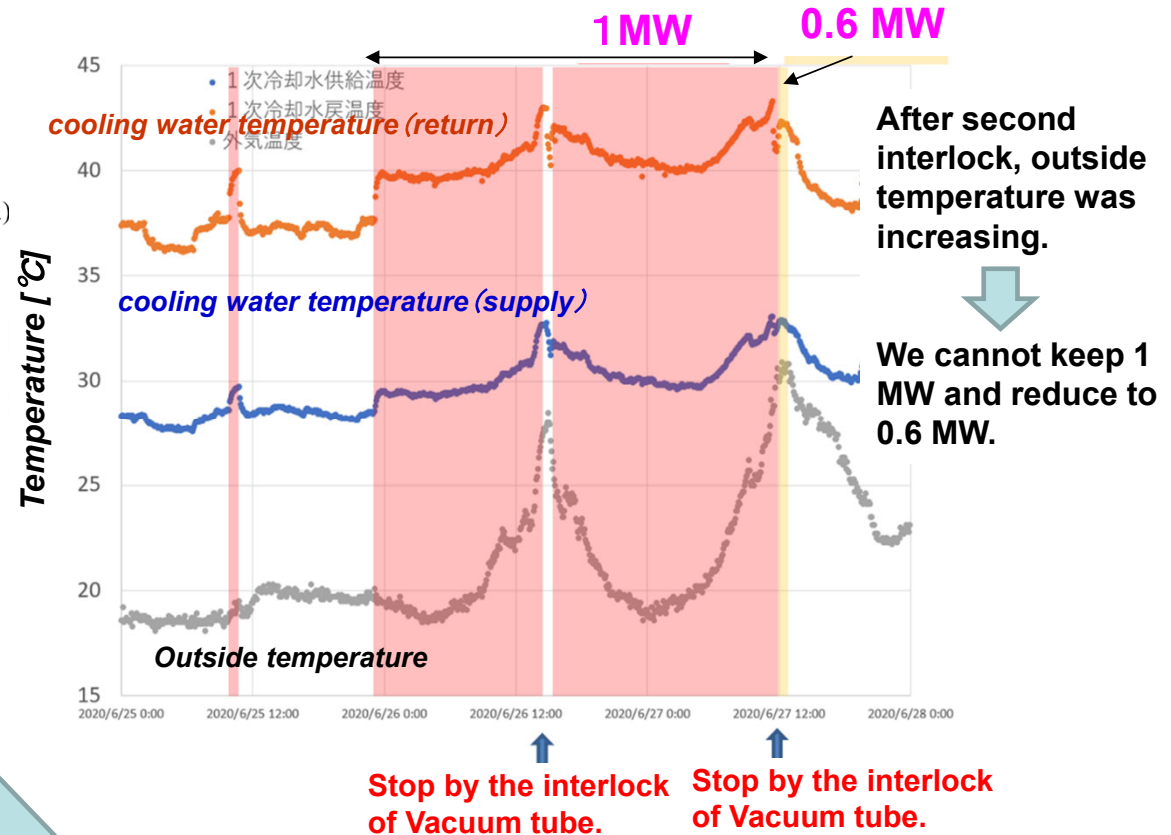
Trend of cooling water temperature in 1 MW trial 2020.

We could not continue the operation of the 1 MW beam when the outside temperature was high

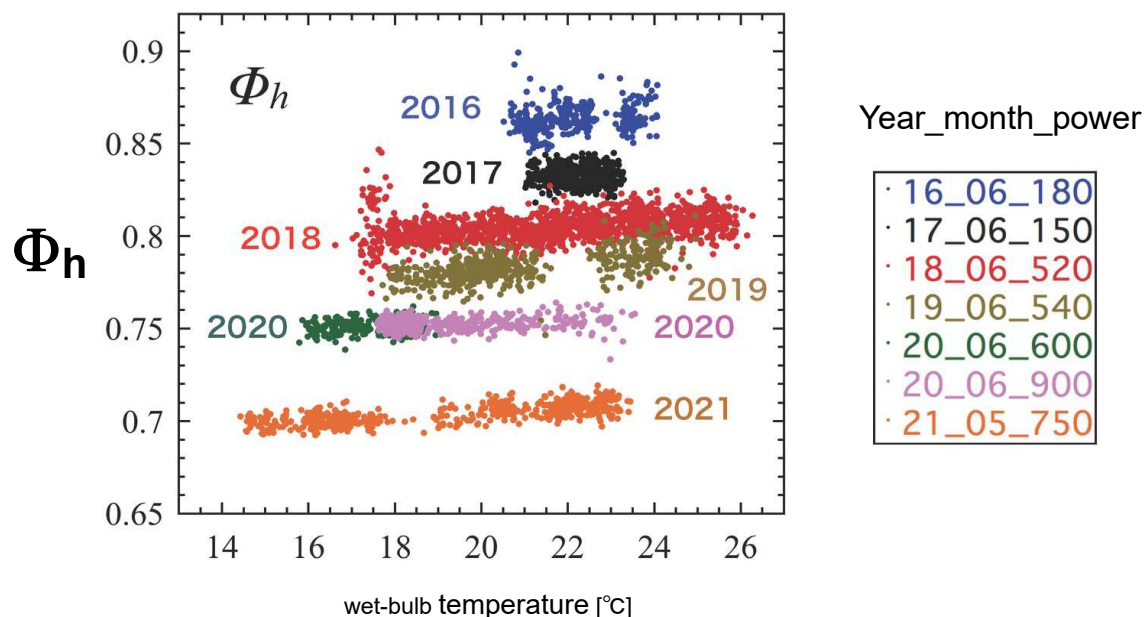
We analyzed the performance of the cooling water system by thermal exchange efficiency Φ_h

$$\Phi_h = \frac{T_{1in} - T_{1out}}{T_{1in} - T_{2in}}$$

Differential between the return and supply temp. of primary water was normalized by the differential between the return temp. of primary water and input temp. of secondary water

Degraded each year!

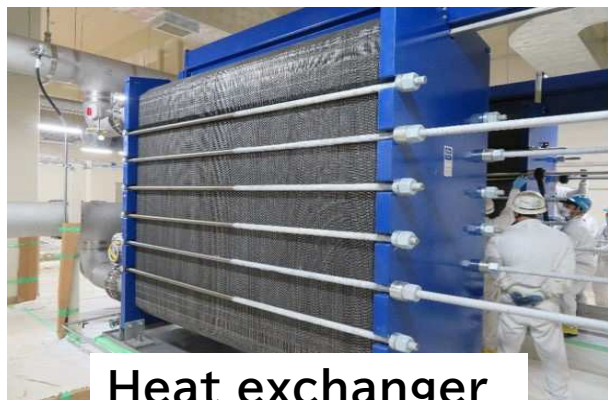
Heat exchanger
Plates are layered

Primary and secondary water flows alternately between the layered plates.

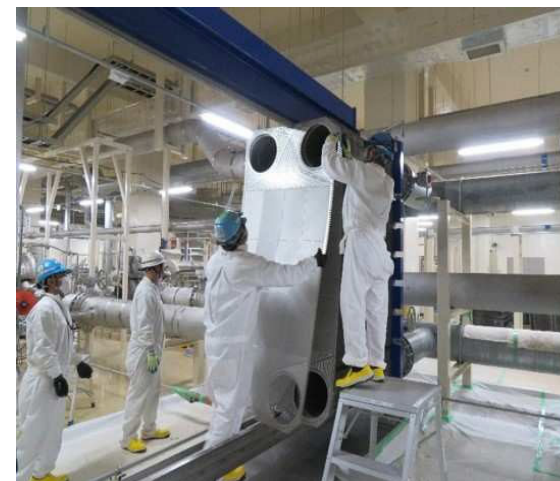
Plates are disassembled.

We disassembled and washed the heat exchange unit in the summer shutdown period 2021.

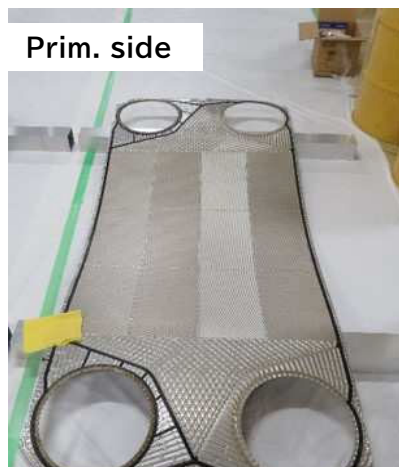
Prim. side

Plate of the heat exchanger

Secondary loop was contaminated with sludge !
Removed it by the chemical cleaning

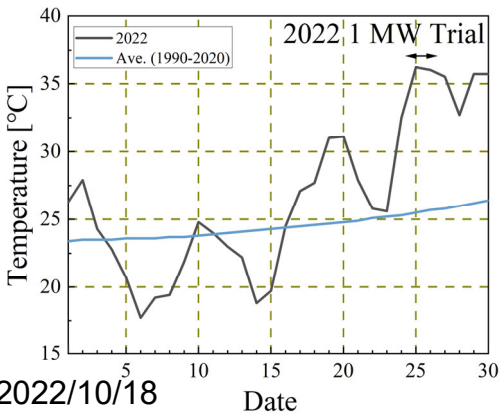
Temperature trend of Mito city (~10 km from Tokai-mura)

Temperature of 25th was more than 35 °C!
This value is just mid-summer!

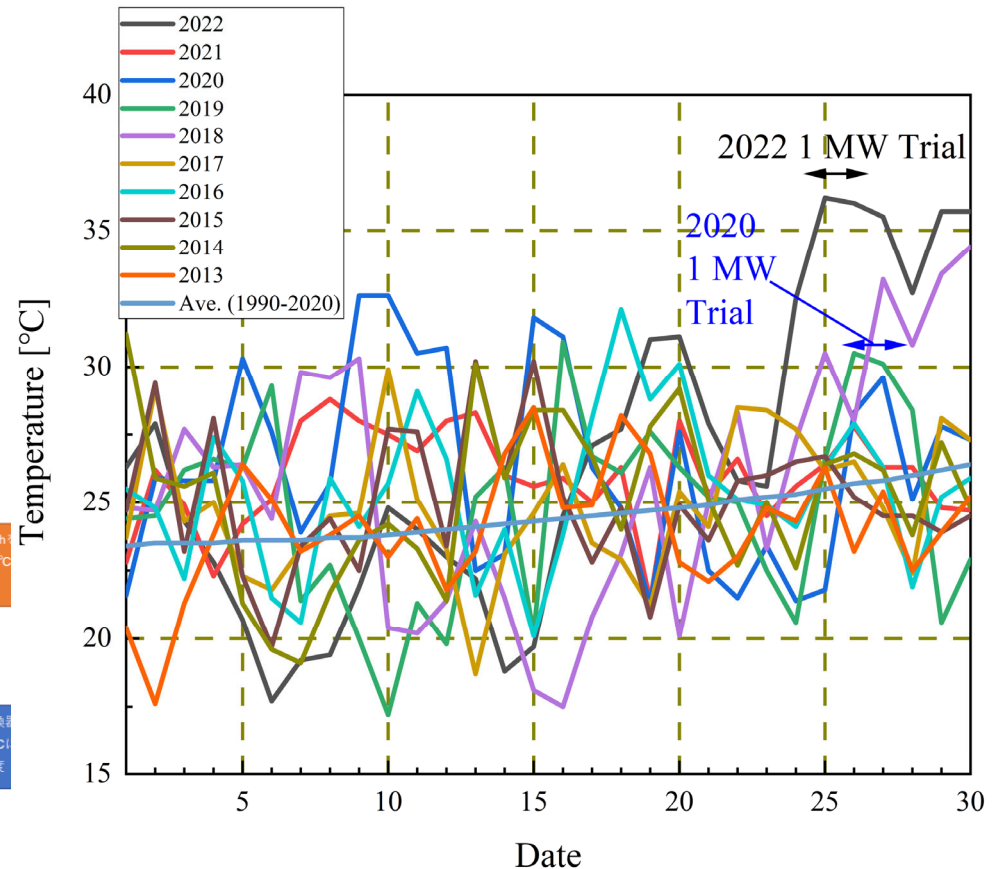
Temperature trend of Mito city during 10 years

Temperature of this year is extraordinary!
We need this new cooling system only a few days
because we stop the operation at the end of June.
Not cost effective.
