Canadian Light Source Vacuum

A shift from reactive to preventative maintenance

Dana Warriner | Dana.Kary@lightsource.ca
Mechanical Engineering, Canadian Light Source Inc., Saskatoon, Canada

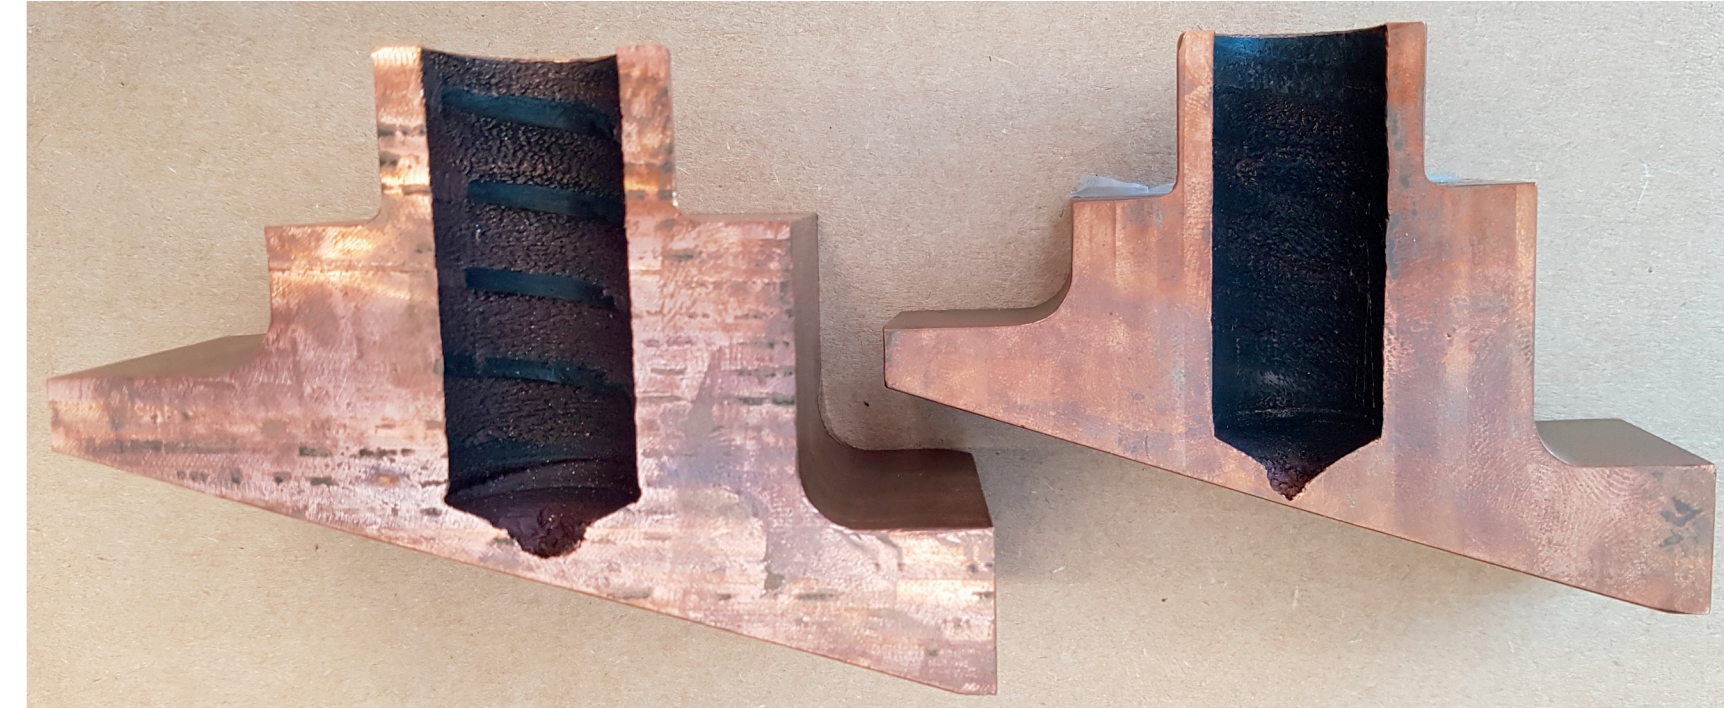
Cutaway of dipole photon shutter run until failure. Low conductivity water that cooled the absorber slowly eroded copper until a pinhole leak developed and water leaked into the vacuum space.

Historically, components in vacuum were run until failure. One example of a component replaced upon failure was a dipole photon shutter that leaked water into the storage ring vacuum space in 2016. This failure brought to attention the need for critical spares and pre-emptive replacements. There were some spare components, but a comprehensive review of components containing and maintaining vacuum had never been completed. There are some critical components for which there are no spares on hand.

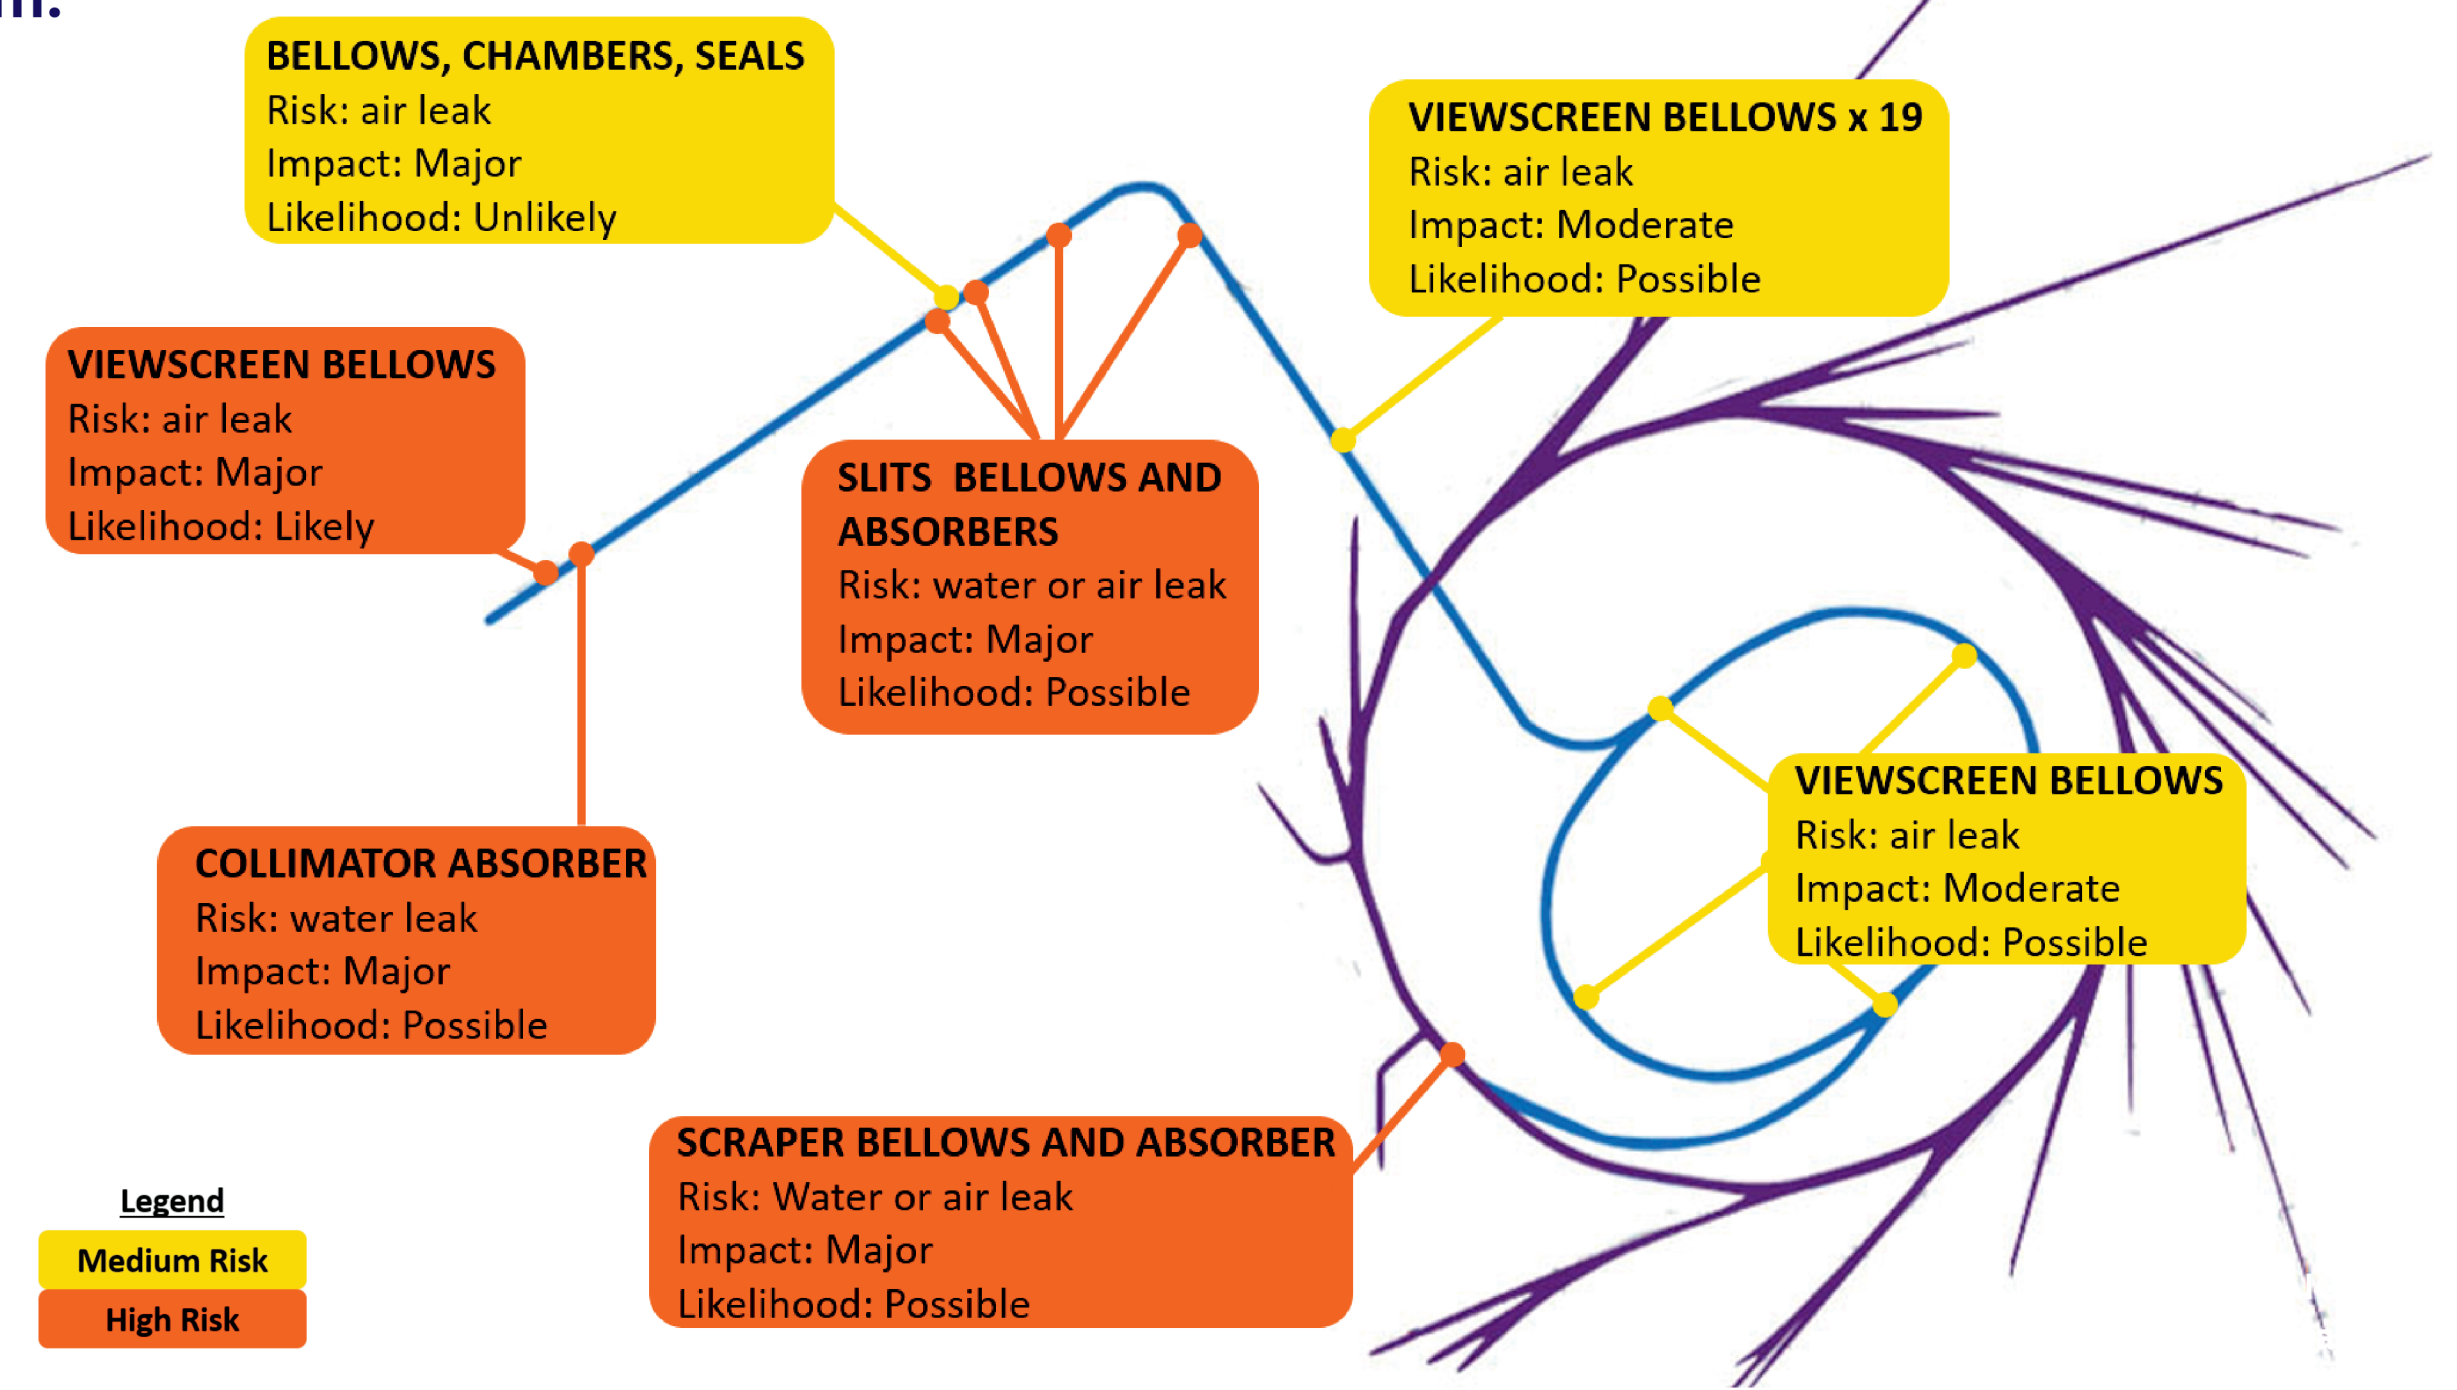
Highlights from Phase 1 of the ERM analysis are shown below. ERM analysis allowed for data-driven decisions on what components to focus on in order to address risks to the vacuum system.

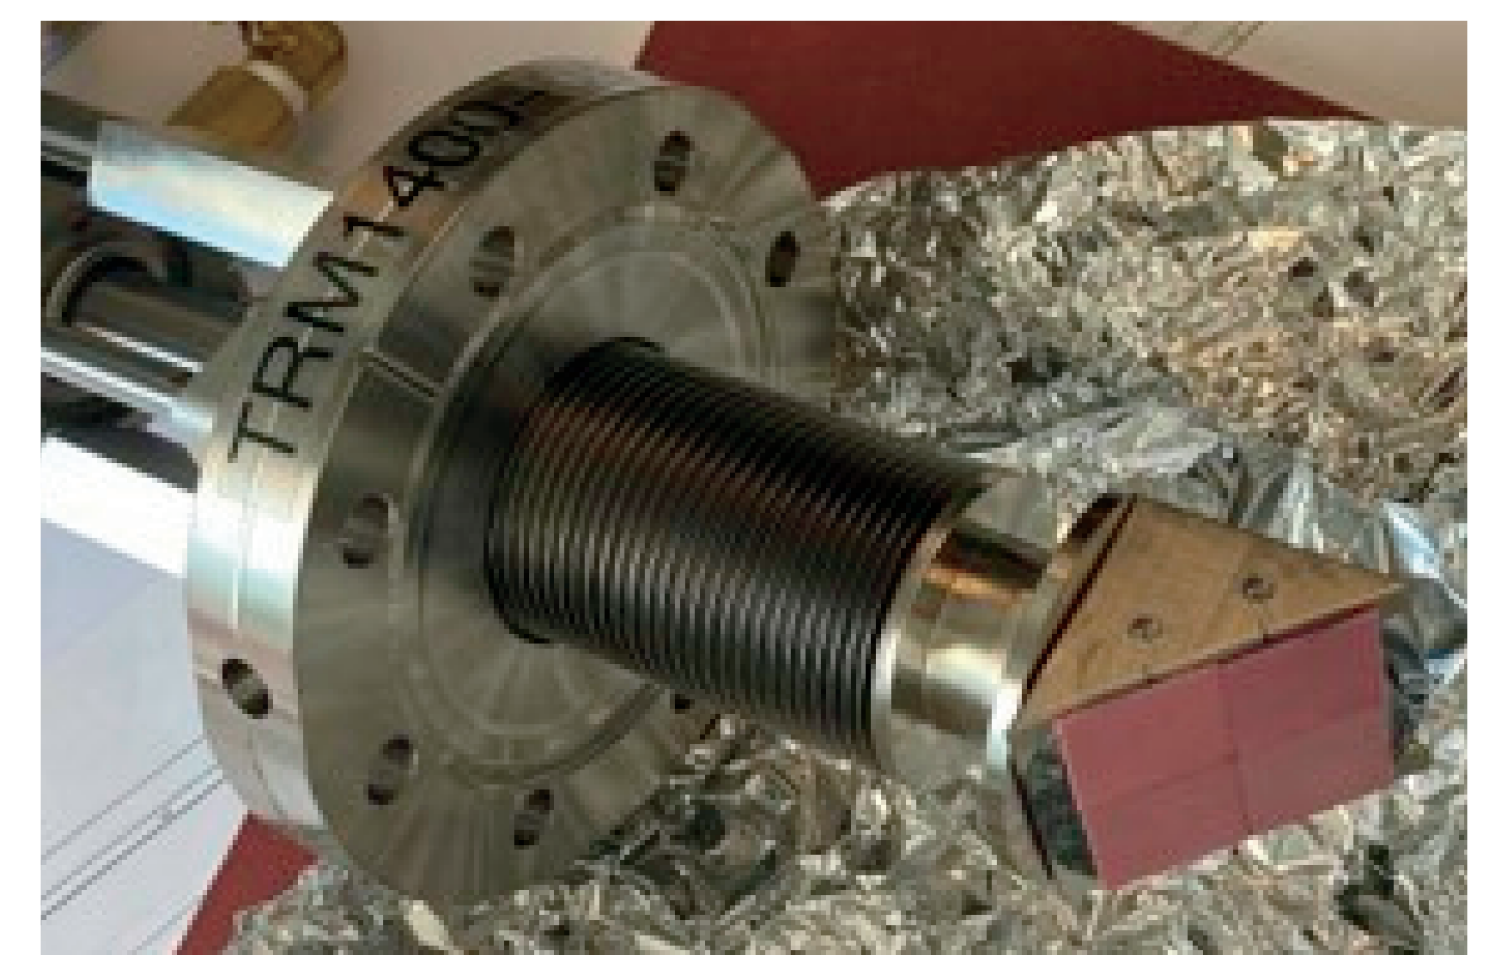
NEW LINAC VSC

- Replaced with new VSC assembly Oct 2022
- New VSC assembly occurs in 18 other locations at the CLS
- One extra bellows ordered to provide spares for 19 components
