A New System for MgB² Coating R&D at LANL

TFSRF 2022 Workshop, 19-23 September 2022

LA-UR-22-29668

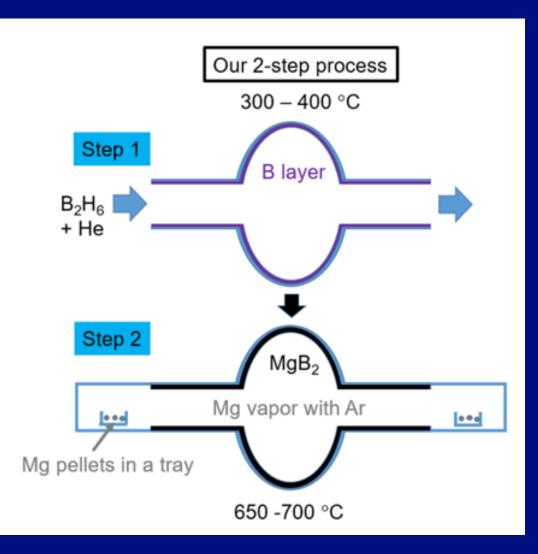
Concept of our 2-step coating process

- The 2-step technique consists of coating B layer on the cavity inner surfaces in the first step, then react it with Mg vapor in the second step. See the next slide.

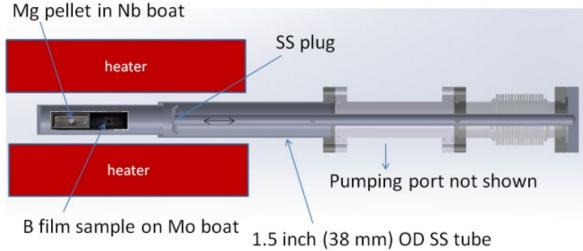
B-Mg reaction test set up with a small tube heater [Tajima et al., SRF2015, p. 700]

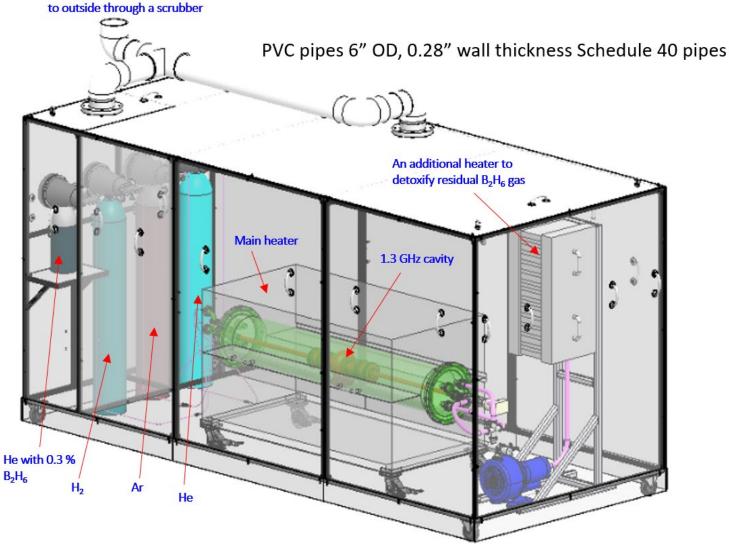
A 3D model of the new MgB_2 coating system at LANL. A ventilation system to handle toxic B_2H_6 gas has been installed.

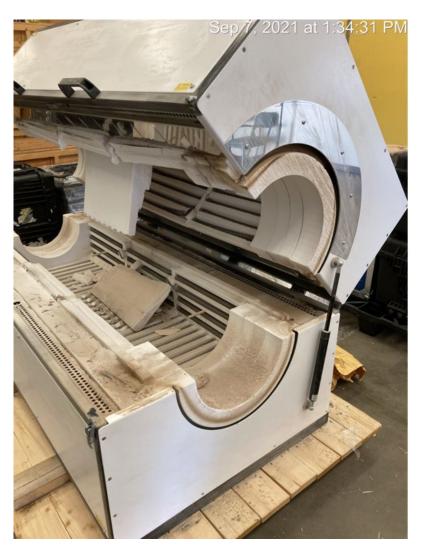
The main furnace was delivered in September 2021 but found damaged in transit.

This furnace was returned to the company in U.K. and repaired and returned to LANL in late January 2022.

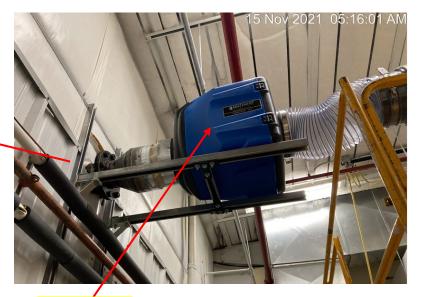
A panoramic view of the PVC piping

Some photos of the new ventilation piping. The new ventilation system cleared intentionally created smoke inside the booth in 3 min.

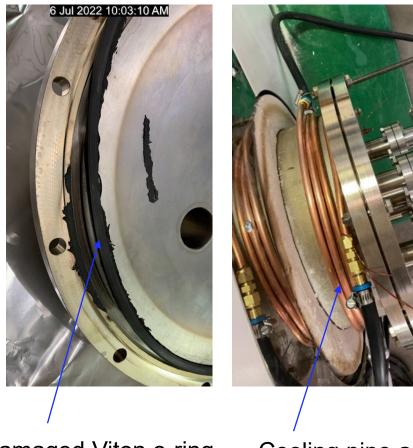
- Raised the furnace temperature up to 800 C and found that the Viton o-ring at the end flanges got damaged due to too high temperature, probably much higher than its limit of ~205 C.
- Added 3/8" OD copper cooling pipes around the beam pipes outside the furnace.
- We tested up to 700 C with the flange cooling and the Viton o-ring was not damaged.

Damaged Viton o-ring

Cooling pipe added

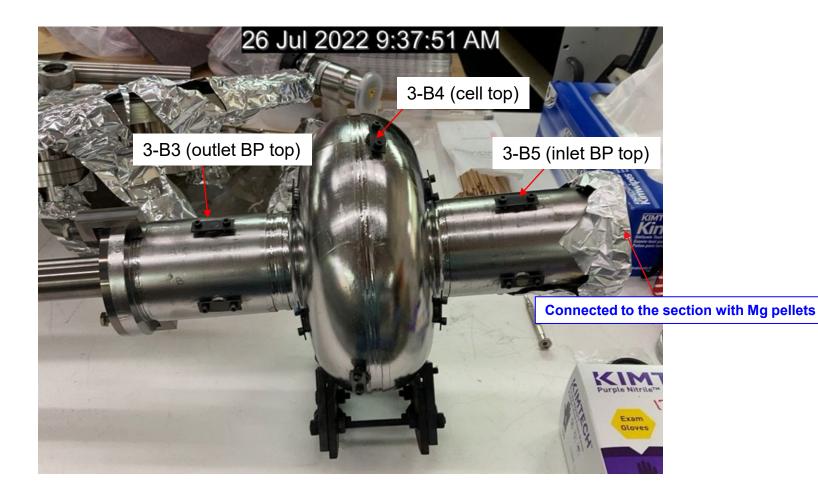
We performed our first B-Mg reaction test on 28 July 2022. Three B coated Nb samples were attached at 3 locations on a 1.3-GHz 1-cell Nb cavity.

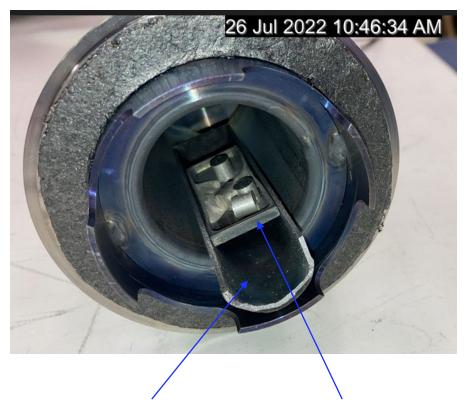
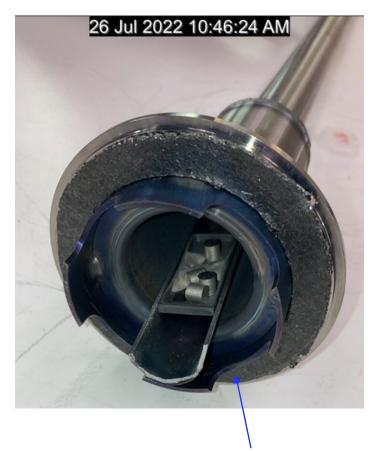
Four new Mg pellets were placed on a Nb tray on a Mo boat in a section next to the cavity

These cutouts are to pump down the cavity

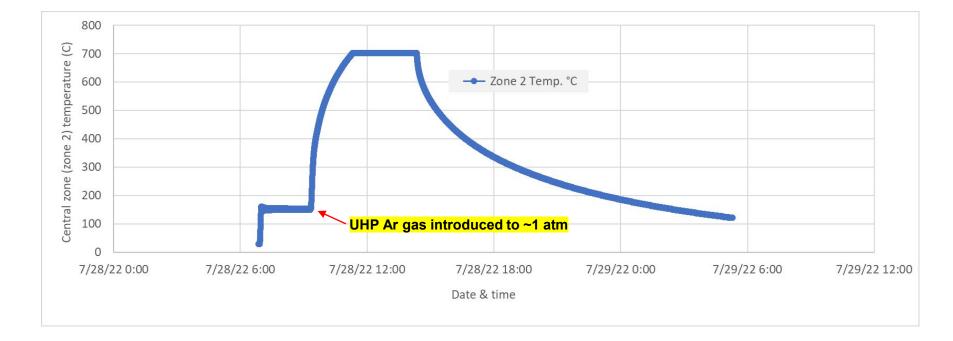
The degassing at 150 C was probably not long enough. We should have waited until the pressure goes down.

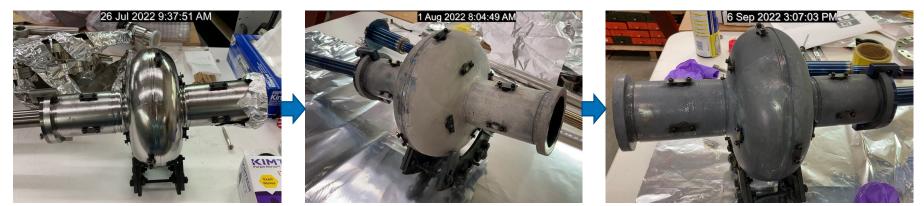
• One thing we noticed was that the cavity outer surface color changed after this reaction, then after heating under vacuum.

After B-Mg reaction in Ar at 700 C (furnace)

After heating at 700 C under vacuum

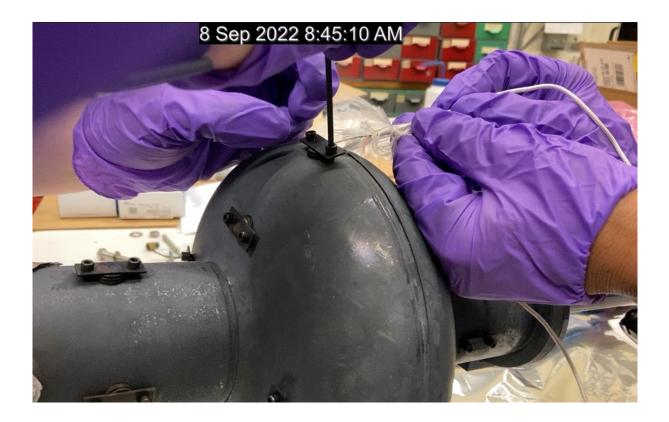
We also measured temperatures at various points in the Inconel pipe when the furnace temperature went up to 700 C

It was found that the Mg section, cell and beam pipe temperatures are considerably lower than the furnace temperature (<532 C vs. 700 C)

- We measured the temperatures on the cavity, Mg section, etc. and found that the temperatures were <532 C when the furnace temperature was 700 C, which is likely to be the cause of failed test.

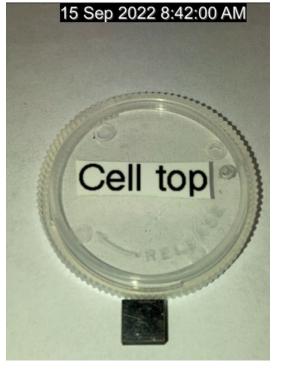
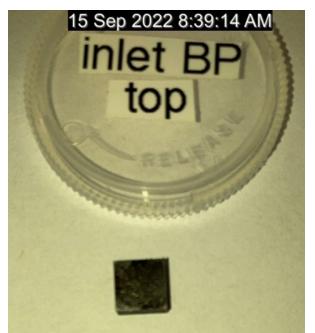
Photos of the samples after the B-Mg reaction test. No pics were taken before. XPS surface analysis will be done soon.

Magnetometer measurements on the 3 samples were performed on 12-13SEP2022 with no superconductivity detected.

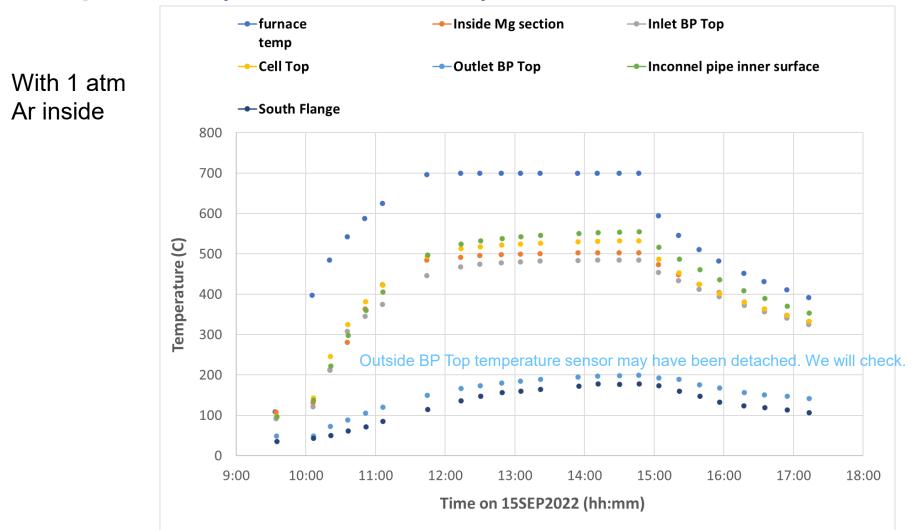
The oxidation may have been due to the air trapped at the port for introducing Ar gas. The air trapped here was pumped through the Inconel pipe

Ar was connected here

70-L/s turbo pump

Connected to a scroll pump

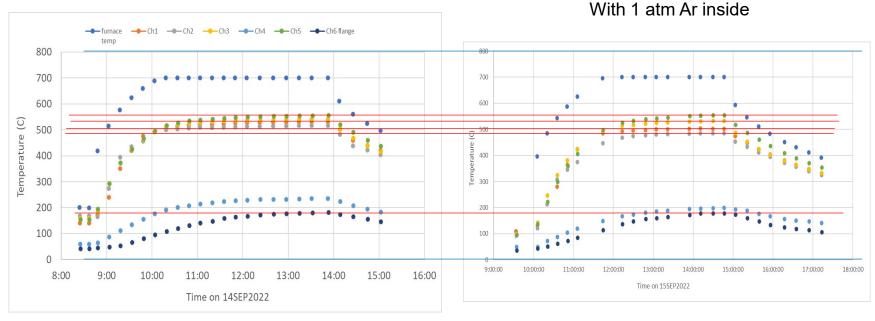
Temperatures of cavity, Mg section, etc. when the furnace temperature went up to 700 C. Comparison between vacuum and 1 atm Ar inside.

- The Mg section temperature (Ch1, orange) got lower with 1 atm Ar from 531 C to 503 C
- The Inlet BP Top temperature (Ch2, gray) got lower with 1 atm Ar from 516 C to 485 C.
- The flange temperature (Ch6, dark blue) did not change much.
- Ch4 is probably not showing correct temperature.

Ch1 (Orange) : Inside Mg section				
Ch2 (Gray): Inlet BP Top				
Ch3 (Yellow): Cell Top				
Ch4 (Light blue): Outlet BP top				
Ch5 (Green): Inconel pipe inner surface				
Ch6 (Dark blue): South flange
