NPS Setup & Performance

Mitchell Kerver

Old Dominion University

Jan 19th 2024

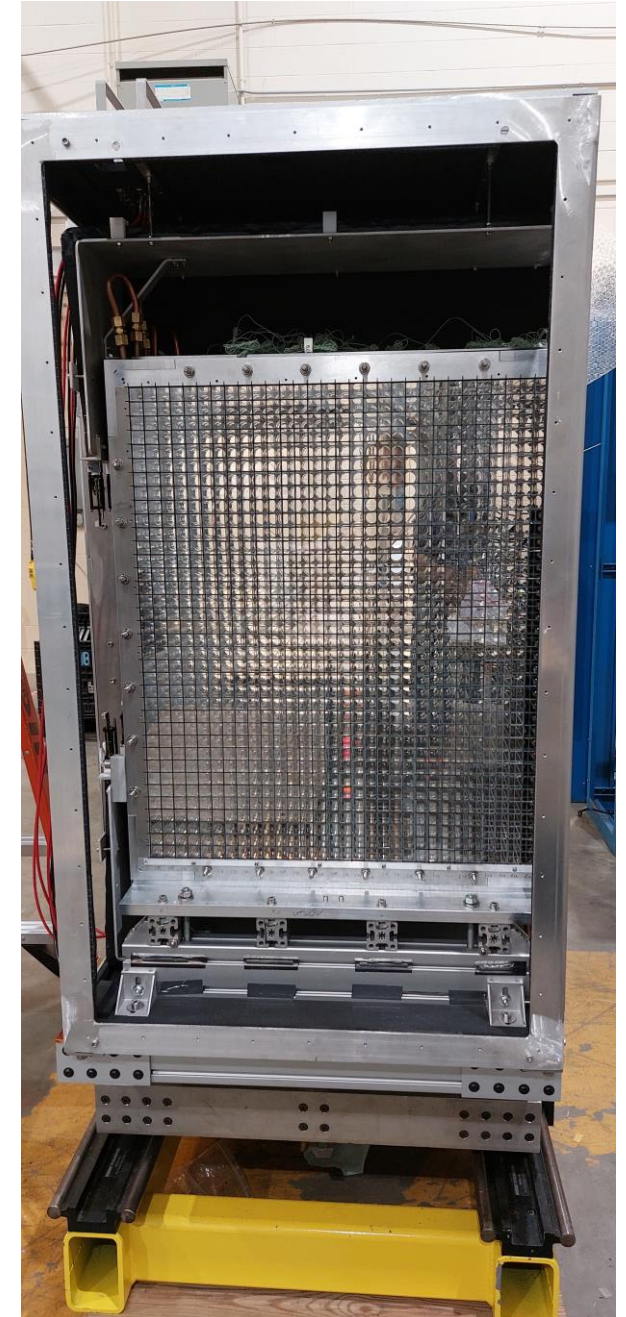
NPS Calorimeter

- 1080 PbWO₄ blocks
 - High energy resolution
 - High light yield
 - RadHard
- Temperature controlled frame
- Hamamatsu 4125 PMTs
- HV divider and amplifier to reduced HV requirements
- LED system for curing and gain monitoring
- HV, LV, and LED signals distributed to an entire column through distribution board

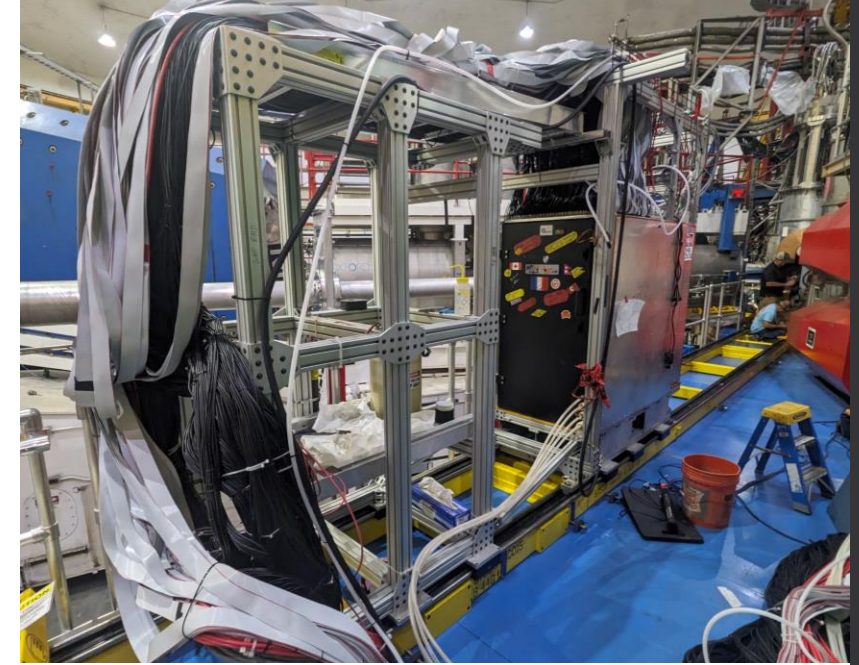
NPS Installation

- Installation and cabling began in April and finished Jun 26th
- Calorimeter installed on sliding rail
- 5 VME crates, 2 HV , and 1 LV power supplies added to SHMS hut
- Cables ran through the hut roof down to the NPS platform
- Sweeper magnet installed in place of Horizontal Bender

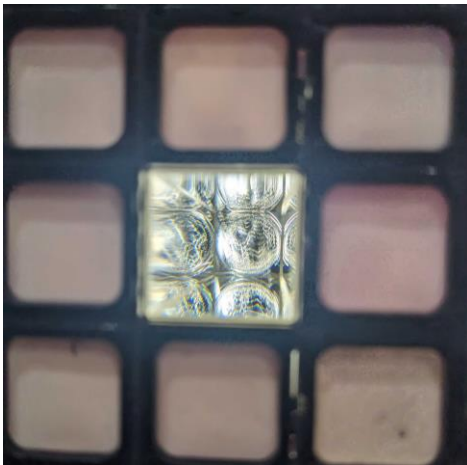
- Radiation causes darkening and discoloring of crystals which reduces the light transmission
- So far, no visual discoloring of the crystals, but there has been a shift in the π^0 mass over time
- Columns on the edges of the calorimeter saw a larger shift in π^0 mass
- This effect is manageable and will be accounted for in calibration

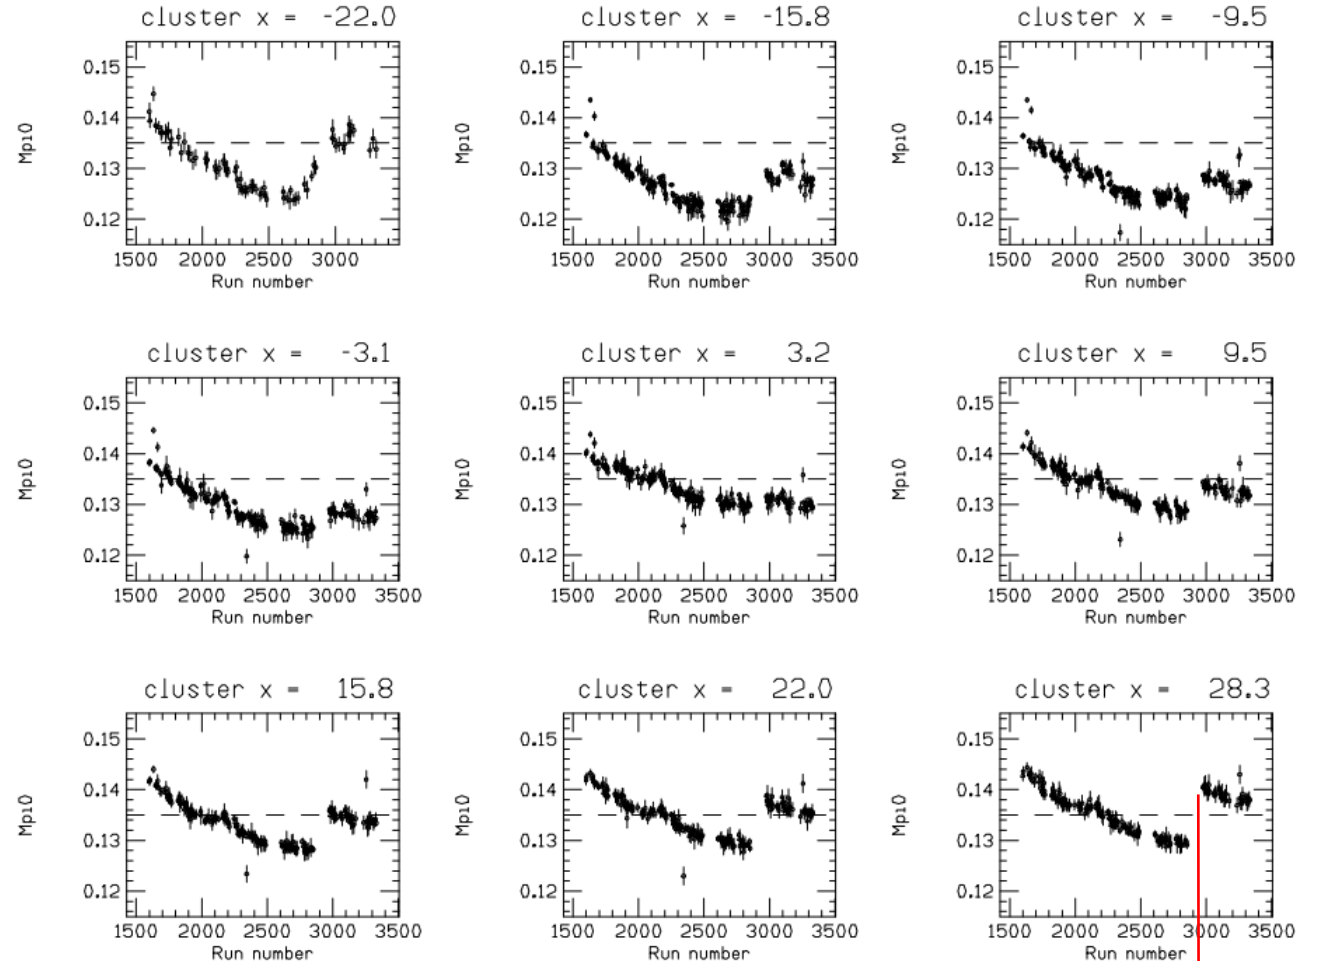
π^0 Mass as a Function of Run# for Different Values of x

Re-calibrated with new HVs

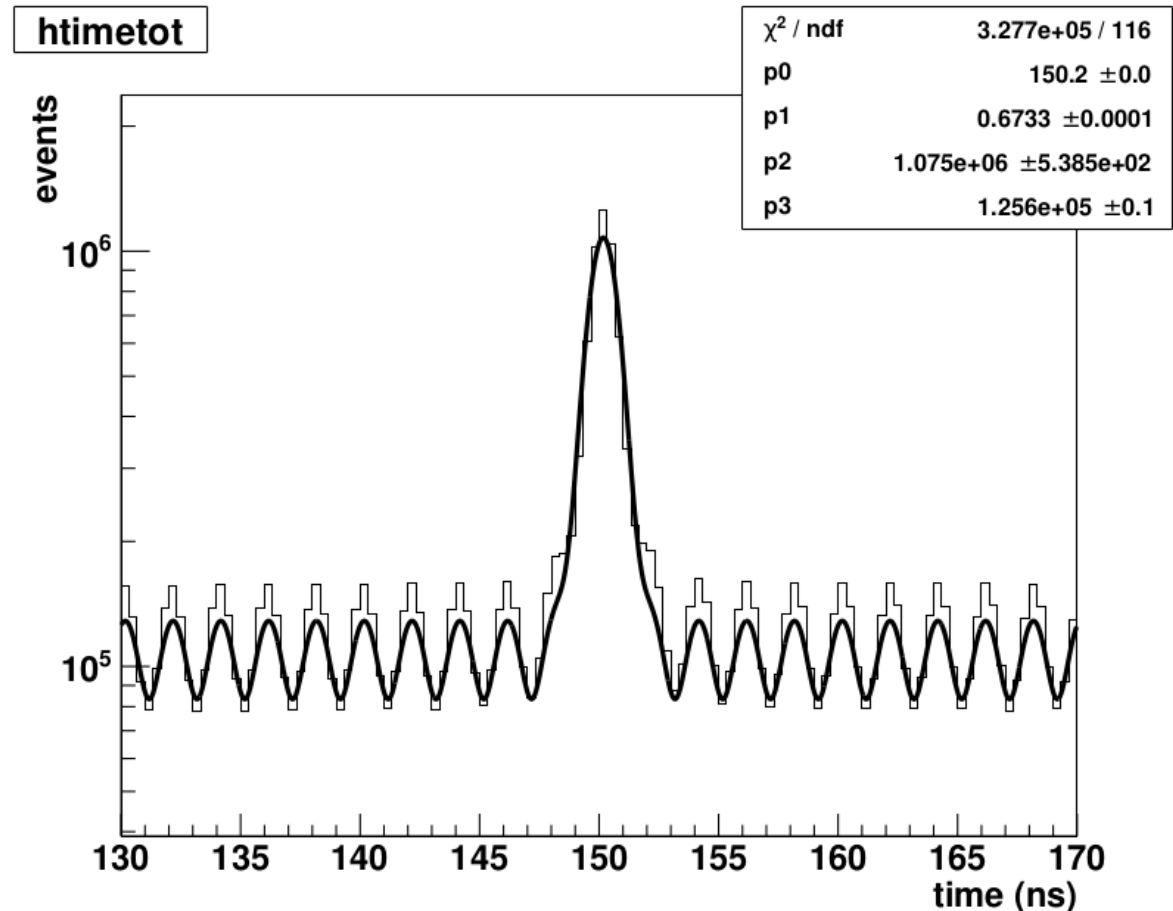
- Time spectrum for all channels show a timing resolution of 0.67ns
- True to accidentals ratio of 10:1

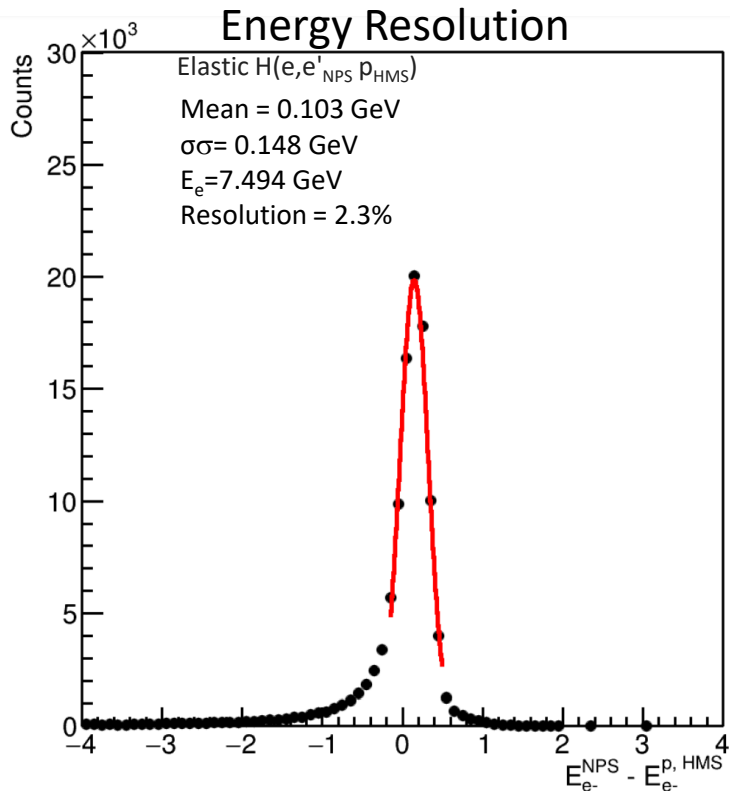
- Exclusivity of the reaction is determined by the missing mass technique
- Missing mass resolution is dominated by the energy resolution of the calorimeter
- Energy resolution from elastic calibration $\sim 2.3\%$ at $E_e = 7.494$ GeV
- Missing mass resolution from π^0 calibration 82MeV
 - Hear Hao's talk for more details on calibrations

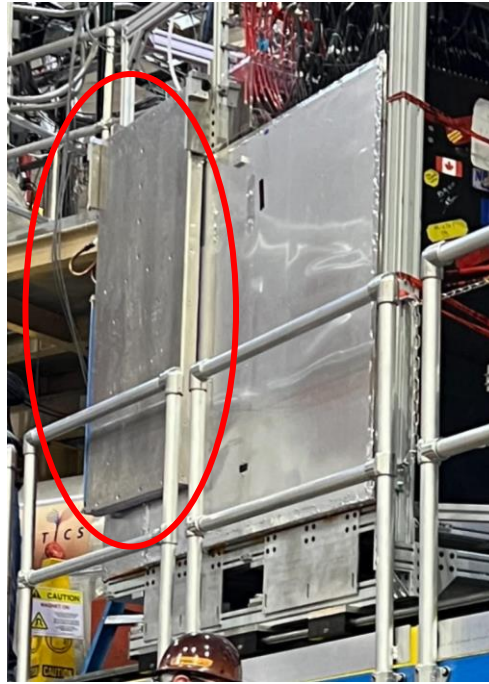
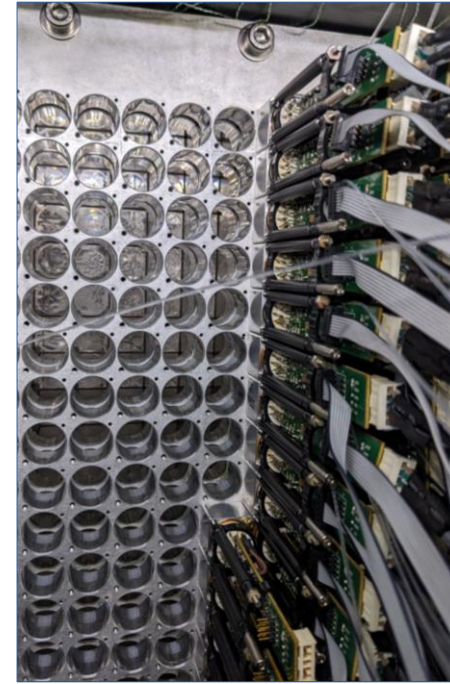
- Started removing damaged bases on Nov 1
- From Dec 15 – Jan 13 full-time work began repairing all channels in columns 0-19
- We removed and disassembled 720 PMT+base assemblies
- LV regulators were bypassed by Chris Stanislav and Josh Crafts
 - Amplifiers were tested without the regulators and seem stable + rad hard
- Lead and polyethylene shielding added to side of calorimeter
