Status of SVT for a 2025 Run

Tim Nelson
June 5, 2024

The HPS SVT

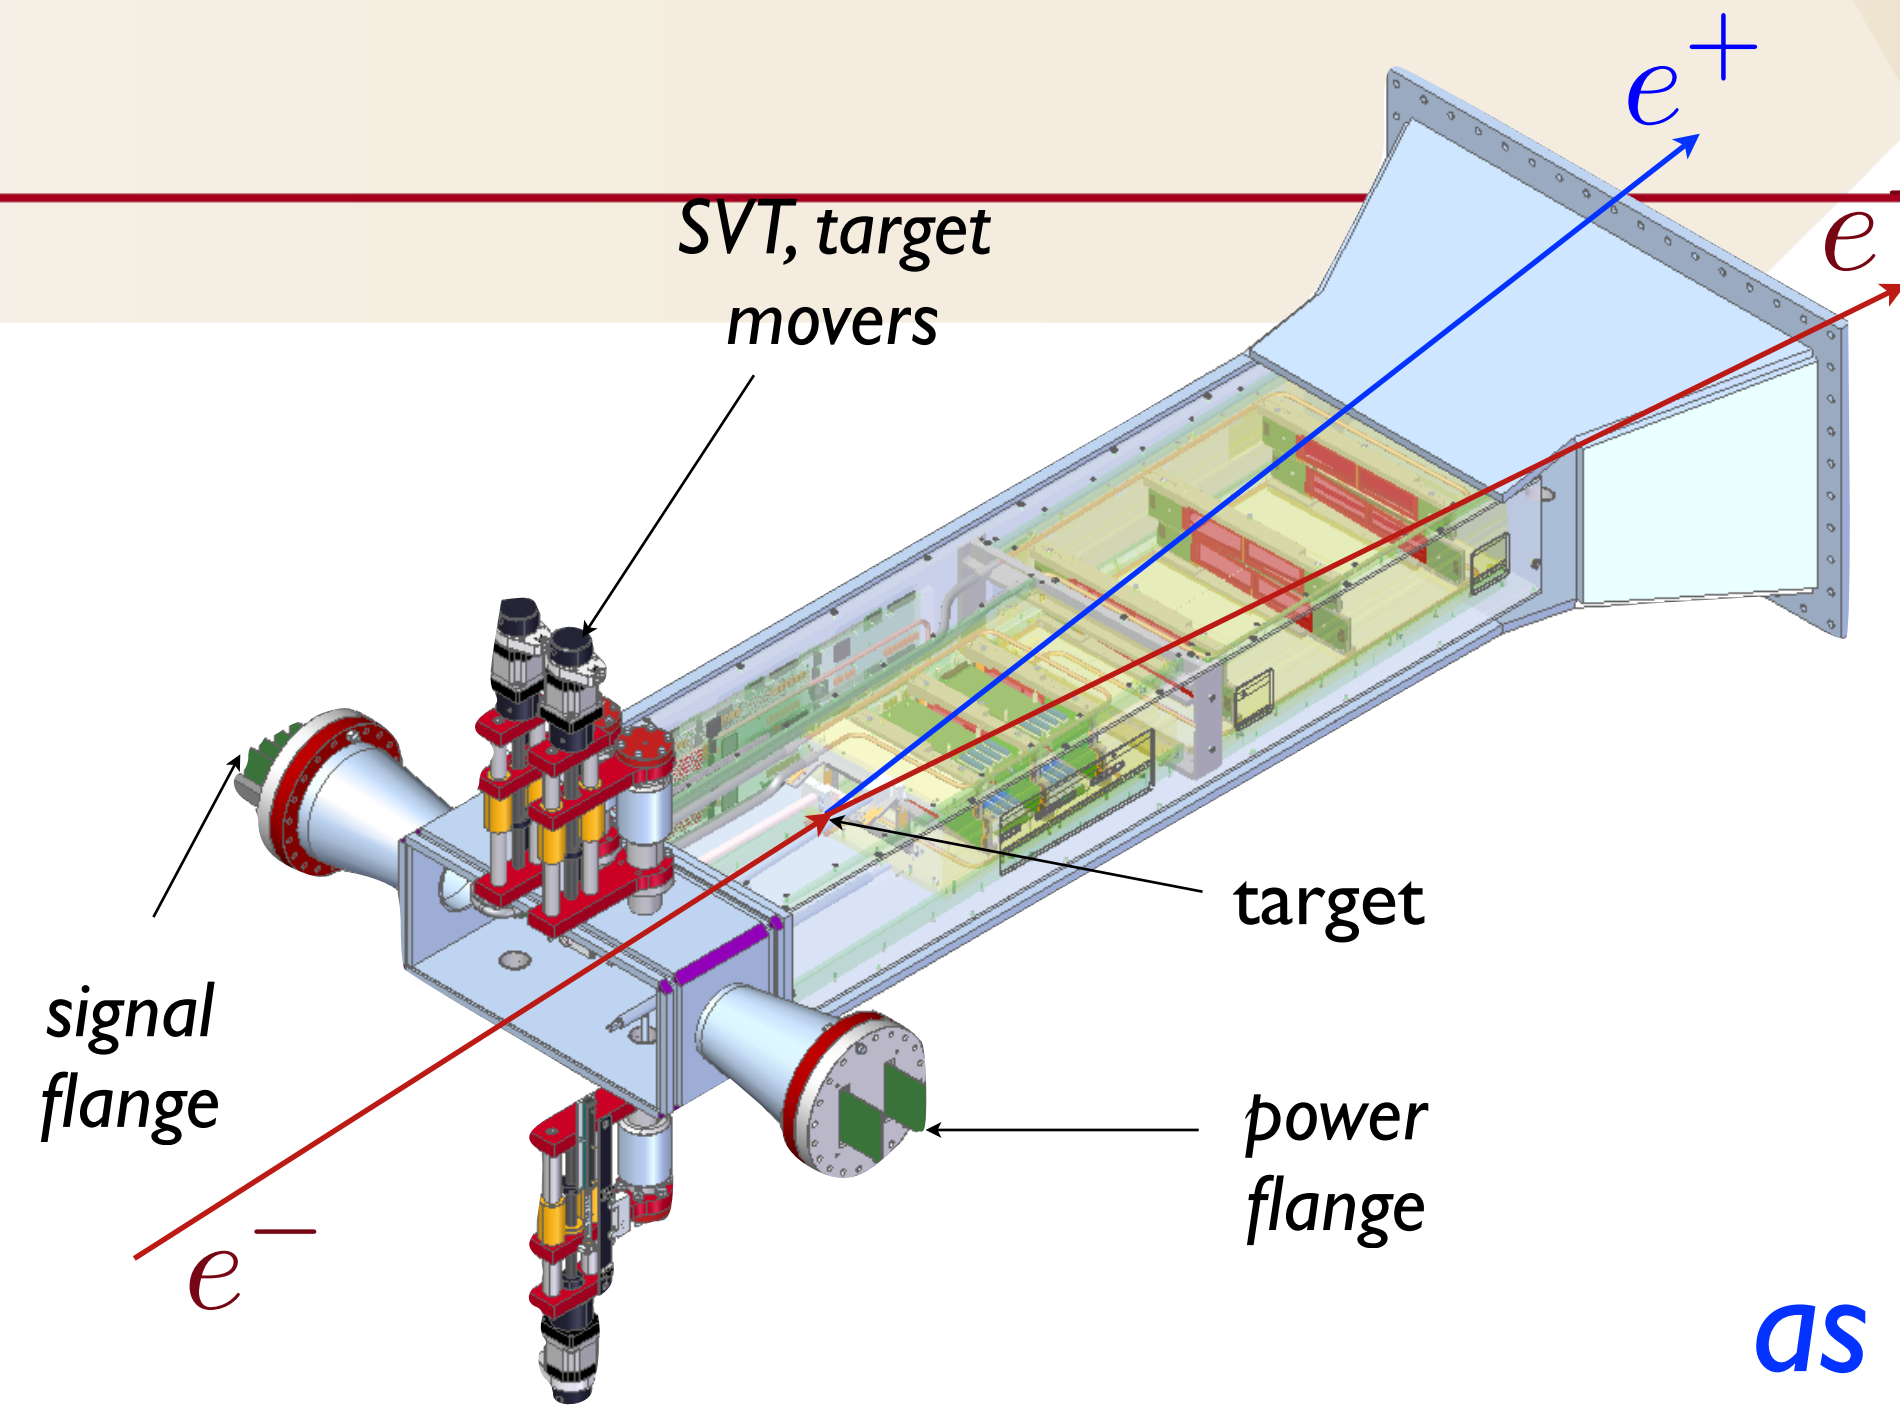
7 double-layers of silicon strips, each plane measures position ($\sim 6\text{-}10\ \mu\text{m}$) and time ($\sim 2\ \text{ns}$) with $\sim 0.2\% - 0.35\% X_0/\text{hit}$.

- beam vacuum and 1.5 Tesla magnetic field
⇒ constrains materials and techniques
- sensor edges 0.5 mm from electron beam in LI
⇒ must be movable, serviceable
- sensors see large dose of scattered electrons
⇒ must be actively cooled to $-20\ ^\circ\text{C}$
- 24528 channels can output $> 100\ \text{gb}/\text{sec}$
⇒ requires fast electronics to process data

as installed
in 2015

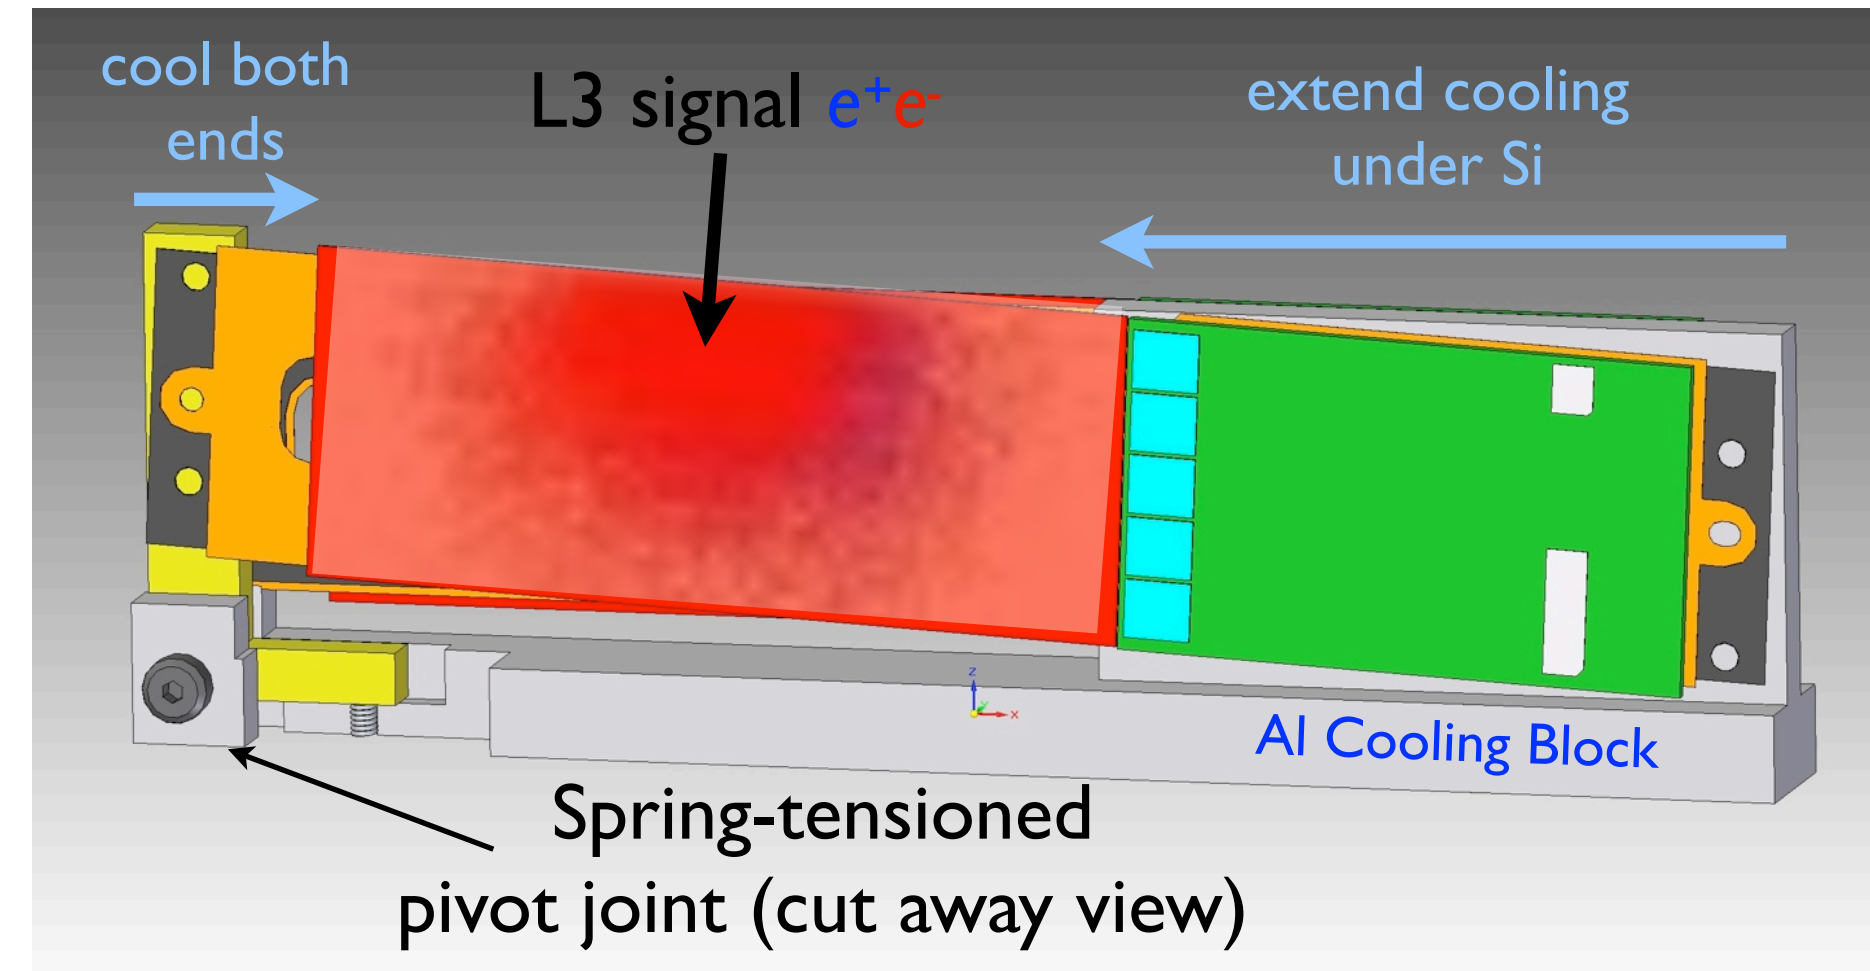
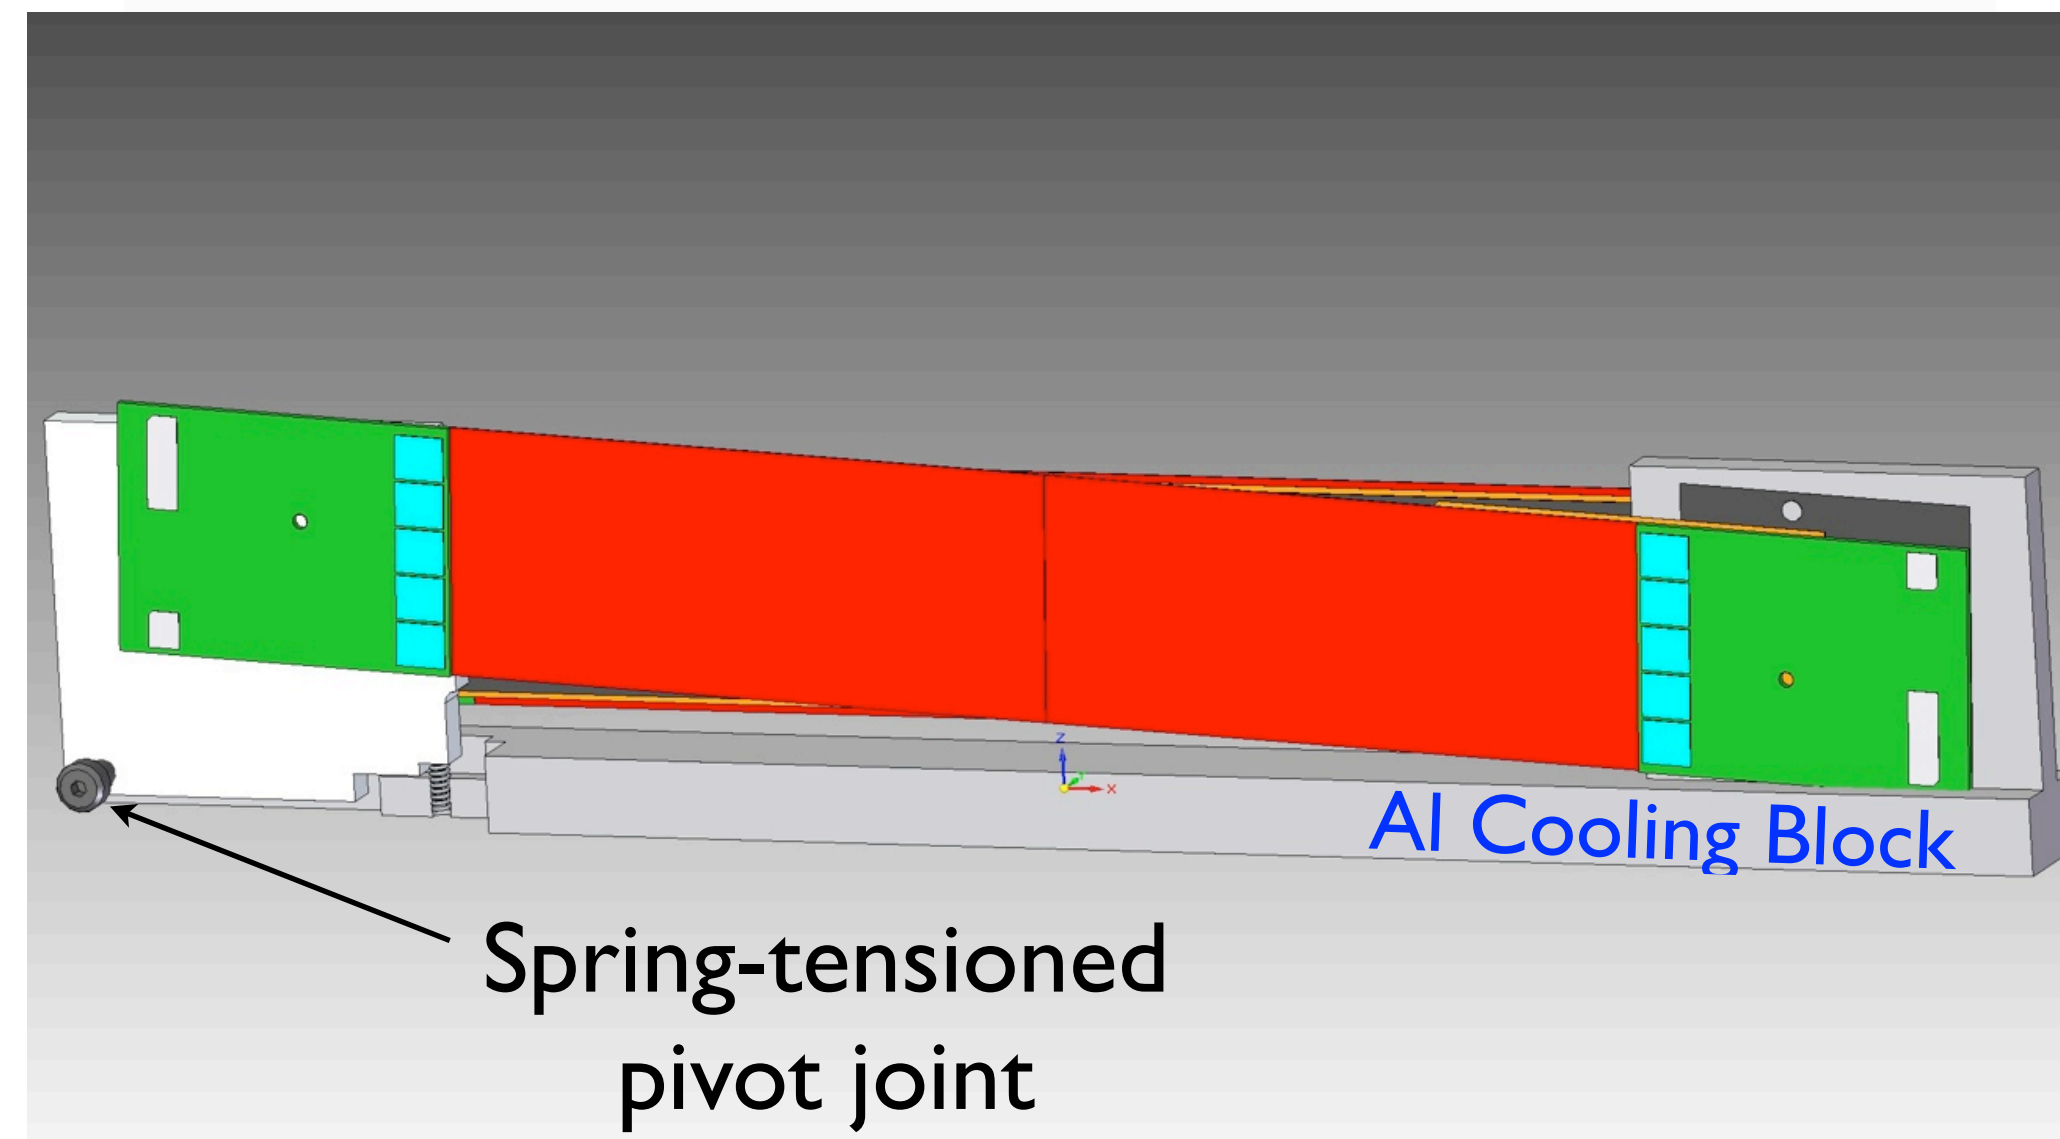
HPS SVT Modules

L3-4 reuses half-modules from HPS Test, but with improved module supports: tension CF between cooled uprights.

L5-L7 extends concept to allow same material budget for longer modules.

Eliminated pigtails in favor of cleaner solution, low-profile Samtec connectors

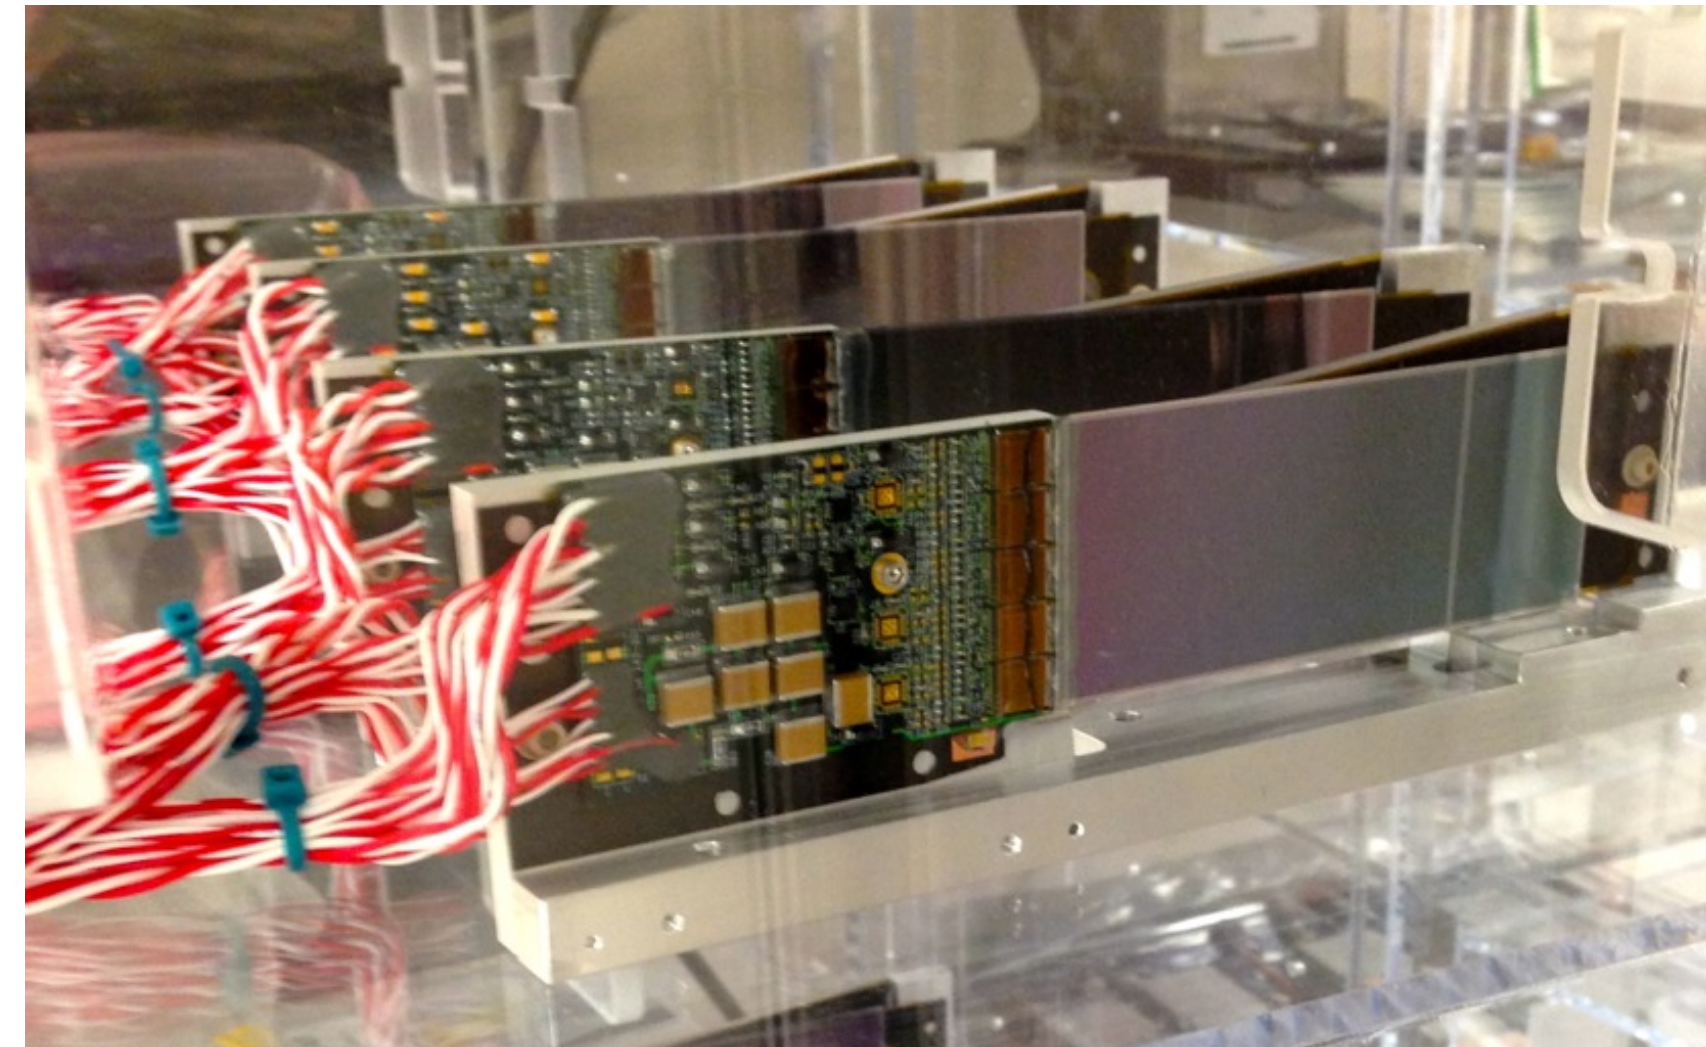
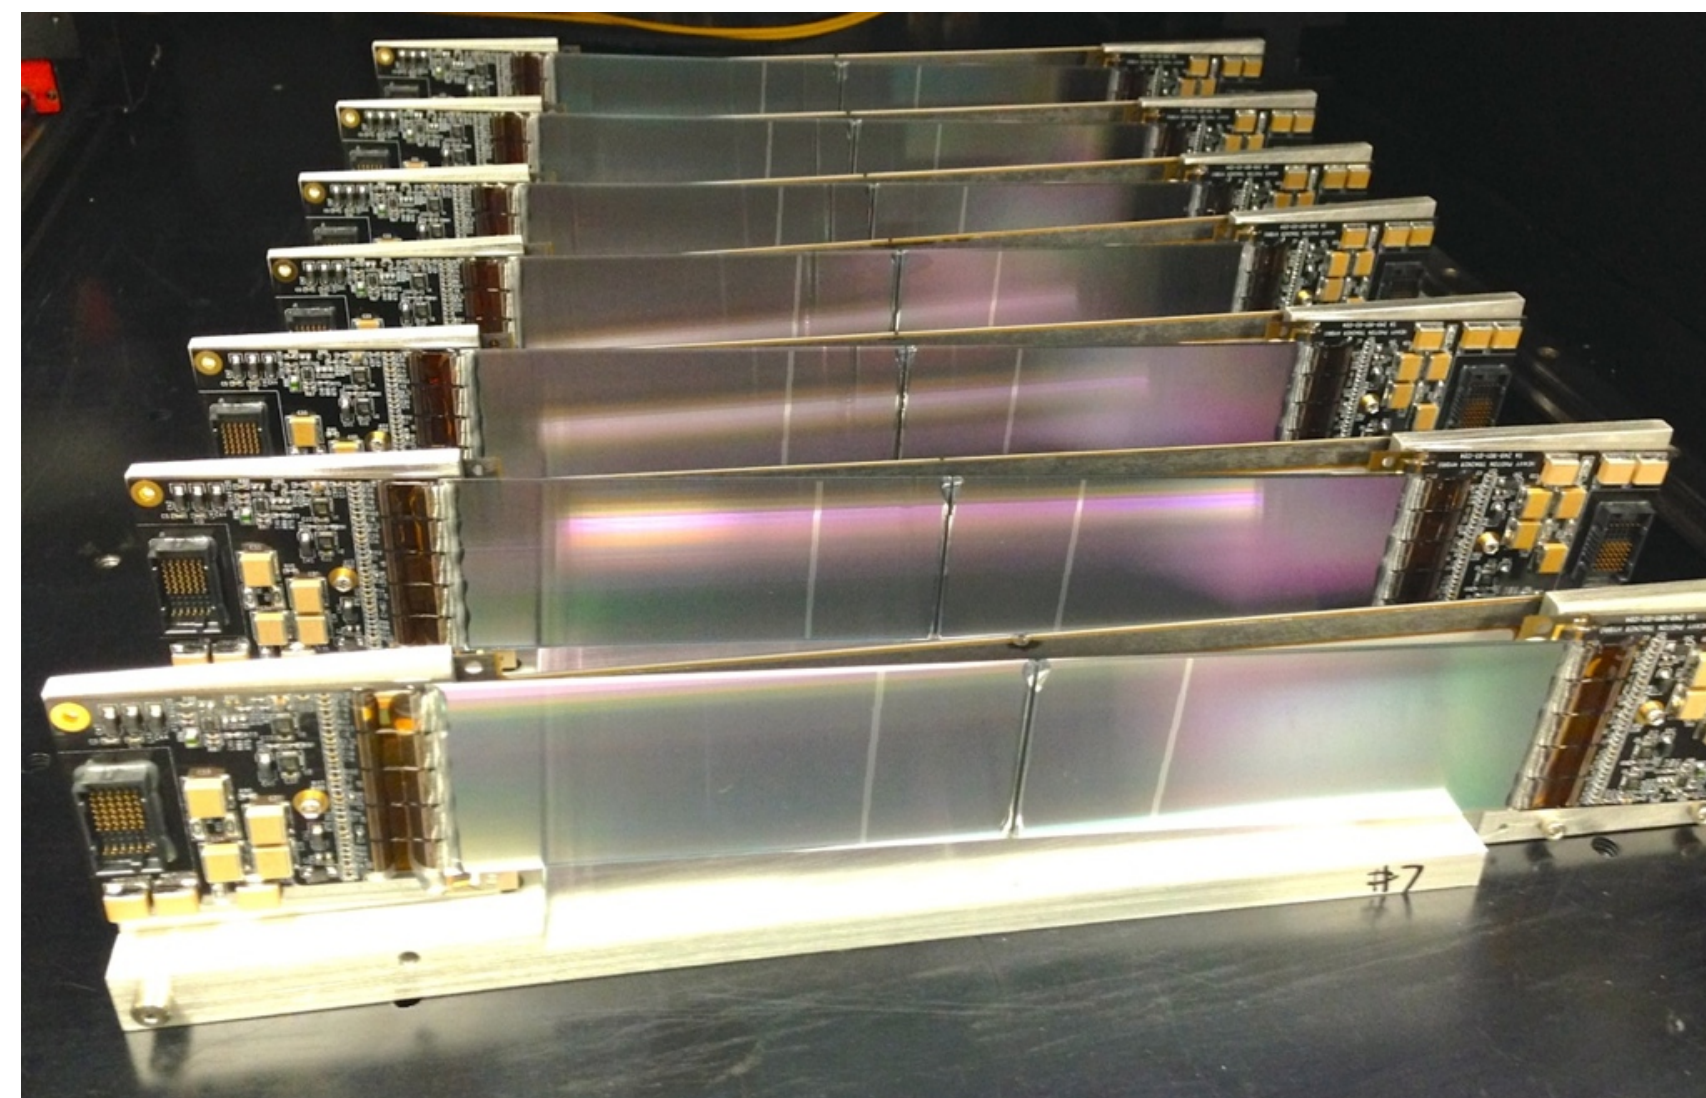
HPS SVT Modules

L3-4 reuses half-modules from HPS Test, but with improved module supports: tension CF between cooled uprights.

L5-L7 extends concept to allow same material budget for longer modules.

Eliminated pigtails in favor of cleaner solution, low-profile Samtec connectors

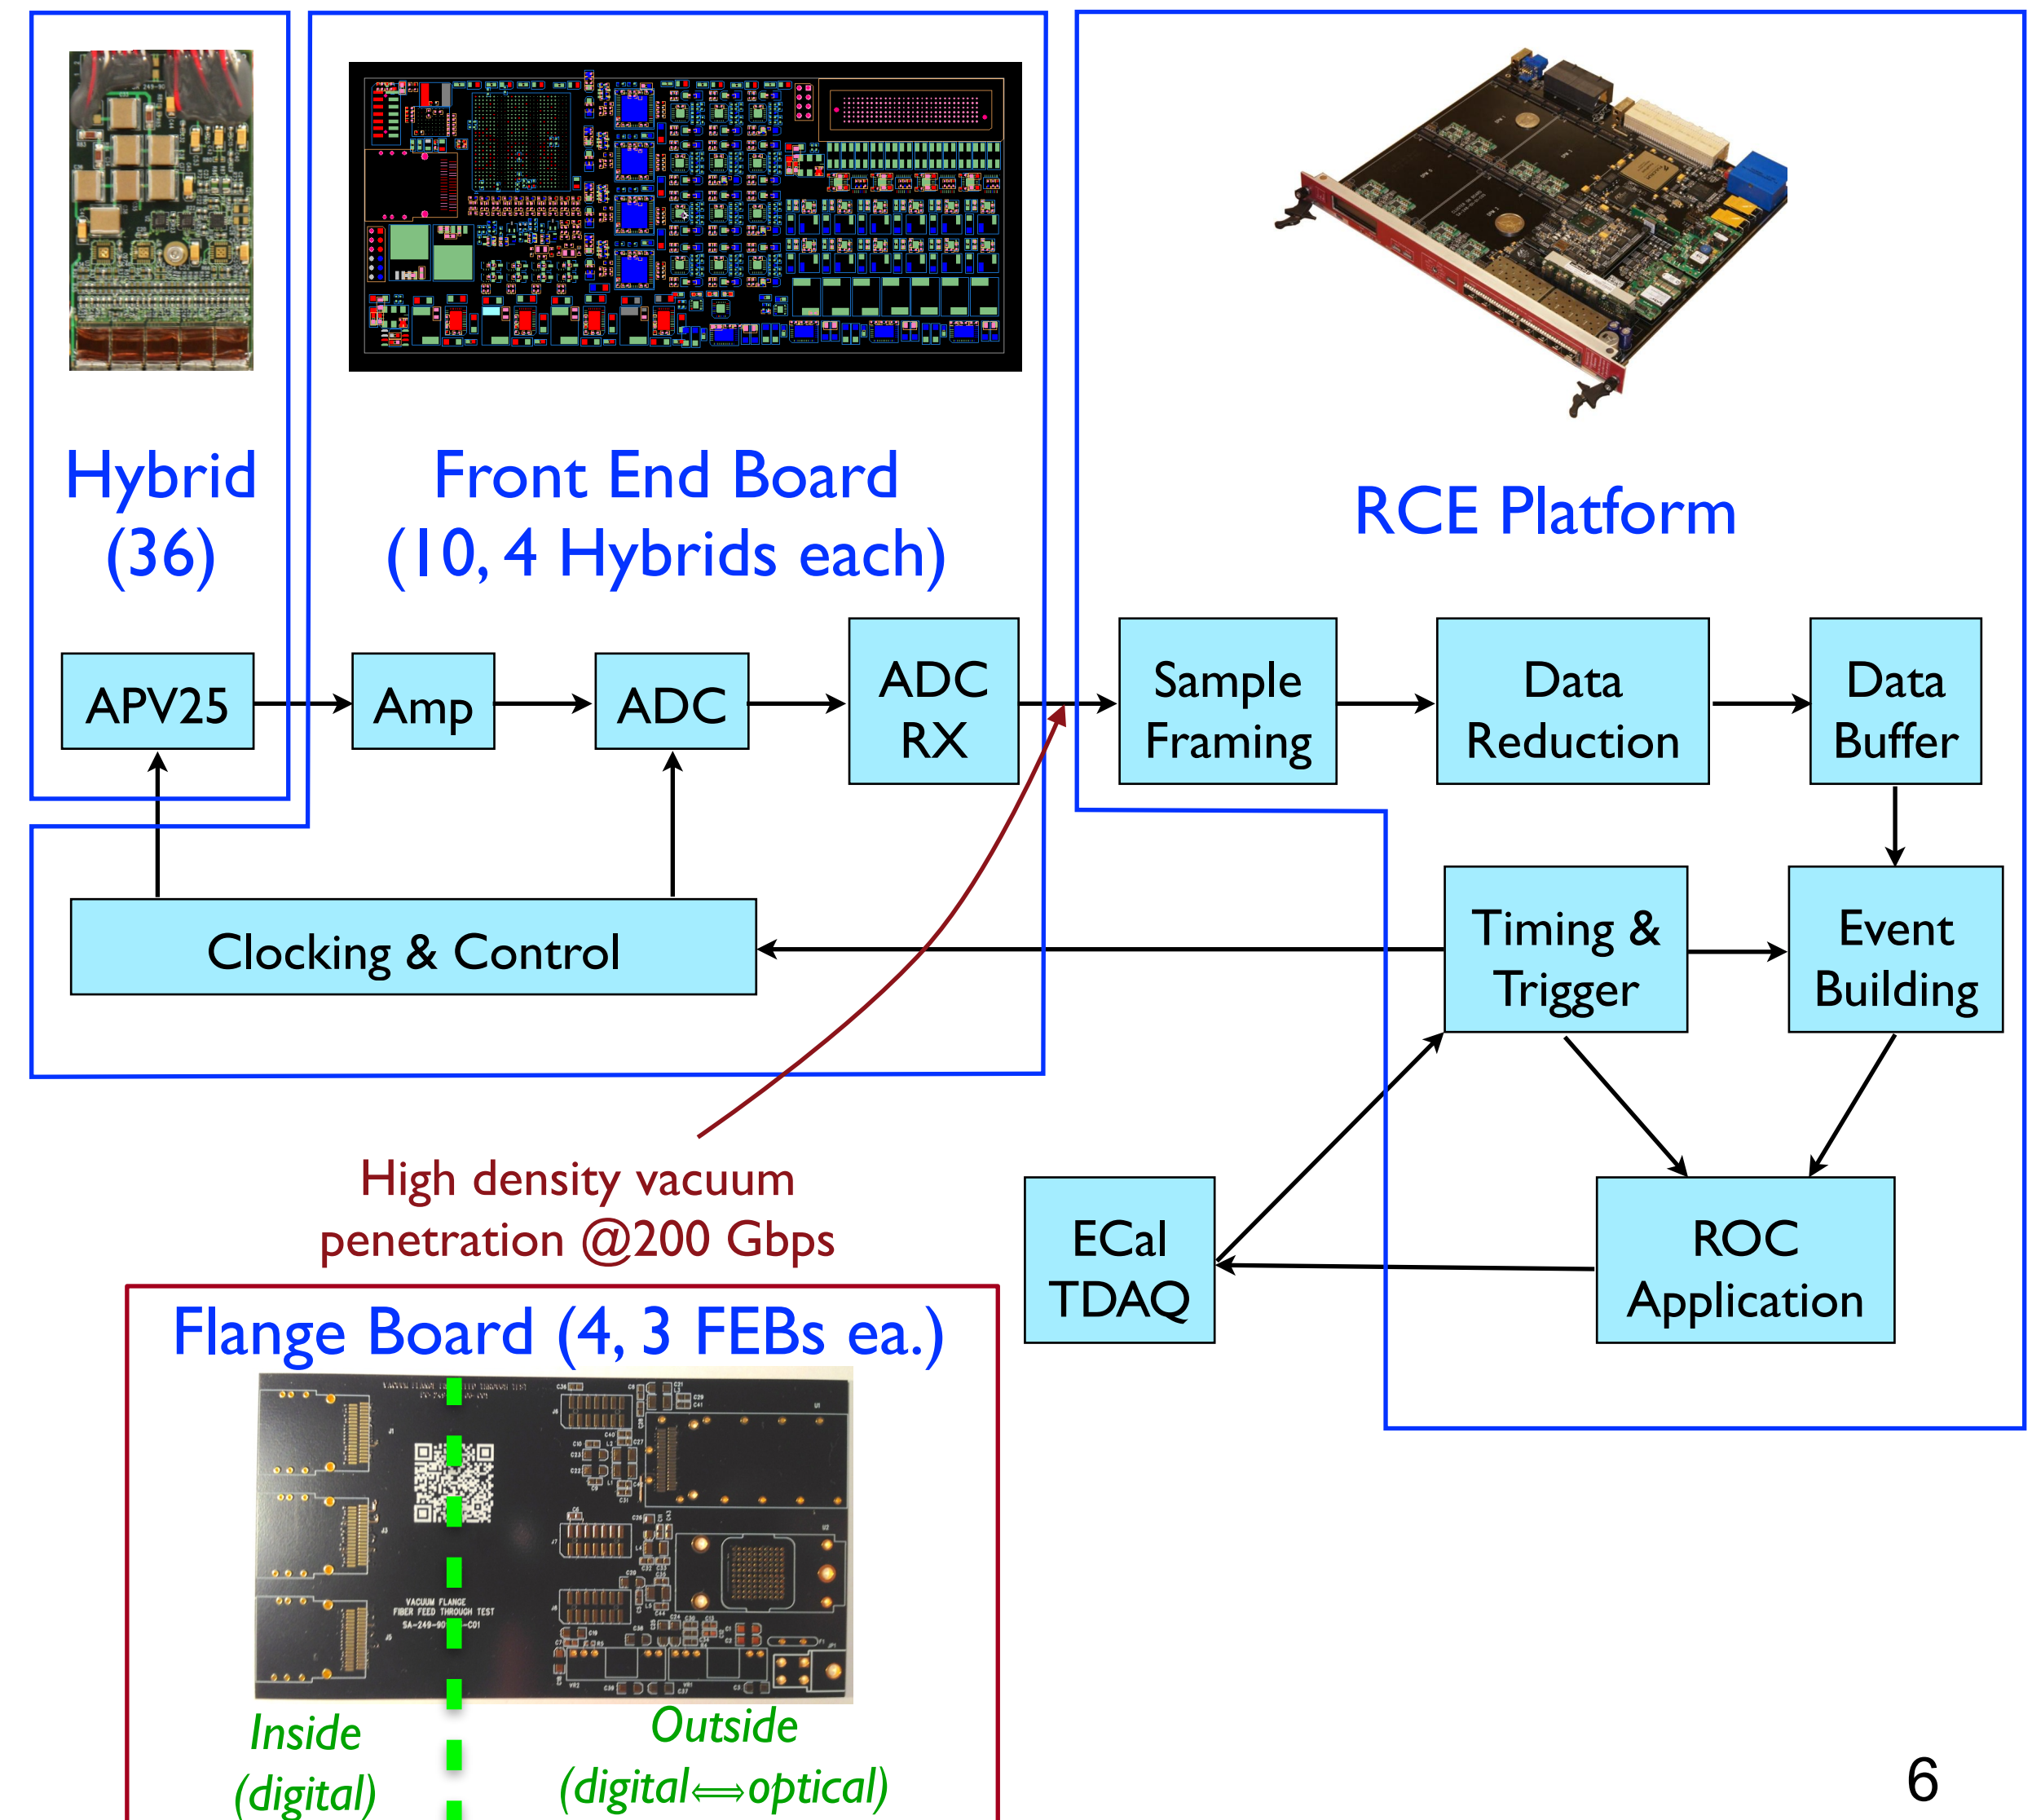
HPS SVT DAQ

- Hybrids hosting, 4-5 CMS APV25 each
- In-vacuum ADC, voltage generation and power distribution/control on Front End Boards
- Penetration for digital signals via high-density PCB through flange. Optical conversion on outside of flange.
- Firmware support for APV25 burst trigger mode (50 kHz trigger rate for 6 samples)
- Wiener MPOD power supplies

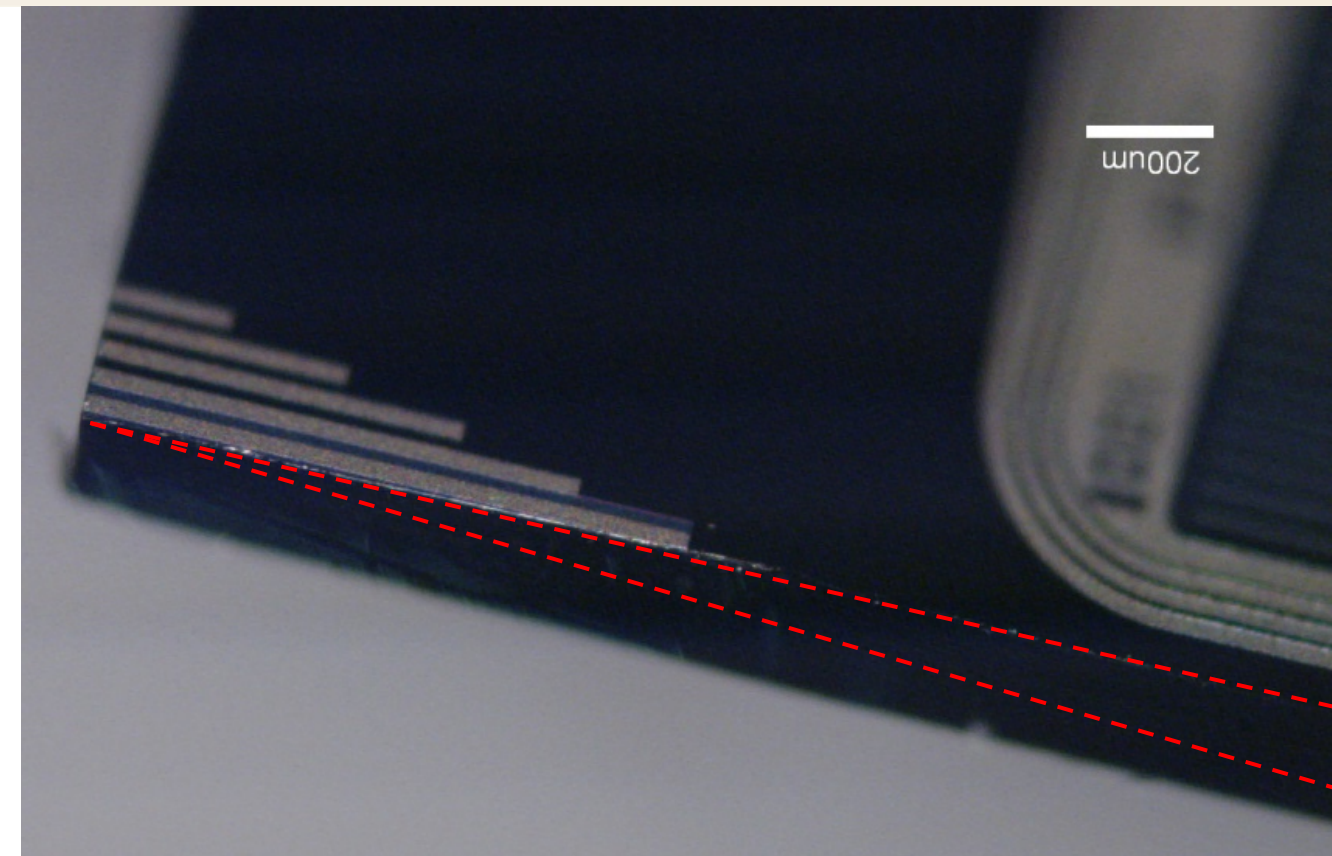
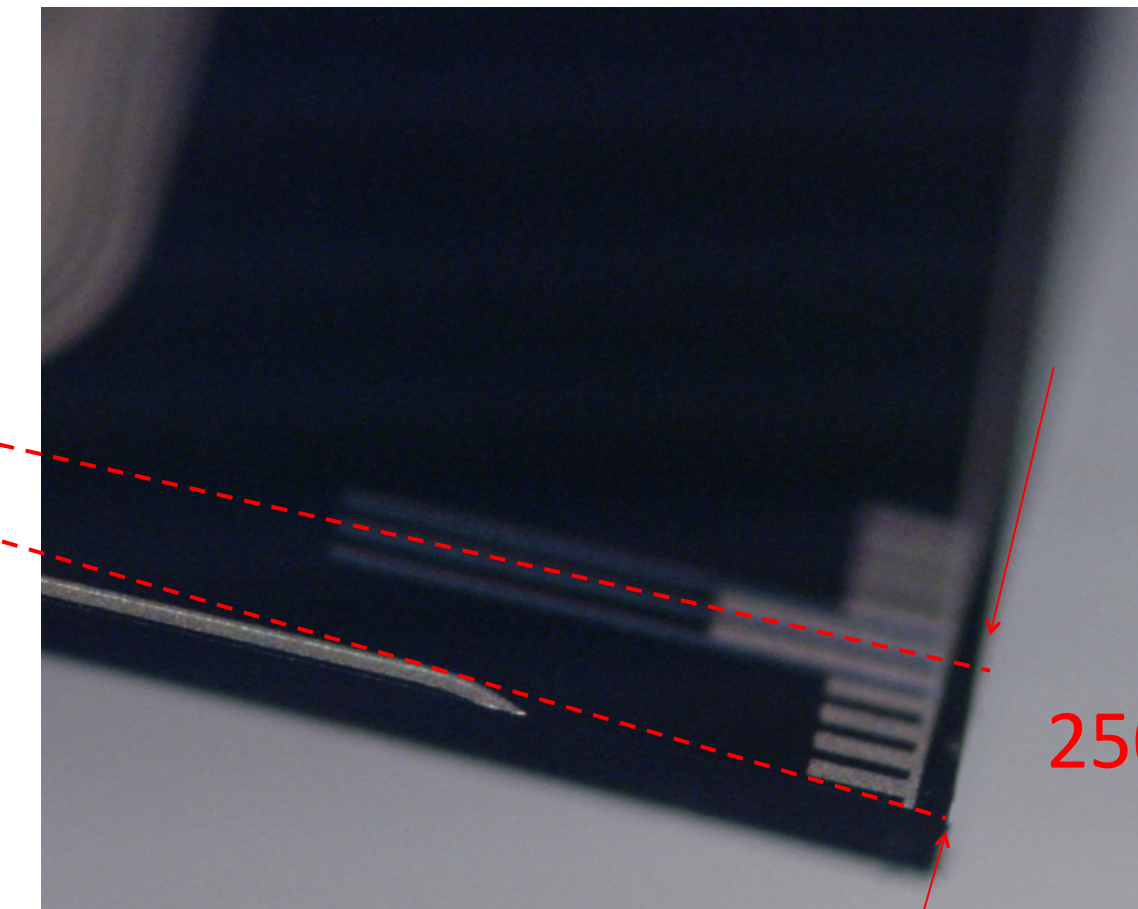
2019 Slim-edge Sensors

- Inconsistent cleaving
- Good breakdown characteristics

SECOND CLEAVING
Deviation of -250 μm over 33500 μm : -0,43 degrees

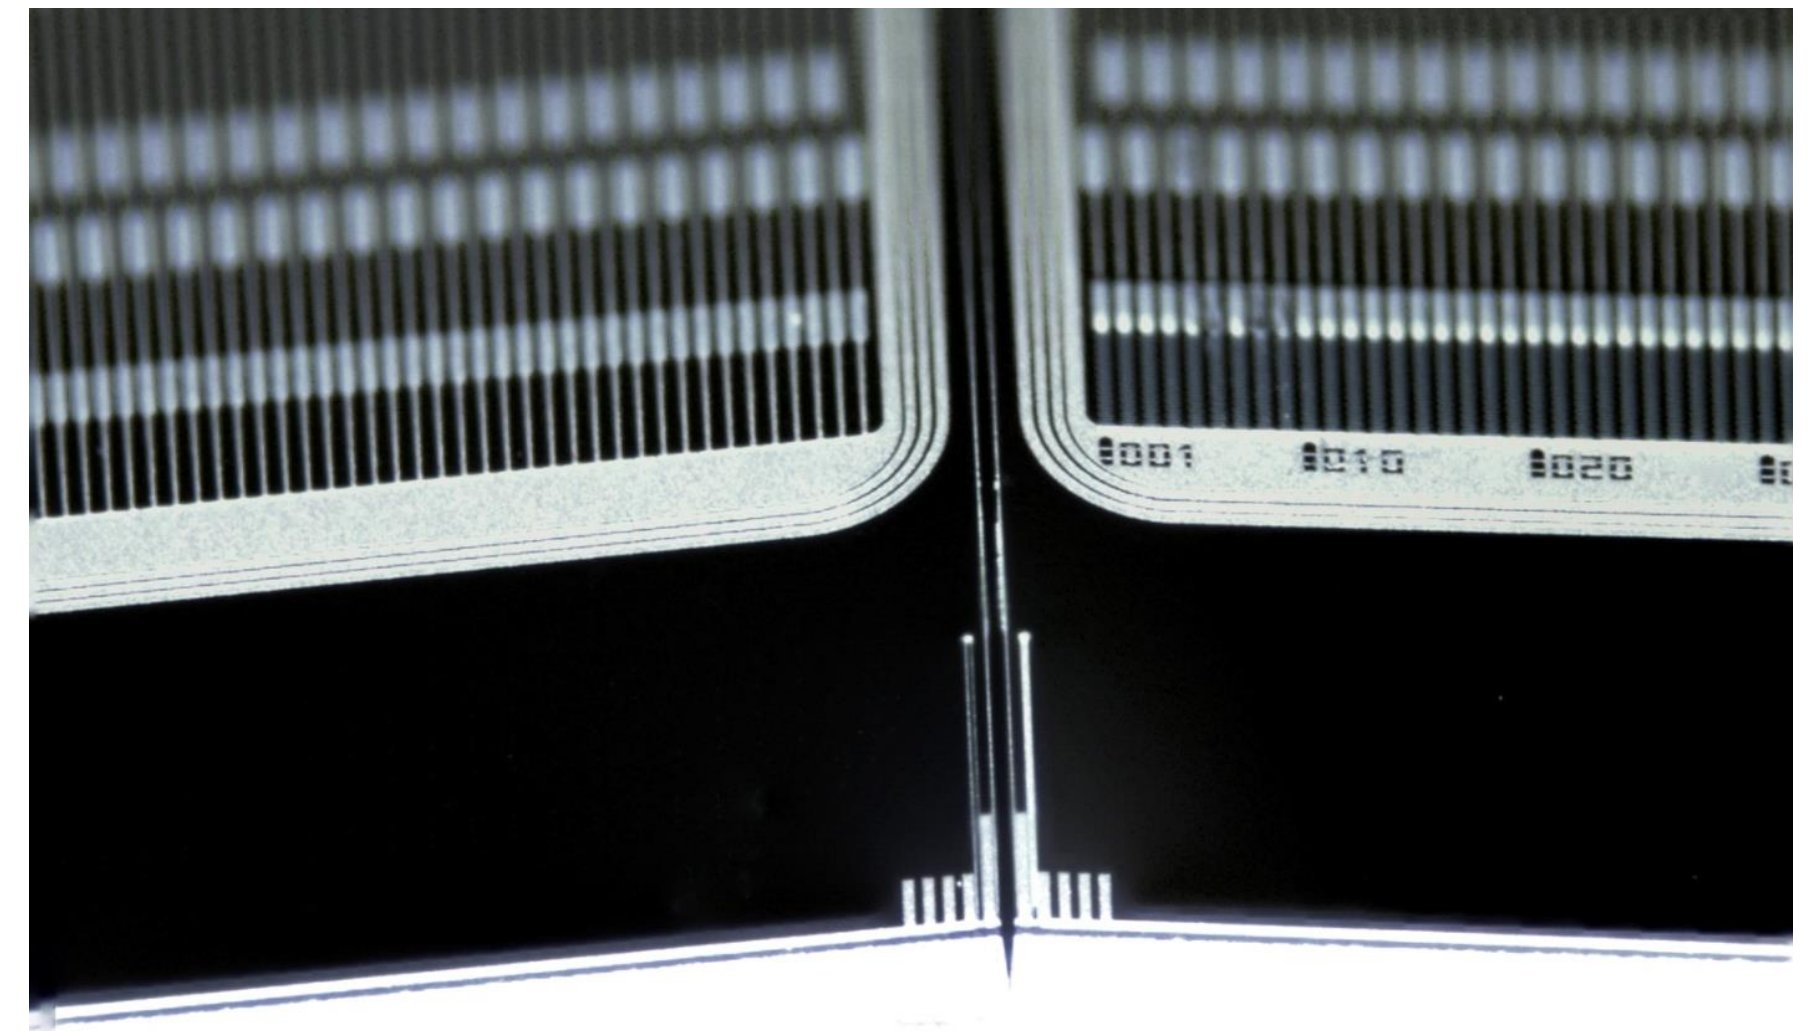
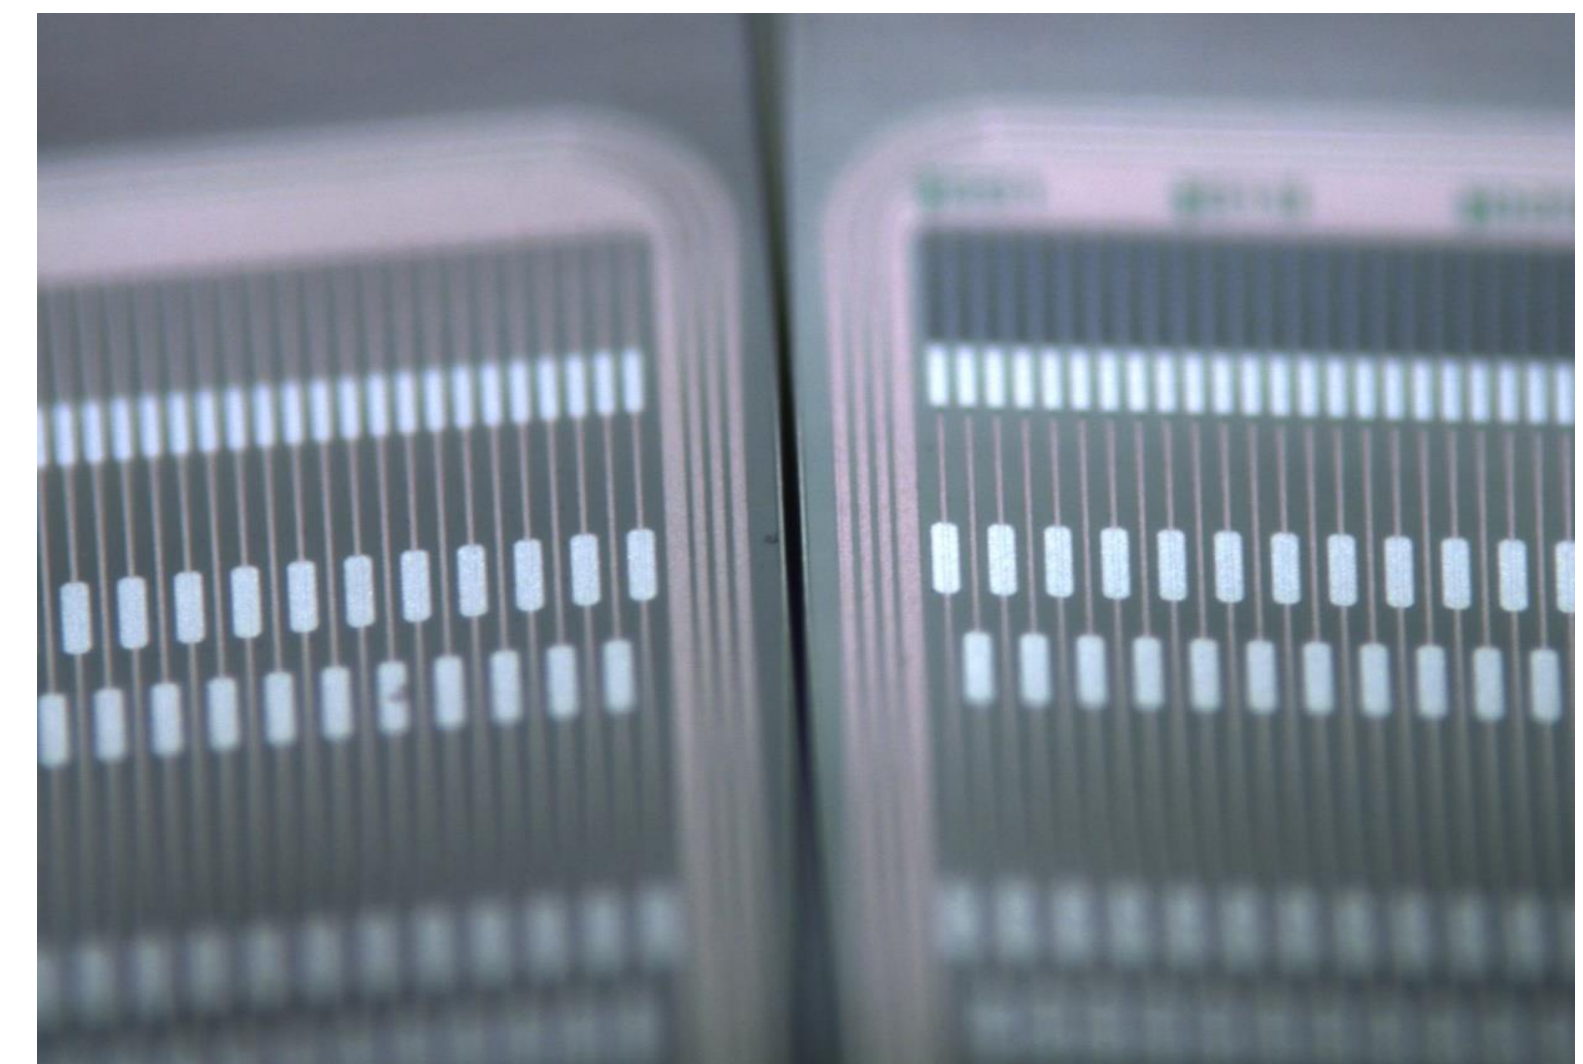
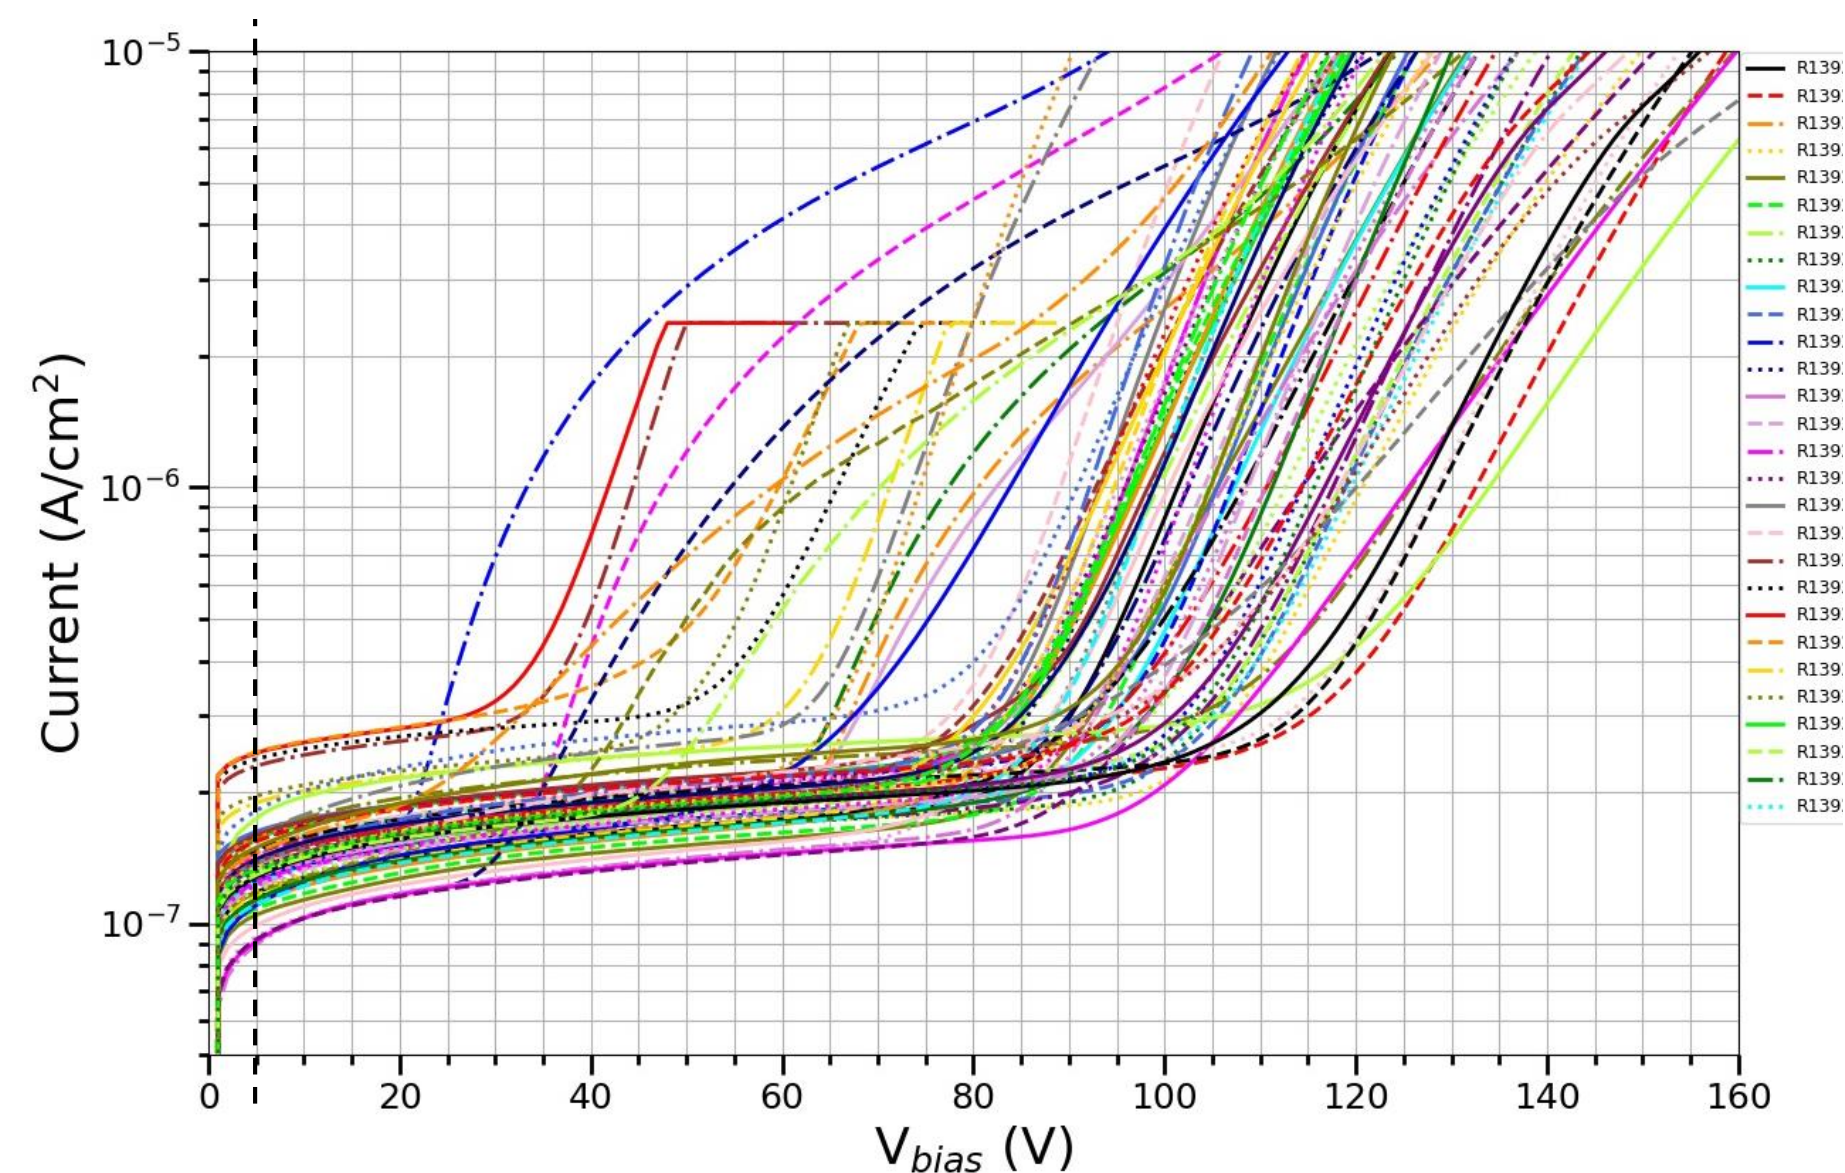
2021 Slim Edge Sensors

- Good cleaving
- Poor breakdown characteristics due to metal contact at edge
