Status of SVT for a 2025 Run

Tim Nelson
June 5, 2024

The HPS SVT

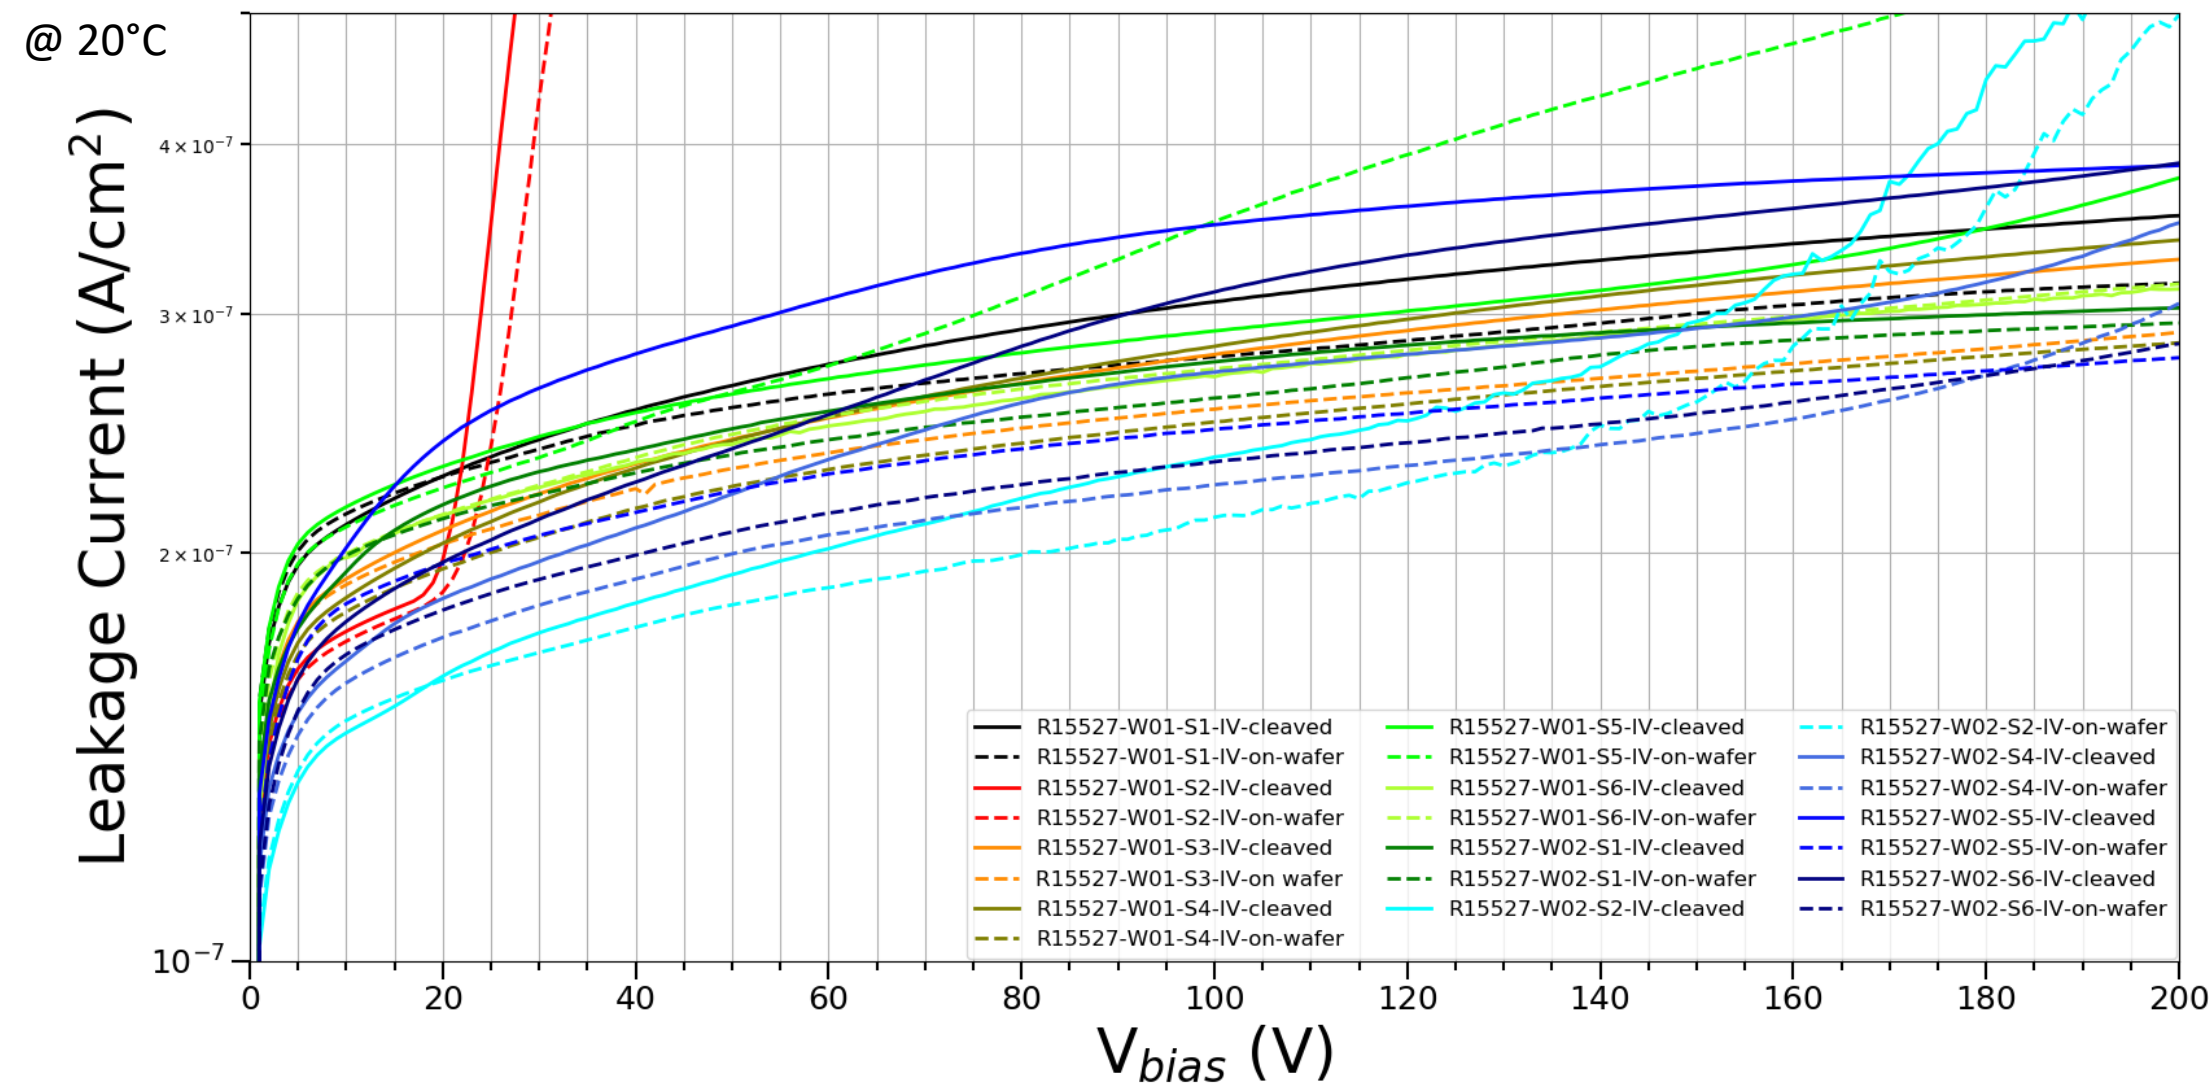
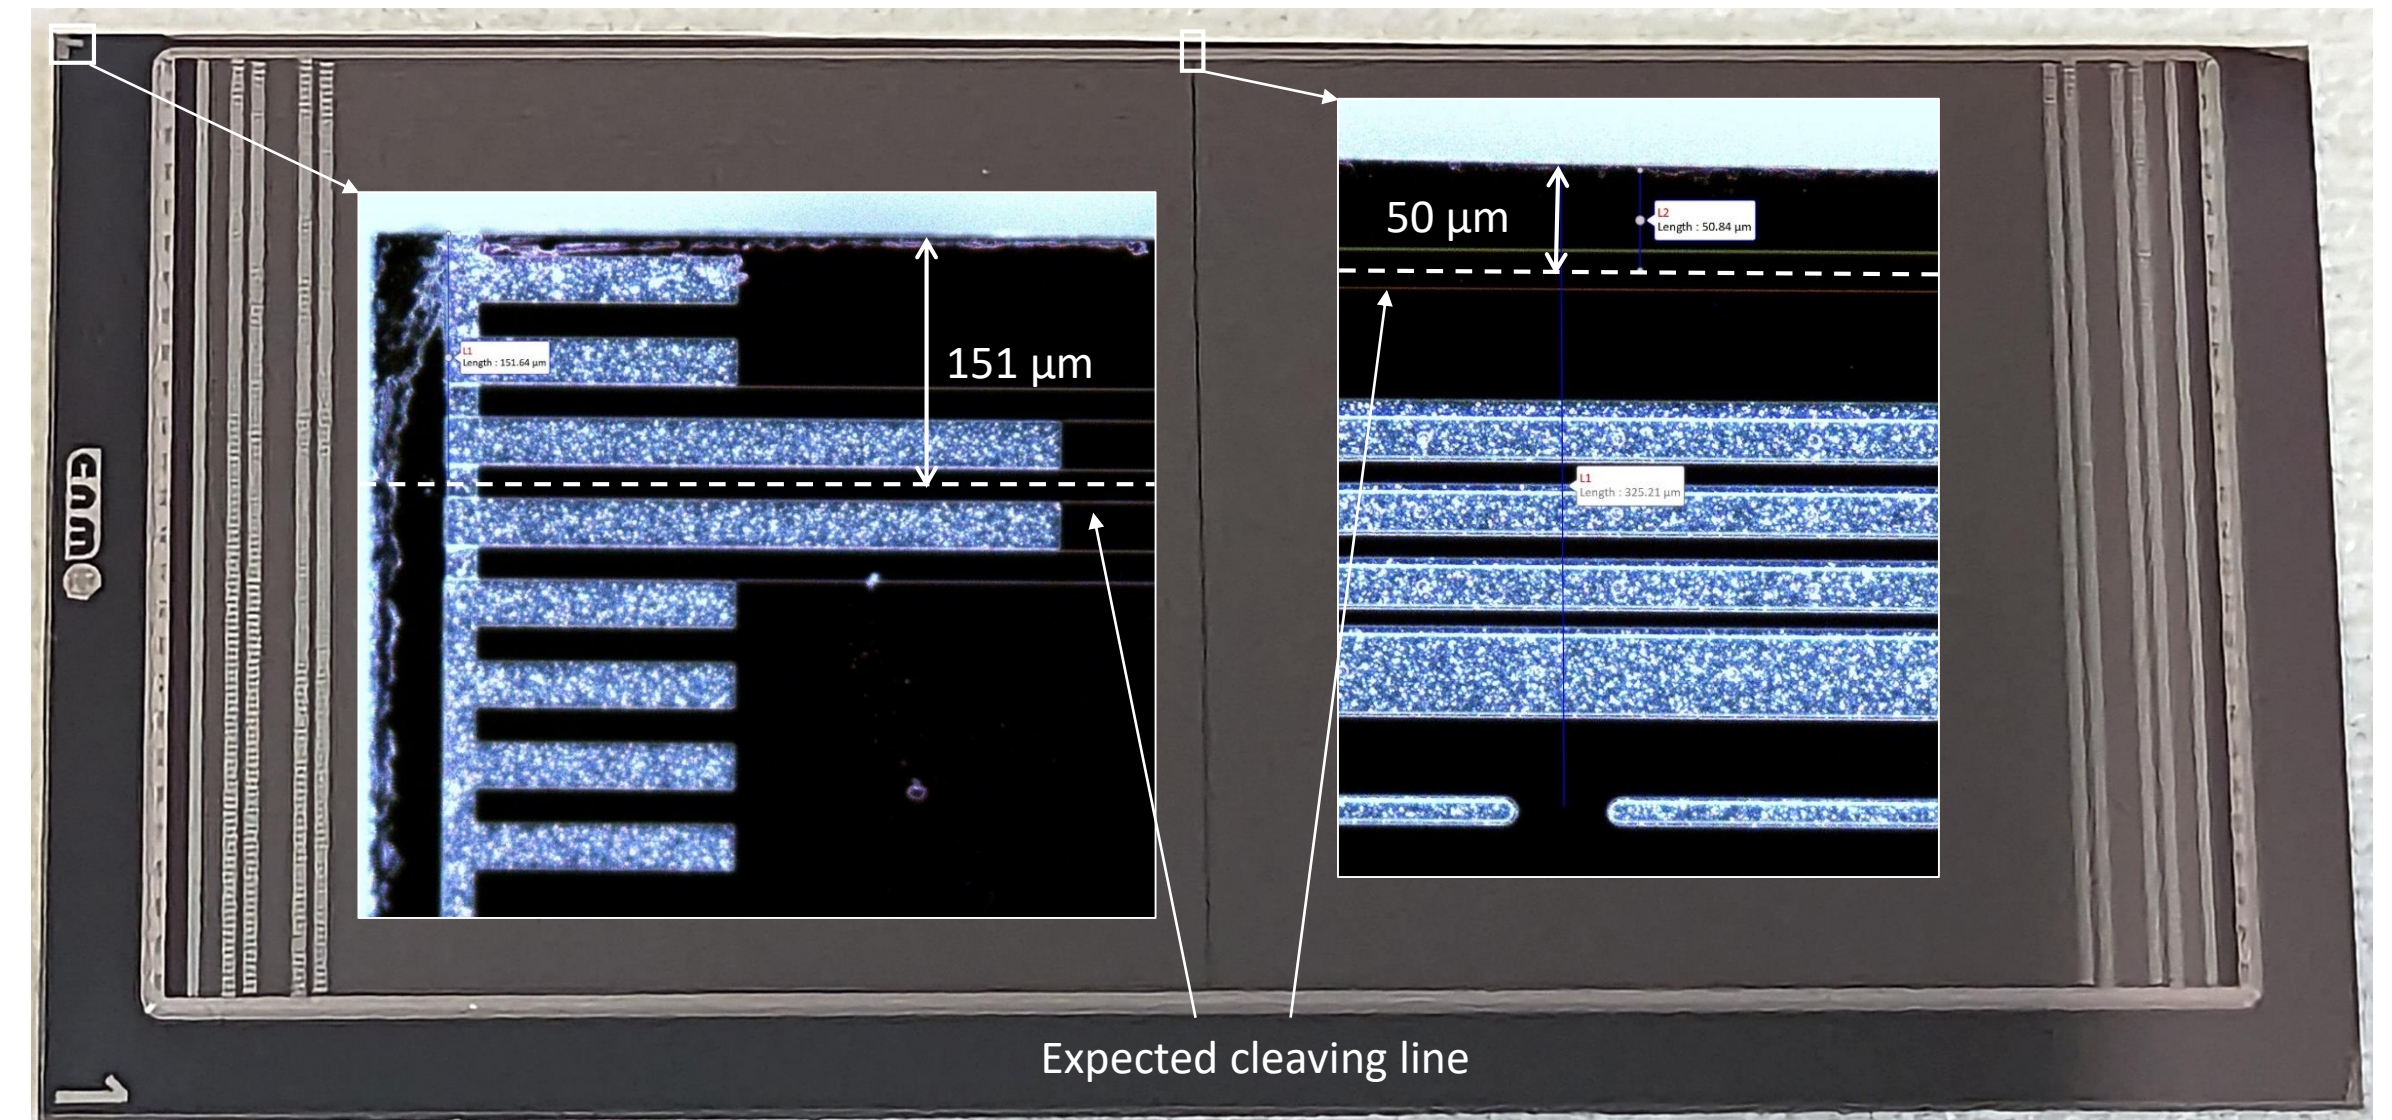
2023 Slim Edge Sensors

- Inconsistent cleaving
- Good breakdown characteristics

The leakage current measured after dicing and cleaving matches the leakage current measured on wafer: the cleaved edge is clean and smooth.

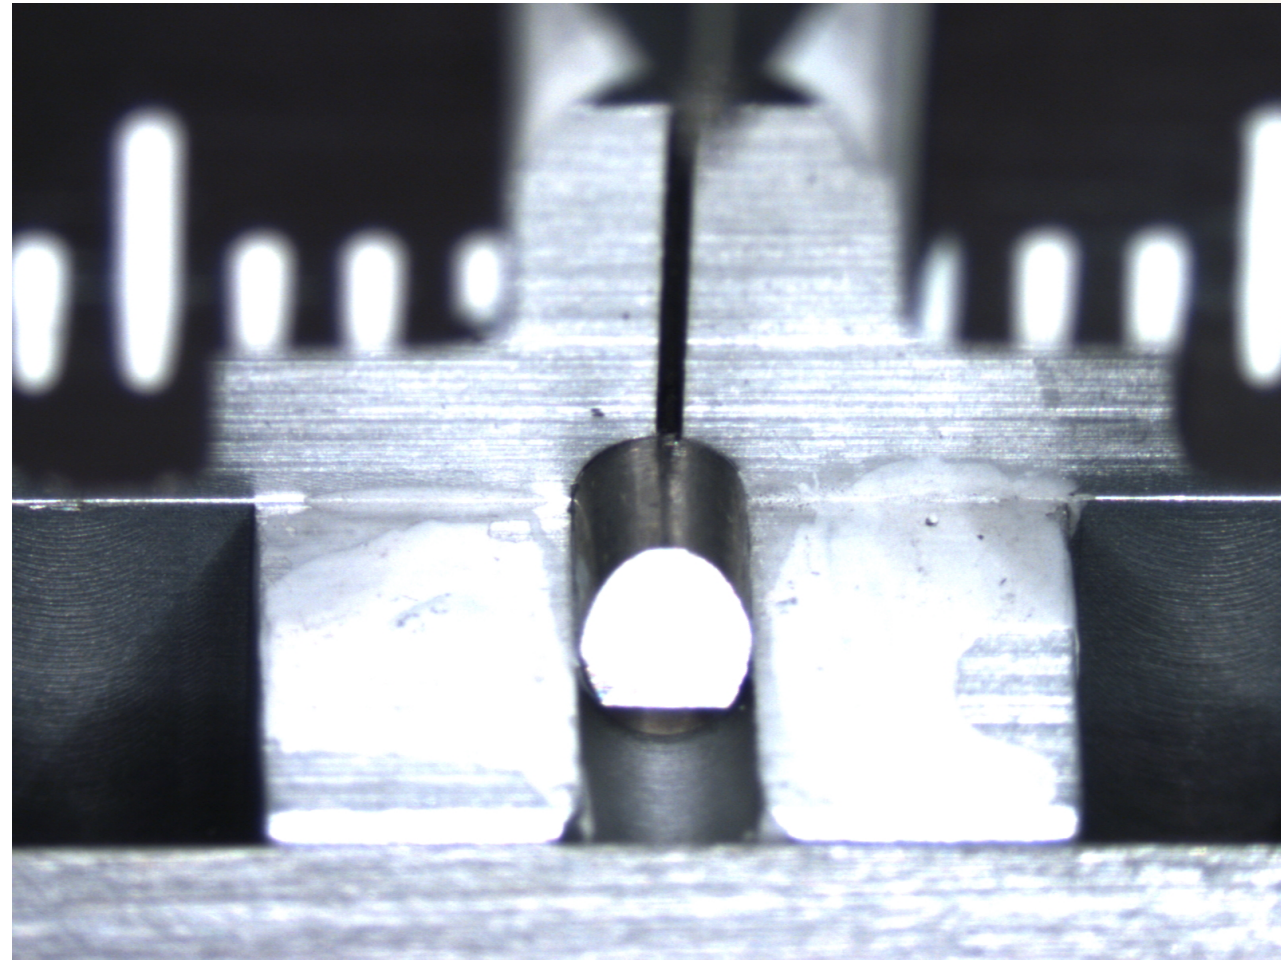
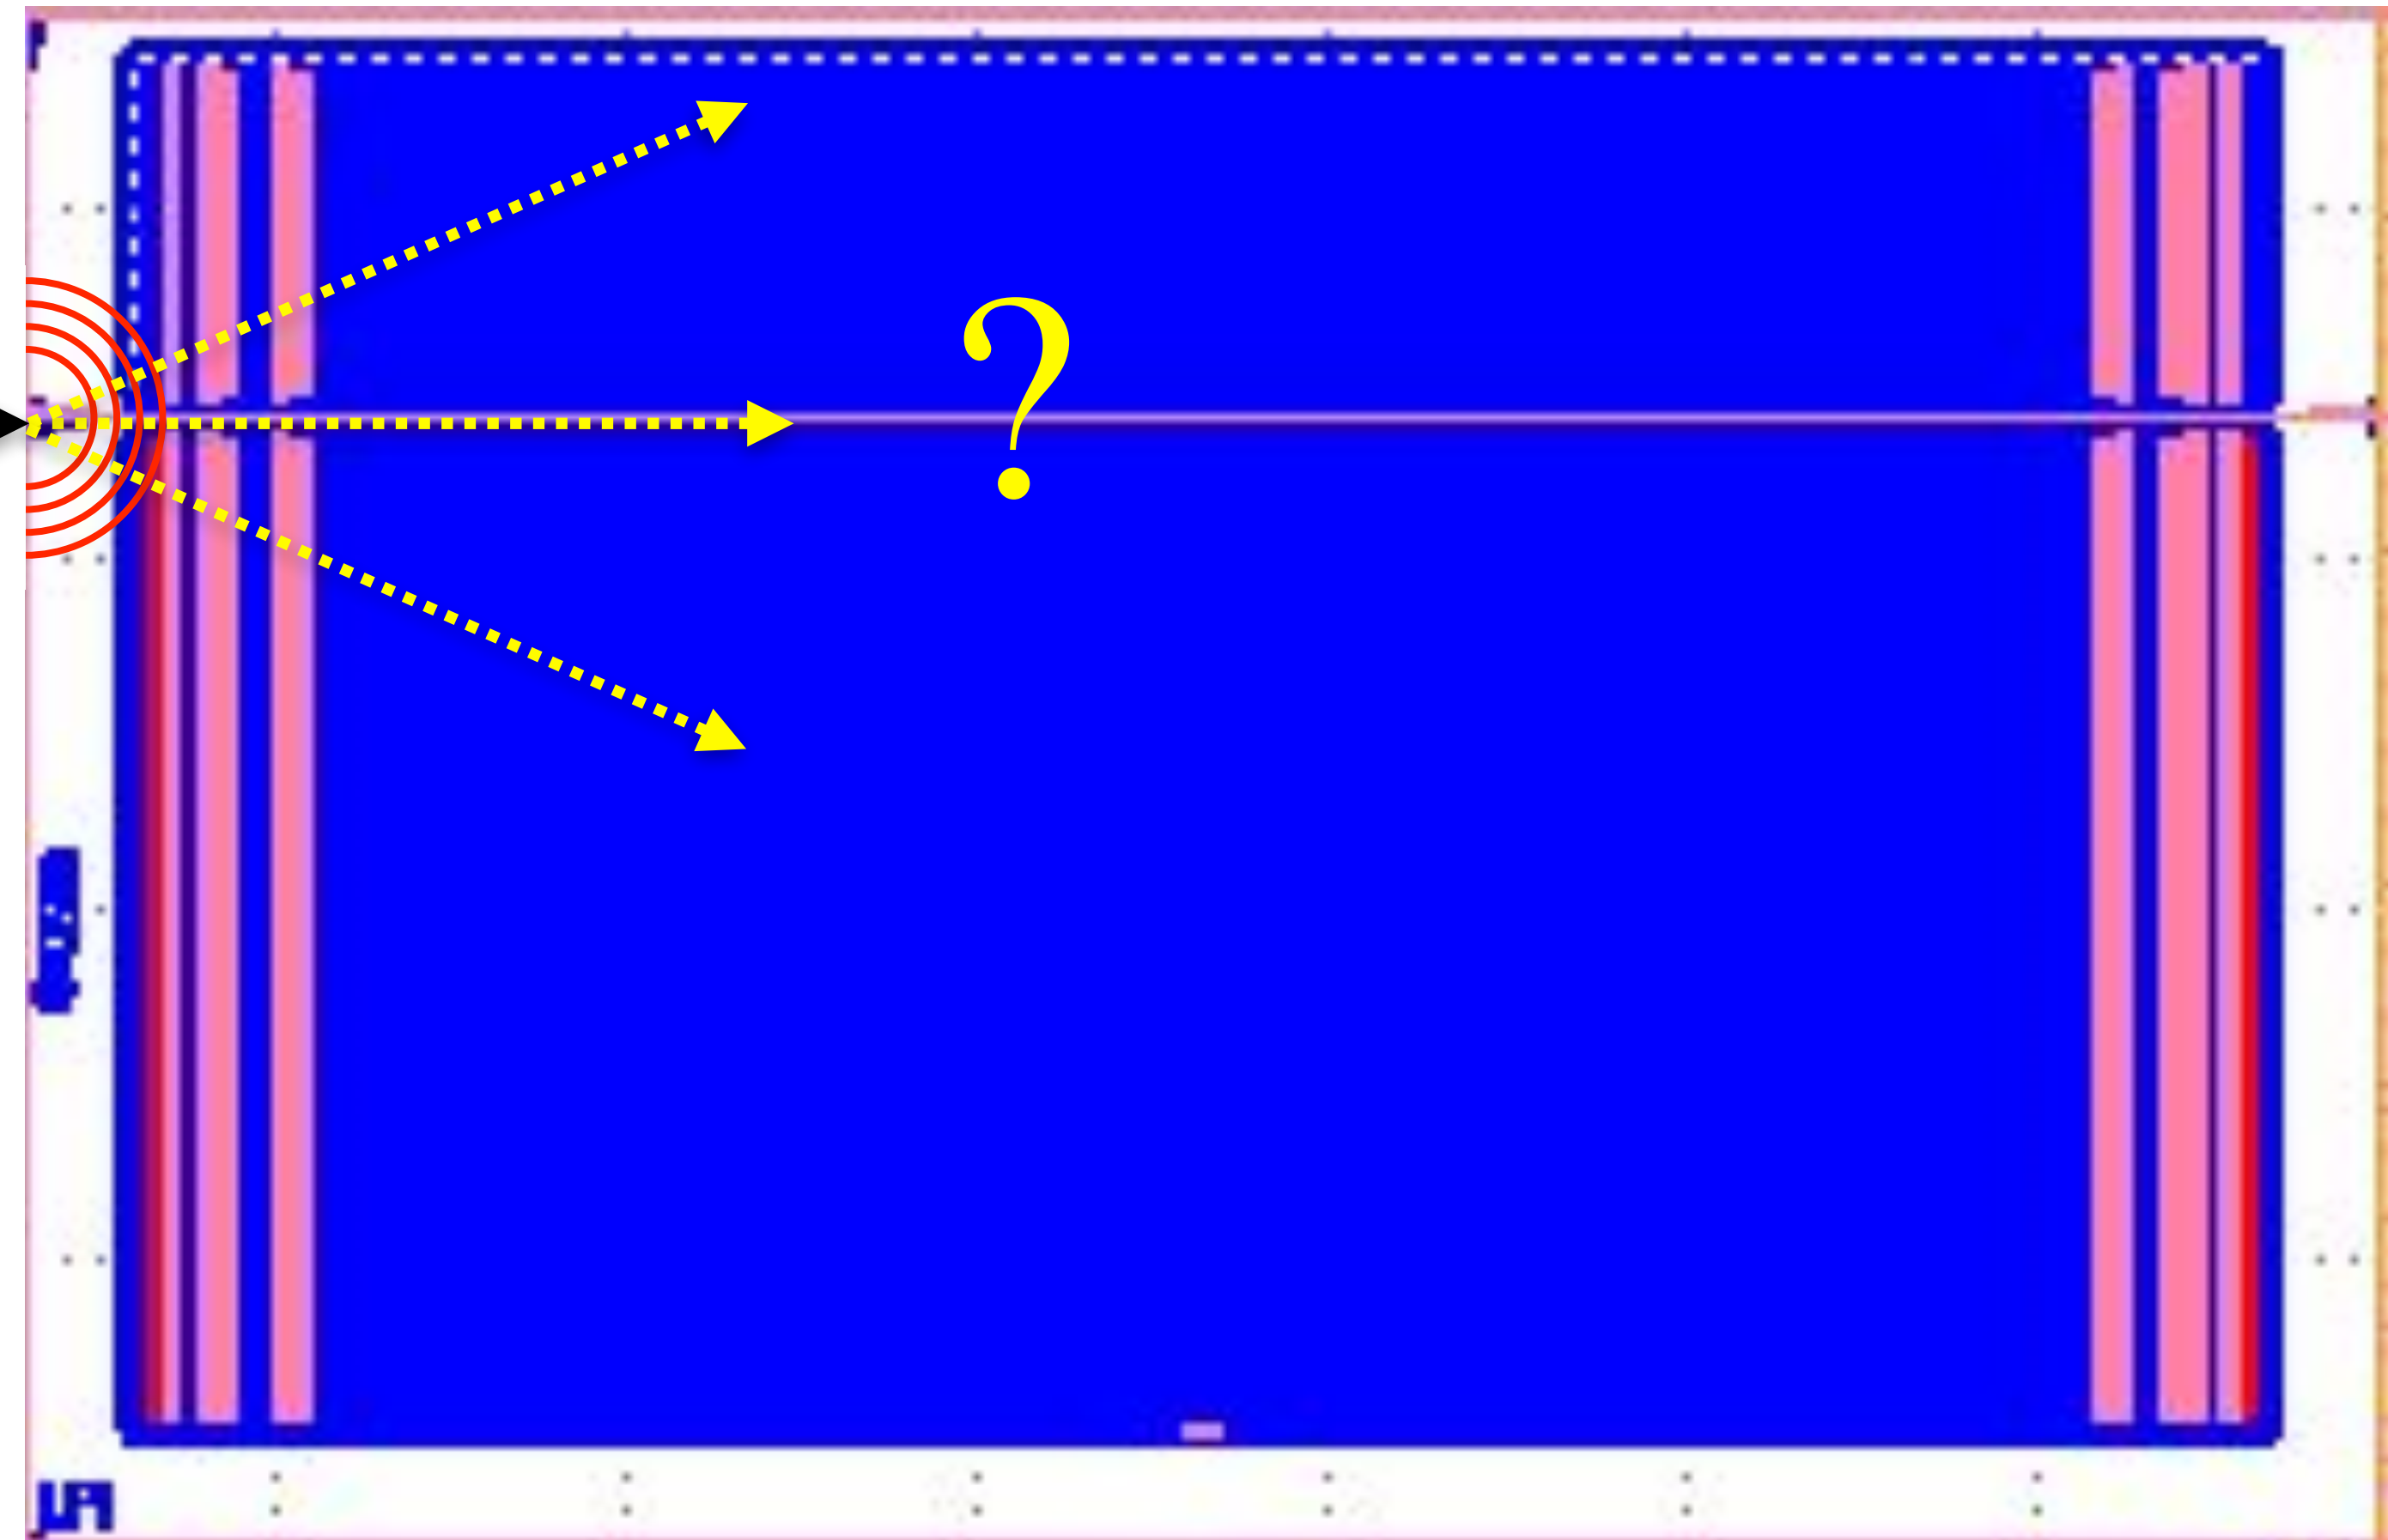
The “cleave” of the silicon sensor is initiated with bending stress at one end

When snapping material like this in the shop – a common practice – one places stress along the entire scoring line.

Perhaps we need to place bending stress along the entire length of the scribed line

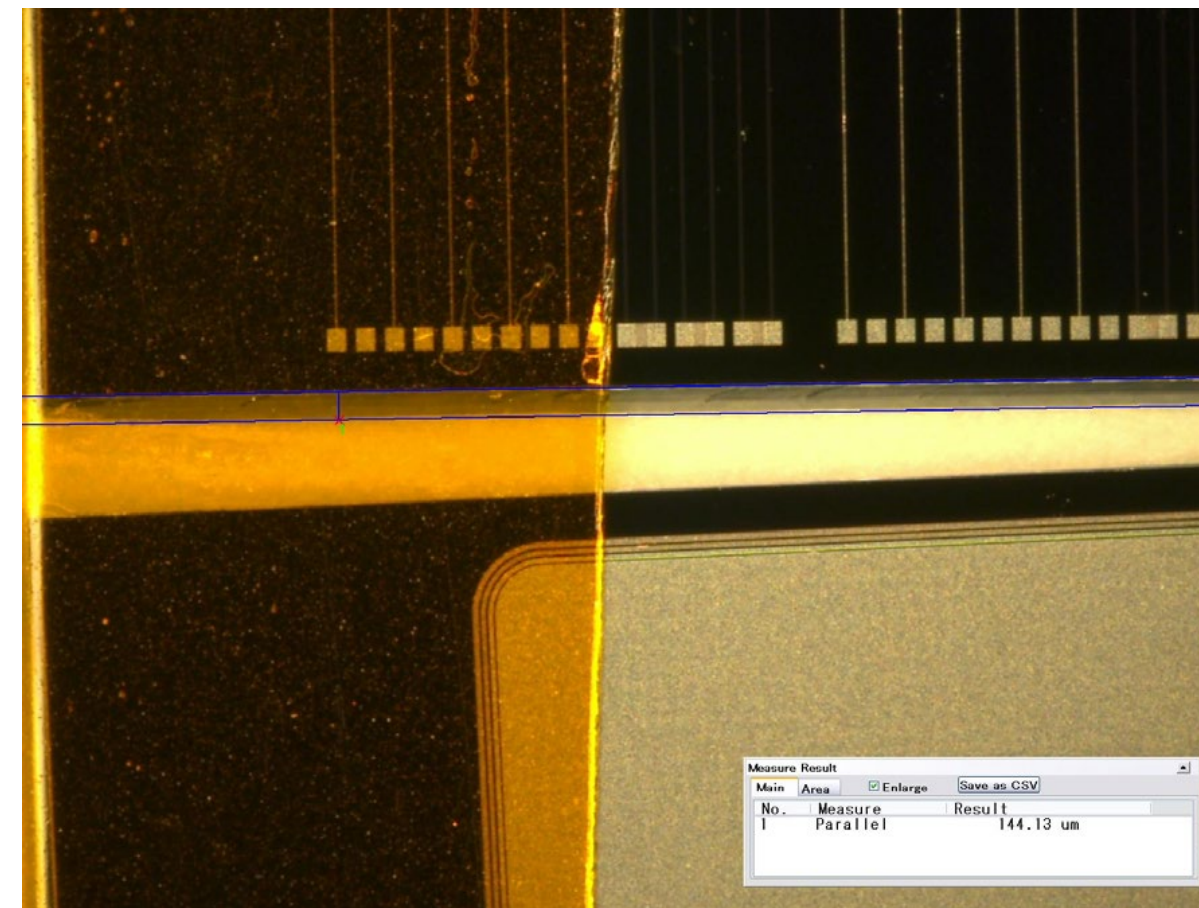
Bottom excess

Better: deviations from cleaving path are small but side wall is often not perpendicular to sensor surface.

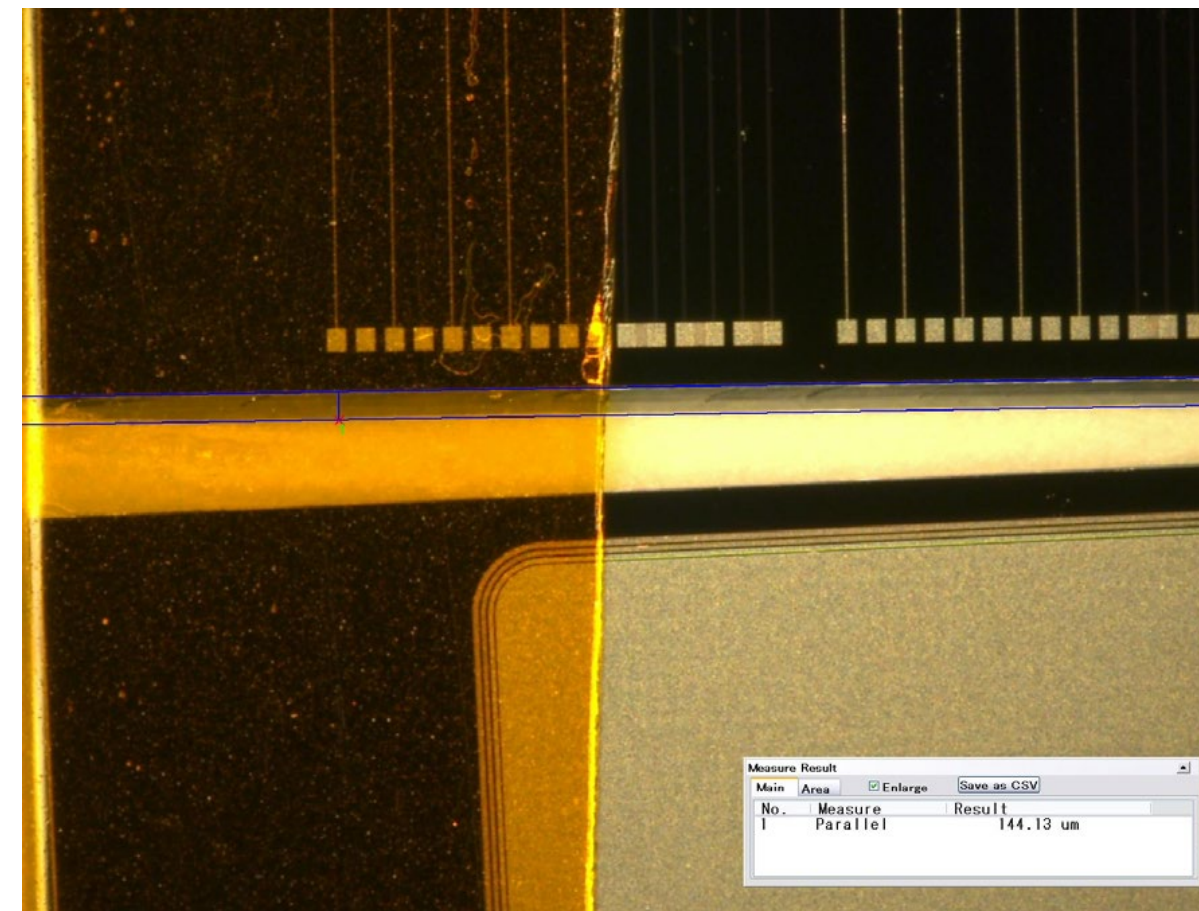
Bottom excess

Better: deviations from cleaving path are small but side wall is often not perpendicular to sensor surface.

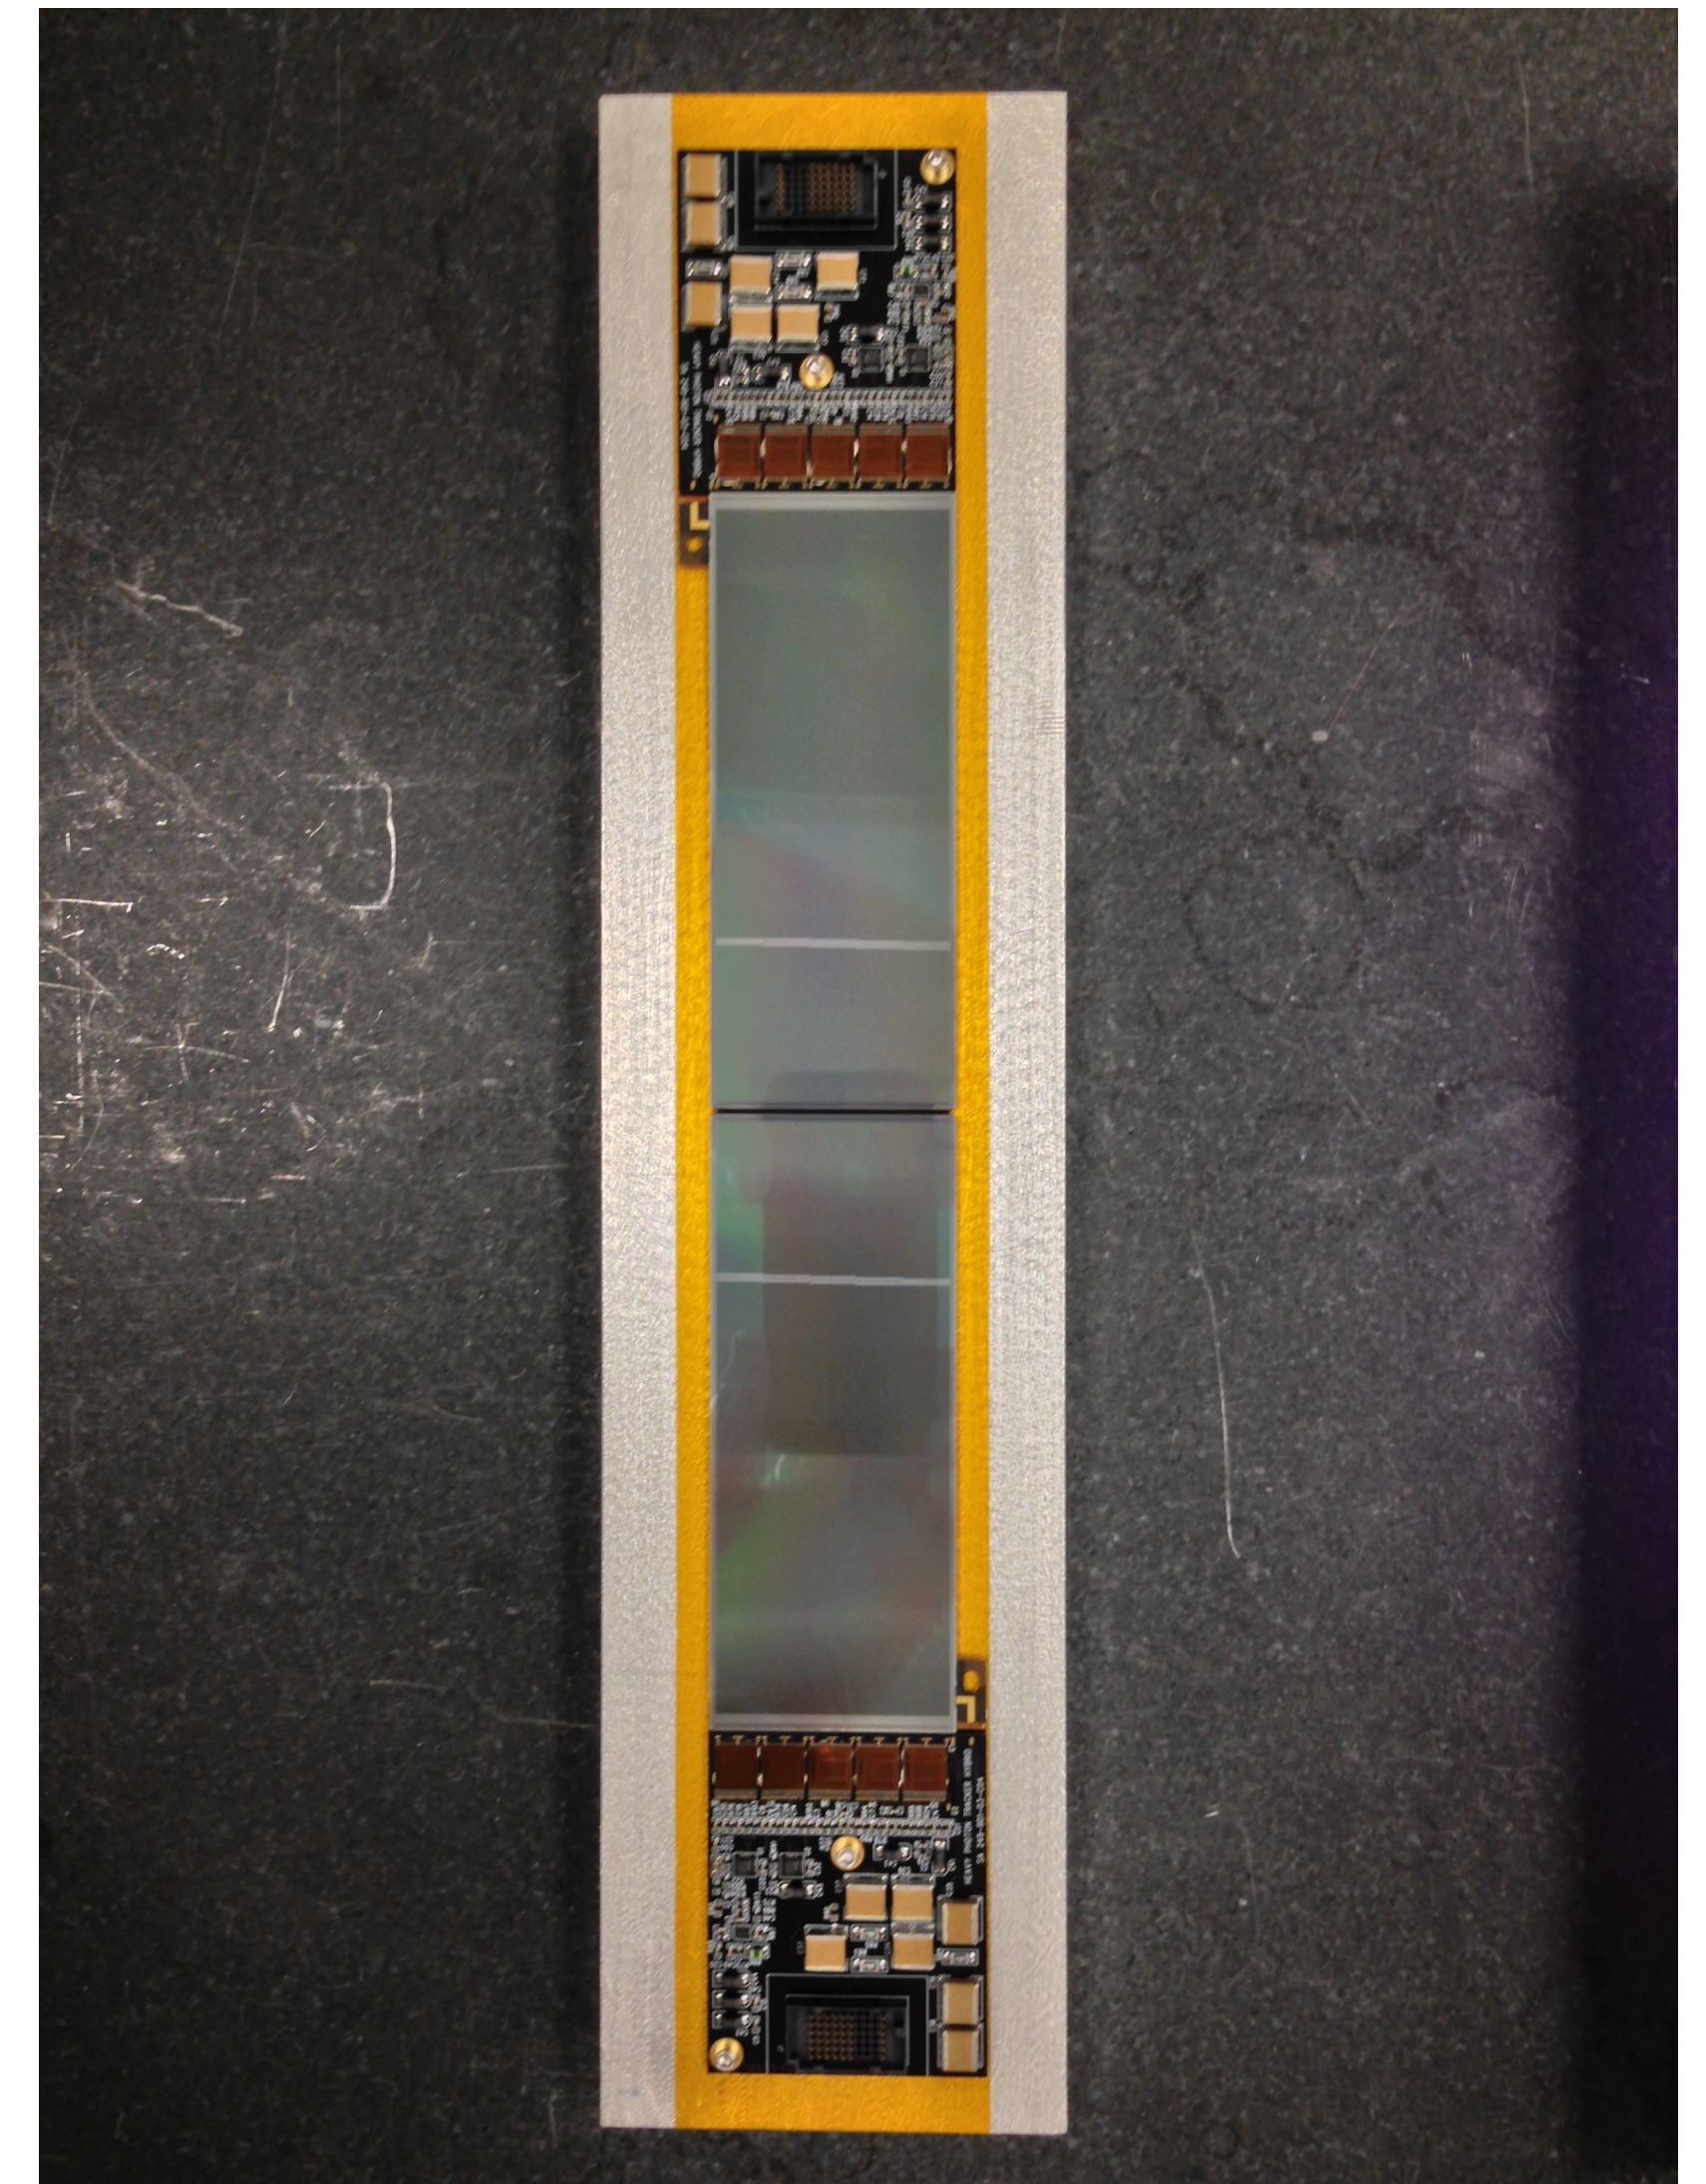
Long modules used in L5-7 were anticipated to be a low-risk item

Instead, these modules have suffered mysterious problems during non-operational periods

- over time, wirebond damage to half-modules facing downstream (now also seen in short modules in L2-3)
- in 2021 partial shorts between some power rails and ground: investigation by Sarah/Cam \Rightarrow likely ESD damage

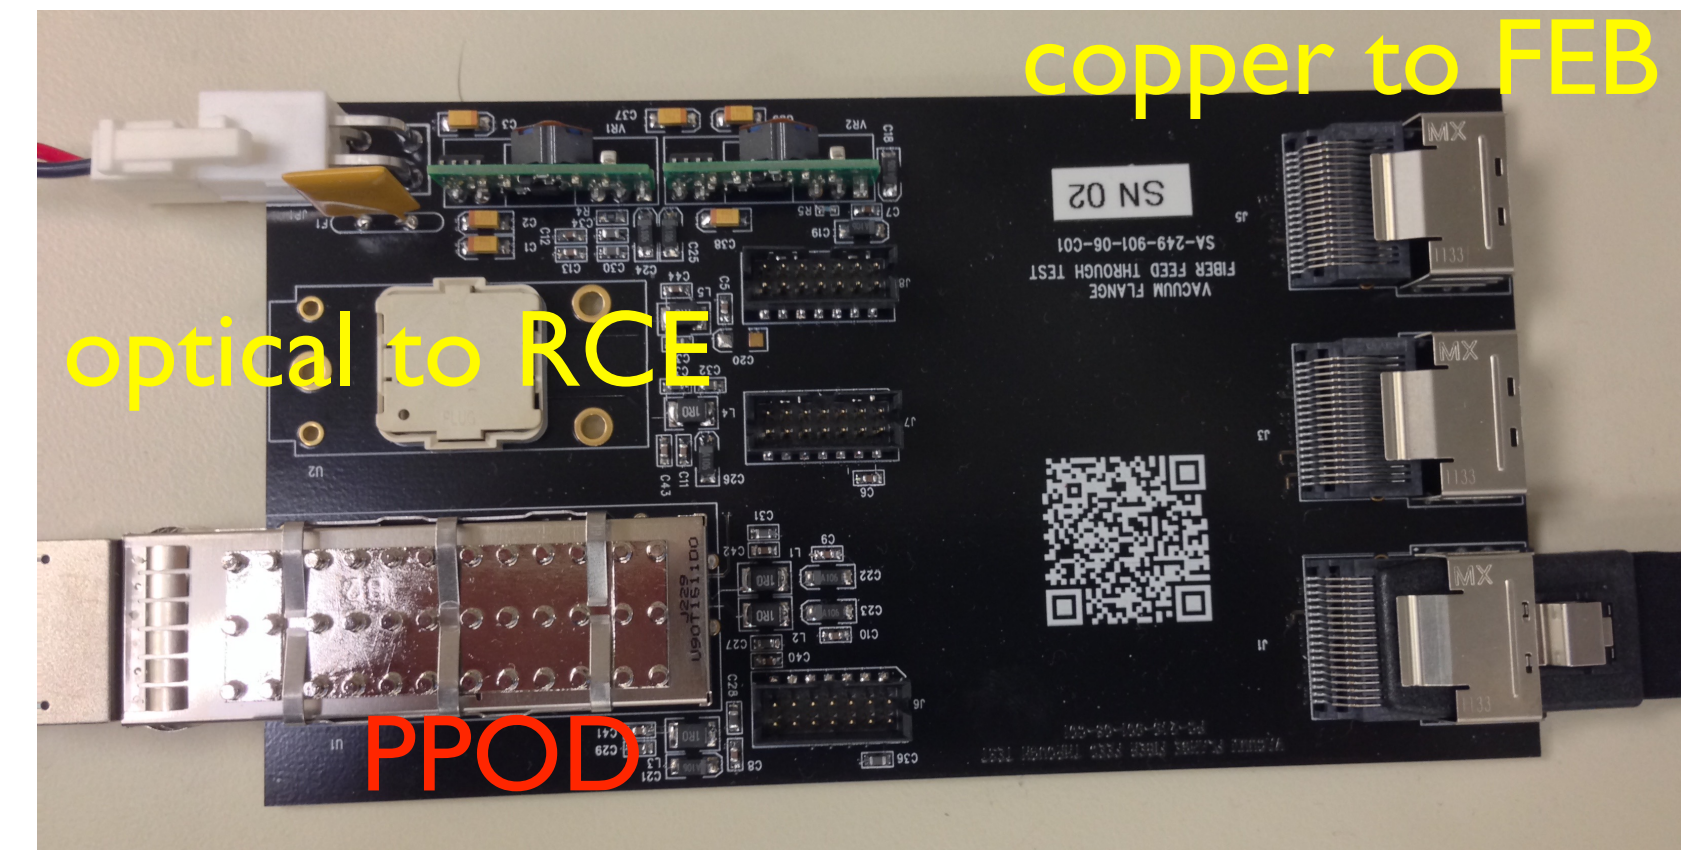
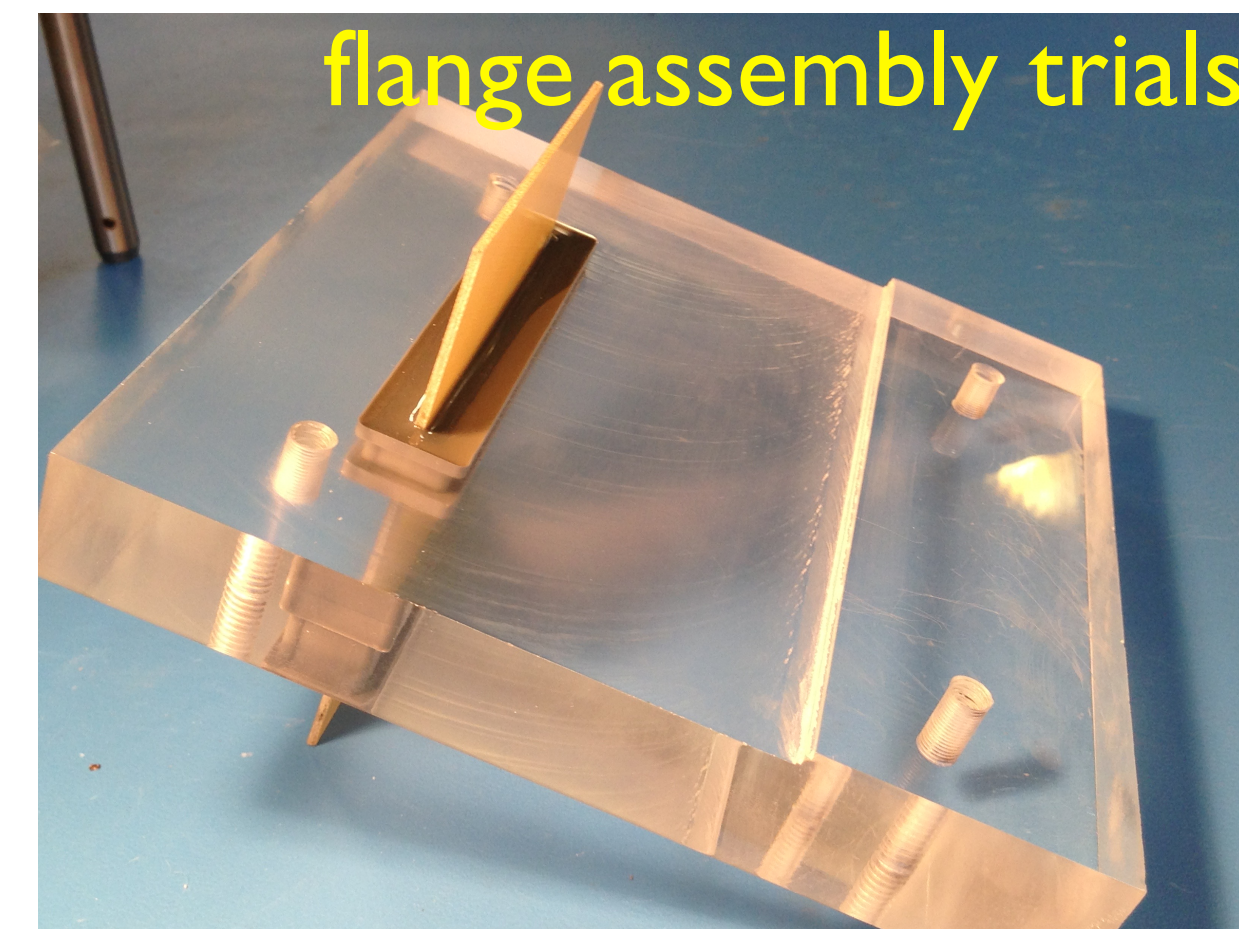
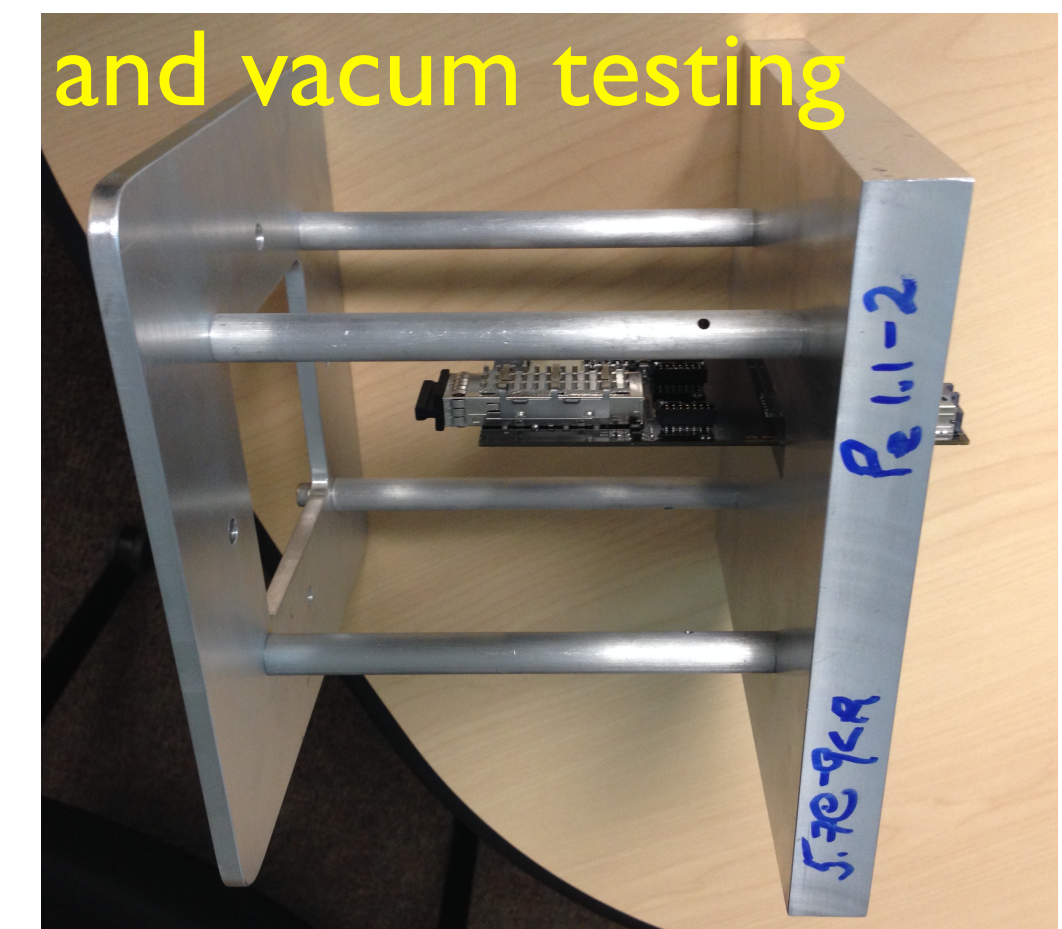
SVT Data Flange

SVT data flange converts FEB control+data on copper to optical connected to RCE back end.

- Four boards with 3 channels each (12 links total)
- Boards are potted through 6" vacuum flange on positron side of upstream vacuum box.
- Two flanges were built: the first no longer has 10 reliably working channels. Spare was used in 2021.
