NPS Calorimeter Refurbishment

Discussion points, not recommendations

NPS Collaboration Meeting

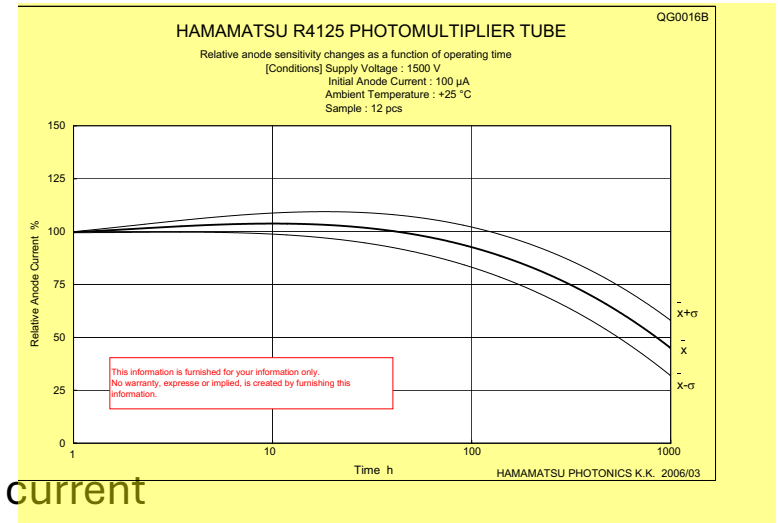
HAMAMATSU R4125 PMT Lifetime

- Fermilab study:
 - <https://lss.fnal.gov/archive/1997/pub/Pub-97-092.pdf>, or NIM A v406 (1998) 103–116
 - 12 PMTs tested, illumination level: 100 μA anode current
 - Gain stable up to anode charge of 100 Coulomb.
 - Gain decrease to 50% after anode charge of 1000 Coulomb.
- NPS, Crystals closest to Calorimeter (very rough estimate)
 - (8 months) \otimes (60%) \otimes (10 μA) \approx 115 Coul
 - Get exact recorded anode charge.
- Probably could run another 100 PAC days without catastrophic failure
 - Ran 3 generations of DVCS experiments in Hall A and only replaced 16 (out of 200) PMTs

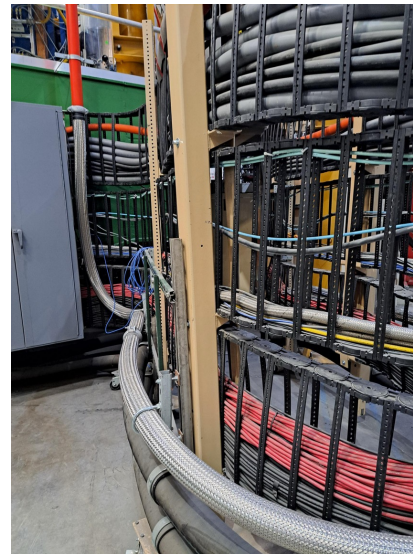
Mechanics

- Distribution boards, PMT+Crystal repair/replacement
- Cable bundle
 - Required crane to move Calo forward/back. Scheduling challenges.
- Build a vertical axis cable tray?
