PRad-II Gas Target Status

Xiangdong Wei
Jefferson Lab

PRad-II/X-17 collaboration Meeting
09/12/2025

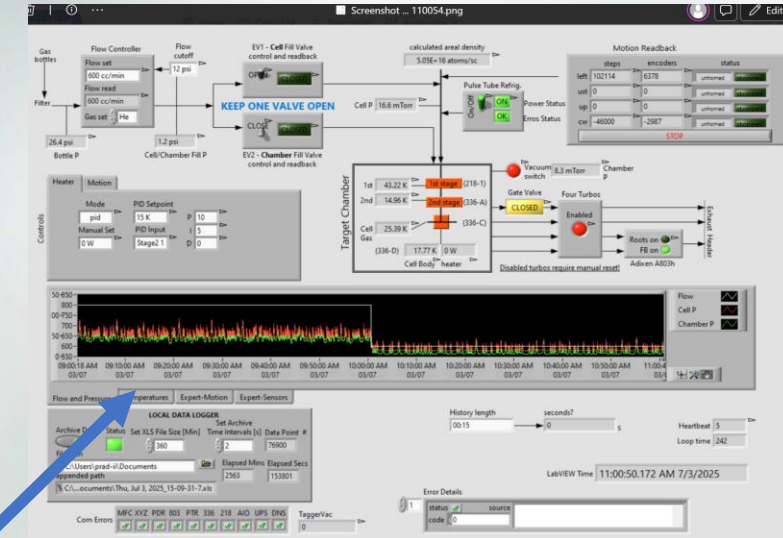
The screenshots of the LabView control program with temperature chart are shown on the left, while with pressure and flow charts are on the right.

The target was cooling down quickly (upper left) and temperature was stable as gas flow changed (lower left).

The large temperature noise (upper right) was fixed by fine tuning the LabView control program (lower right).

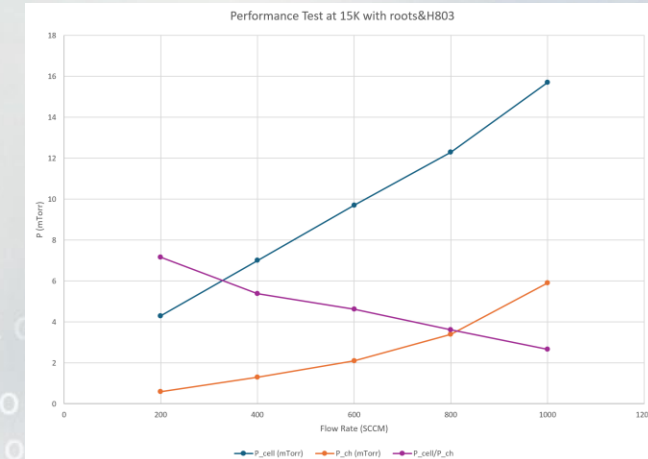
P_{cell}, P_{ch} and P_{cell}/P_{ch} at 15K

The **cell pressure were too low**, ~ 2 orders of magnitude less than the data in published target paper. Those results indicated that the gas leaked out through hole(s) much bigger than 2mm.

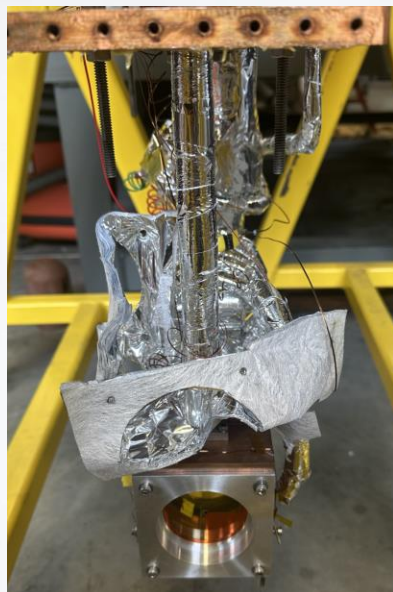
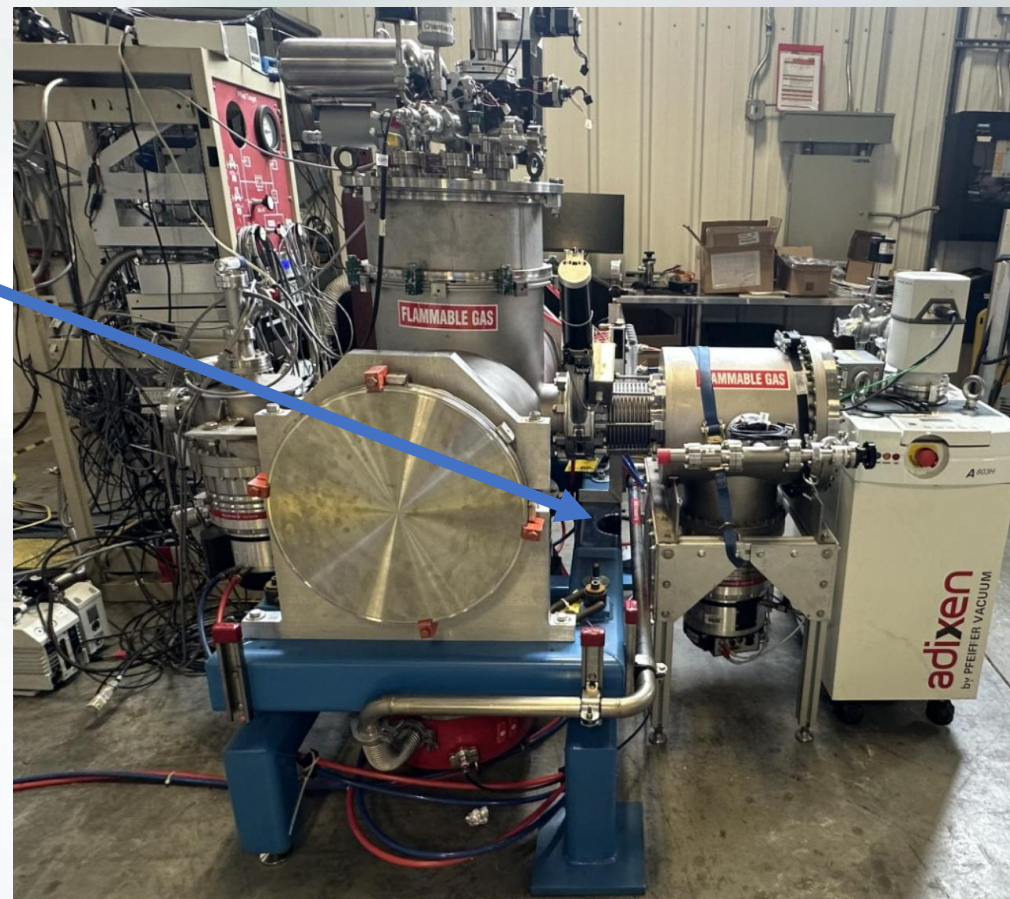
Target stand was modified (see picture on the right) while waiting for fixing the broken windows. Target Group made a pair of new windows and mounted them on target cell. After several surveys, the target is back in the chamber and installed on the Modified Stand.

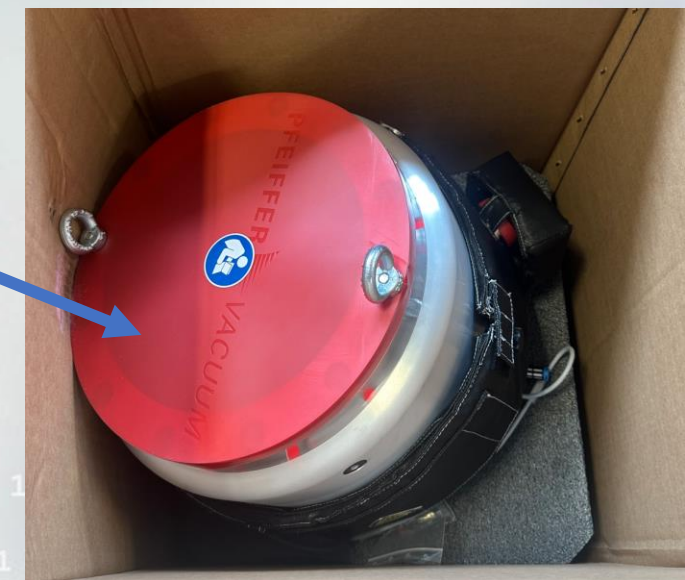
The backup turbo pump, **HiPace2800-IT** purchased by Duke University, has arrived and will be tested before Hall-B installation.
