Strategy and Status of Reference Cavities for European XFEL

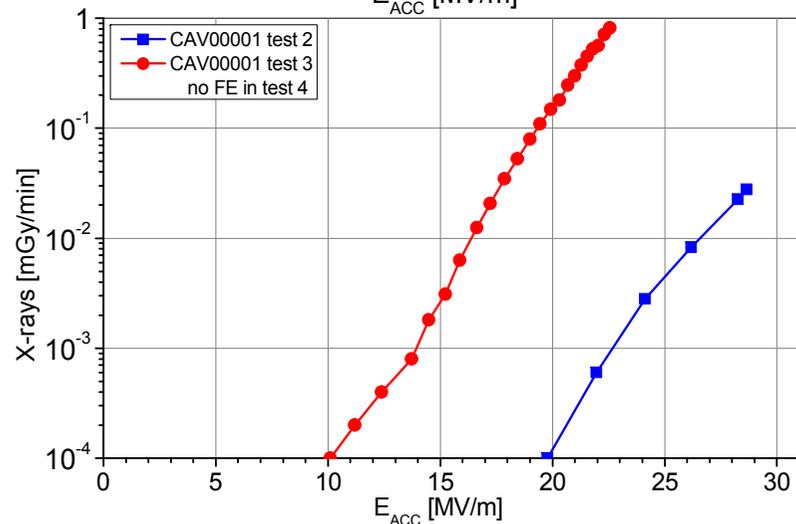
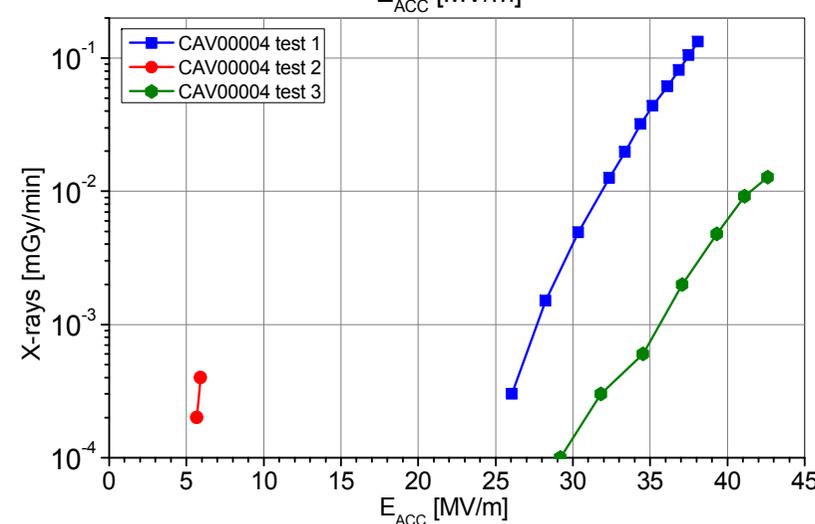
- Test of Slow Pumping / Slow venting at **RI** done with CAV00001 (left) => **failed**
- 2. attempt of SPSV at **RI** done with CAV00004 (right) => **failed**

test 4 → cavity retreated by DESY (HPR)

test 3 → cavity retreated by DESY (HPR)

■ CAV00001 by HPR @ DESY after RCV#1 failed at RI => **successful**

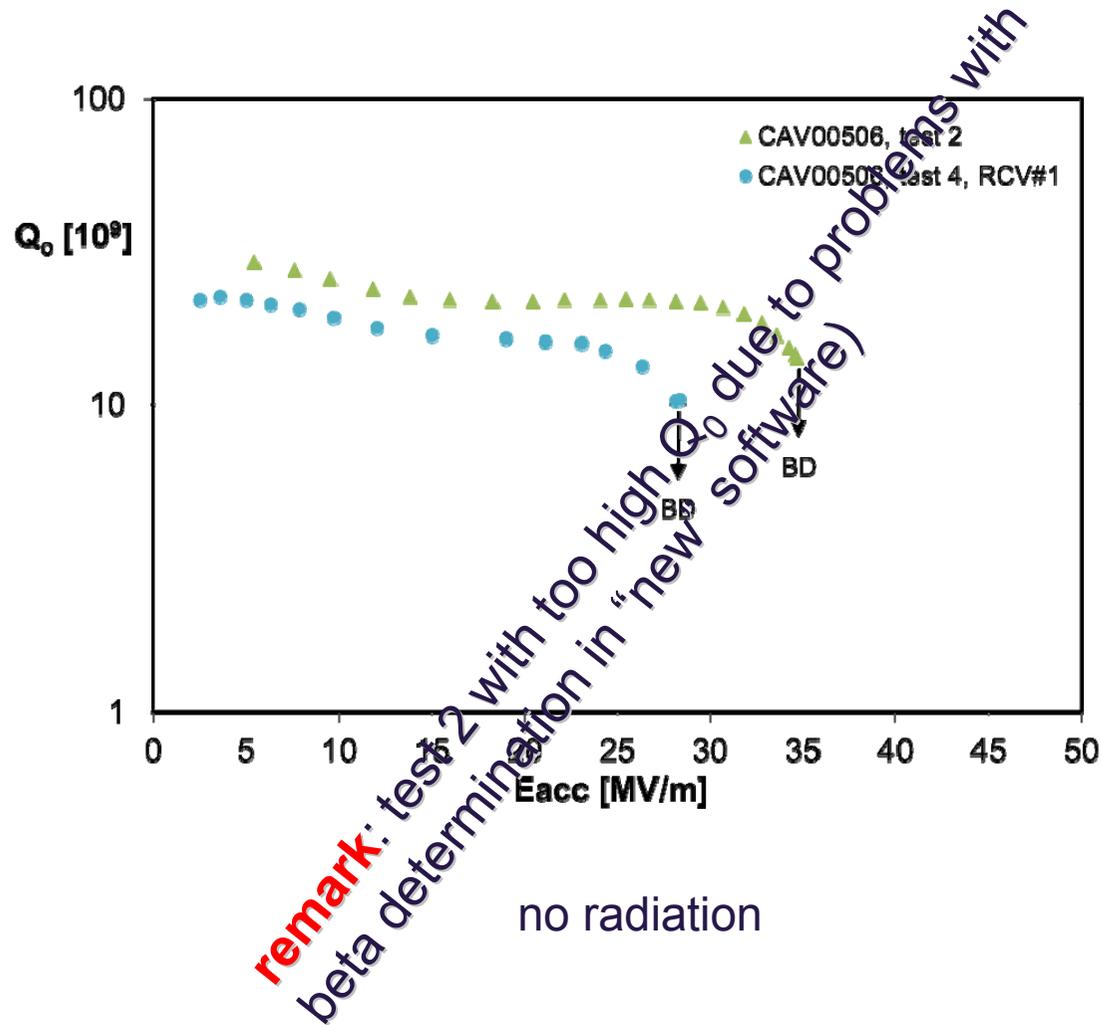
- Test of SPSV at **EZ** done with CAV00506 => **successful**
