Condition of electron beam welding toward a high gradient application

**TESLA Technology Collaboration (TTC) Meeting
November 6, 2012, Thomas Jefferson National Accelerator Facility**

KEK

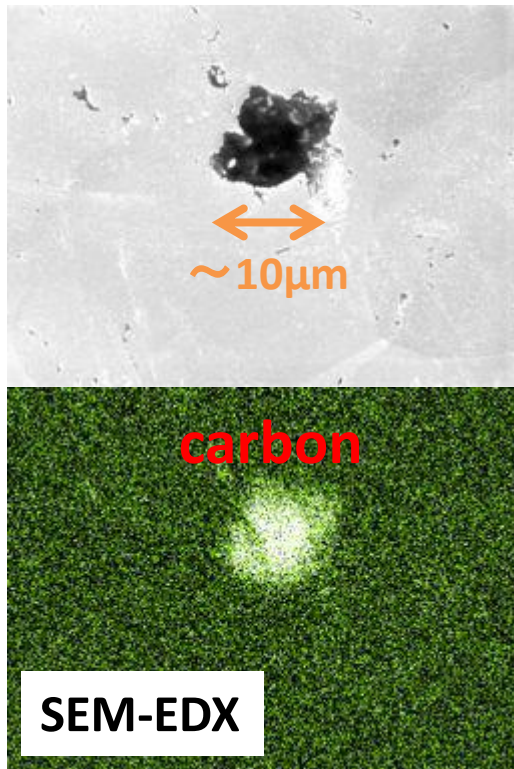
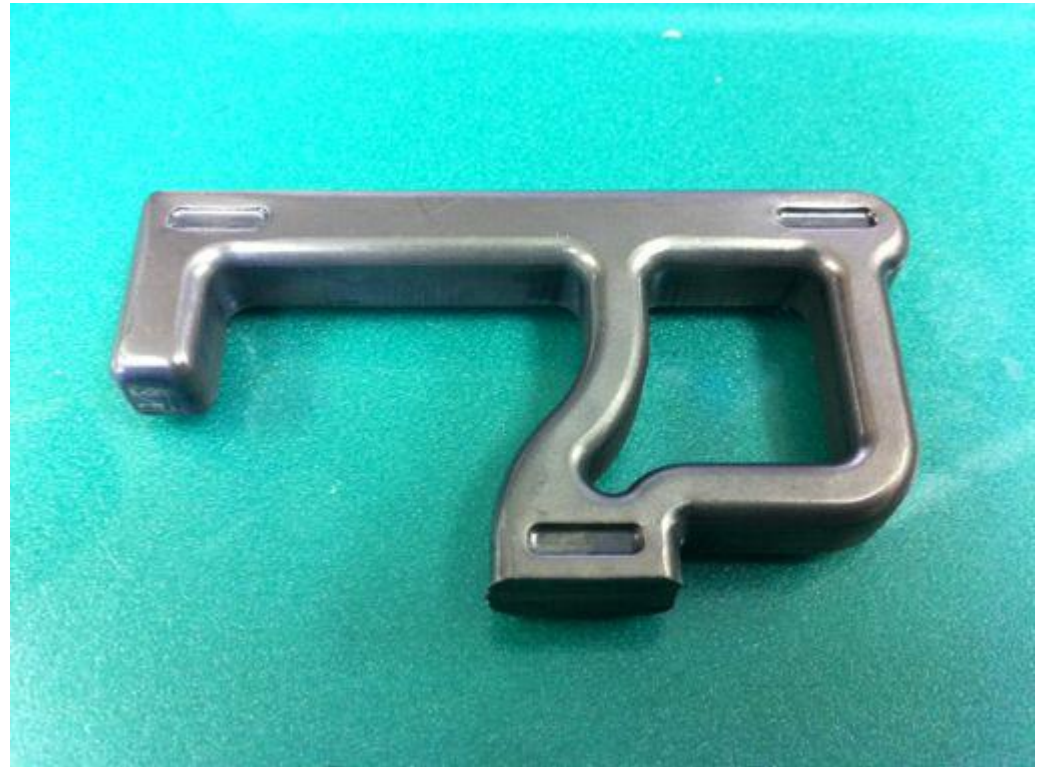
In the process of observing the surface of HOM antenna cut by water jet, carbon including contaminants were found.

HF rinse (30min) + BCP (200μm) + HF rinse (30min)

Example of a surface condition just after
BCP + pure water rinsing

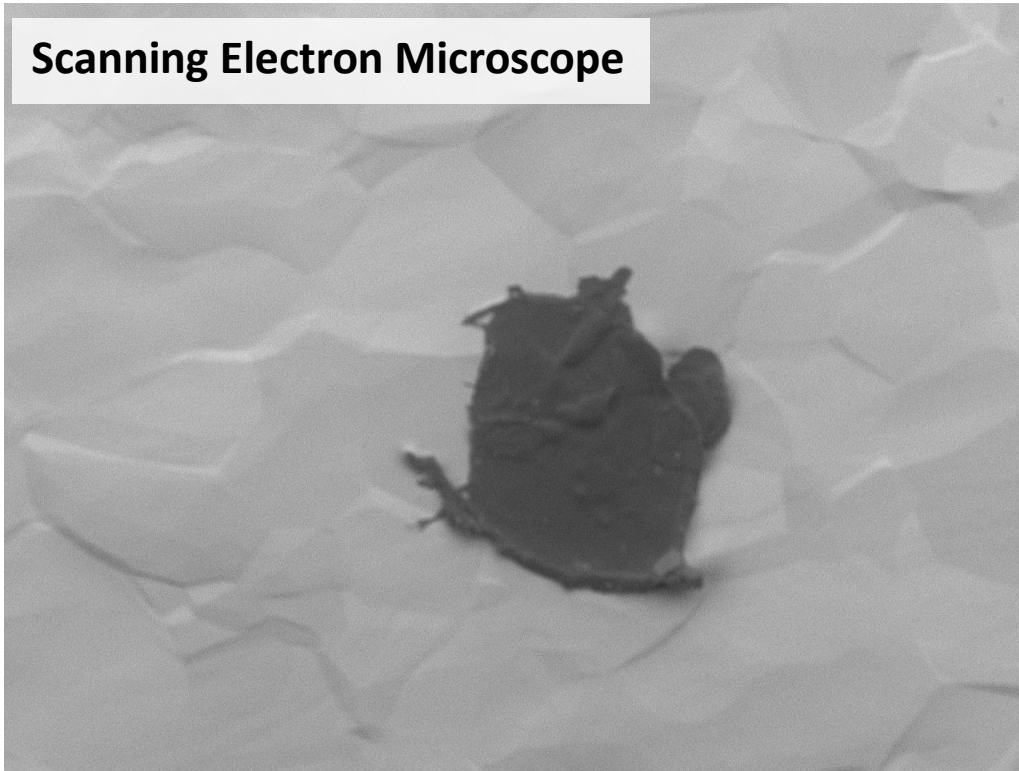
2012/05/16 16:30 FLSD4.0 x400 200 um

A contaminant is transparent and like a membrane.

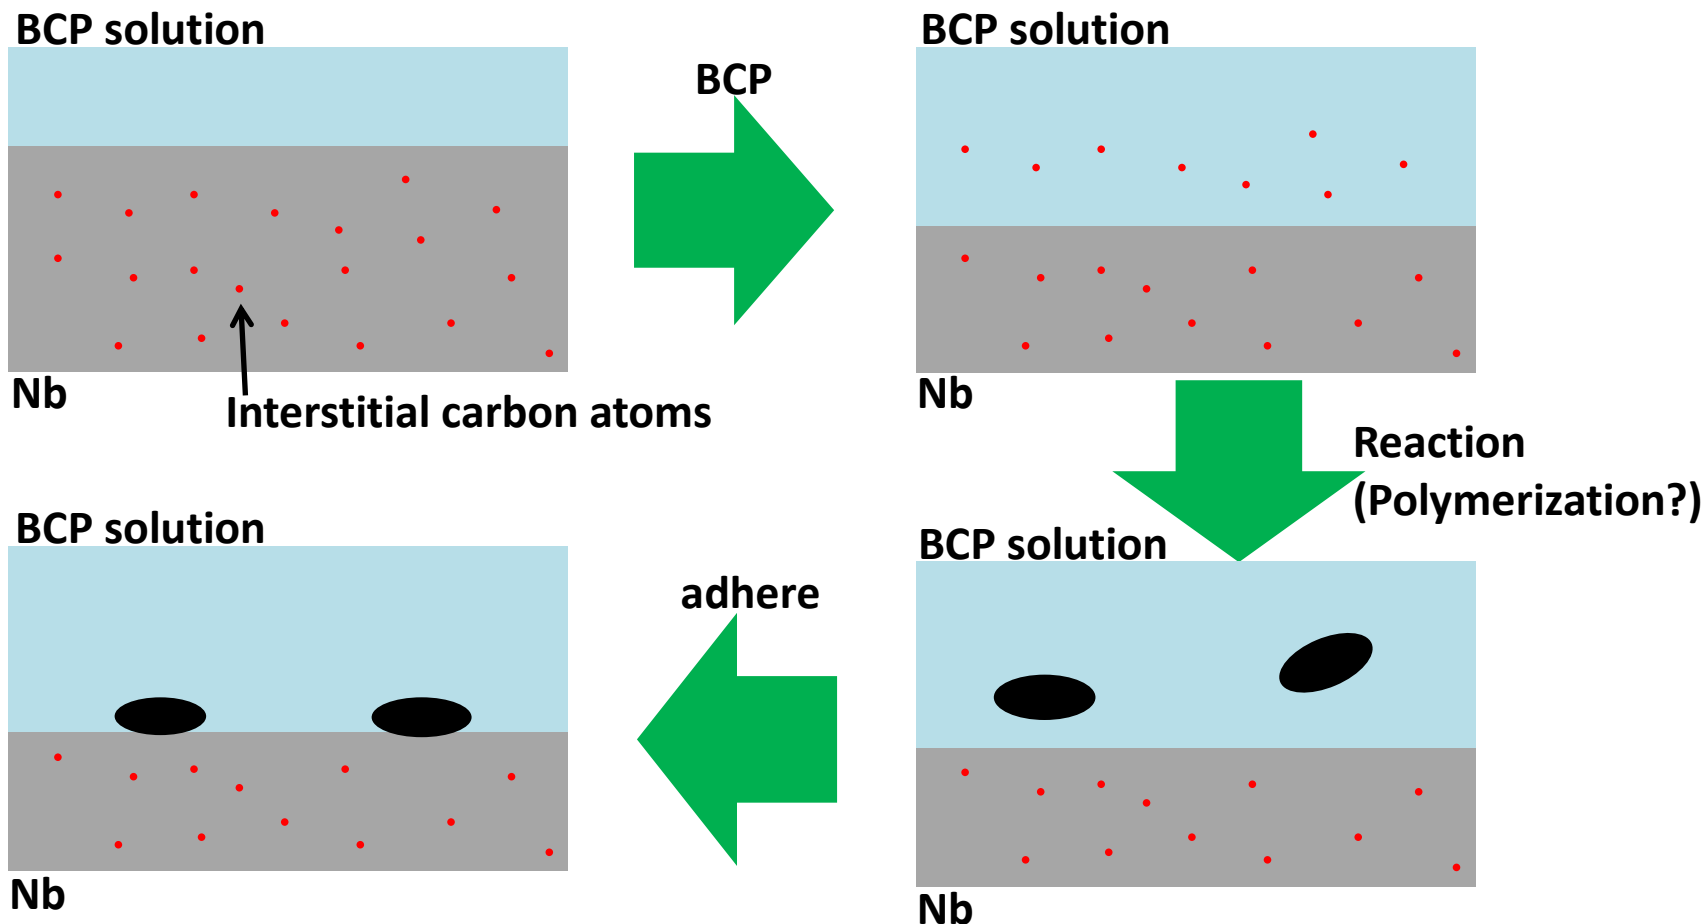
Origin of “carbon including contaminants” have not been understood.

1. BCP solution container (PTFE, PFA)?
2. BCP solution contamination?
3. From environment?
4. Carbon in Nb (< 10ppm)? → **likely**

- For the case that $40\mu\text{m}$ of materials are removed from Nb piece ($5\text{mm} \times 10\text{mm}$), the volume of dissolved Nb is $2 \times 10^{-3}\text{cm}^3$. Its weight is about $2 \times 10^{-2}\text{g}$. This means that $2 \times 10^{-7}\text{g}$ carbons (10ppm contaminants in Nb) are dissolved or drifting in BCP solution. This corresponds to $1 \times 10^5\mu\text{m}^3$ in terms of graphite volume, **which is equivalent volume of 1000 pieces of contaminants with $1\mu\text{m} \times 10\mu\text{m} \times 10\mu\text{m}$!**

- For the case that $40\mu\text{m}$ of materials are removed from Nb half cell (inner diameter: 56mm, outer diameter: 260mm), the total weight of carbon from Nb corresponds to $2 \times 10^{-4}\text{g}$. This corresponds to $1 \times 10^8\mu\text{m}^3$ in terms of graphite volume, **which is equivalent volume of 10^6 pieces of contaminants with $1\mu\text{m} \times 10\mu\text{m} \times 10\mu\text{m}$!**

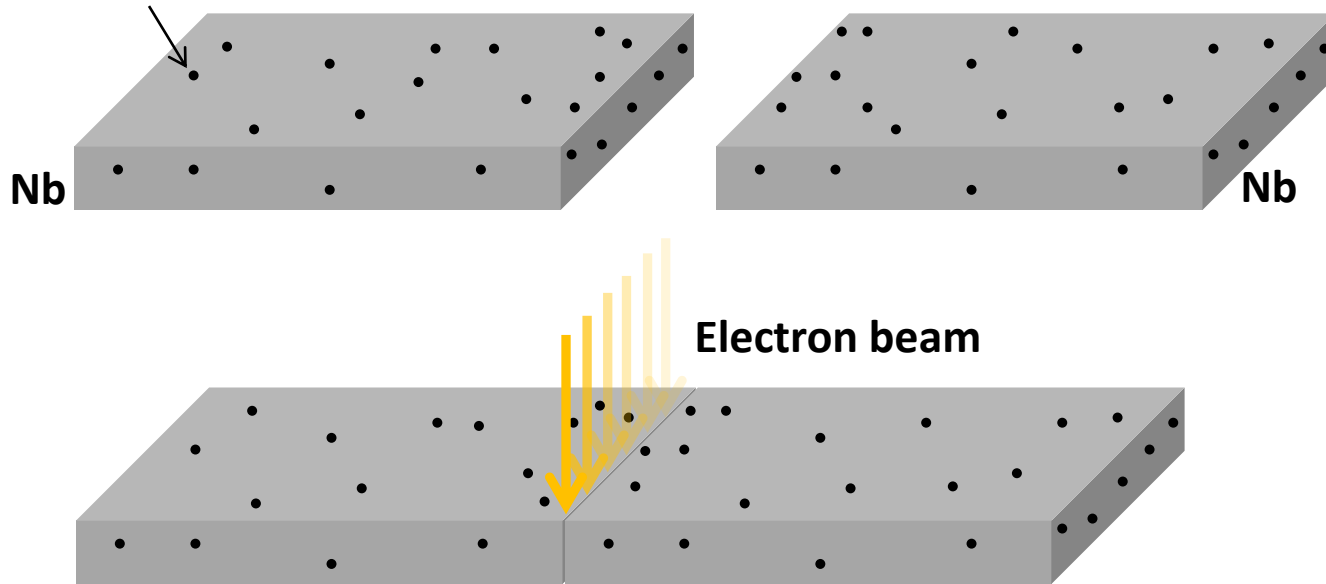
This means that **EBW processes have been carried out under the presence of “carbon including contaminants” so far!**

Carbon including contaminants

Contaminated EBW environment might be a part of reasons generating pits found on and around EBW seams.

→ **Effect on pit formation should be studied.**
