Preparing the SVT for Operations in 2021

Tim Nelson - **SLAC**

HPS Collaboration Meeting

JLab - November 20, 2020

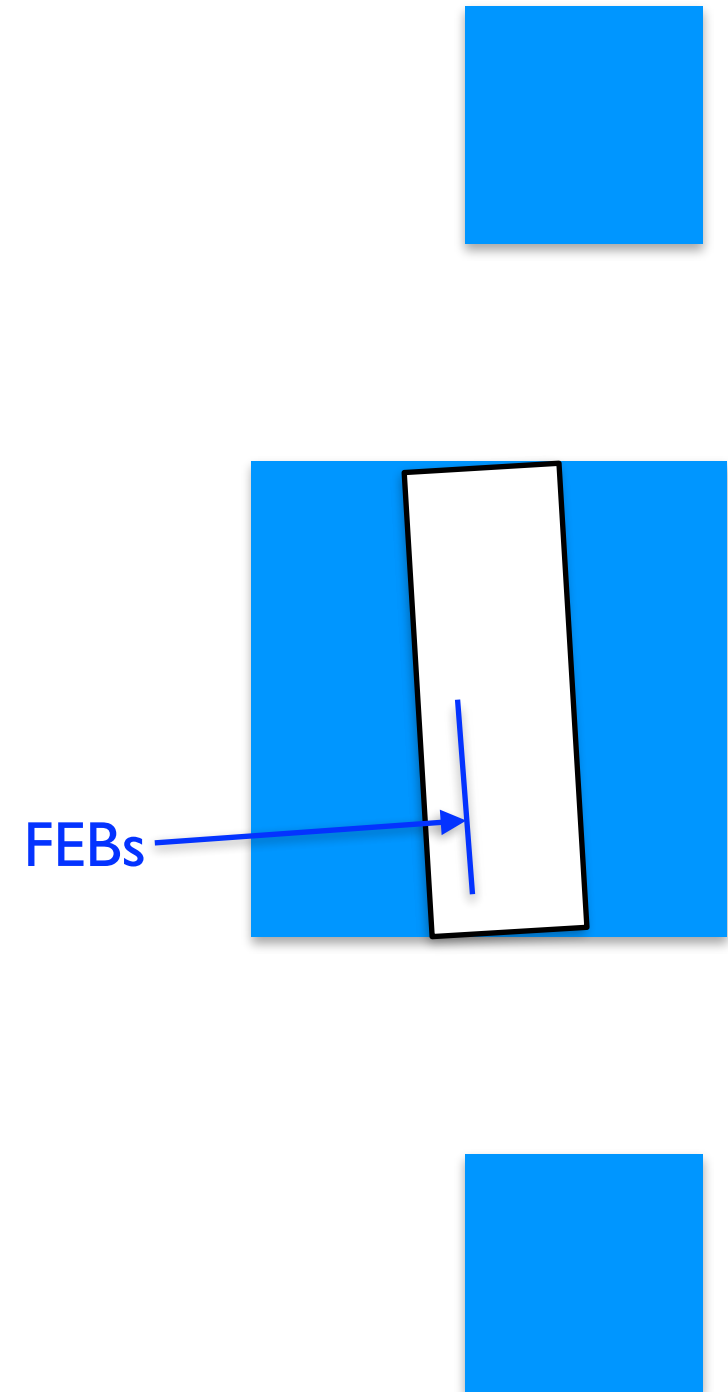
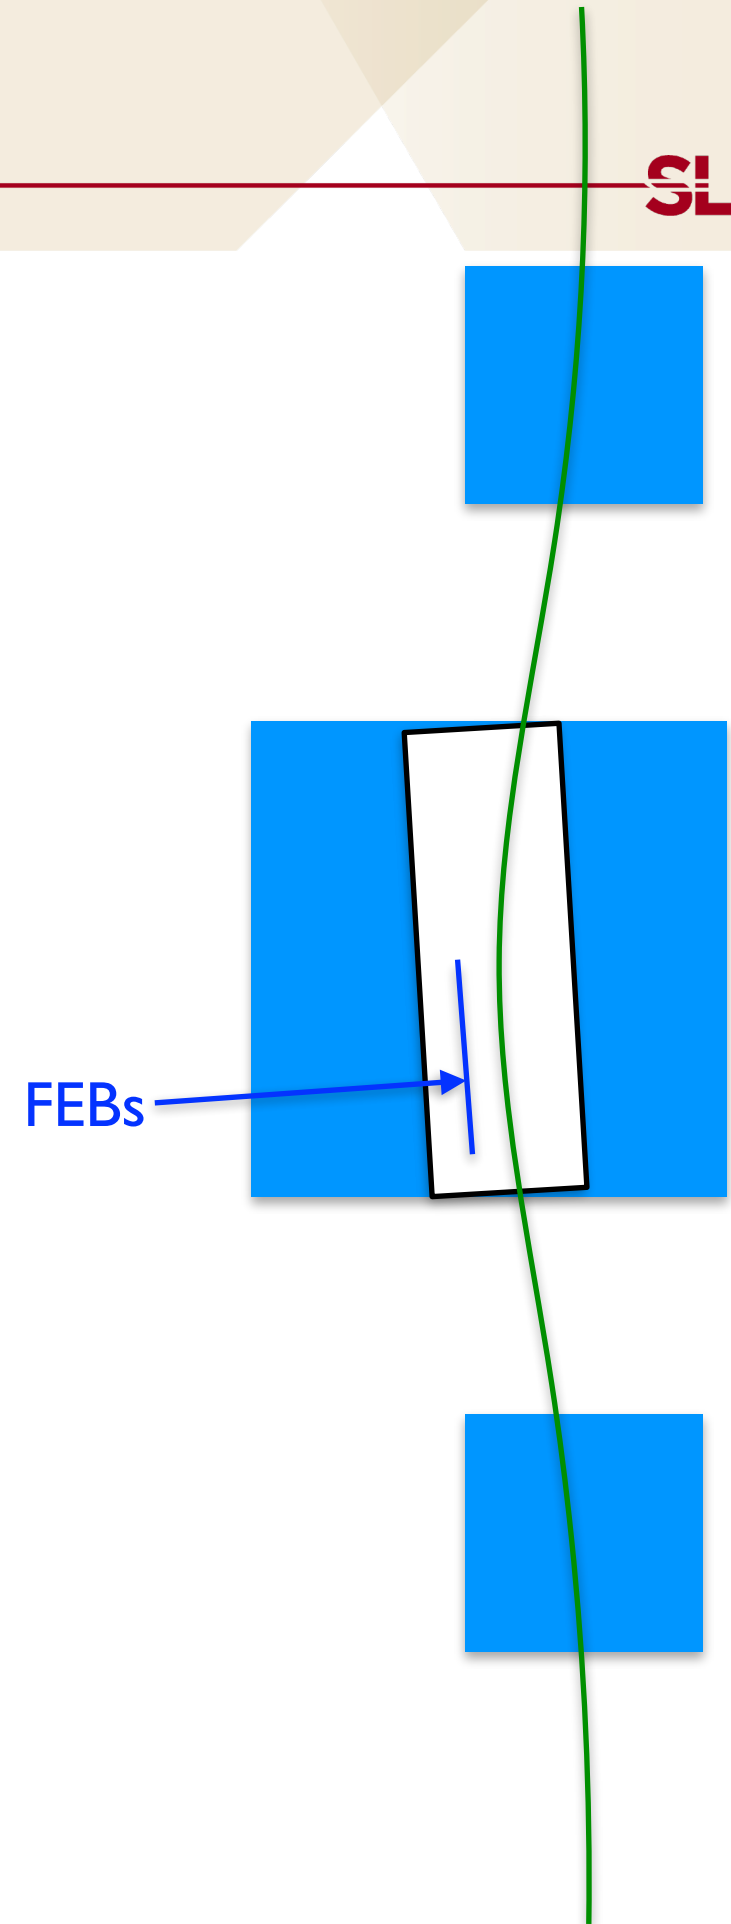
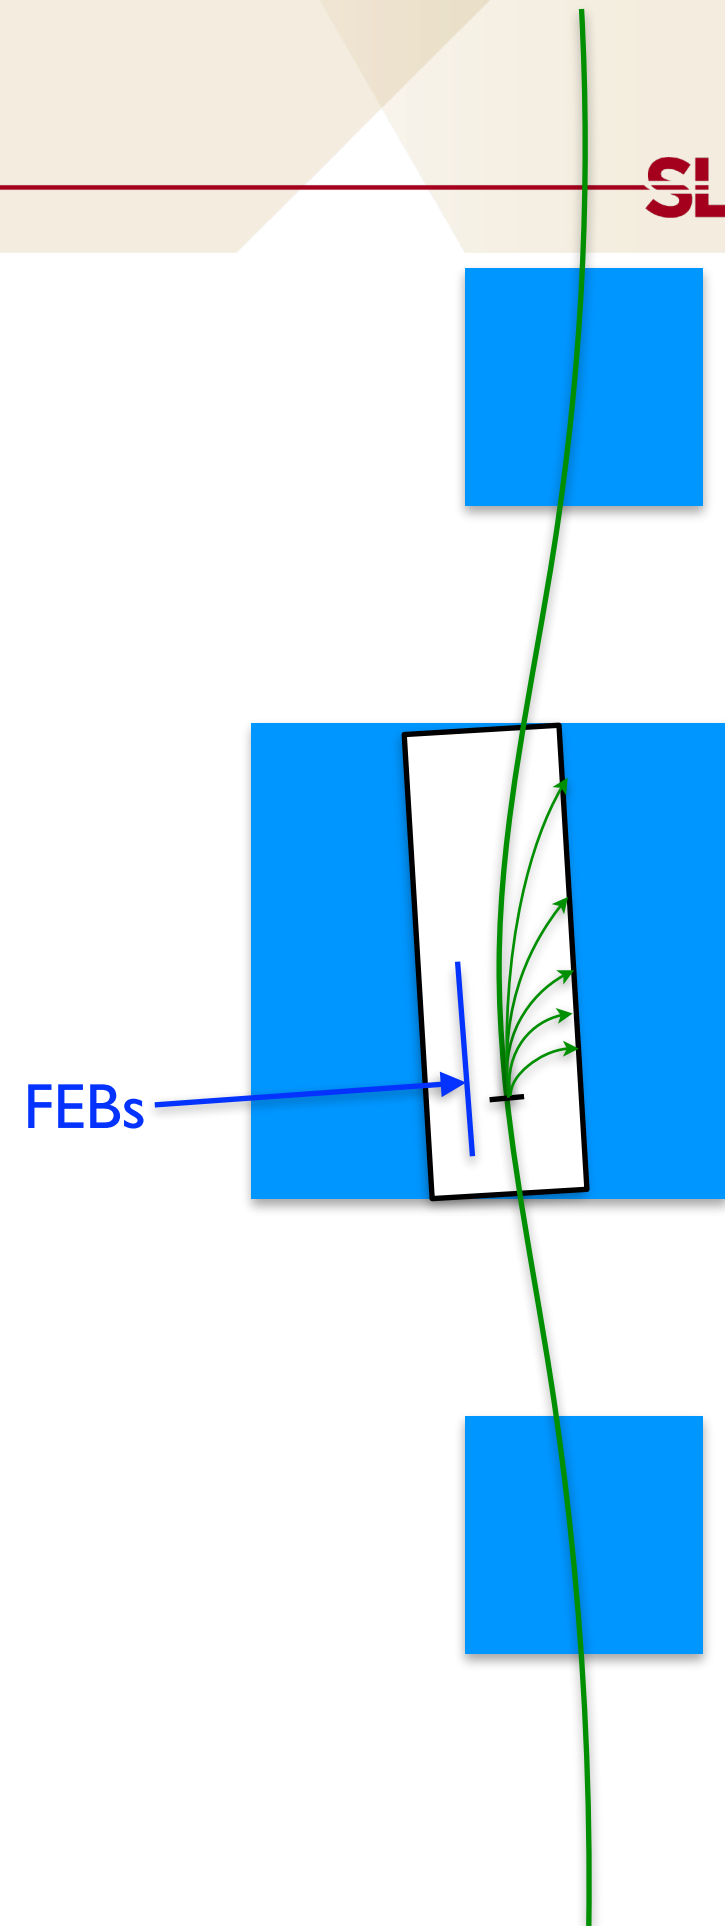
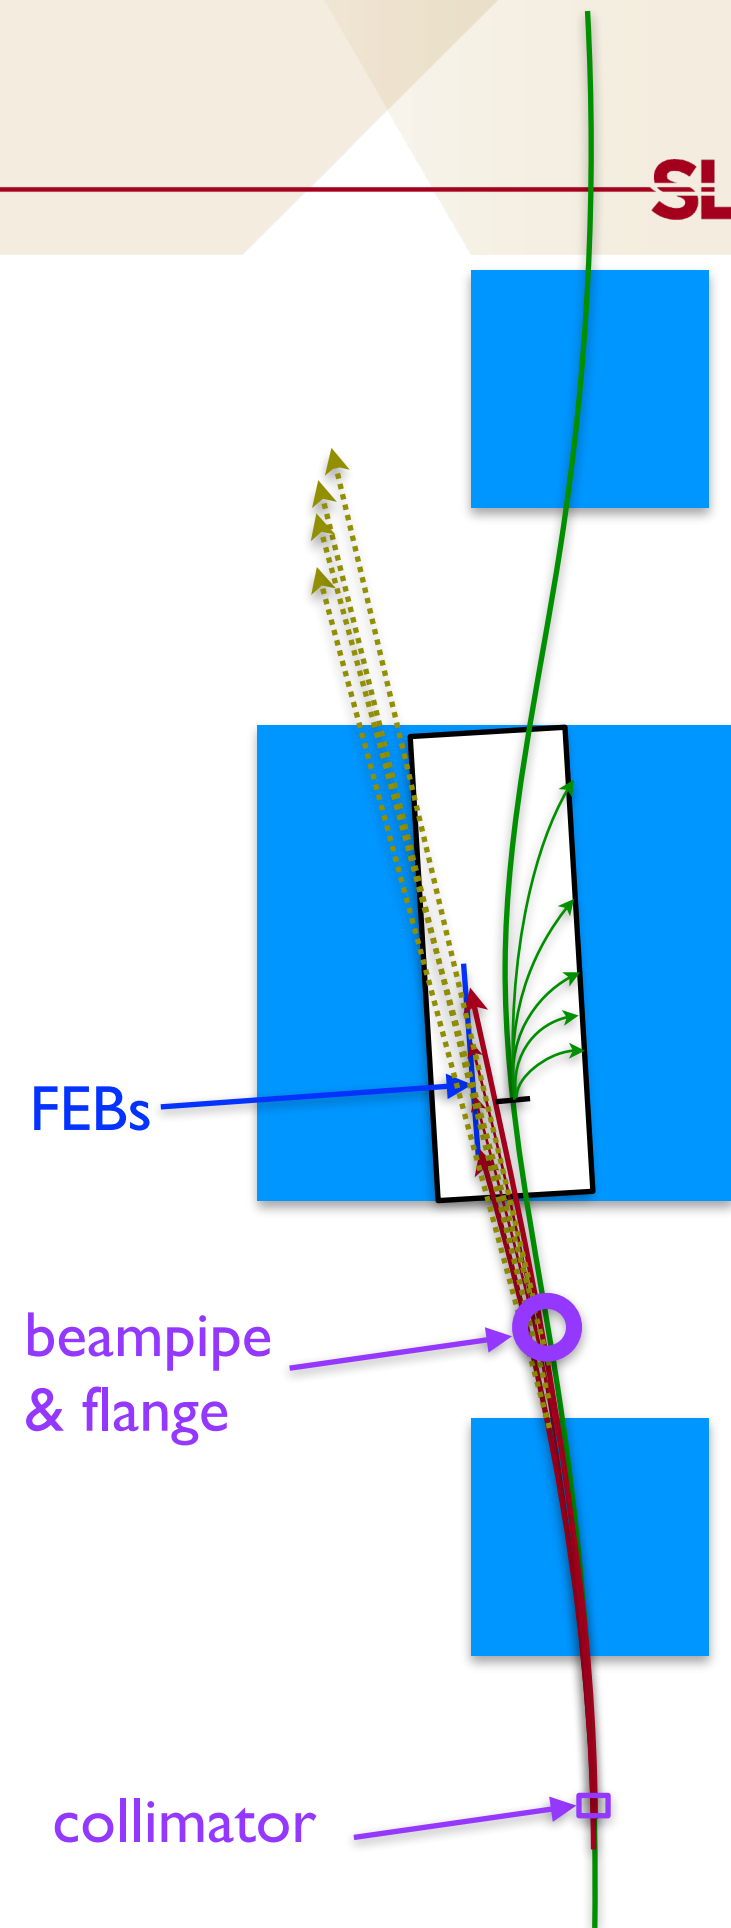
FEB degradation manifests as drooping 5V / 500 mA regulator designed to supply ~300 mA total:

- 24 preamps for APV before ADCs (~10 mA each)
- bias voltage for 12 regulators that supply voltages to the hybrids (~5 mA each)

No current monitoring, so mechanism has been unclear, but lowering temperatures improved overhead.

Damage meant loss of data from L7T, one of four hybrids in L5B for most of the run.

Once recognized, we improved monitoring and were more careful with the beam to limit further damage.

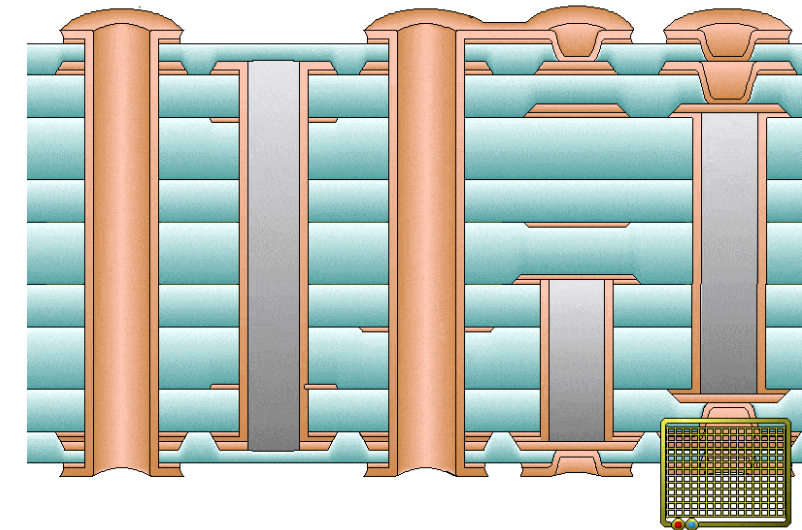
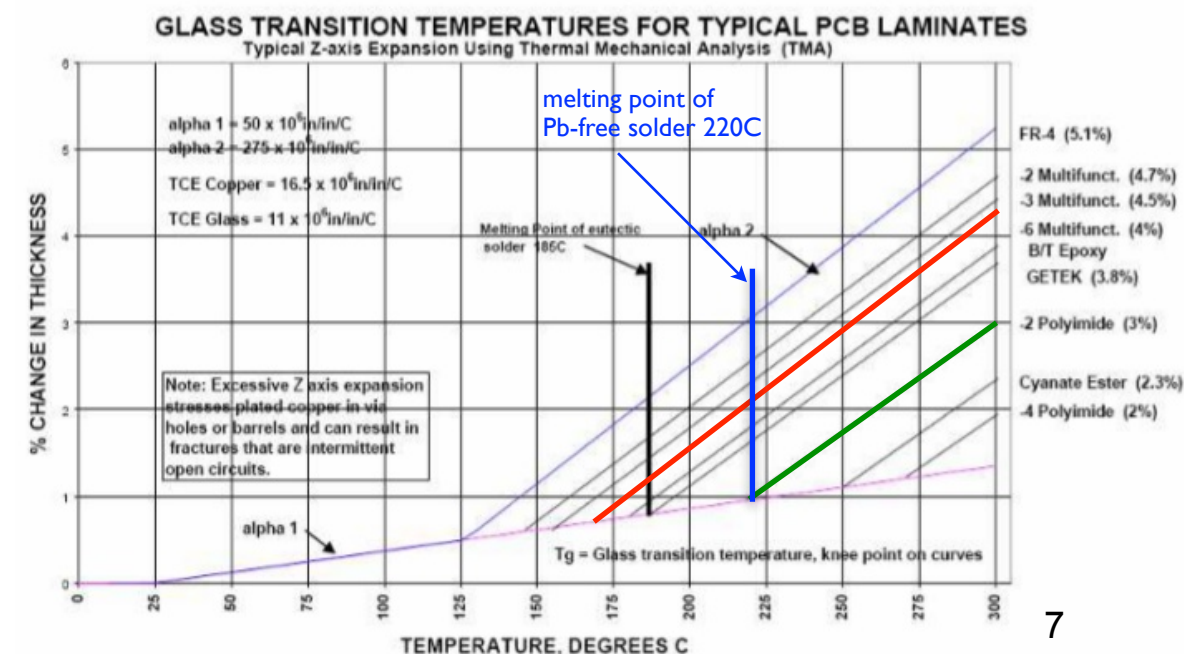
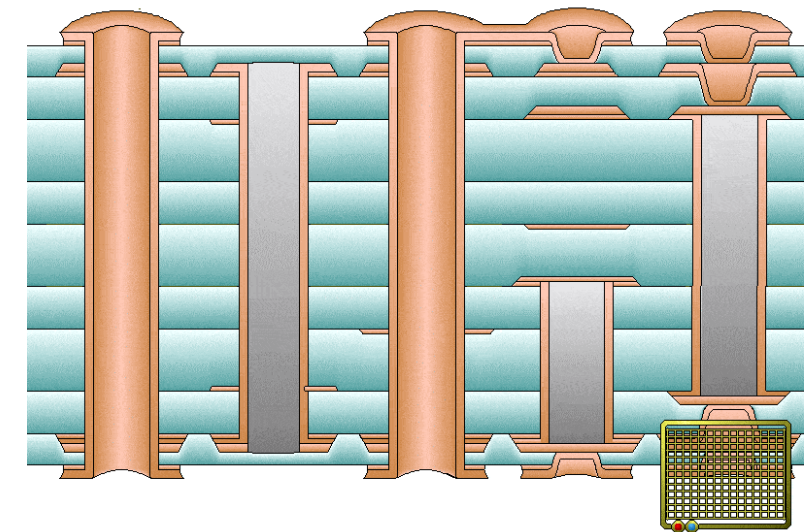
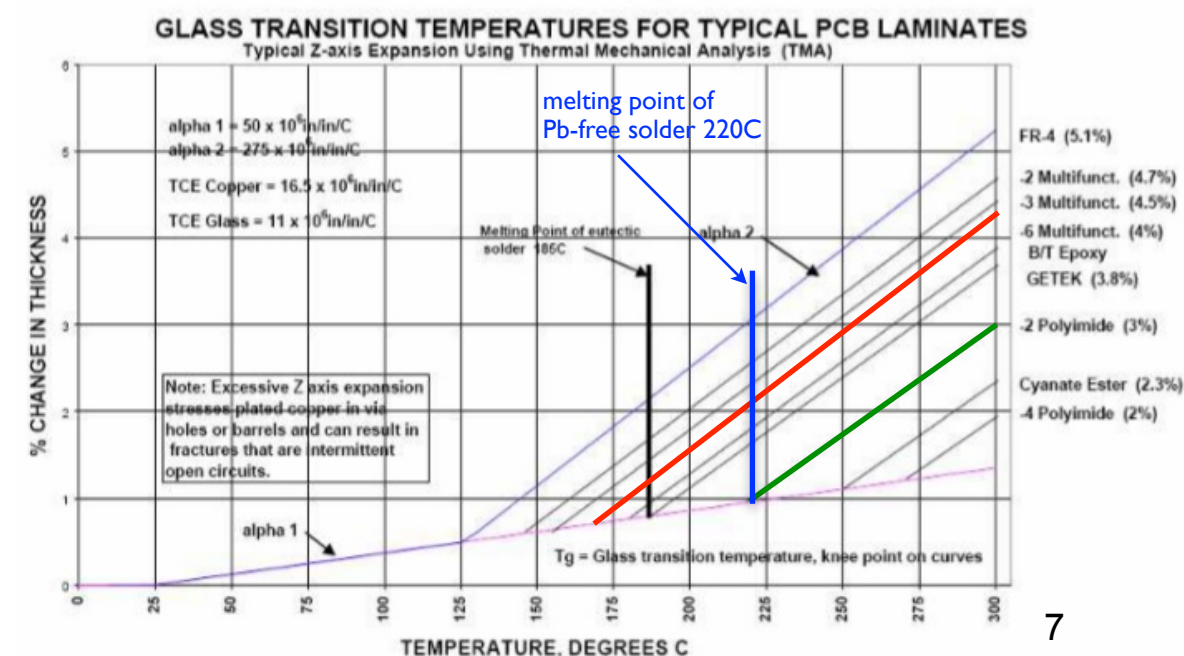
- 15 built, 10 needed. After replacements during 2019 installation, no perfect spares left.
- 3 show symptoms of damage in 5V supply
- 1 has some kind of damage to VI25 control for one hybrid, set by AD5144 digital potentiometer (50 in the system). Possibly a fluke, but are discussing how to study this.

- Not clear how to accommodate component changes (e.g. larger regulator) with a repair.
- Repairs have often created new problems due to CTE stresses
- Repairing these complex boards has proven to be a time sink. Labor costs for repair likely exceed M&S for new boards by a large factor, even for improved board construction.
- Given historical problems with these boards, possible that there were initial quality problems or material issues resulting in cracked vias that a new spin gives us opportunities to solve.

Replacement allows opportunity to mitigate observed failure modes and obtain a proper pool of spares at reasonable cost.

Our budget covers 20 new FEBs in polyamide, which greatly reduces CTE stresses during loading/rework heat cycling

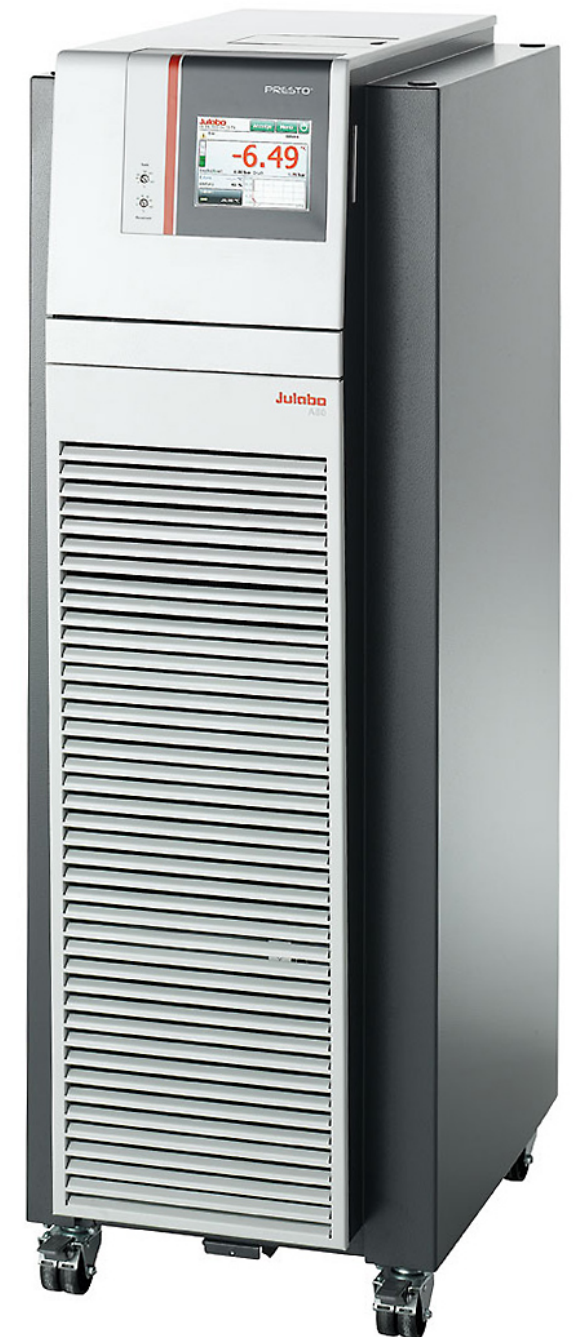
- SVT chiller has become grumpy. Chiller has been moved to EEL for service.
- Loss of HFE during 2019 run indicates a leak in chiller or lines external to the detector. Will need to carefully test.

- Proper modification of FEB “octopus” wiring harness to gang bias voltage for extra sensors in upgraded SVT.
- Addition of features to solidly lock SVT into place in case of magnet trip.
- Possible repairs of SVT motors, damaged by work in the alcove.
- Installation of thin sheet of shielding material on back of SVT Support Box to mitigate physical damage to wire bonds on sensors facing downstream.

SVT must be removed to EEL for this work, including the DAQ, power supplies, and cable plant. Plan to do module installation and survey at JLab also.
