# TTC High Q WG meeting -

### Quench studies 9 cell cavities for LCLS-II prototype – Preliminary as of Feb 25<sup>th</sup> 2015

Ari D. Palczewski, SRF Scientists Jefferson Lab, USA 02/26/2014

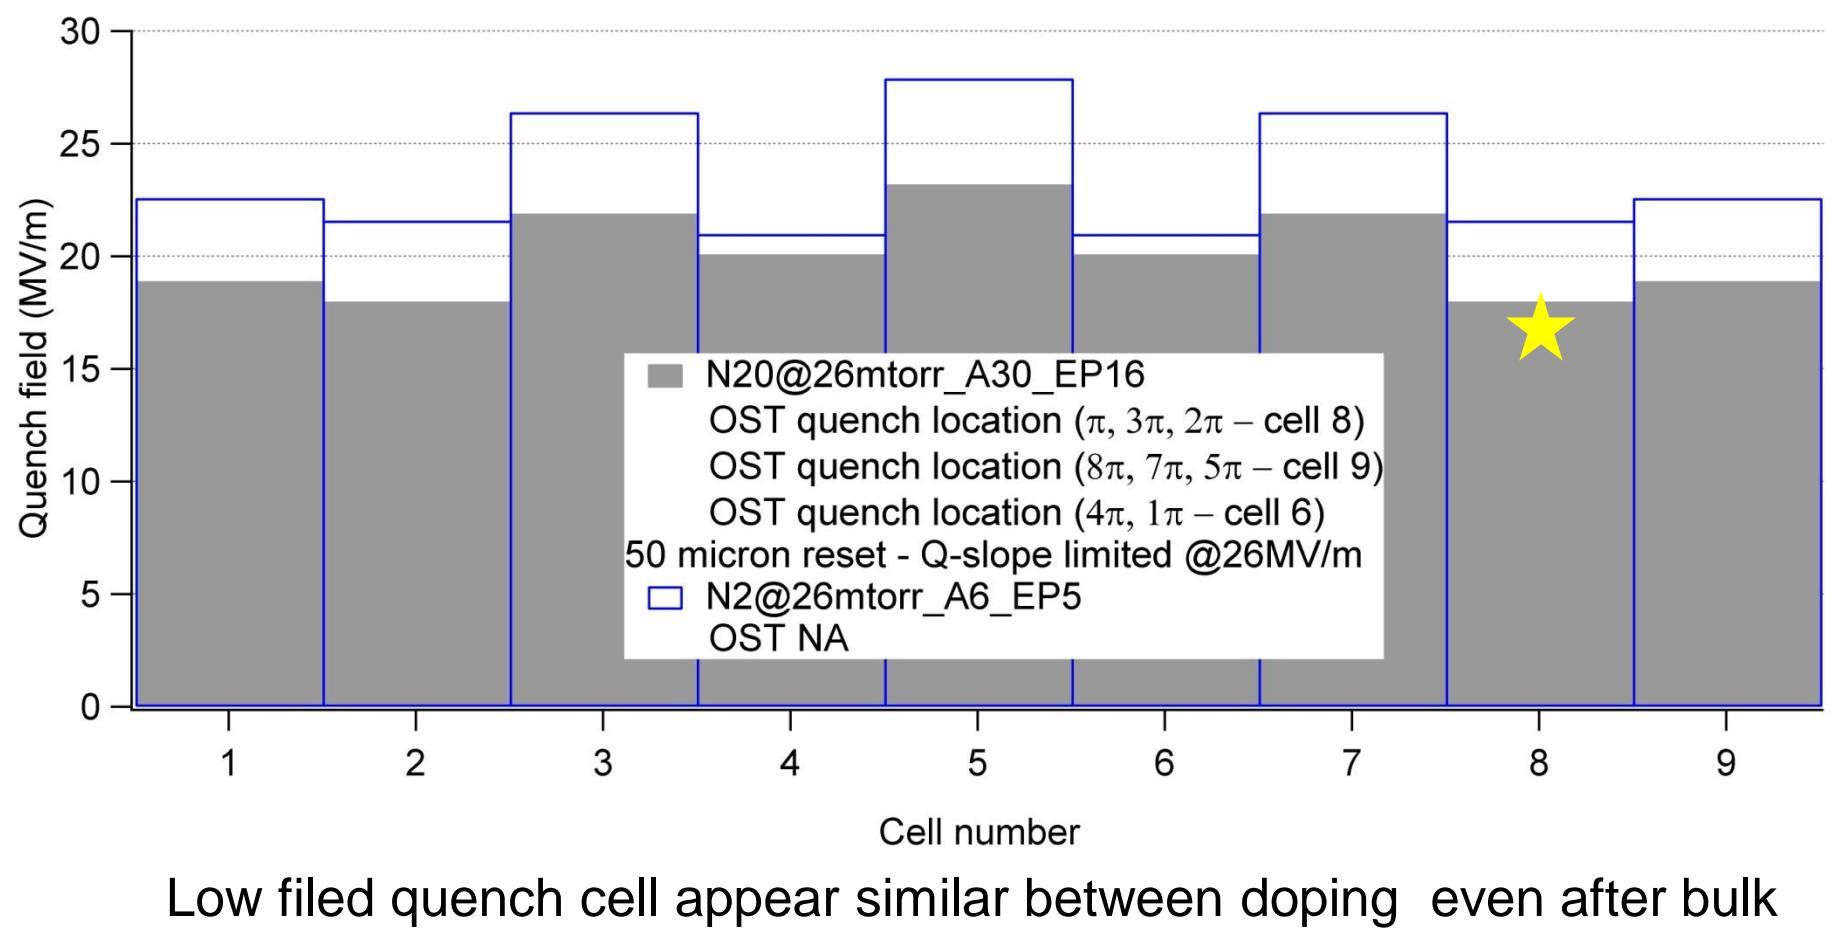
#### Quench Mode Analysis TB9AES033

removal - maybe

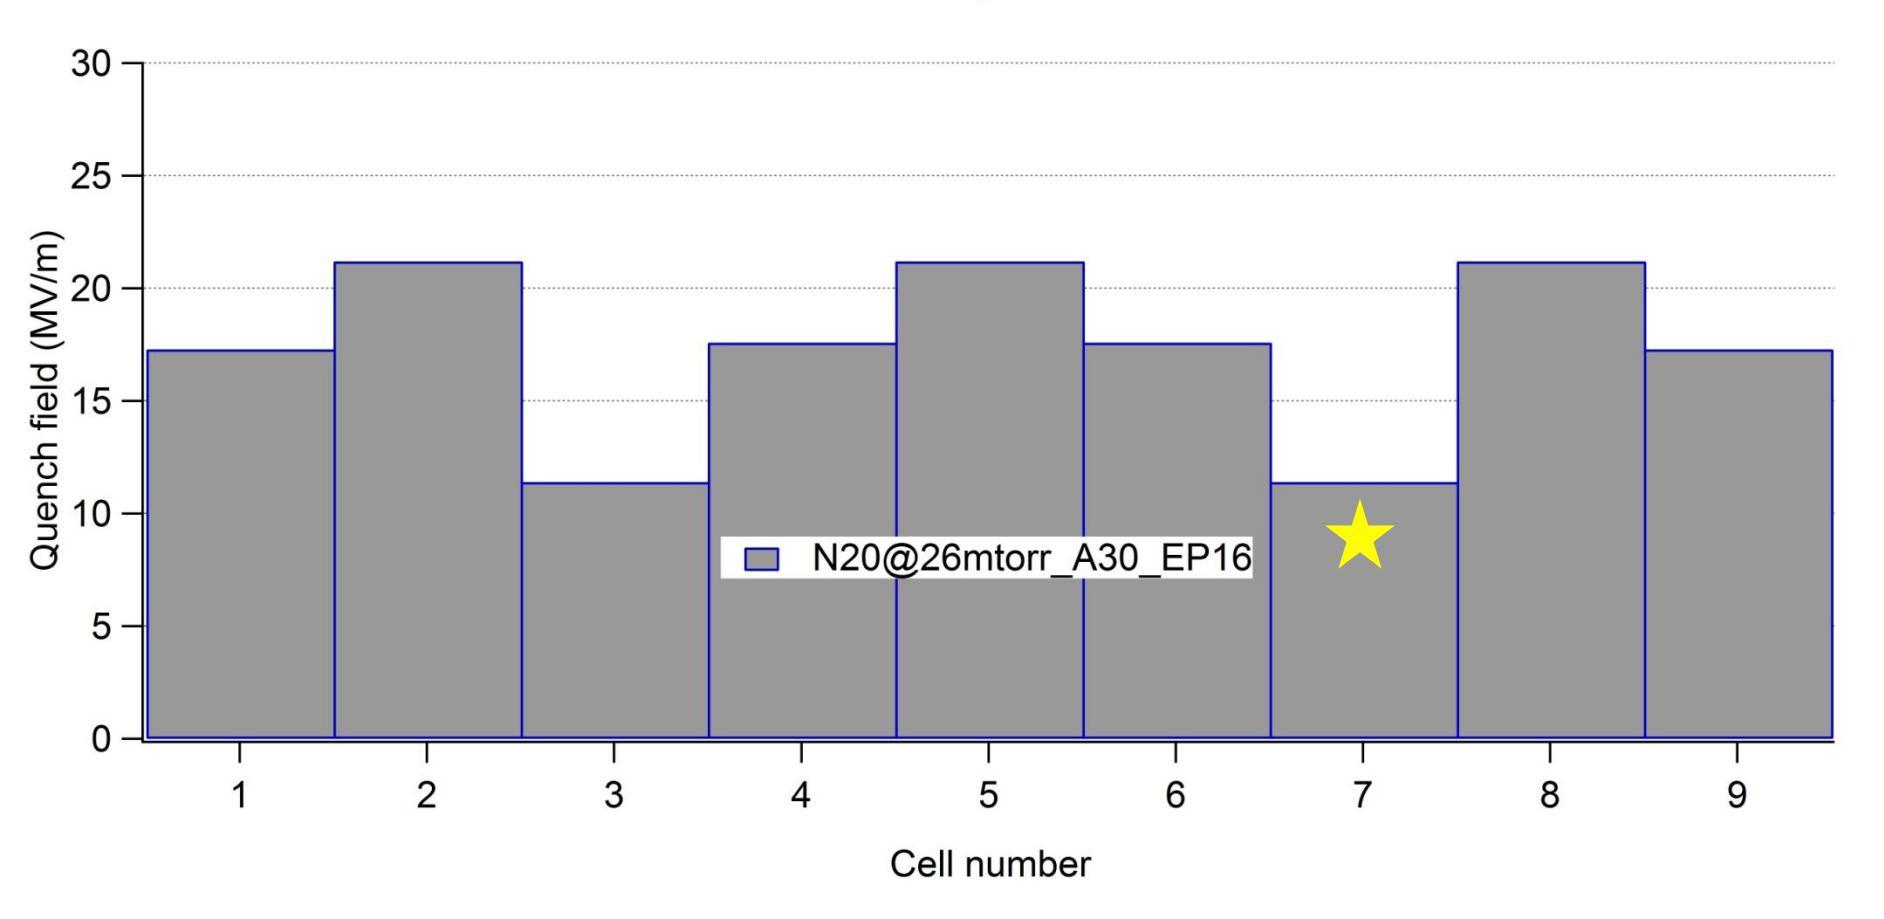
#### Quench Mode Analysis TB9AES034

Most outstanding feature 200 micron dia. Deep pit Leading candidate defect for quench at 11 MV/m during vertical test

Multiple other defects found – sent for CBP  $\sim$  120micron

- Large pit like defects will show a larger Q-drop at lower quench fields than standard cavities (TB9AES034)
- For heavy doping quench location appears to be random at this point, especially compared to un-doped cavities – i.e. no defects, multiple quench location at ~ same field (TB9AES033, TB9AES033)
- Bulk re-rest of surface appears randomize quench location after re-doping (TB9AES035, TB9AES033?)
- Light doping after reset produces a higher quench field on average (TB9AES033, TB9AES035)
- Light EP after baseline heavy doping raised the quench field (small amount) but not likely to change quench location (TB9AES031)
