Analysis of BLM System Performance

Kitty Price

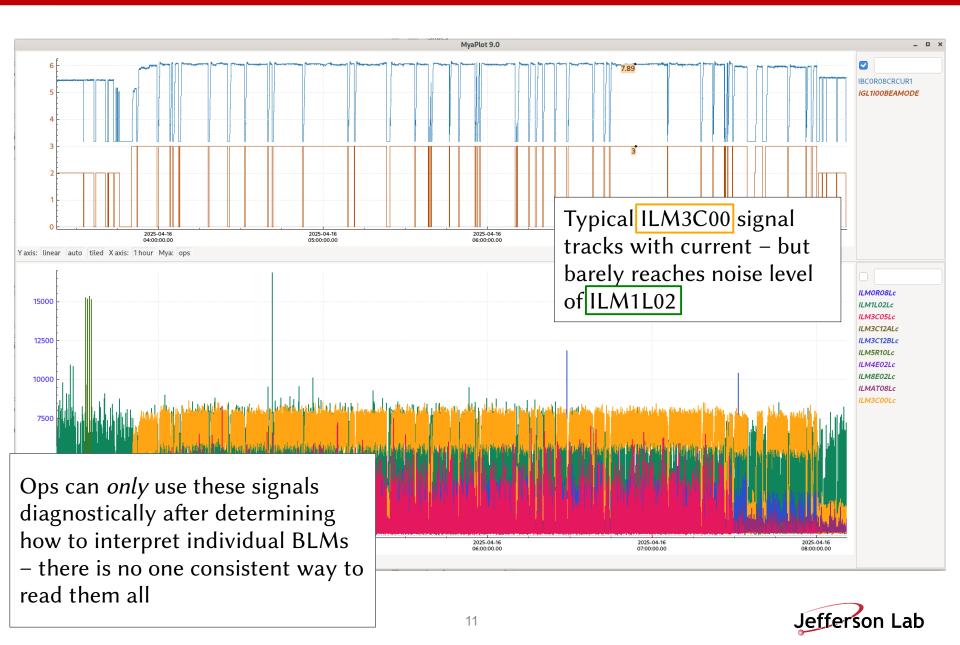
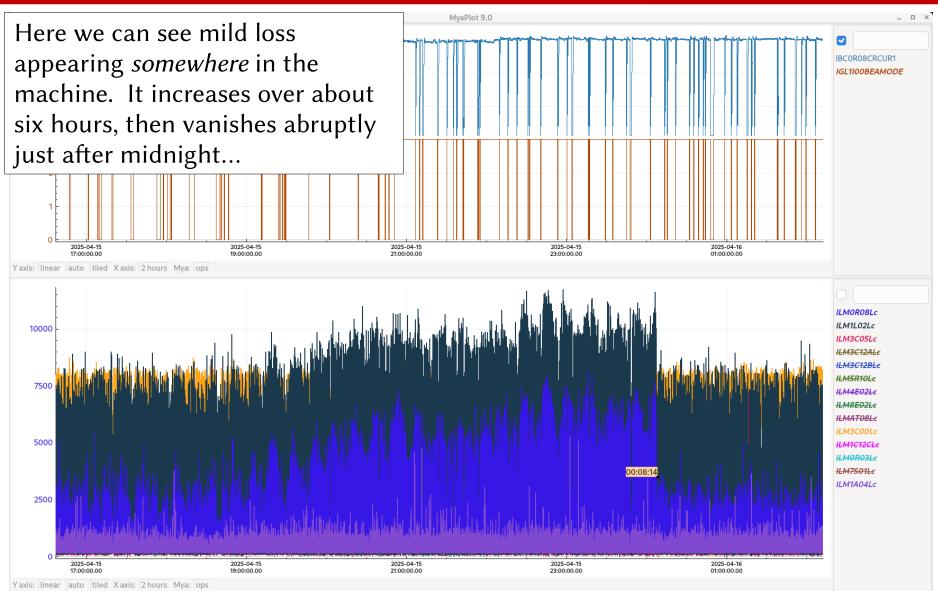
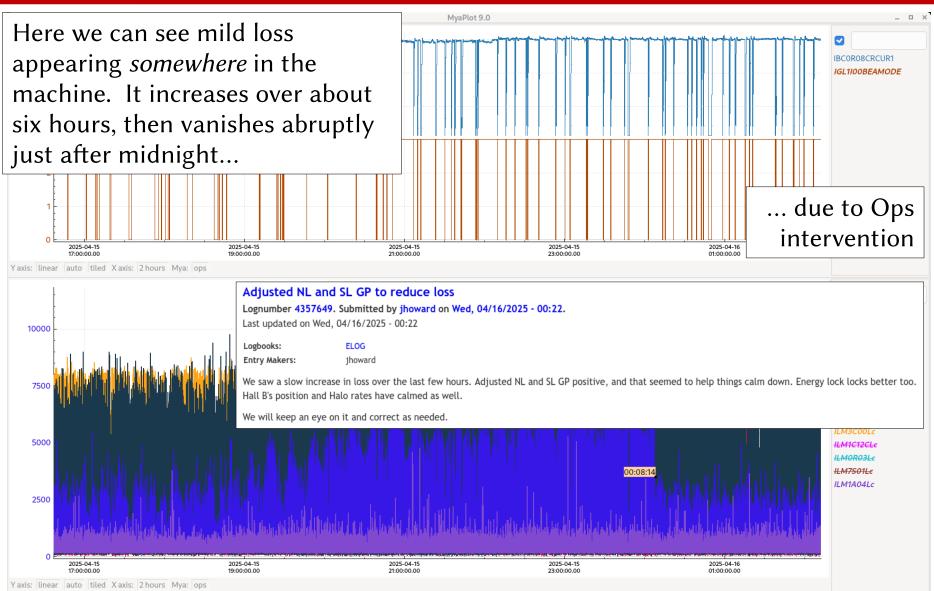
Note the large disparity in noise levels, especially between ILM1L02 and ILM3C05 (which displays no noise)

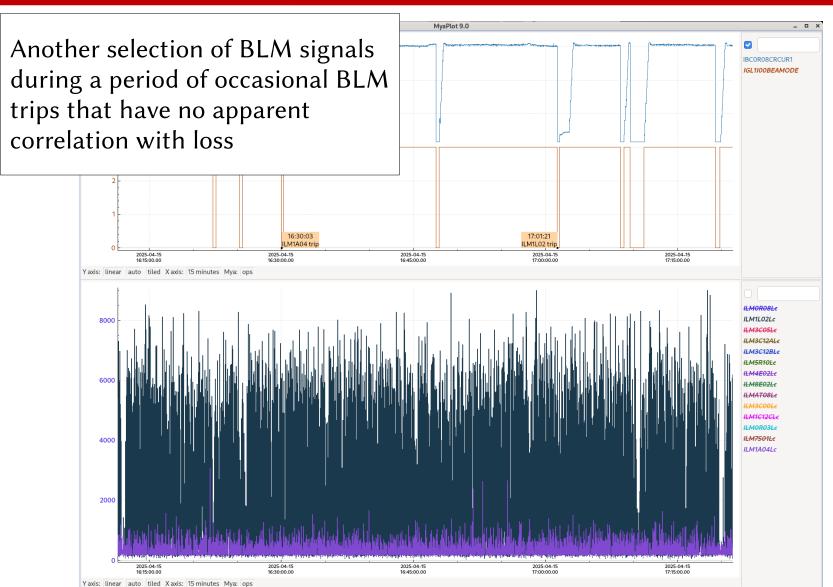
Another selection of BLM signals during a period of occasional BLM trips that have no apparent correlation with loss

Troubleshooting a spate of BLM trips like this means the control room has to start from square one: there might be loss somewhere, and not necessarily near the location of the BLM(s) that caused the trips
