Industrialization of E-XFEL string and module assembly at CEA- Saclay

CEA contribution

- CEA contributes to the E-XFEL Cold Linac construction through String Assembly (WP9), Module Assembly (WP3) and BPM (WP17)
- Accelerator Module Assembly (WP3-WP9) : assembly of 103 accelerator modules with 1 per week throughput ! operated by an industrial contractor on the Saclay site.

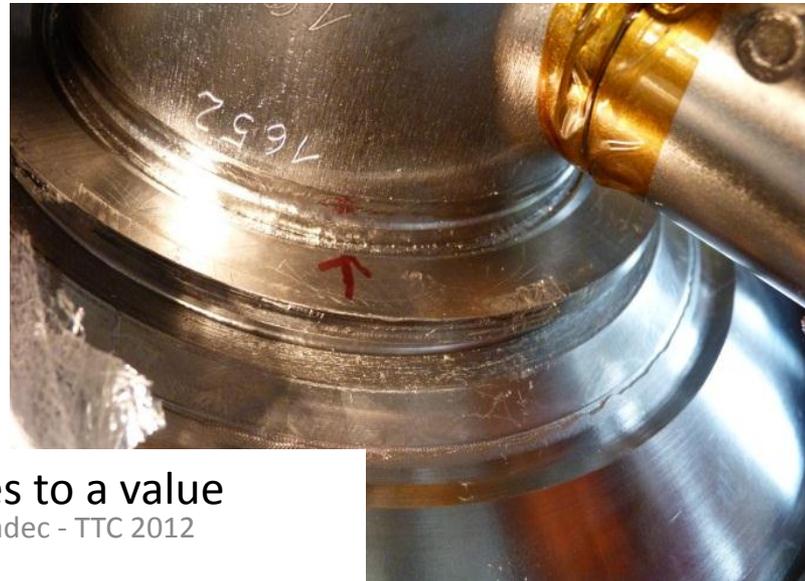
- PXFEL2_2:
 - Leak on cavity 6 helium vessel (isolating vac and He circuit)
 - No exchange at CEA because of time constrain for XM-3
 - Not full penetration welding between the cones and the cavity.
 - For serie production, full penetration welding

Leak rate on cavity AC121 rises to a value higher than 1 e-5mbar.l.s-1

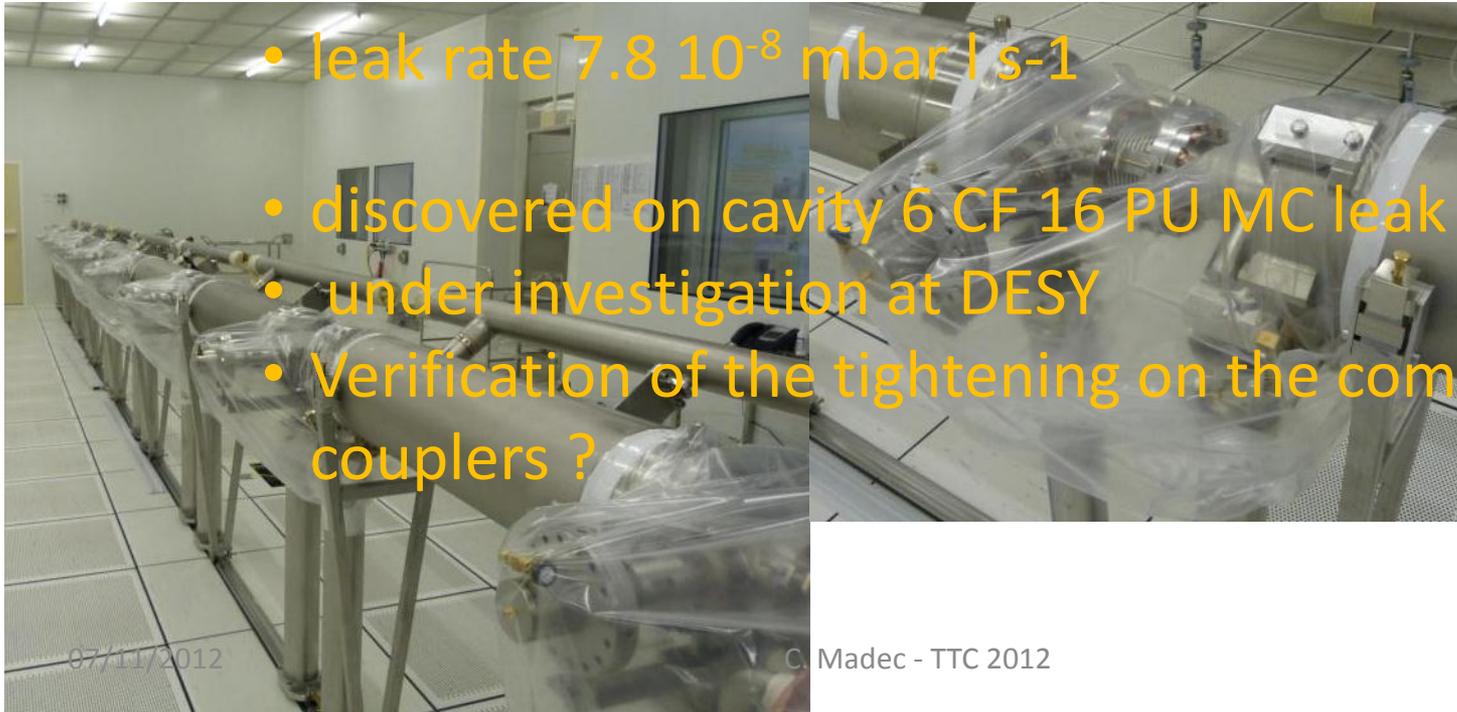
- PXFEL2_2:
 - In situ leak appeared at the leak test of the cavity string before shipping (acceptance criteria) :

- leak detection before roll-out 10^{-10} mbar.l.s-1
- leak rate $7.8 \cdot 10^{-8}$ mbar.l.s-1

- discovered on cavity 6 CF 16 PU MC leak
- under investigation at DESY
- Verification of the tightening on the coming couplers ?
