### THE MEDAUSTRON ION THERAPY CENTER EXPERIENCES FROM 6 YEARS OF CLINICAL OPERATION

C. Heuer, S. Nowak On behalf of the MedAustron Team

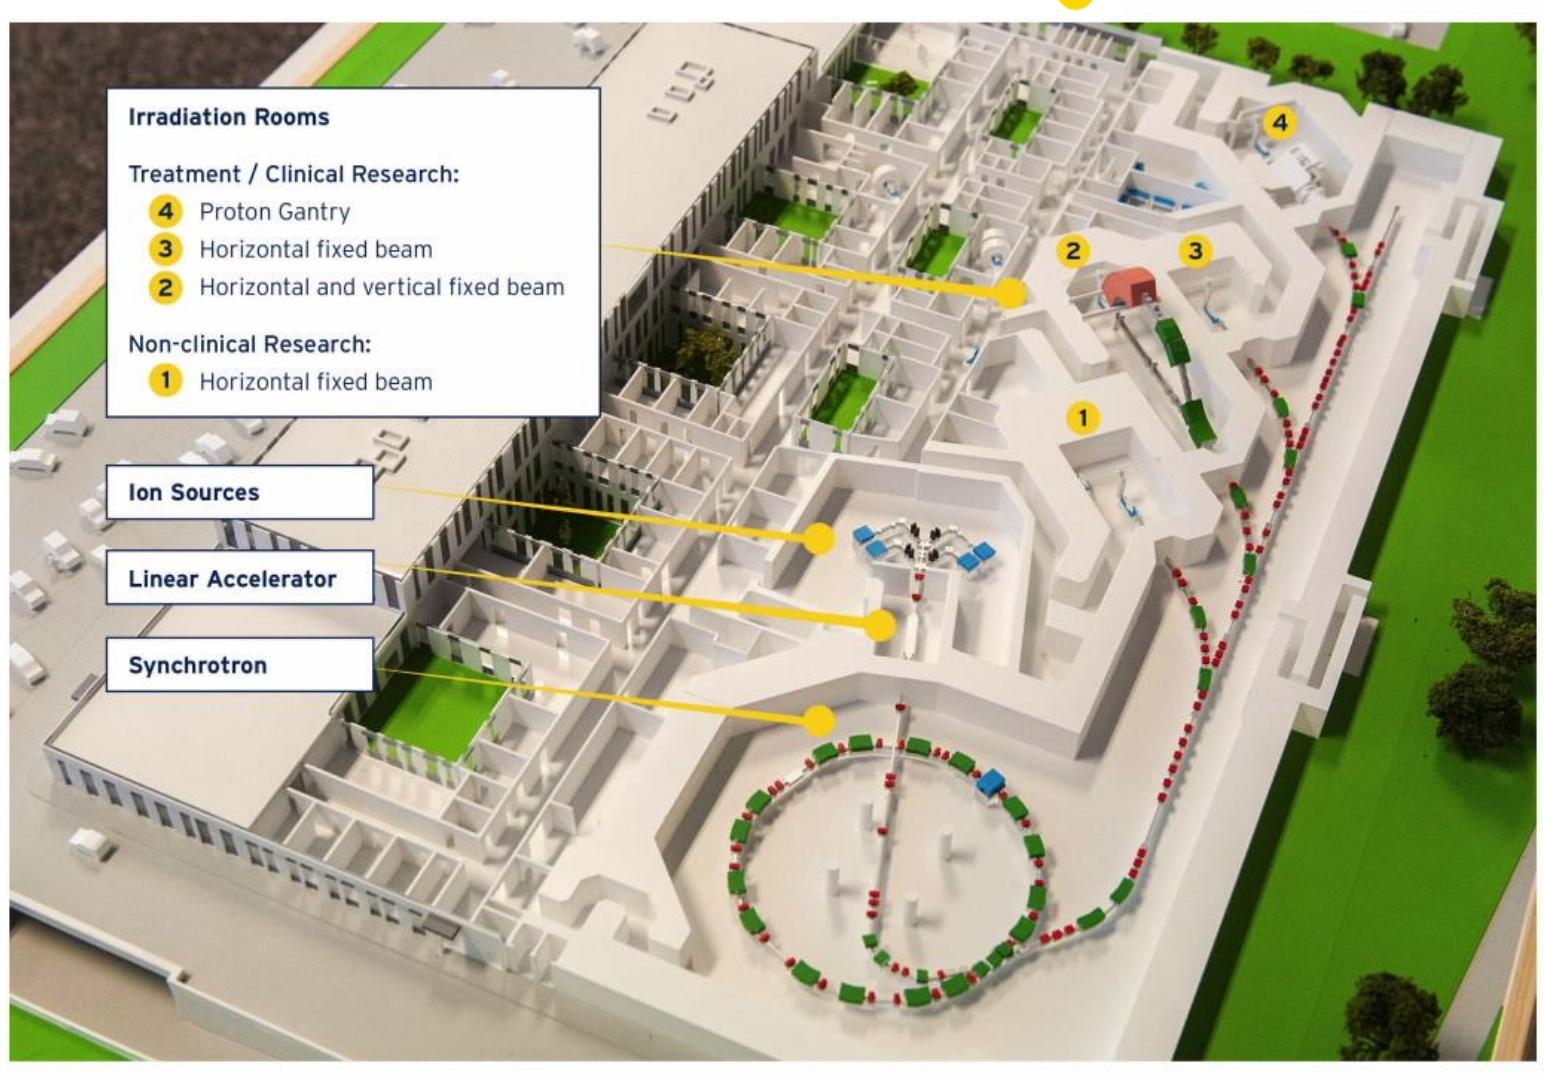
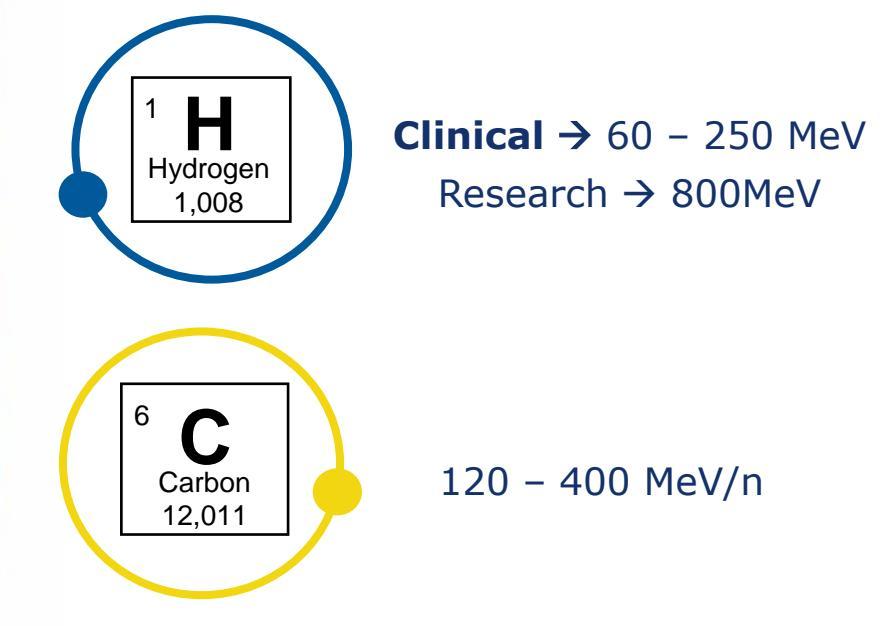
### FACILITY OVERVIEW

- Synchrotron based
- Injector operated at 7 MeV
- 77.6 m circumference Synchrotron
  - Extraction via betatron core

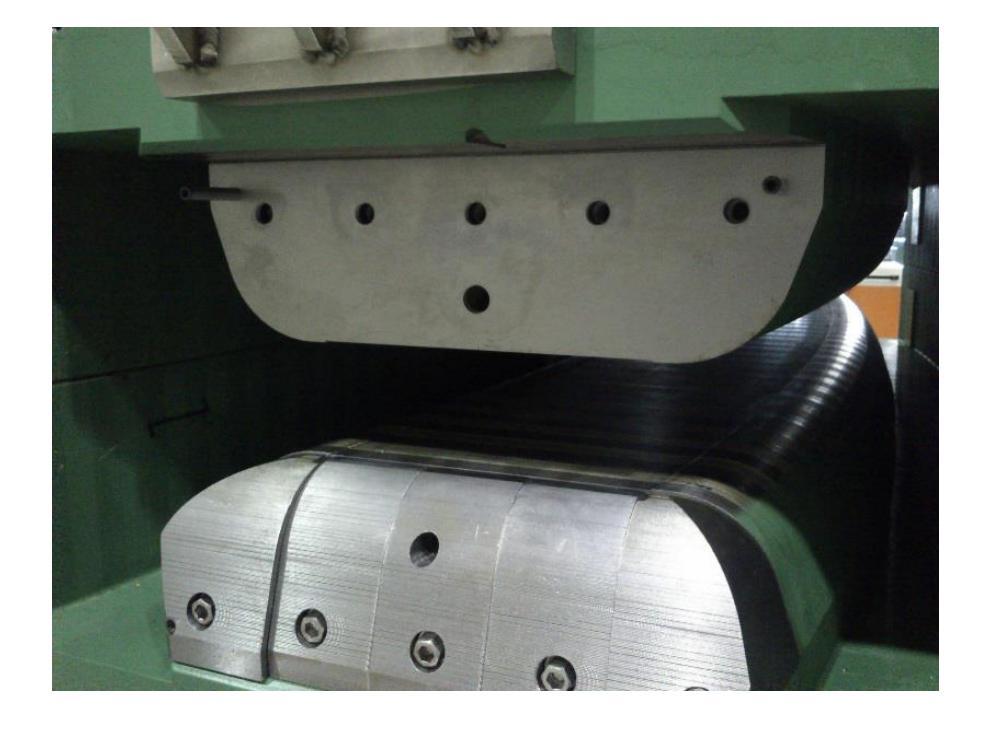
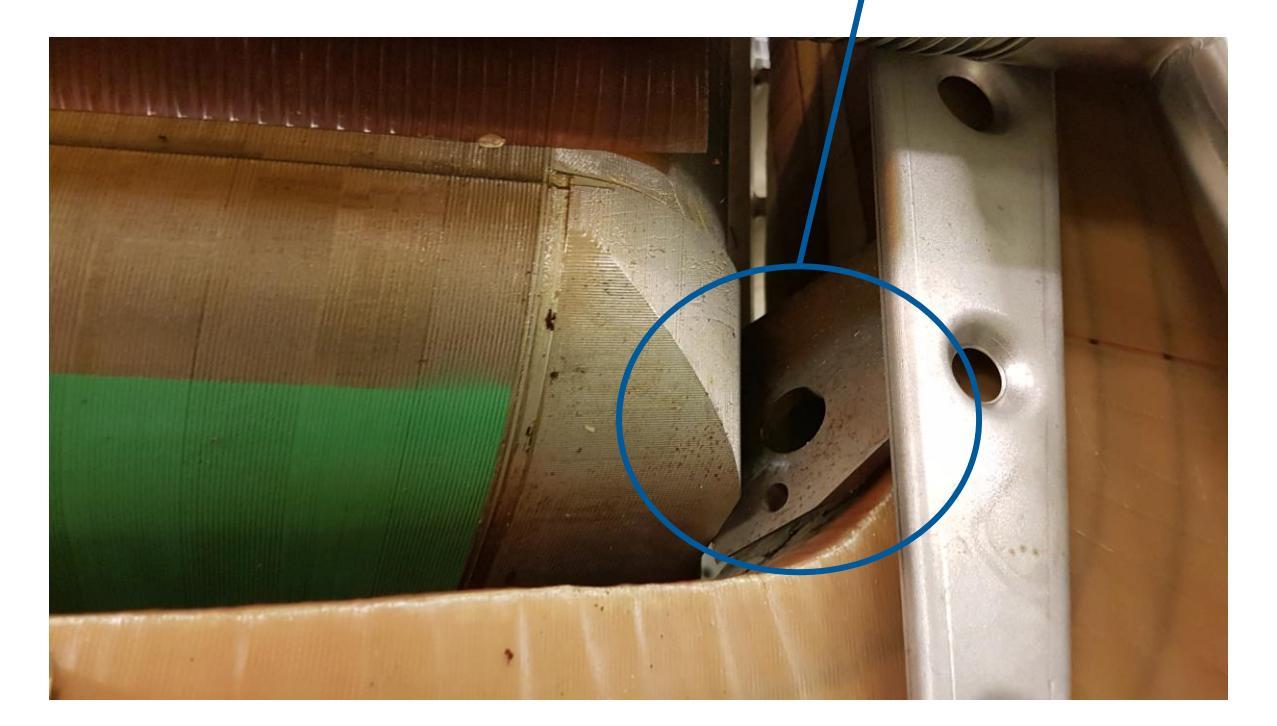
### SHIM-CIDENT (before patient treatment)

### Shims:

- Correct magnetic field inhomogenities
- Adjust magnetic field length

#### What happend?

- Change in beam orbit
- Beam losses
- Intensity reduction

- Immediate (temporary) shim repair
- Find long term solution (redesign)

- Re-commissioning
- Re-acceptance of beams
- Pulsing test annually

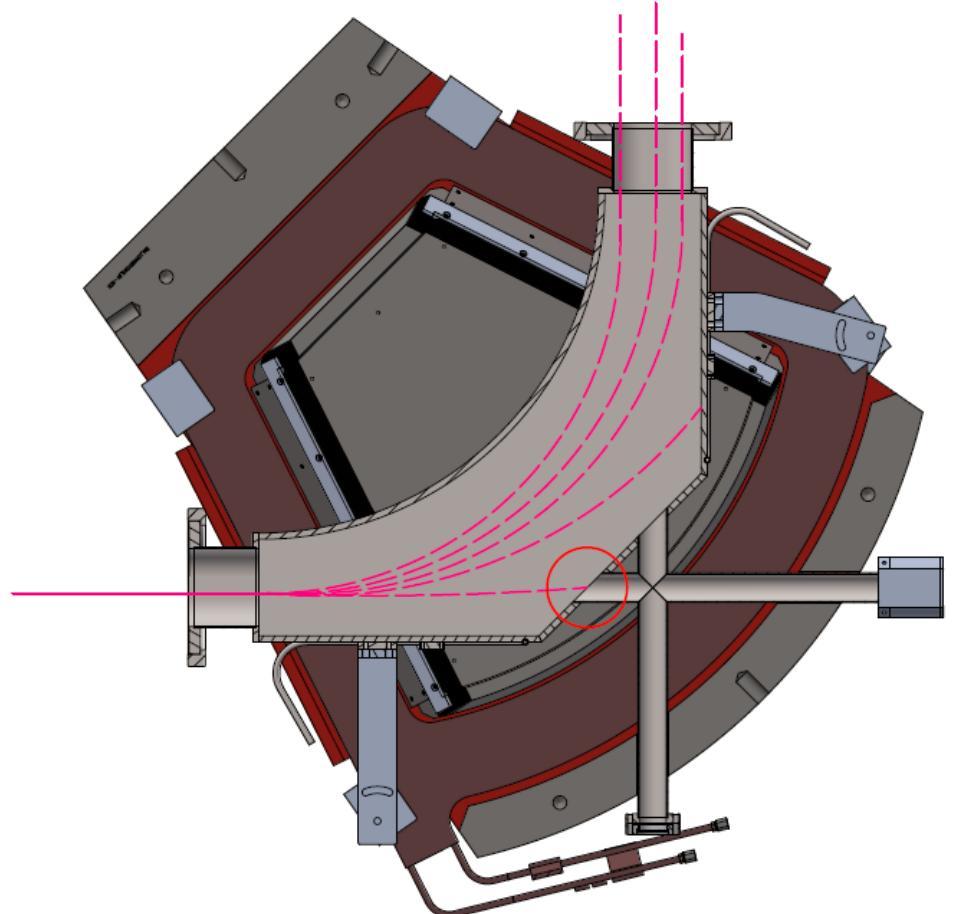
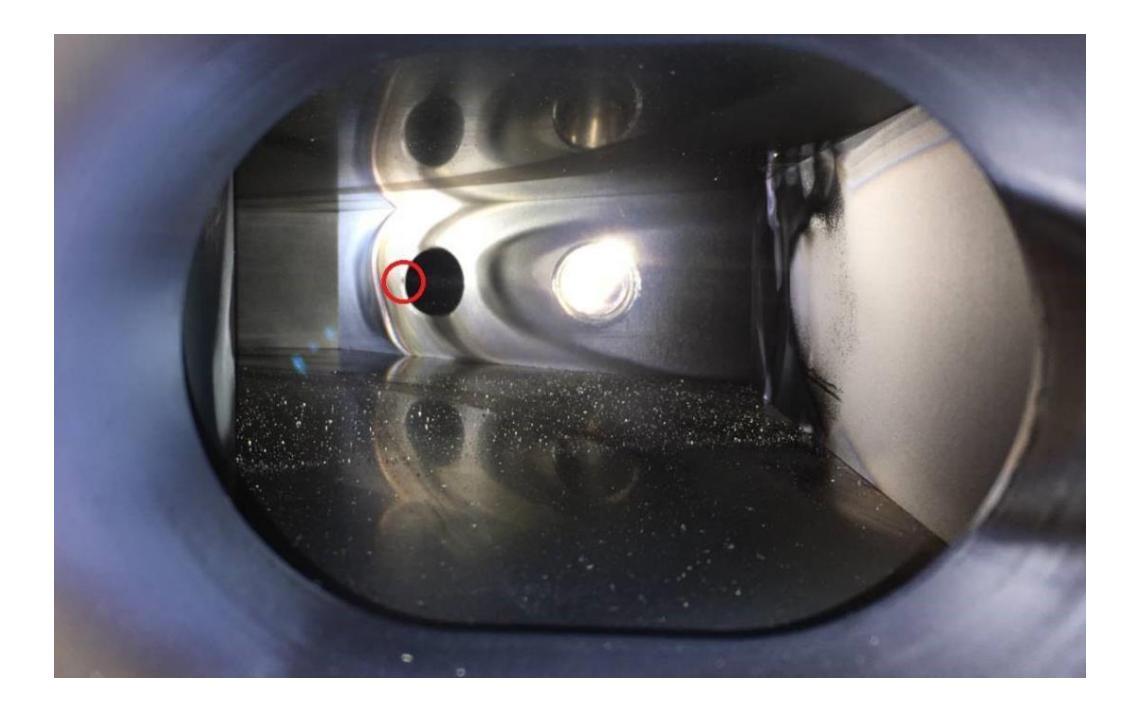
# DIPOLE CHAMBER LEAK

- Carbon beam hitting weld of chamber
- Weld is leaking

- Increase of vacuum pressure on extraction side of Source
- Unstable working conditions
- Occurence: 2 times

- New chamber design  $\rightarrow$  weld outside
- Thicker out wall
- Pulsed operation of the ion source is being considered

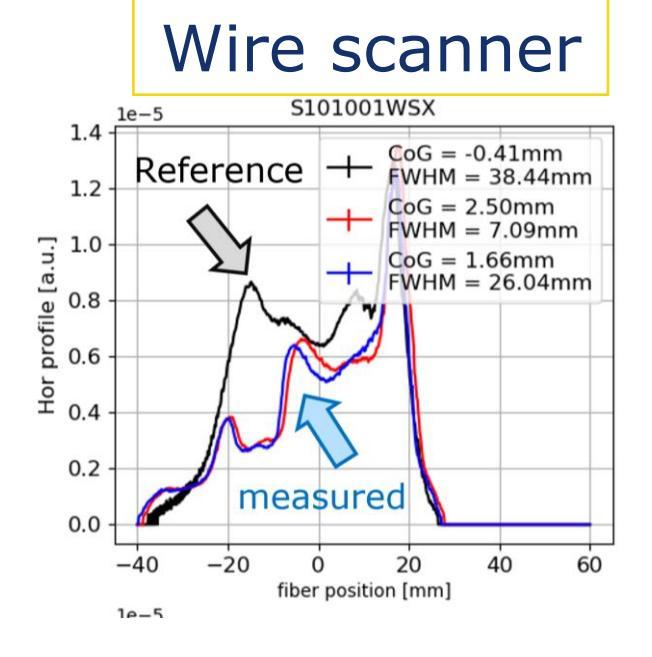
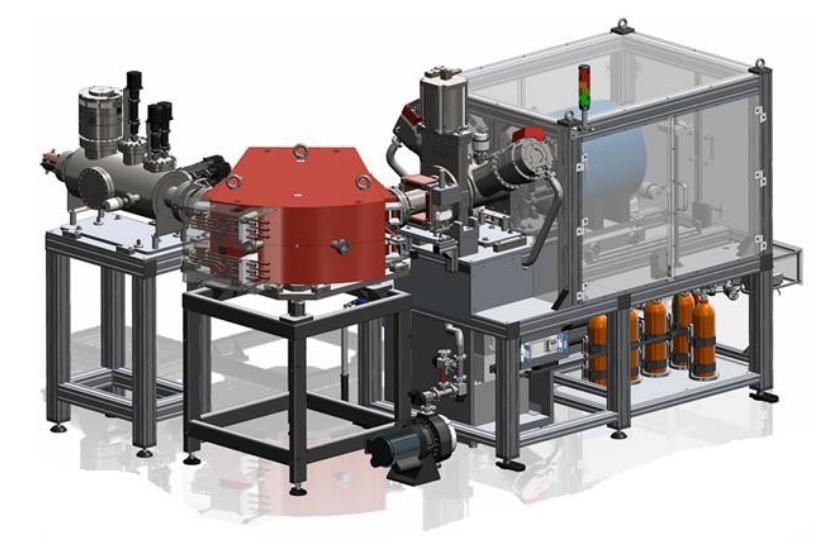
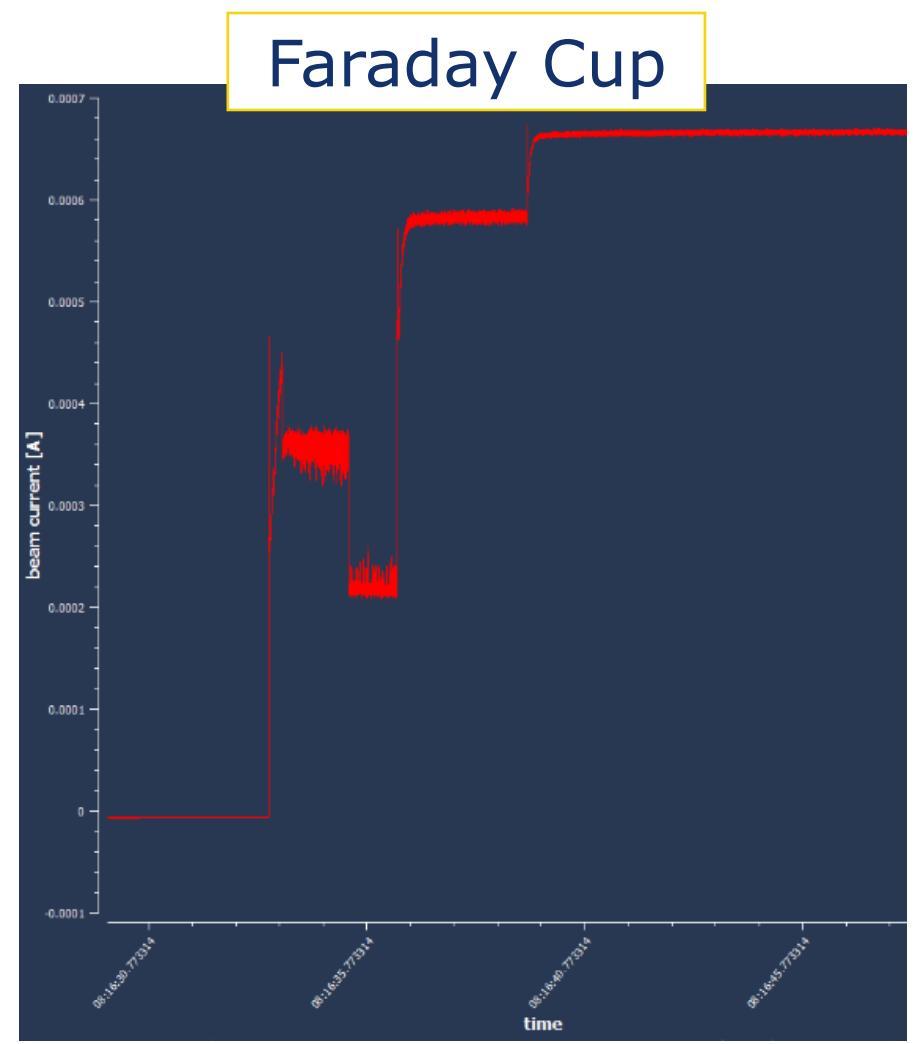
# DIPOLE CHAMBER DEPOSIT

#### **Reduced p+ current**

- Beam profiles after spectrometer different compared to the reference
- There are no intercepting beam line elements between ion source and beam diagnostic tank

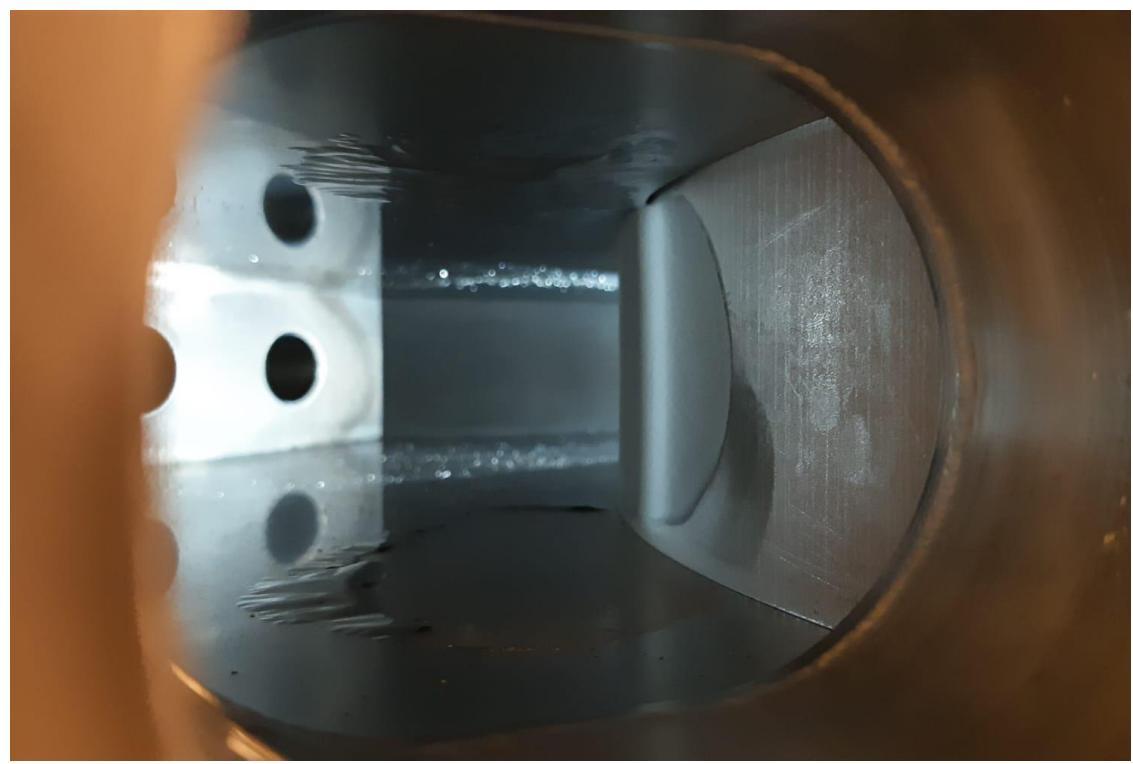
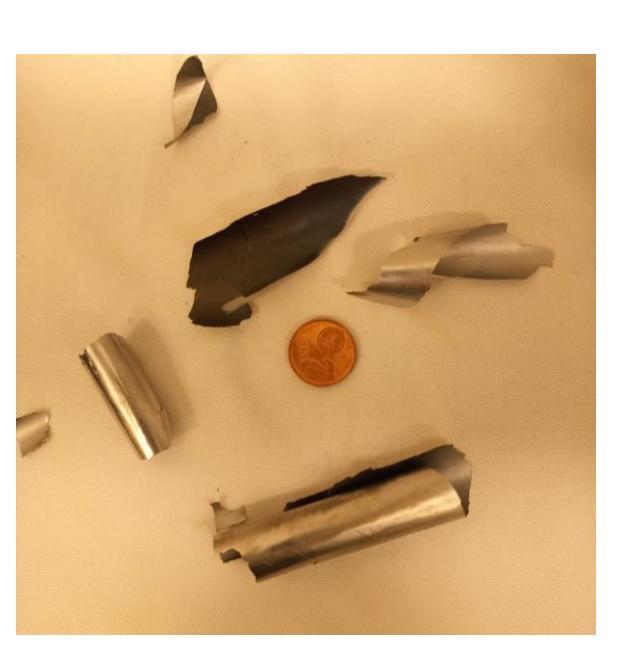
# DIPOLE CHAMBER DEPOSIT

- Large metallic flakes were found inside the chamber
- Changes in the magnetic field moved these flakes and affected the beam
- Chamber has been magnetized

#### **Measures:**

- Preventive
  - maintenance adapted
- Observing
  - **QA-measurement**
