CEBAF Particulate Field-Emitter Control

Rongli Geng July 15, 2015

C50-12 Rework Cryomodule Cavities

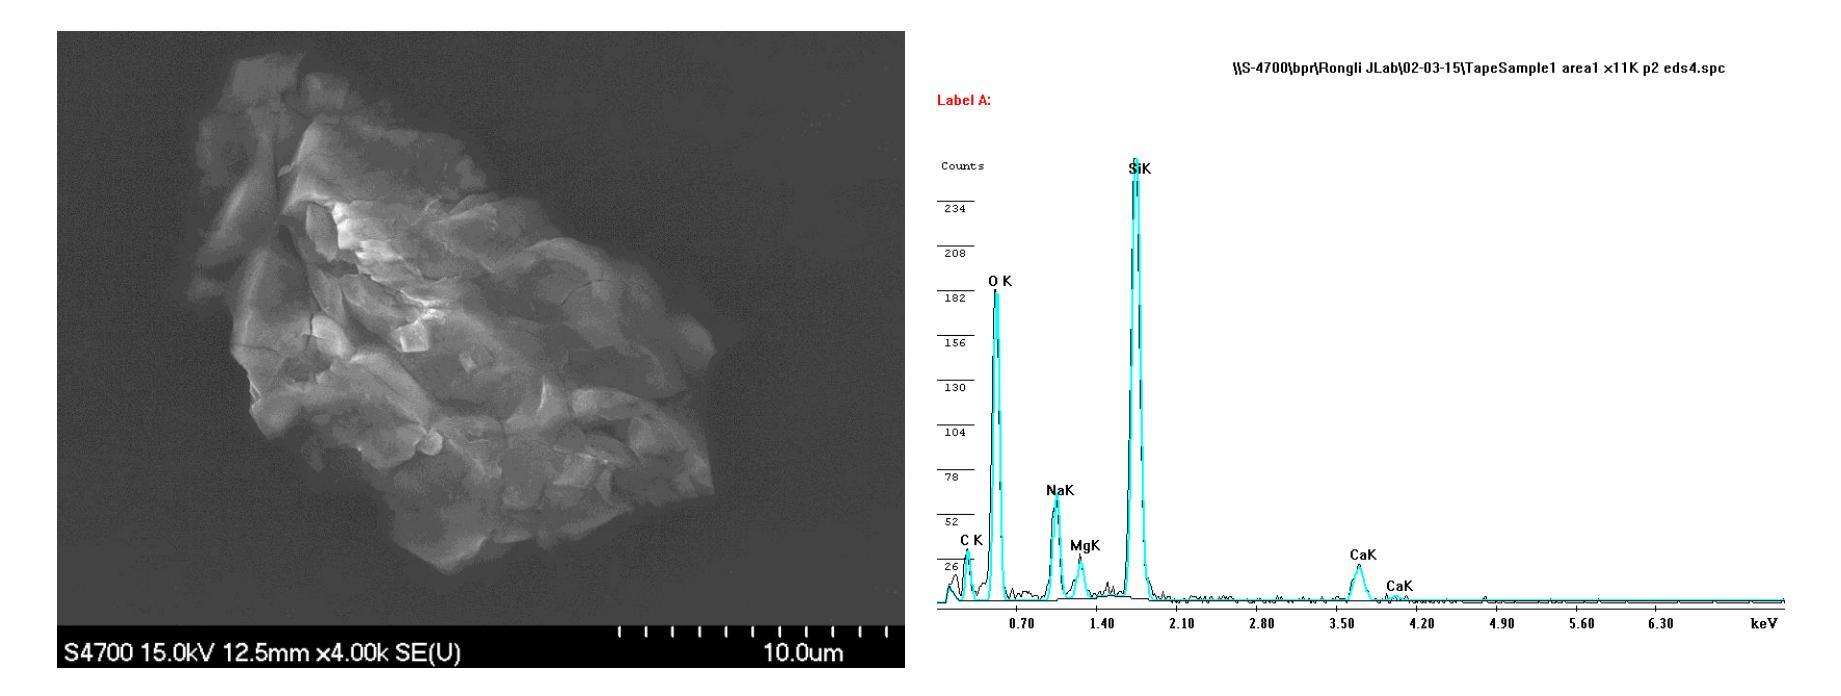
Ca, Na, Mg, Si

Most probably air-borne particles?

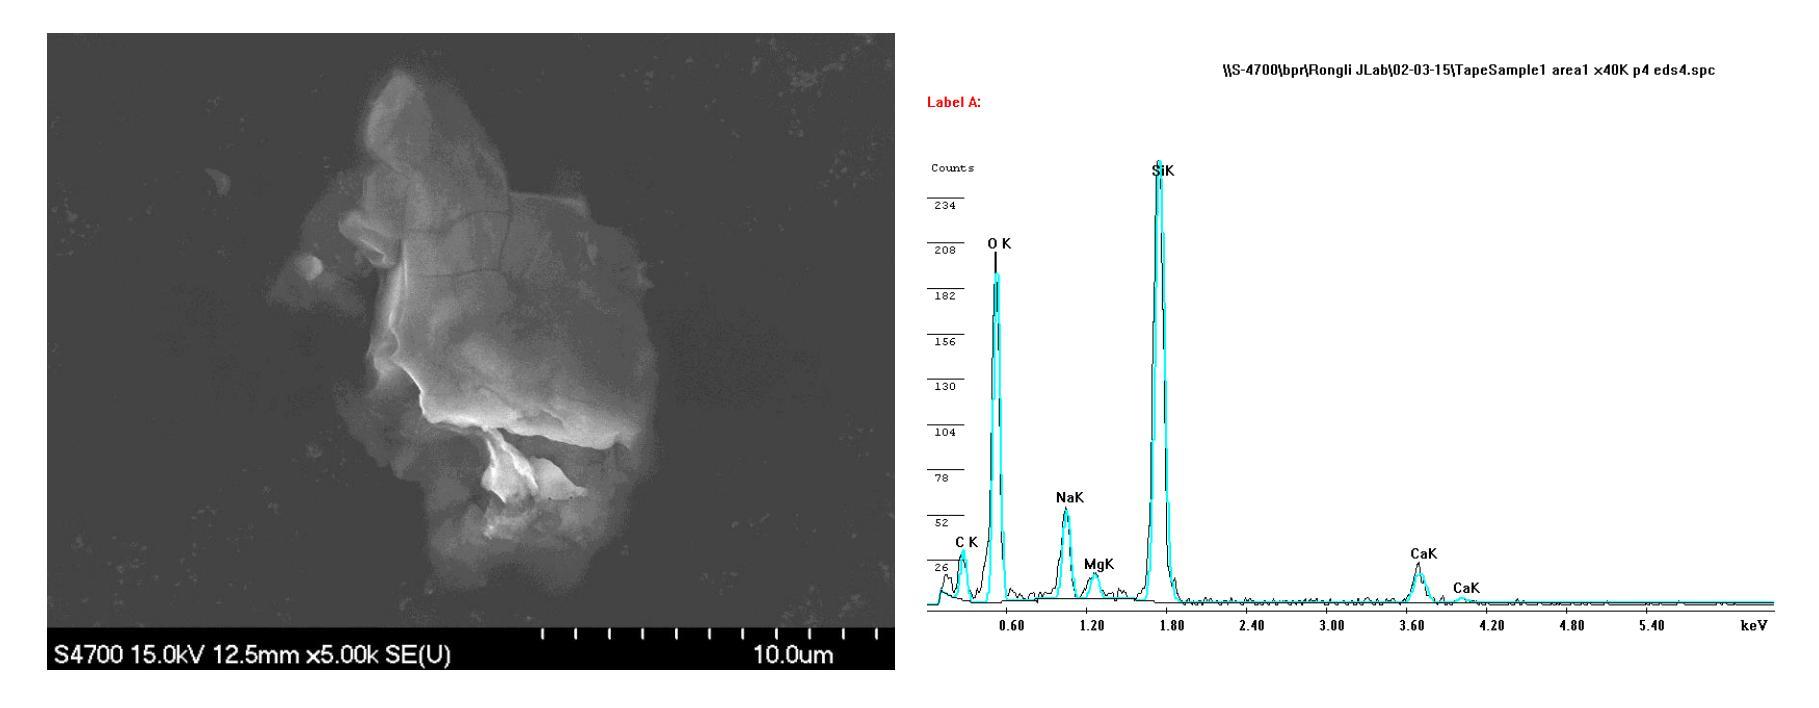
Ca, Na, Mg, Si

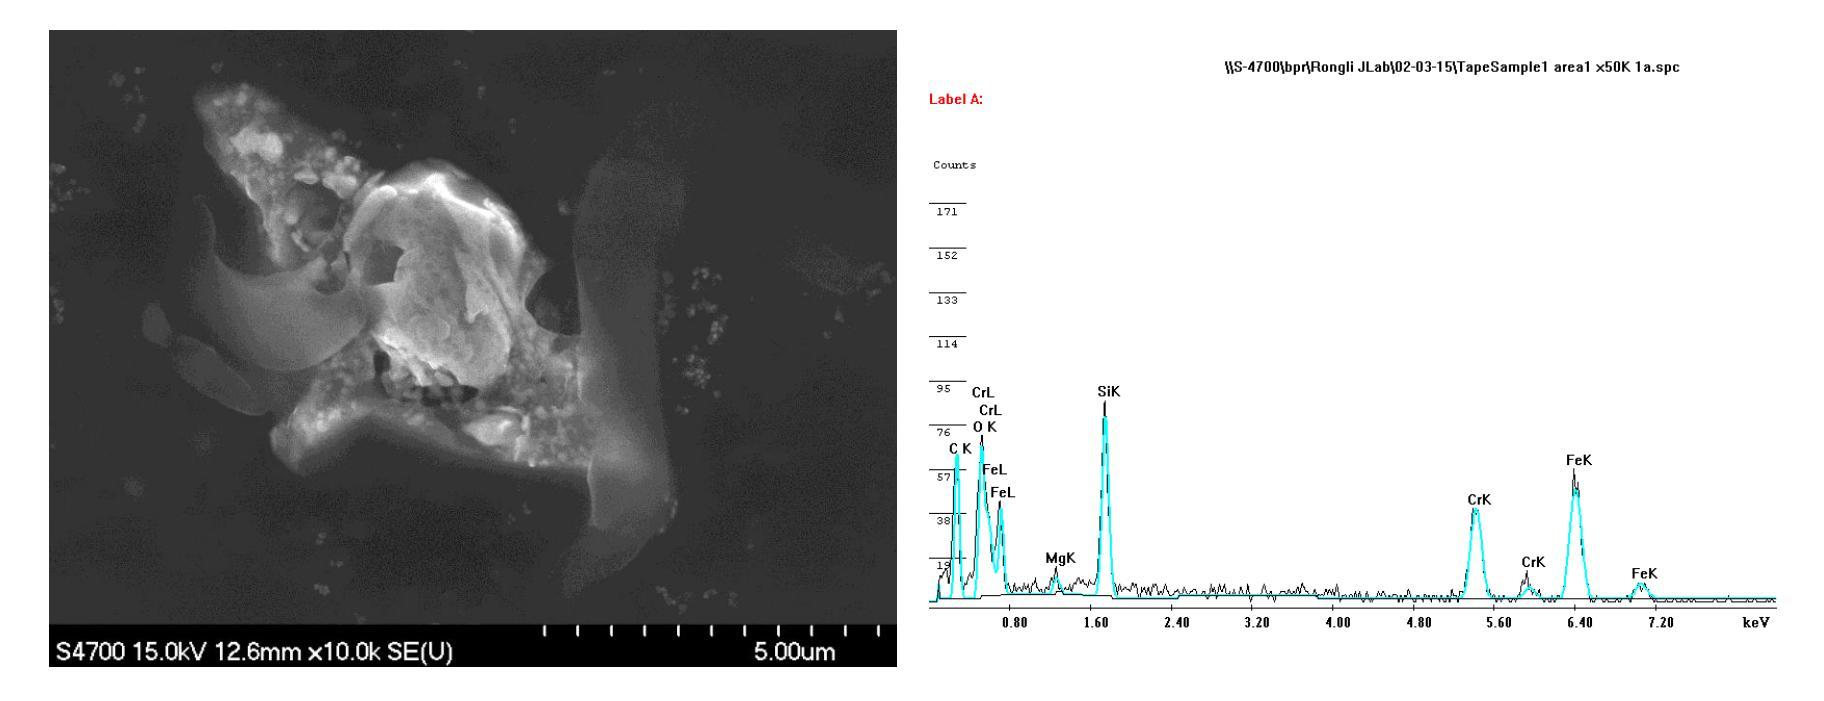
Fe, Cr, Mg, Si

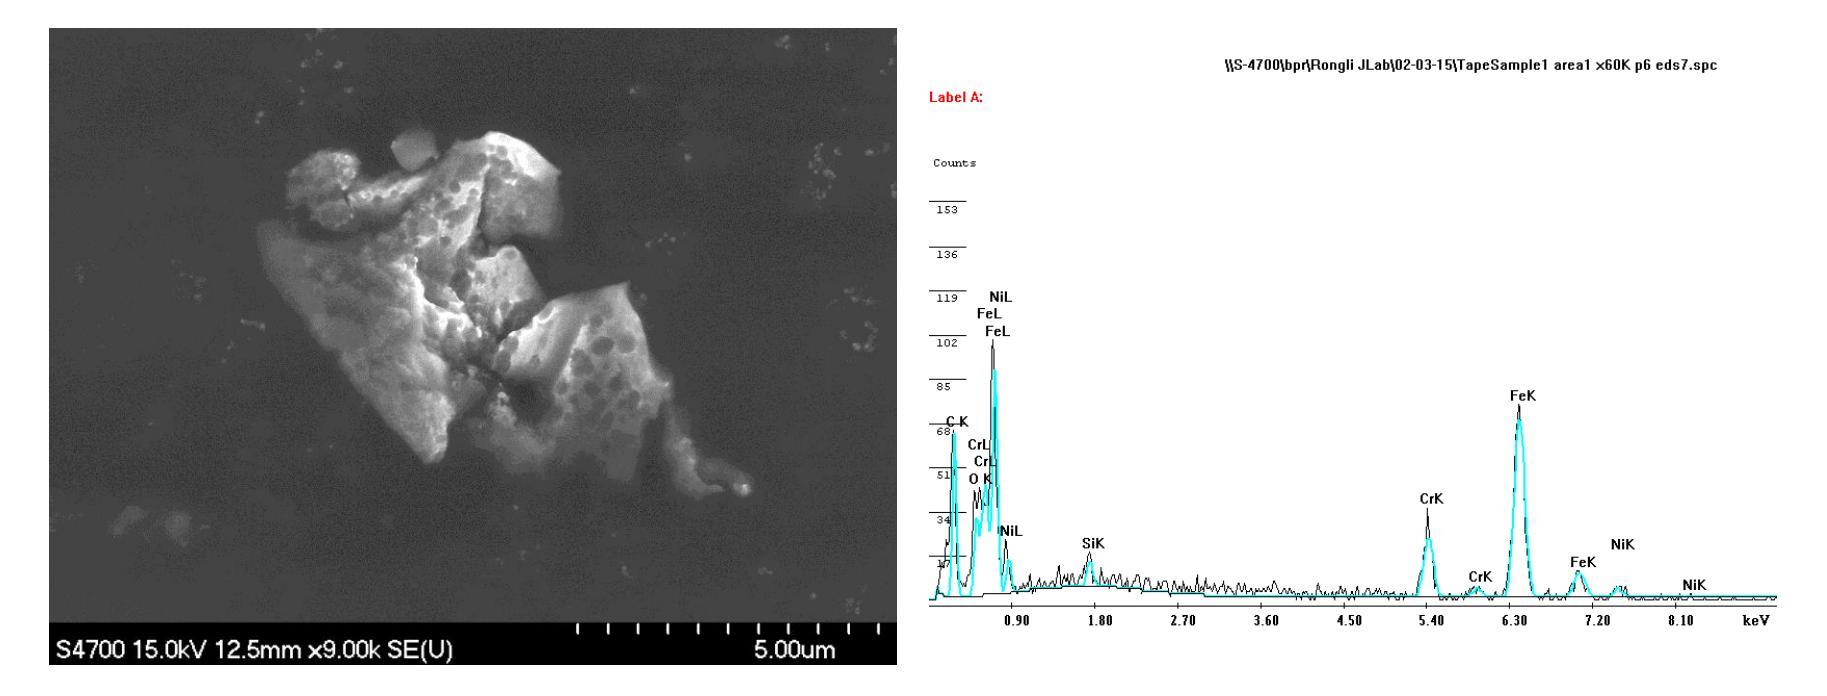
Fe, Ni, Cr, Si

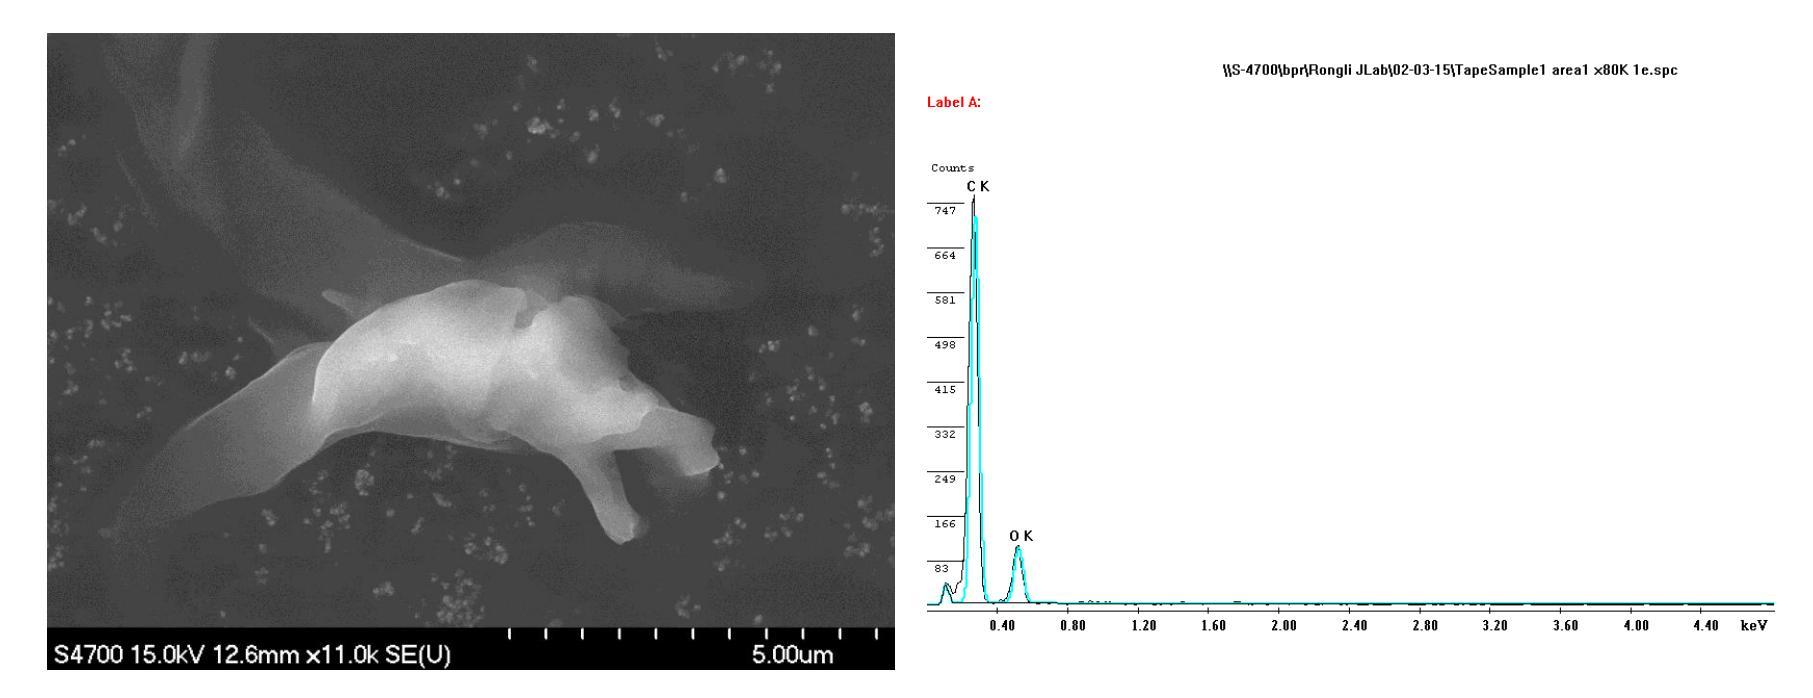
С, О

Tape artifact?

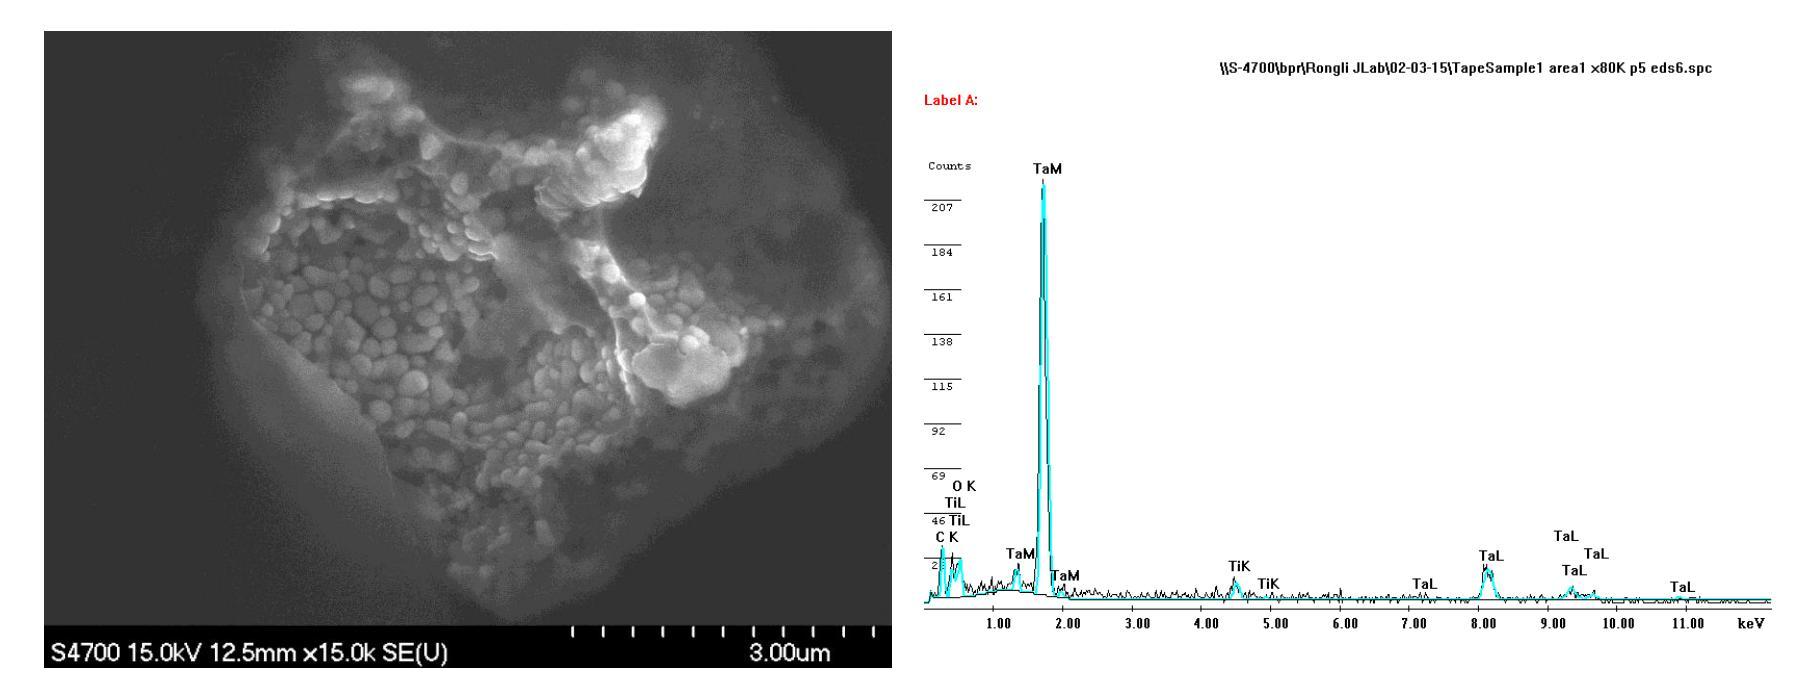
Ta, (Ti)

Composition to be determined 10feb15

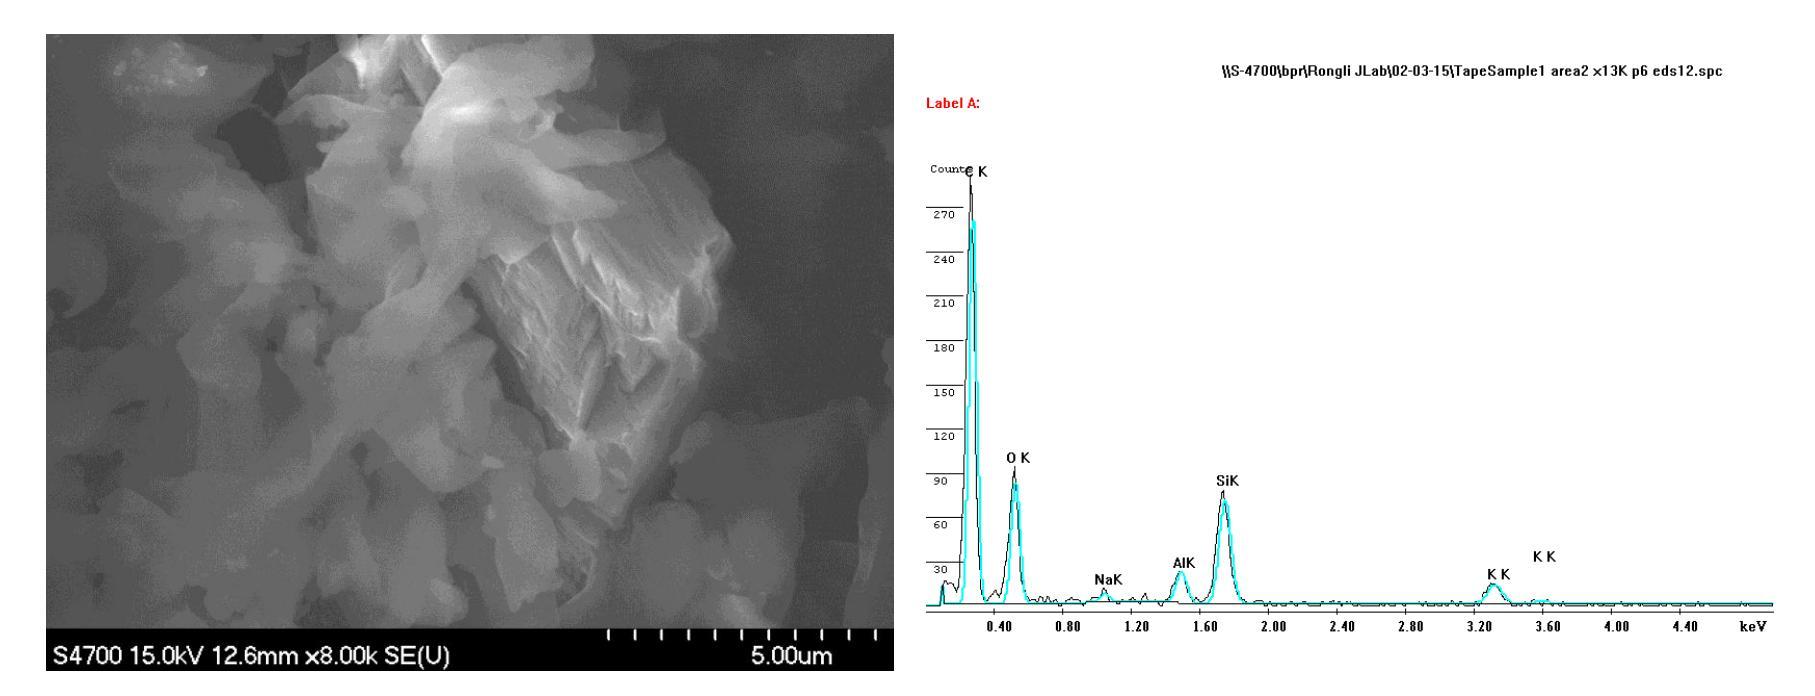
K, Na, Al, Si

Clay particle mixed with Si residual?

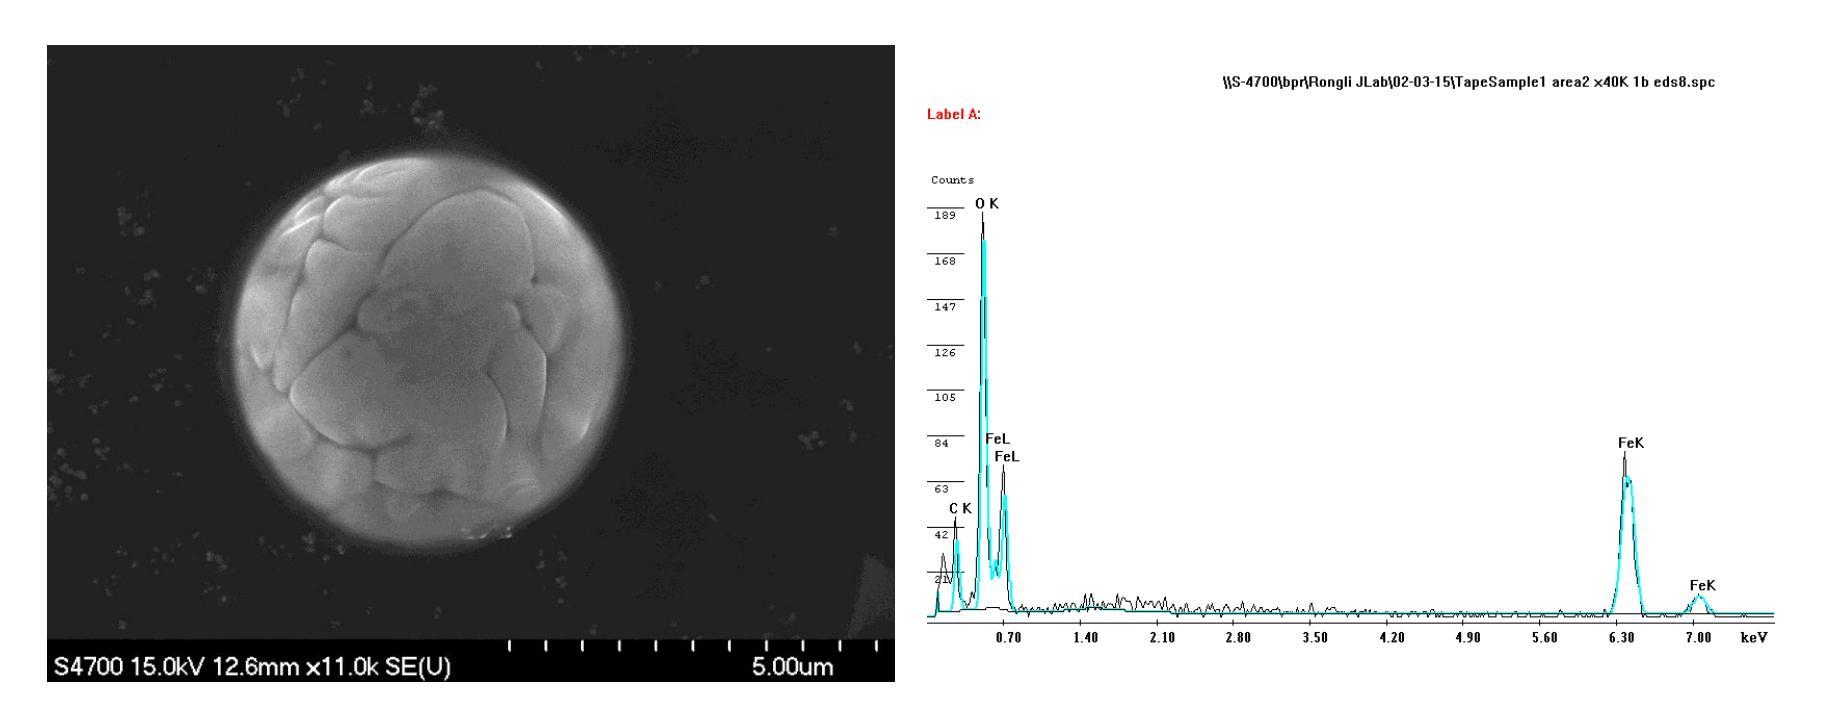
Fe

Melted iron ball?

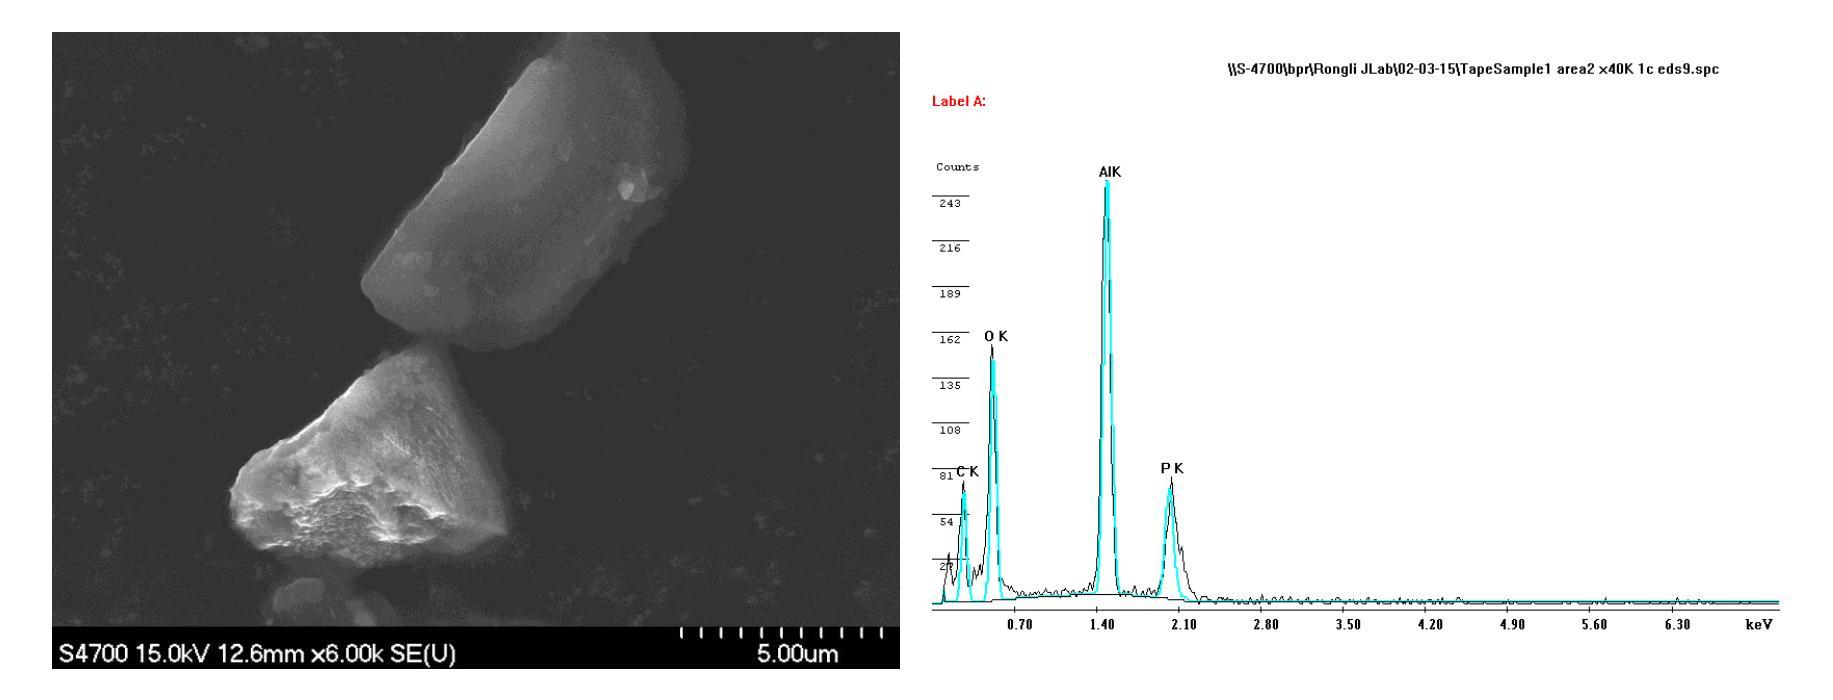
Al, P

Check EDS again 10feb15

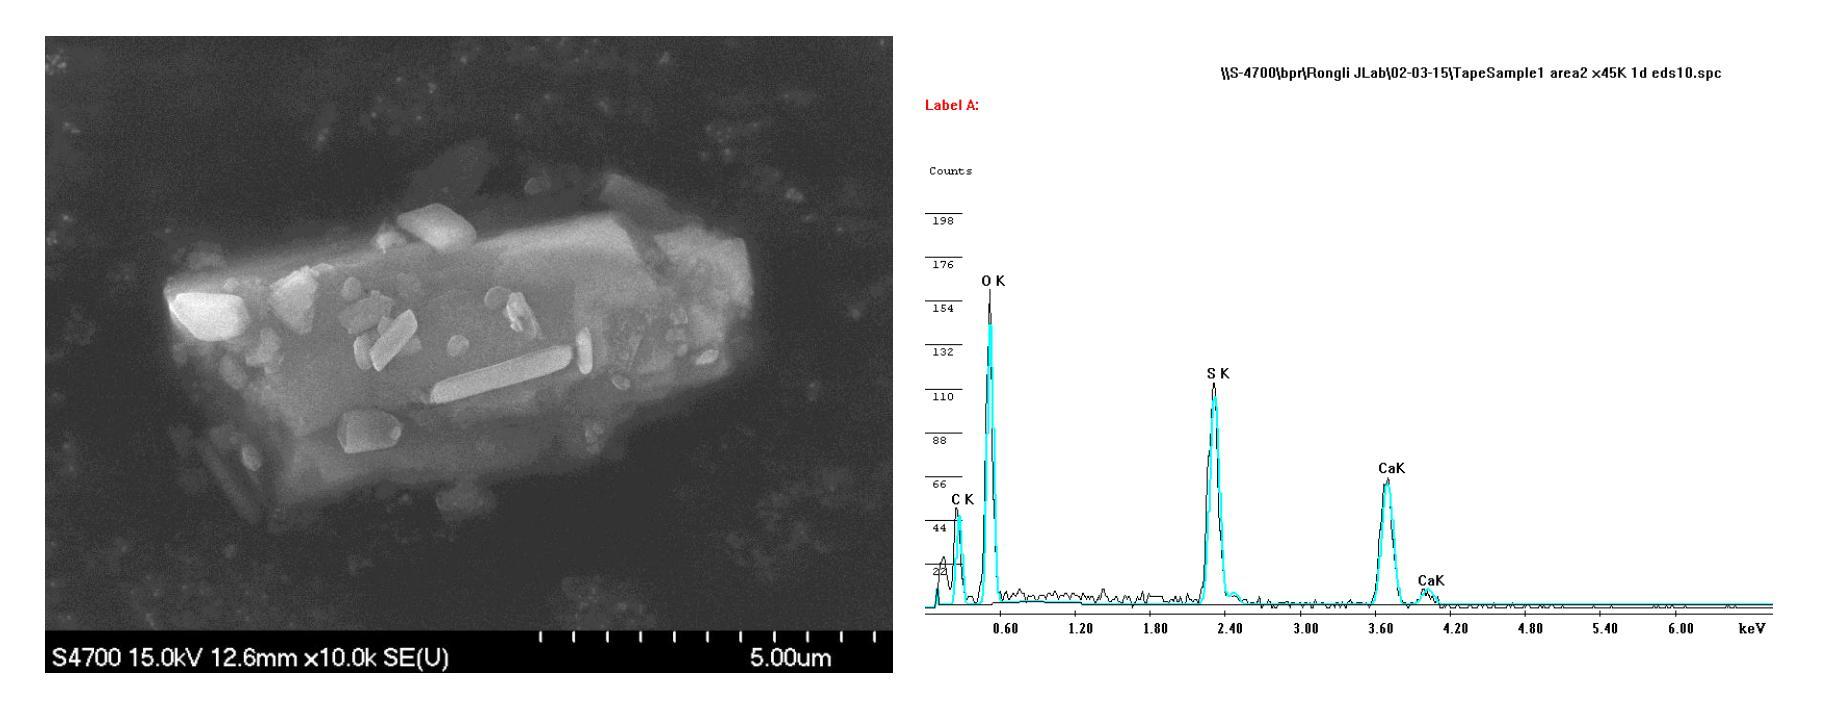
Ca, S

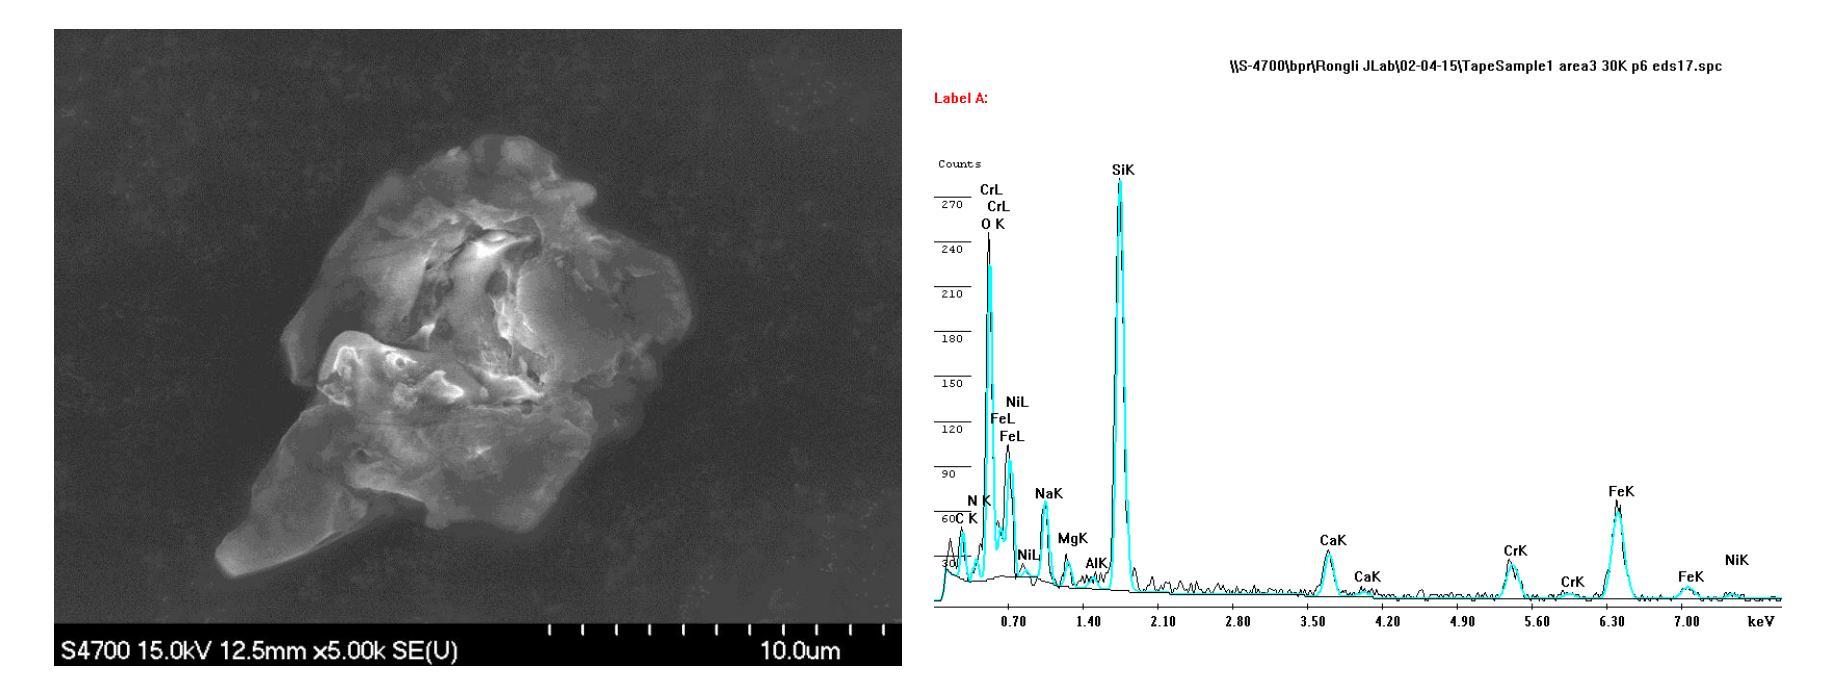
Fe, Cr, Ni, Na, Mg, Al, Si

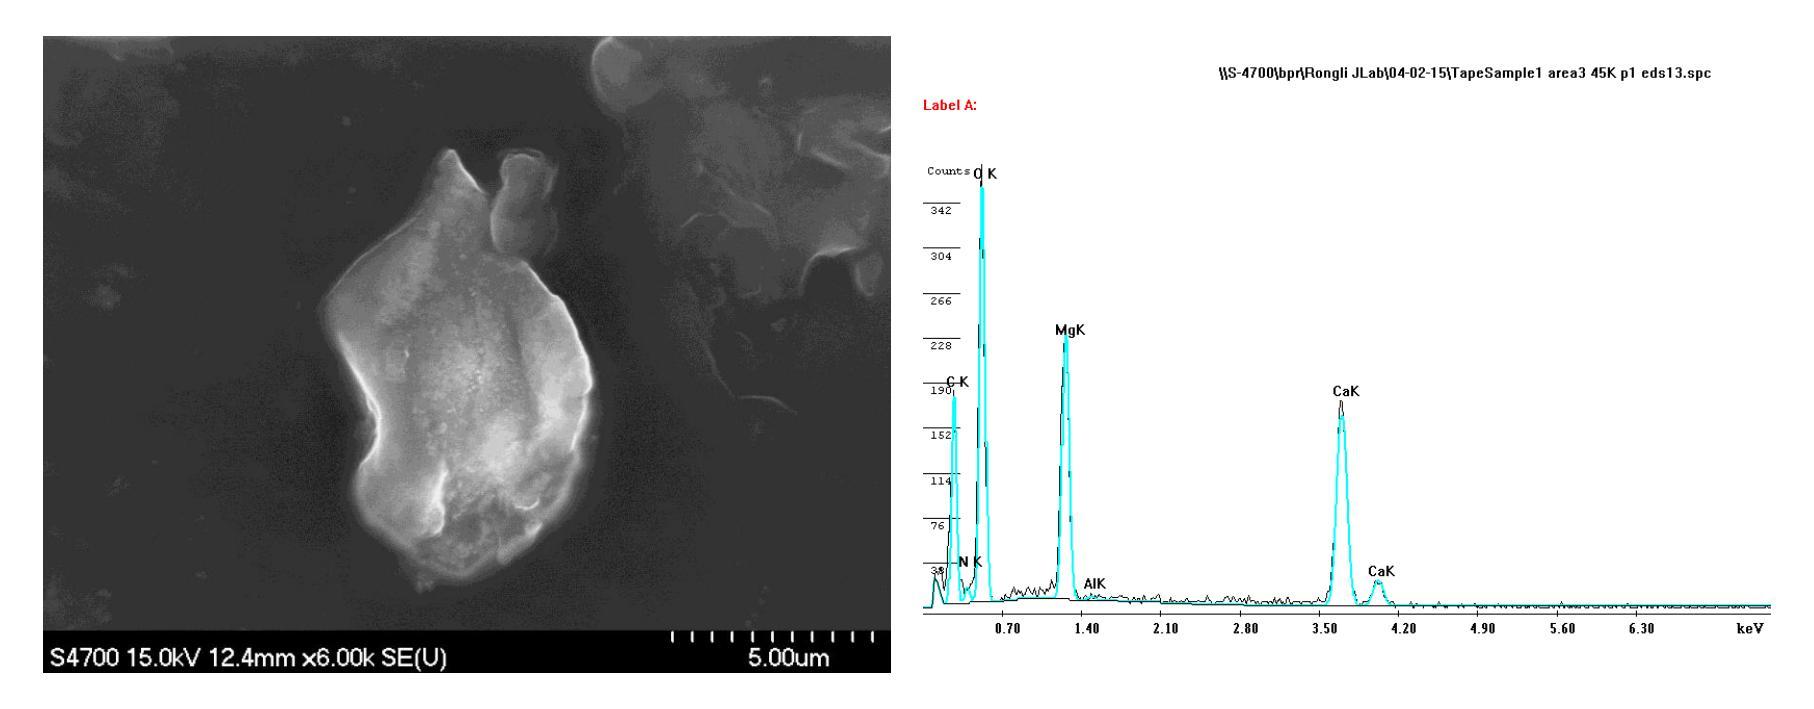
Ca, Mg

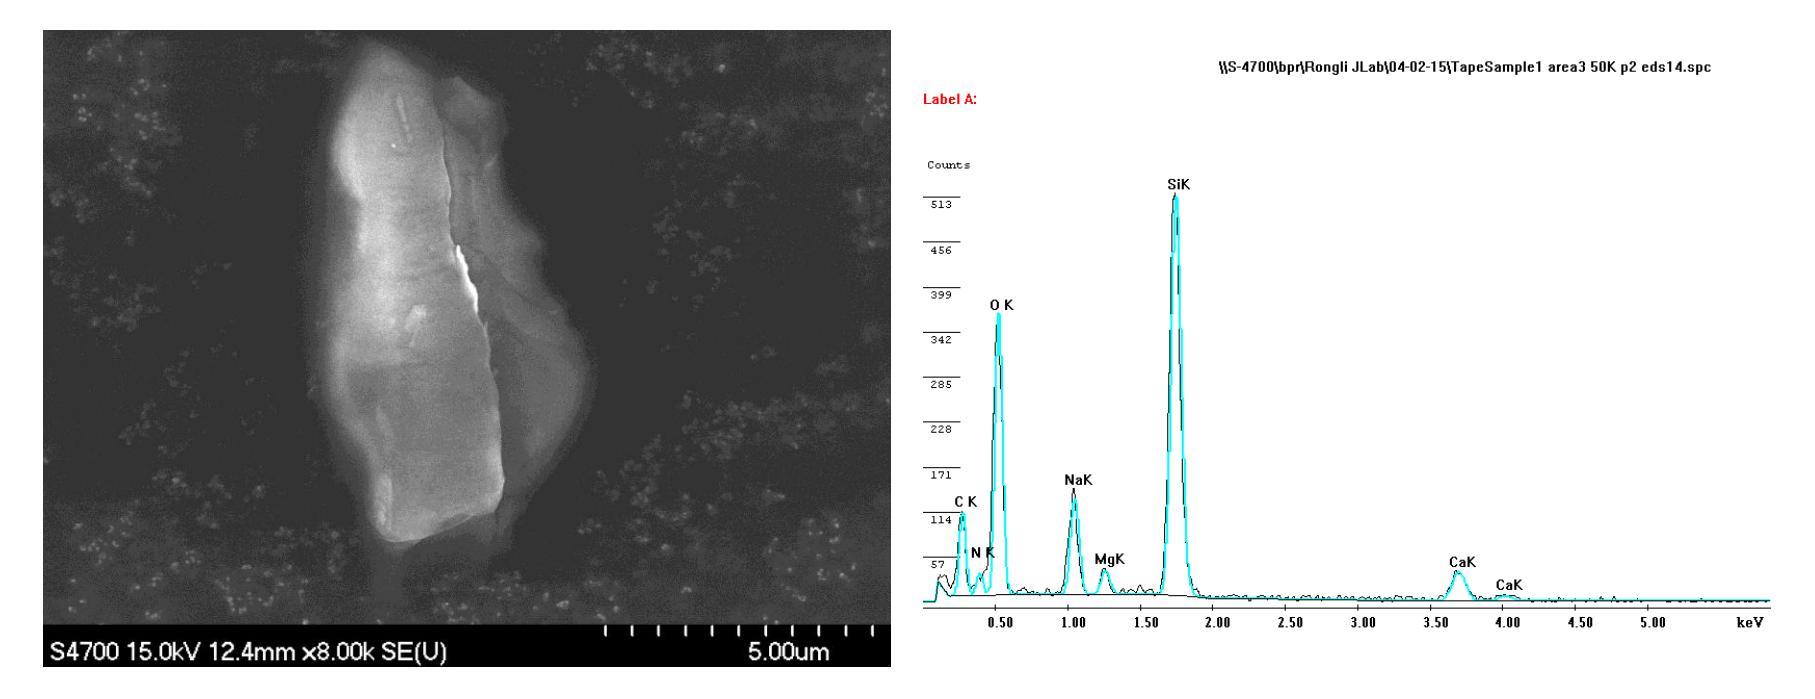
Ca, Na, Mg, Si

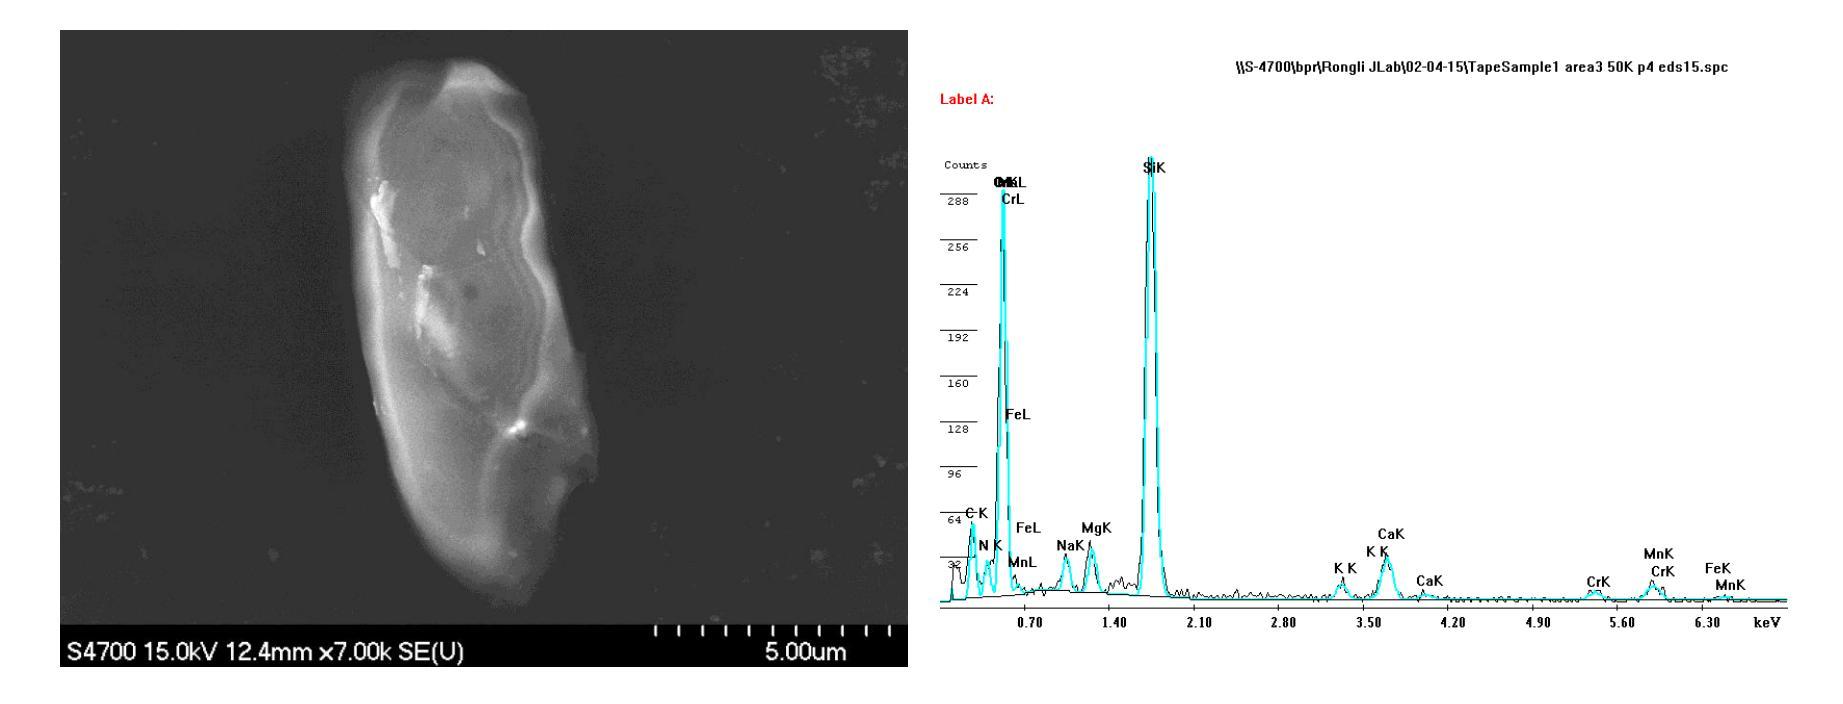
Cr, Fe, Mn, Ca, K, Na, Mg, Si

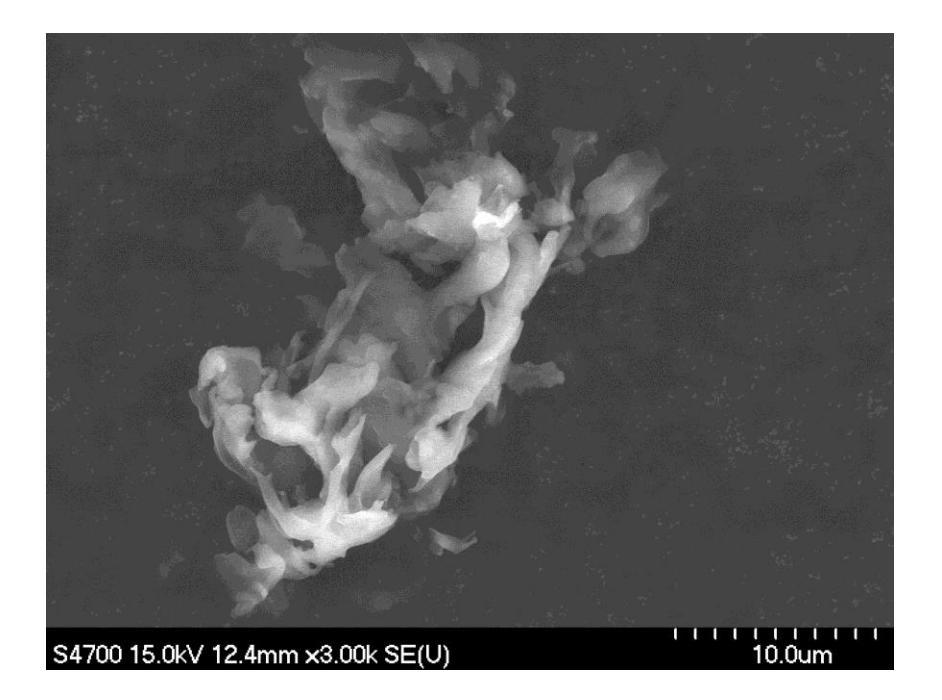
TapeSample1 area2 x3K1a_q00

С, О

Quick EDS analysis showed C and O peaks in the ratio close to that of a substrate. No significant charging was registered. This could be a carbon tape artifact.

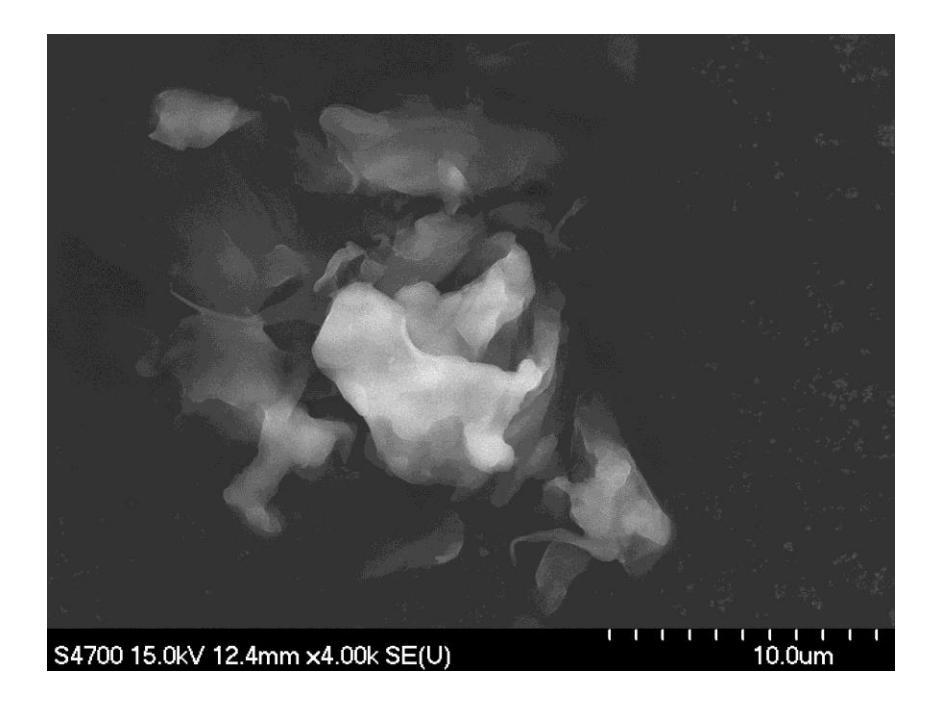
TapeSample1 area3 x3K p7_q00

С, О

Quick EDS analysis showed C and O peaks in the ratio close to that of a substrate.
No significant charging was registered. This could be a carbon tape artifact.

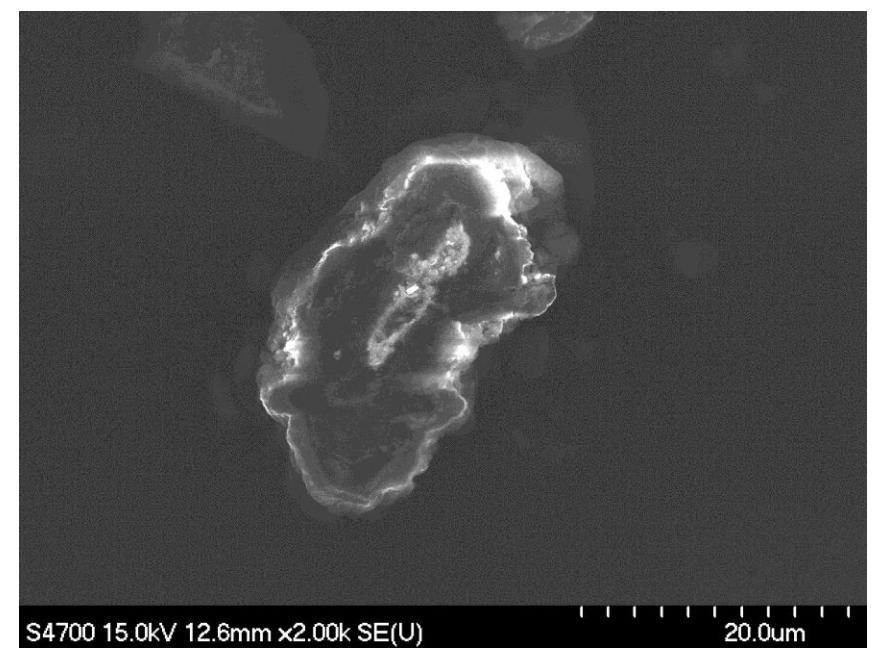
TapeSample1 area3 x4K p2_q00
IA080 Inner Surface SS Beam Tube

Al, Si, Ca, Na Typical clay

Quick EDS analysis showed
Al, Si, Ca and Na peaks
typical for clay or/and dust
particles. C and O peaks
were present due to the
carbon tape substrate.
Particle demonstrated
significant charging.

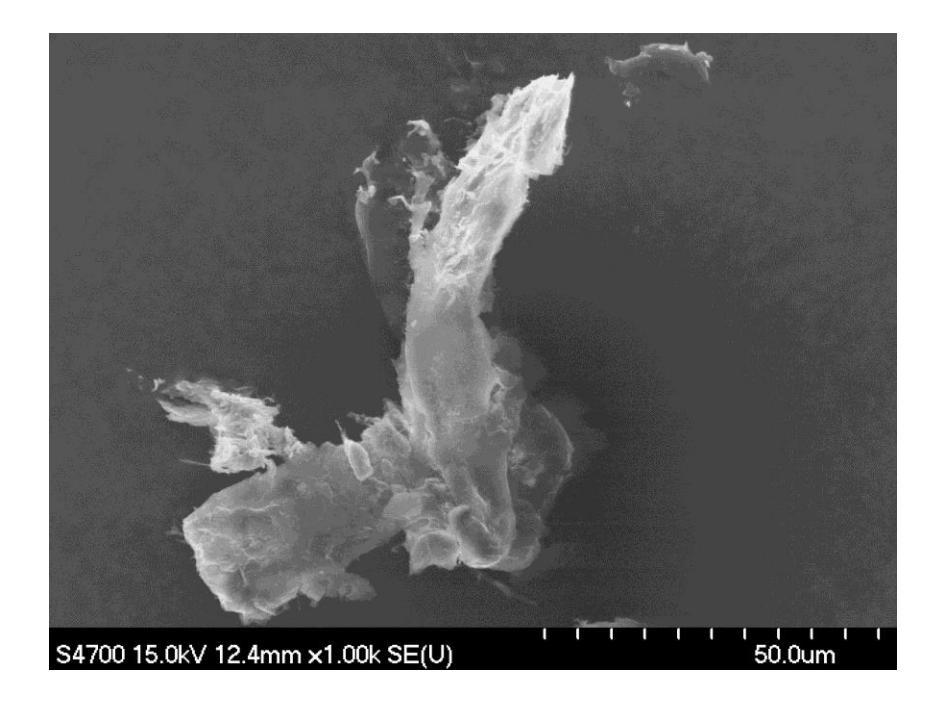
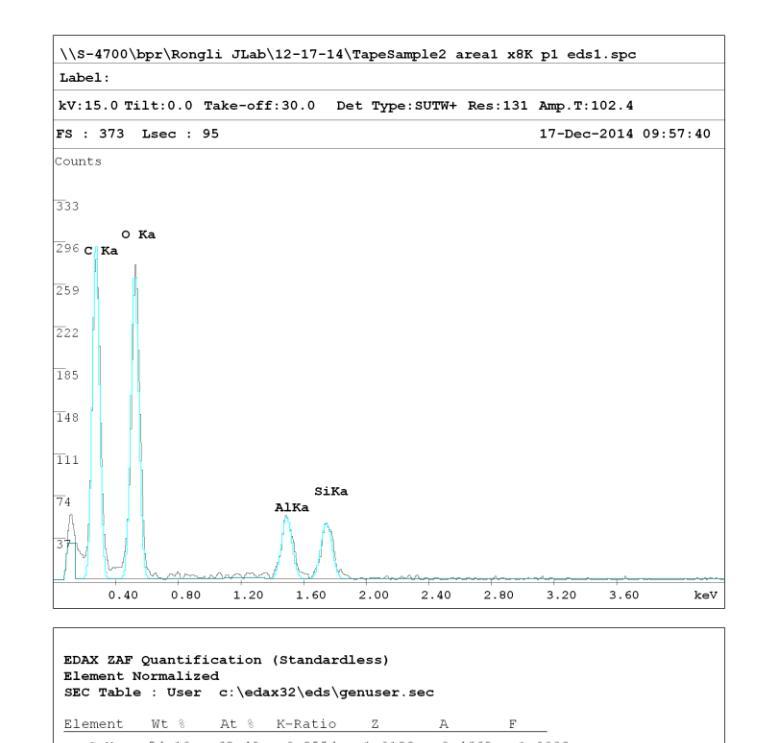
IA080 Inner Surface Nb Beam Tube

Al, Si, O, C

Quantify composition 10feb15

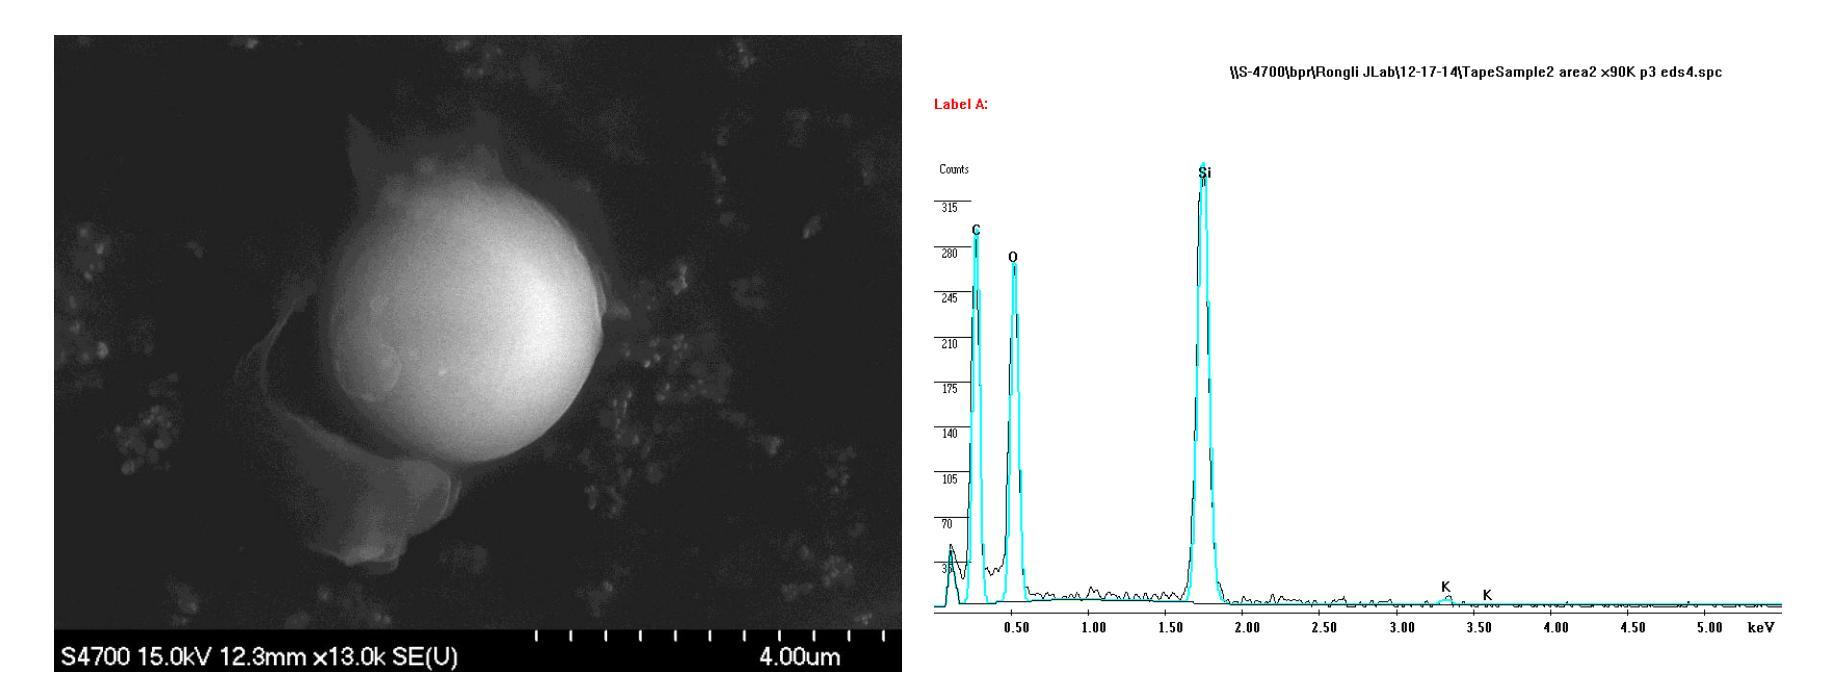
IA080 Inner Surface Nb Beam Tube Si, (K)

Melted Si ball? Check size of Si ball from Huitian barrel polishing
