CEBAF Particulate Field-Emitter Control

Rongli Geng July 15, 2015

C50-12 Rework Cryomodule Cavities

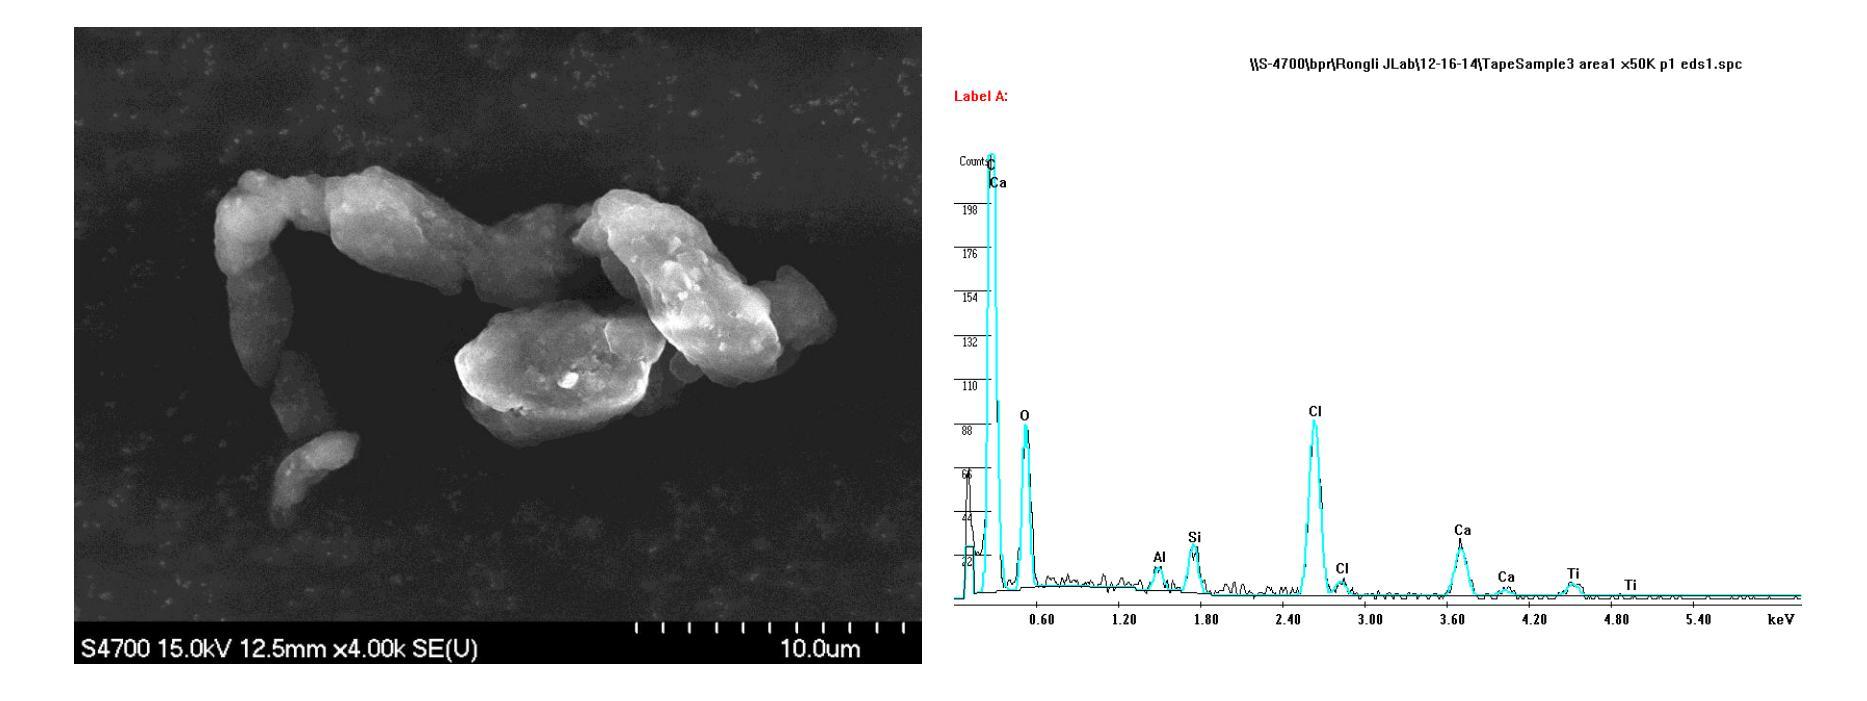
IA080 1st Iris from Gate Valve Al, Si, Cl, Ca, Ti

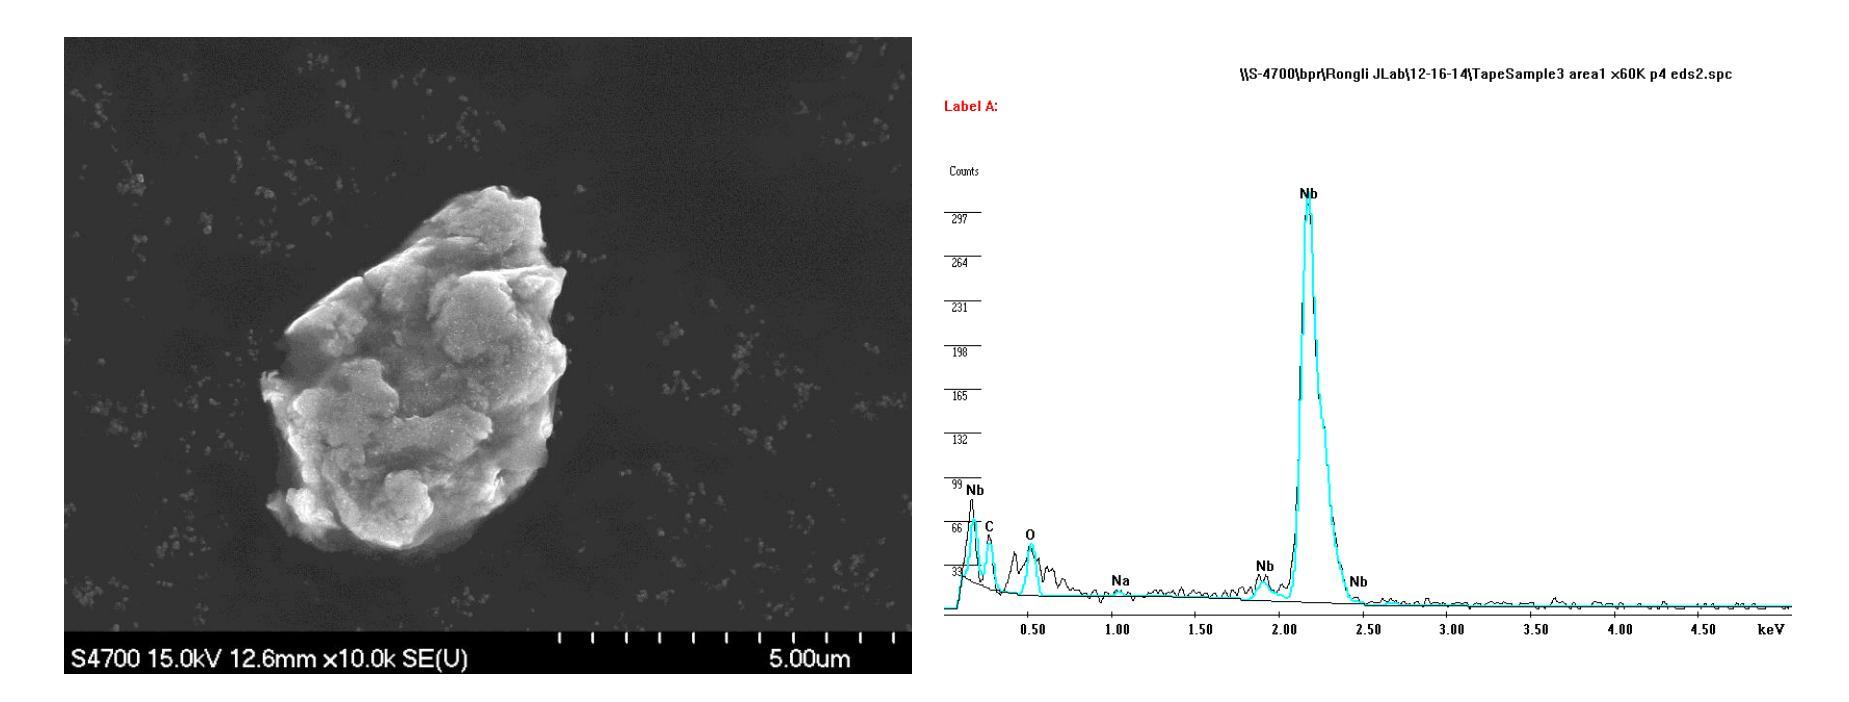
IA080 1st Iris from Gate Valve Nb

Clear proof that the wiping/transferring technique works

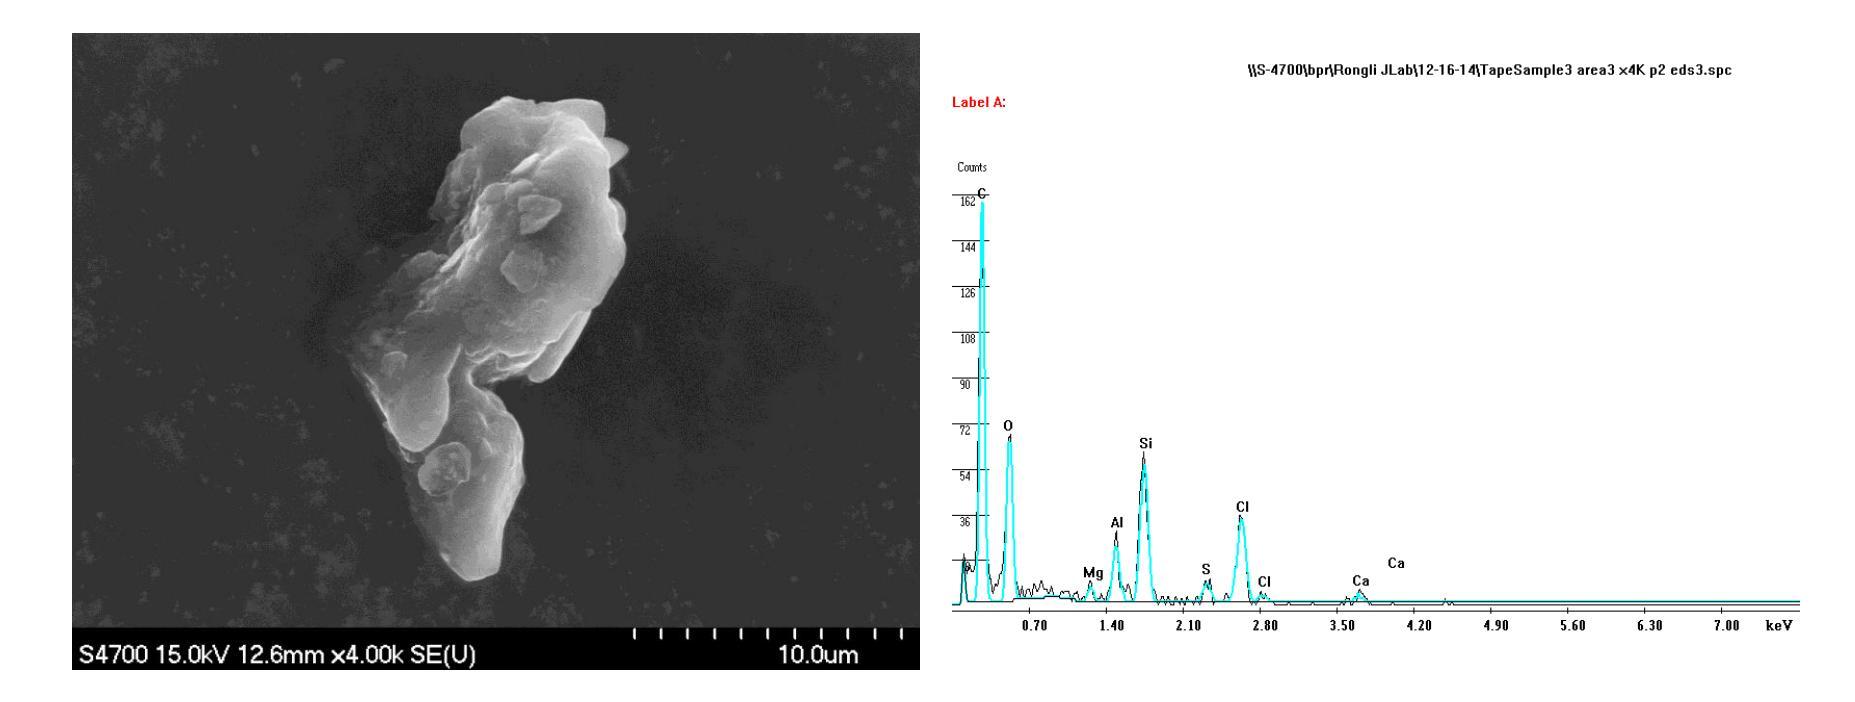
IA080 1st Iris from Gate Valve Mg, Al, Si, S, Cl, Ca

clay

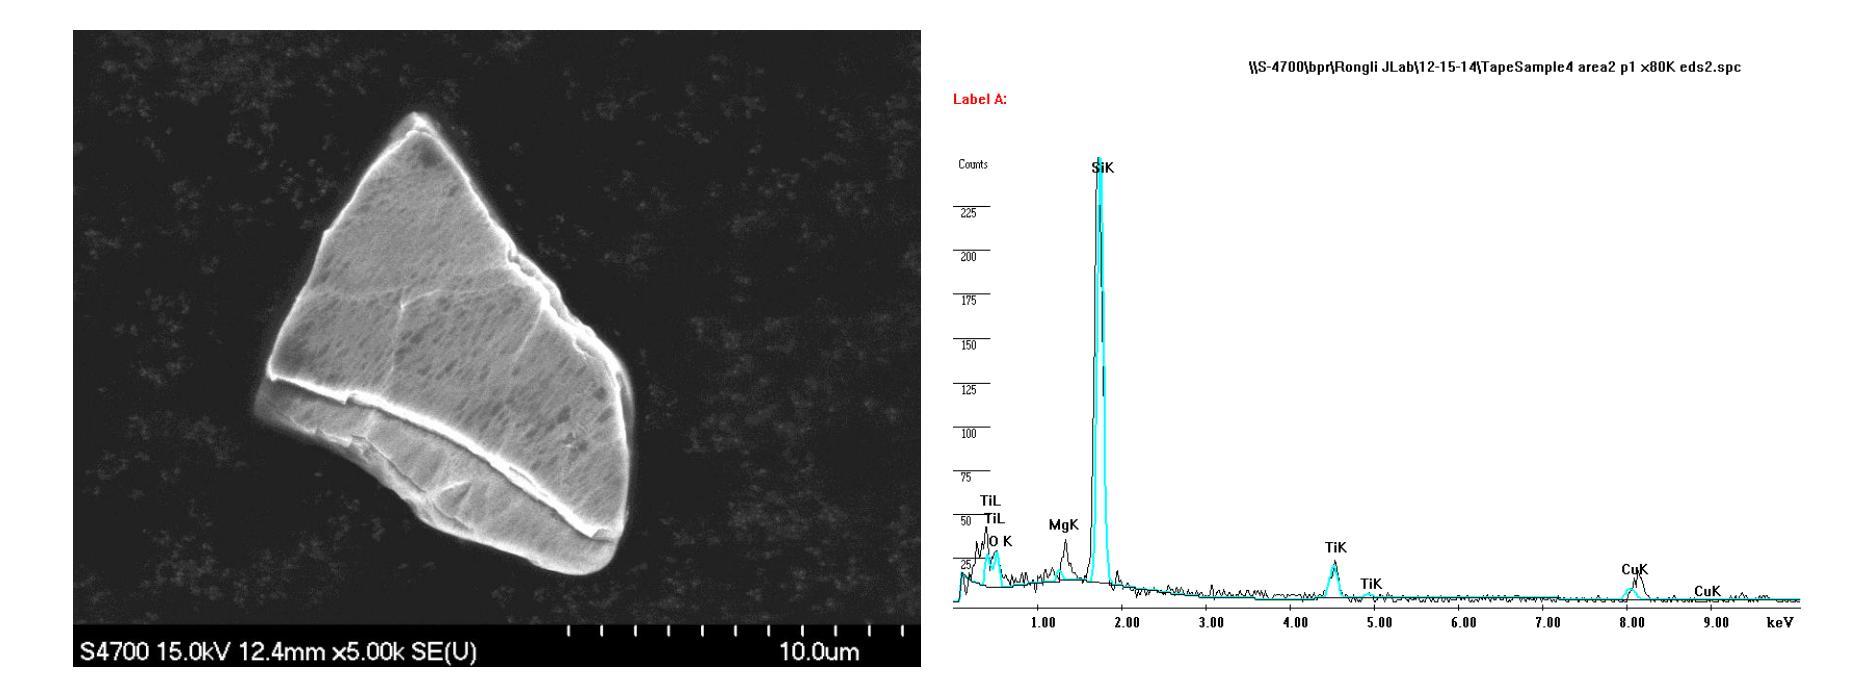
IA080 2nd Iris from Gate Valve Si, Ti, Cu, Mg

Quantify composition 10feb15

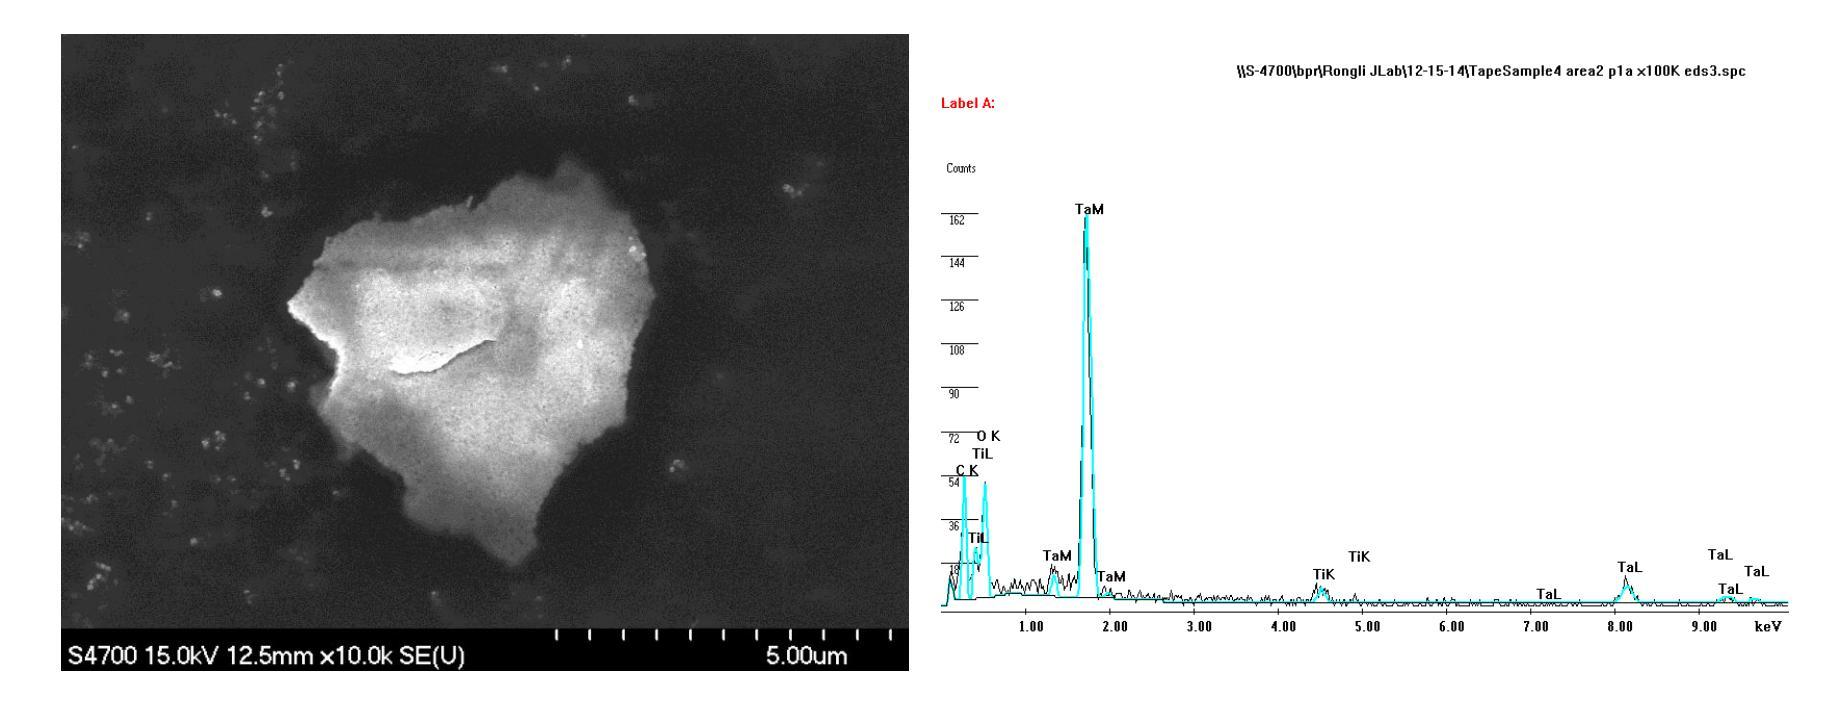
IA080 2nd Iris from Gate Valve Ta, Ti

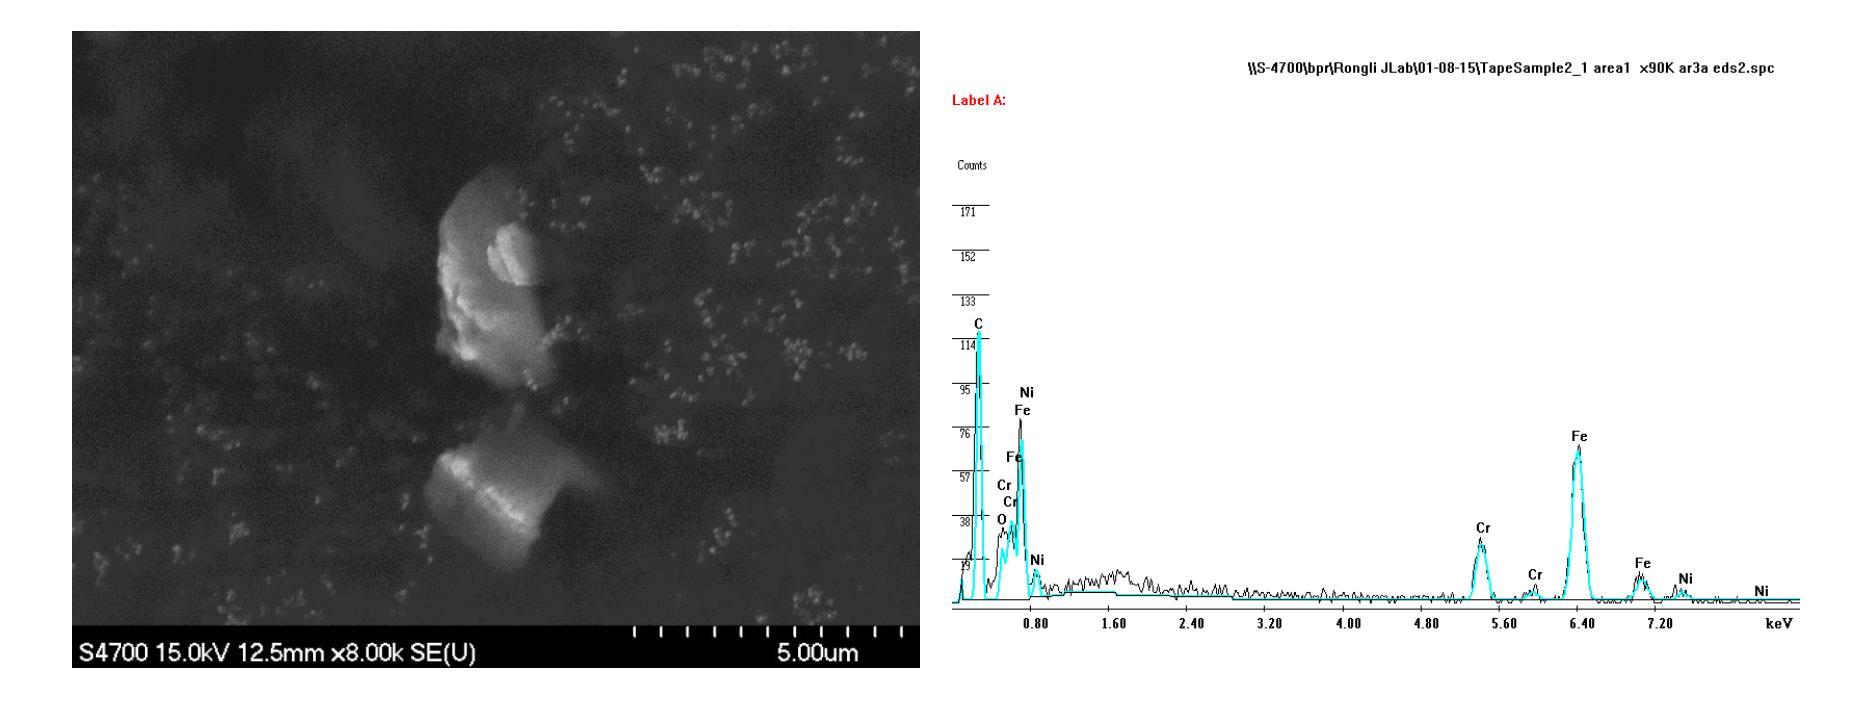
IA355 SS beam pipe 6 o'clock, 2 Fe, Ni, Cr

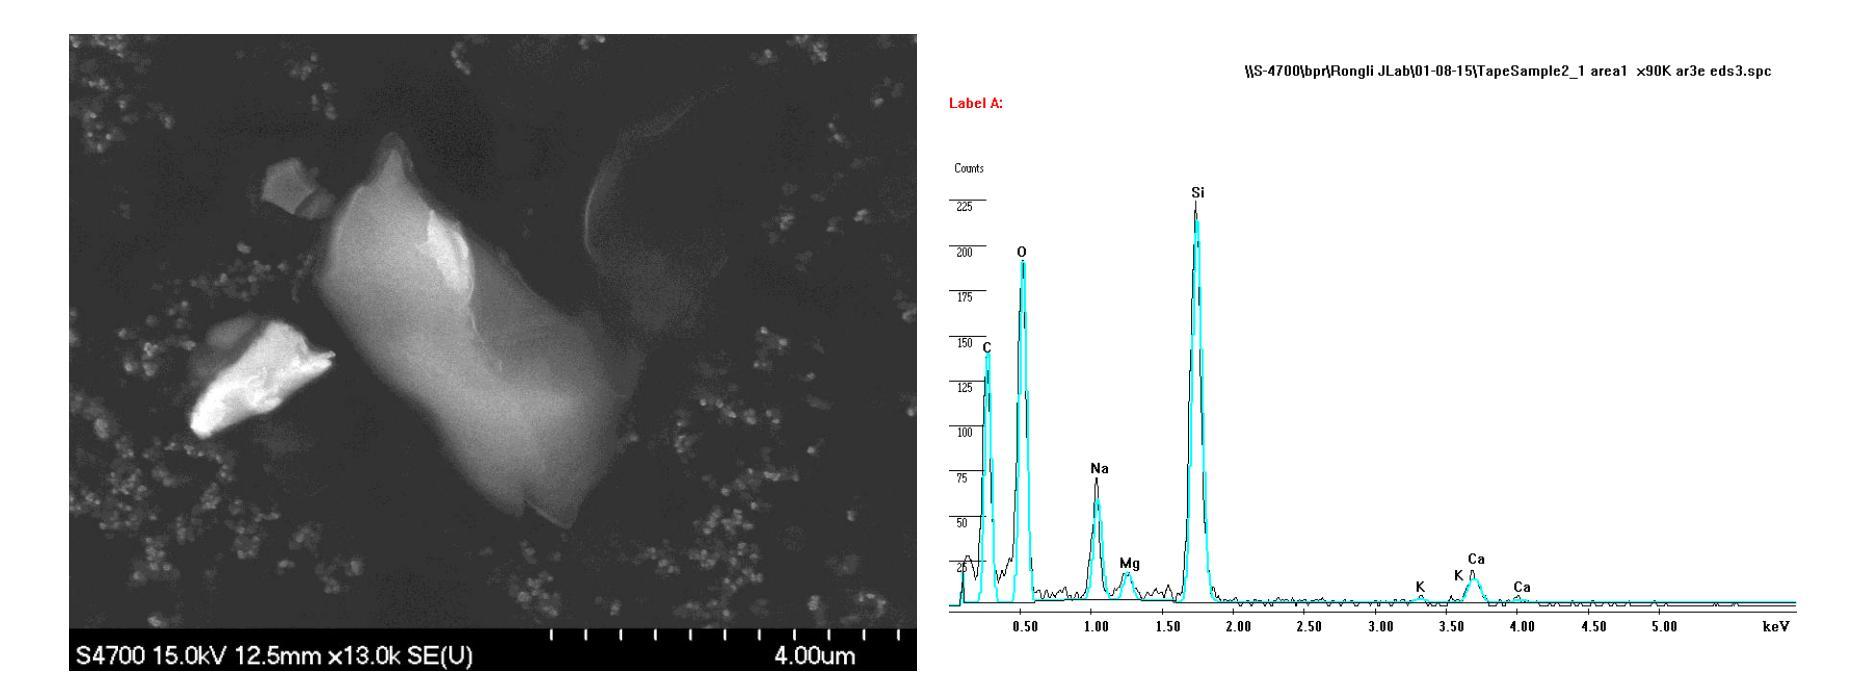
IA355 SS beam pipe 6 o'clock, 3 Si, Ca, Na, Mg, K

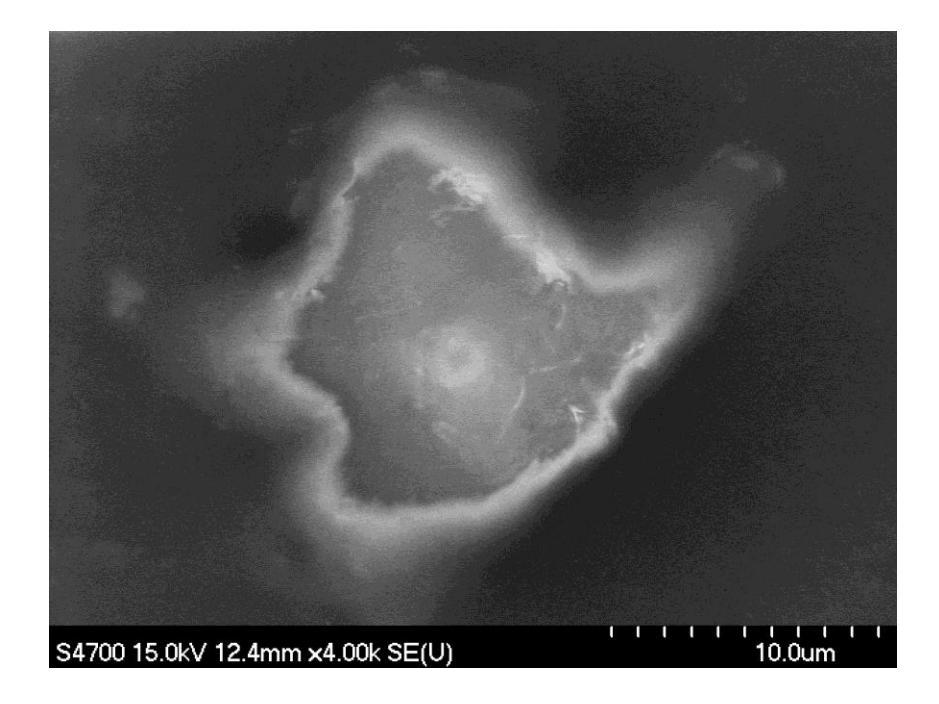
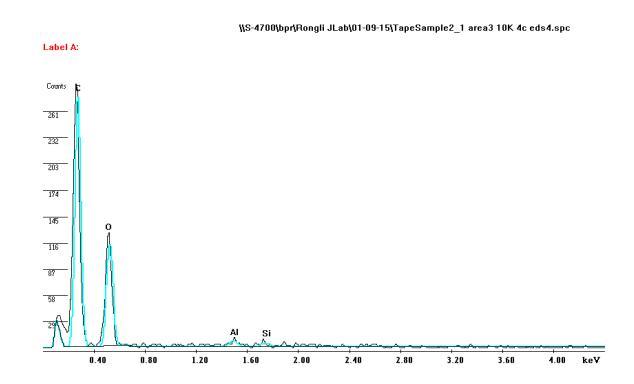
IA355 SS beam pipe 6 o'clock

C, O peaks (high level of O), traces of Al and Si. Sample charges heavily.

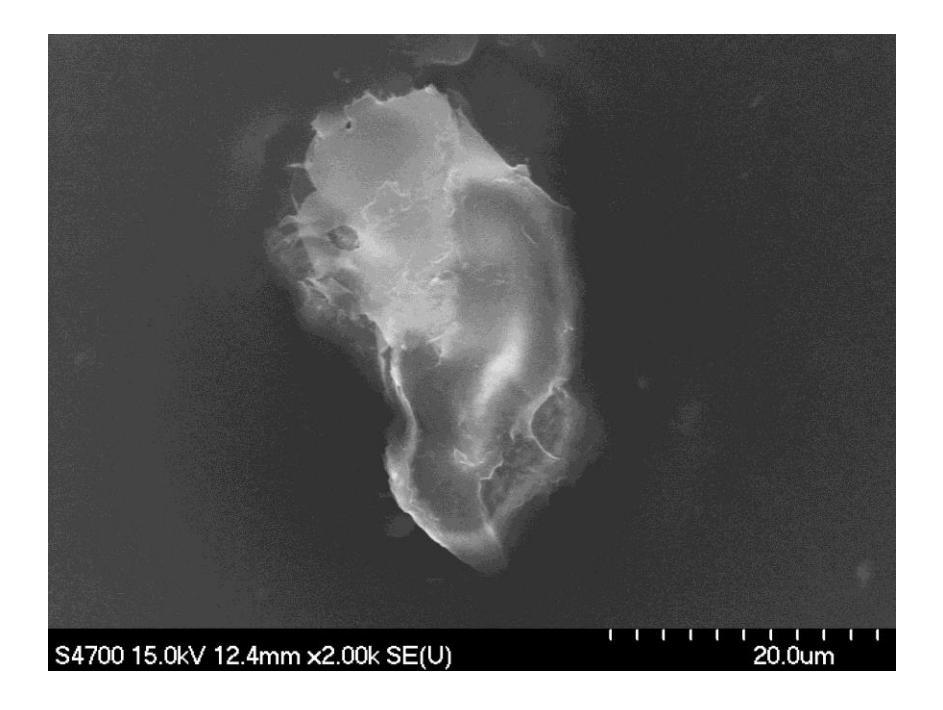
TapeSample2_1 area3 x2K 5_q00

C, O peaks. Sample charges heavily. EDS results are similar to the previous particle.

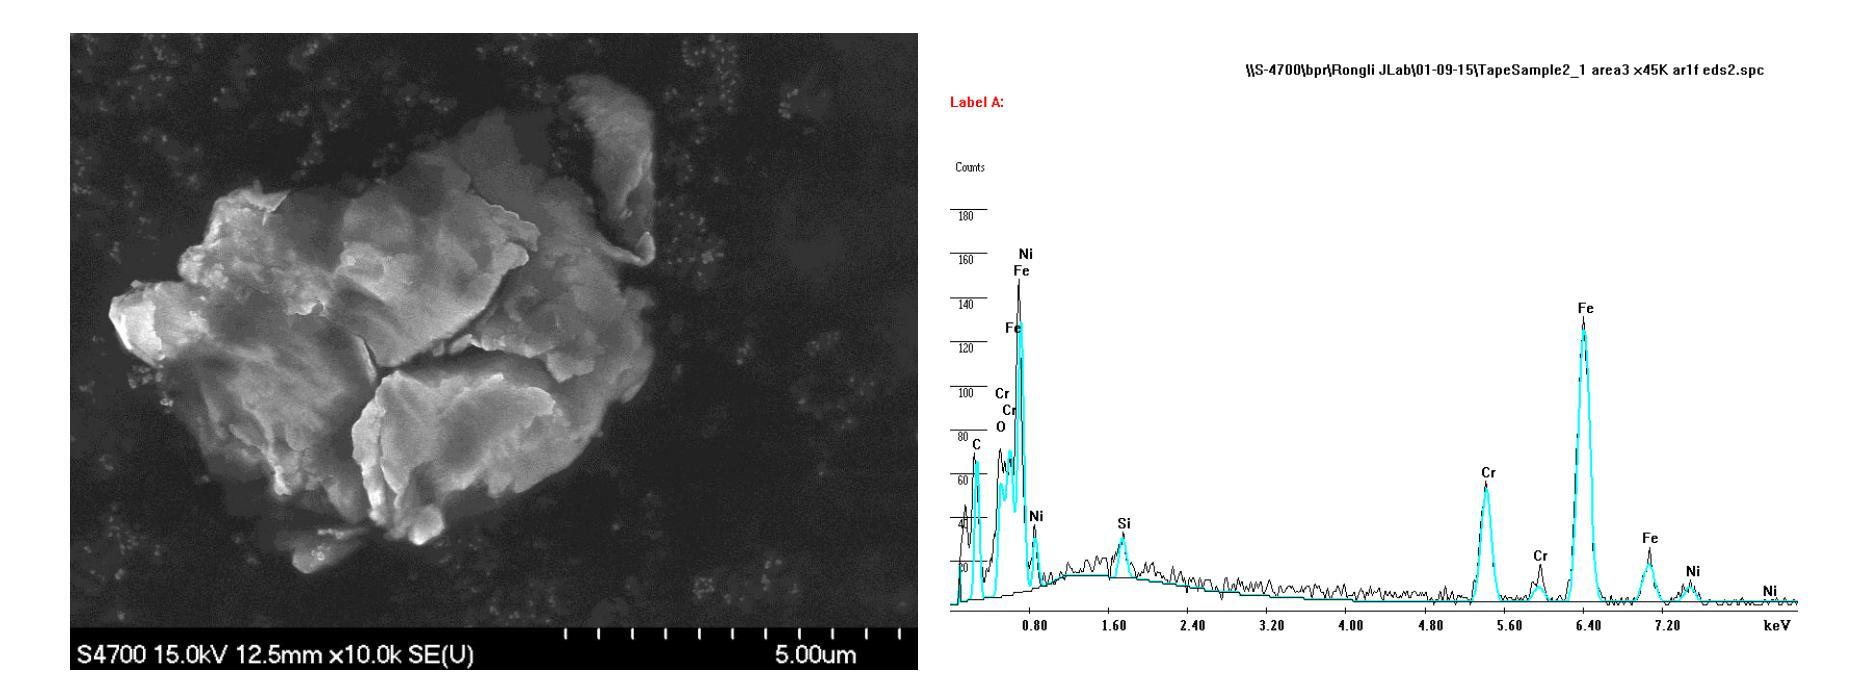
TapeSample2_1 area3 x10K ar1f_q00

IA355 SS beam pipe 6 o'clock Fe, Ni, Cr, Si

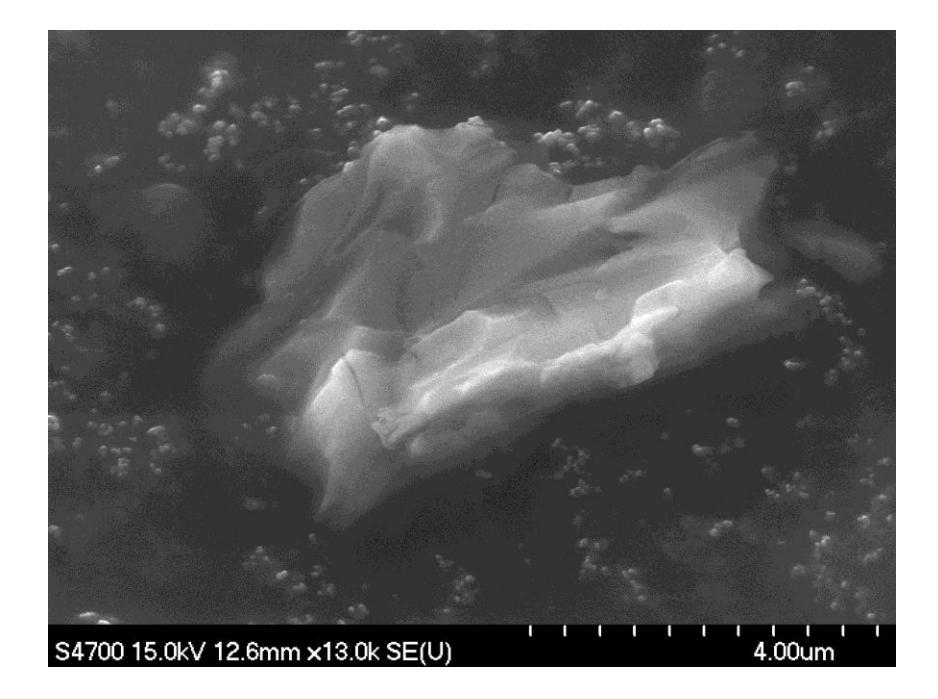
TapeSample2_2 area1 x13K 4_q00

EDS results are similar to the previous sample: Si, Ca, Na, Mg peaks.

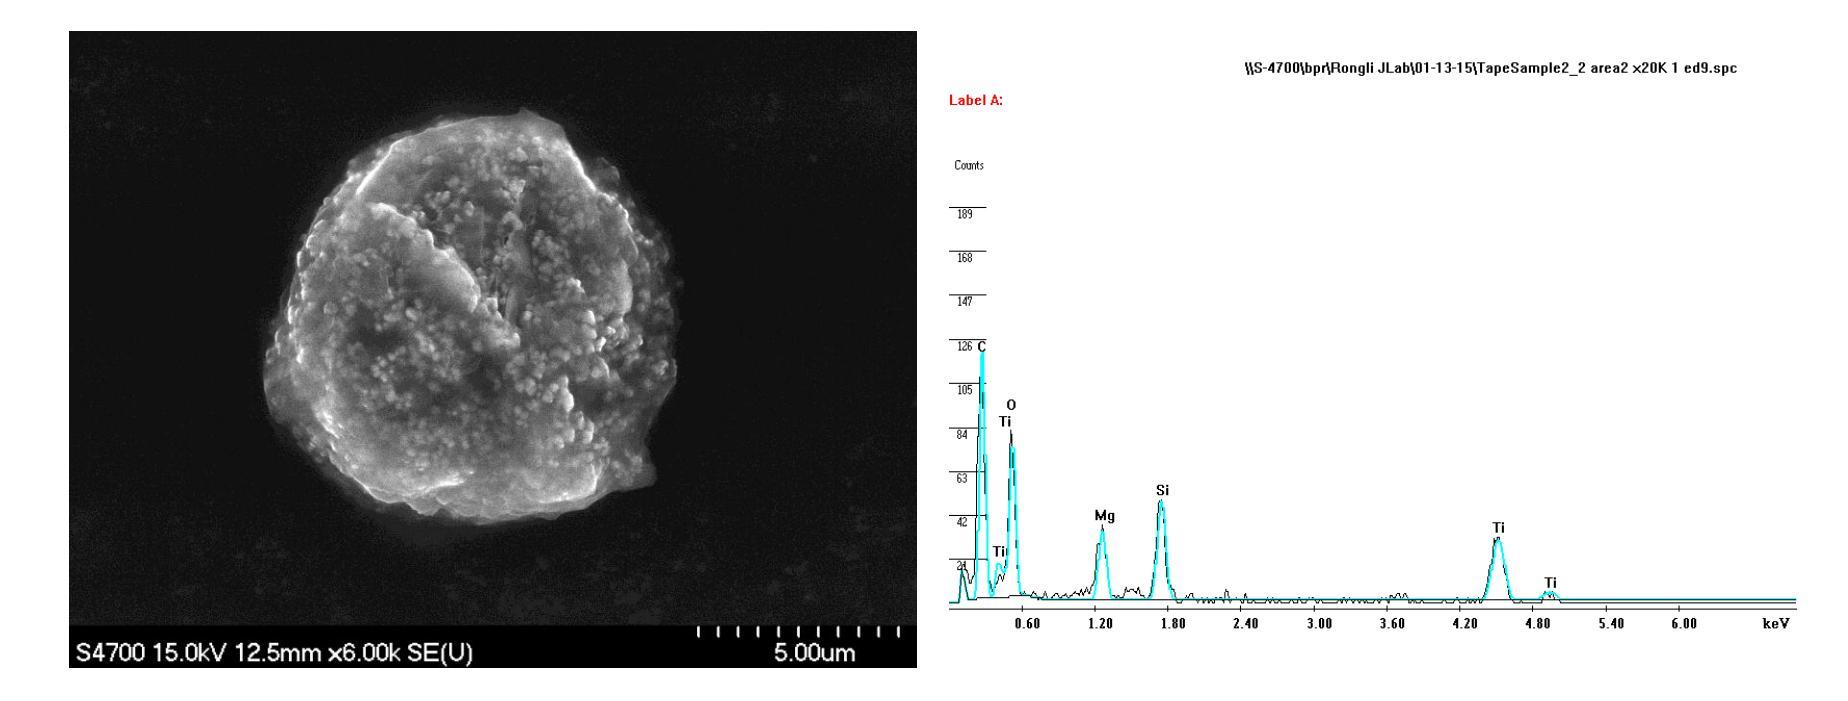
IA355 SS beam pipe 3 o'clock Ti, Si, Mg

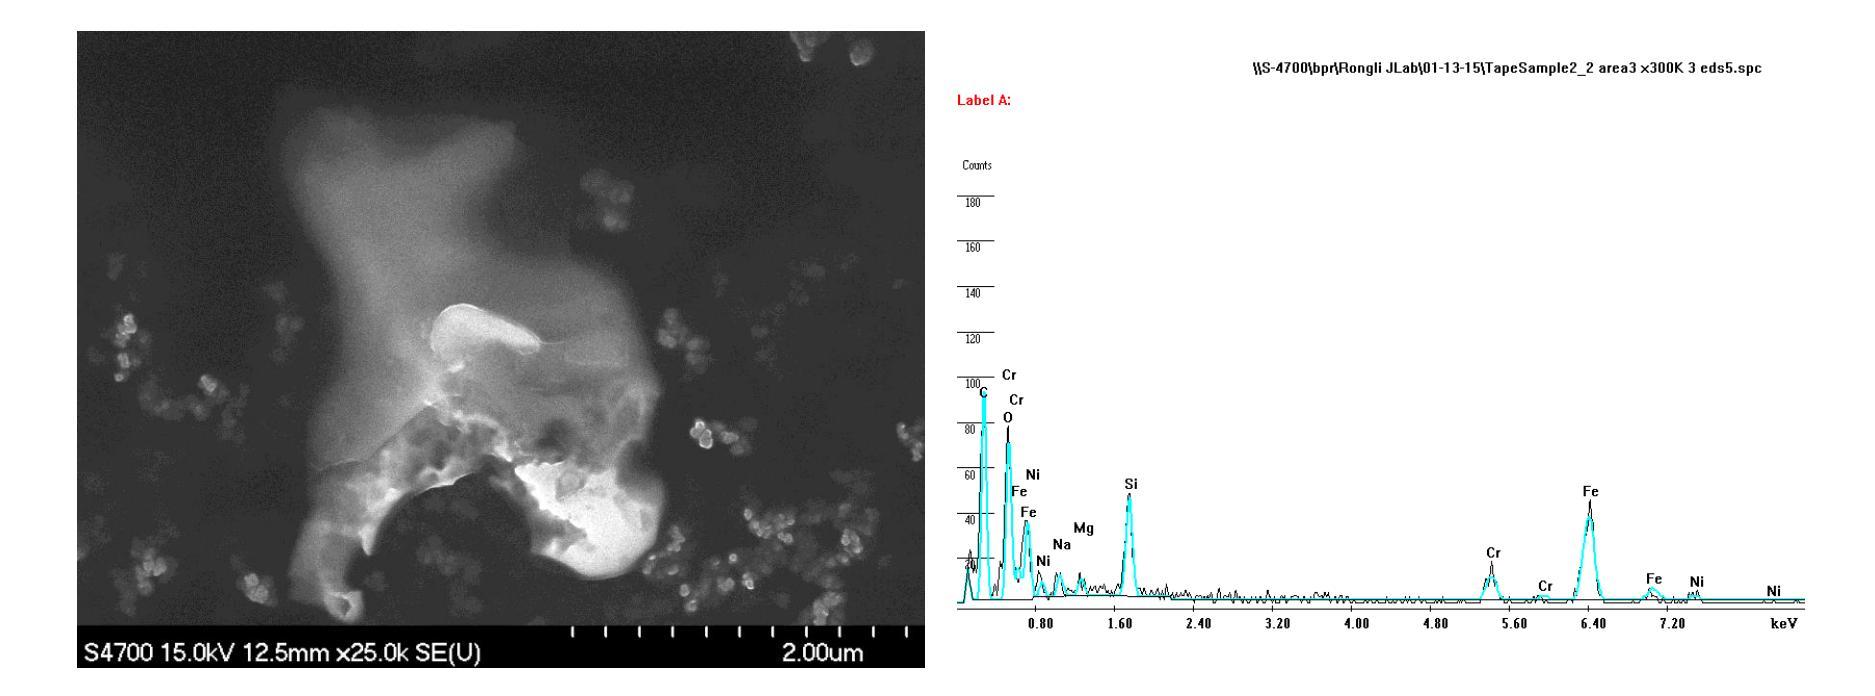
IA355 SS beam pipe 3 o'clock Fe, Ni, Cr, Si, Mg, Na

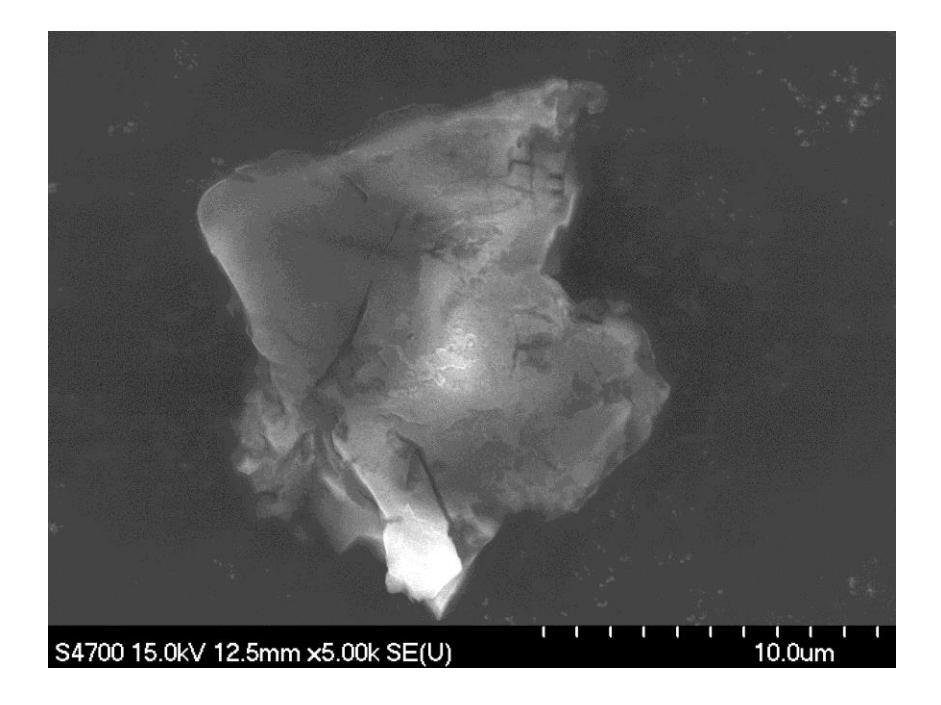
TapeSample2_2 area4 x5K 3_q00

Quick EDS analysis showed Si and O peaks (C peak is always present due to the carbon tape substrate).
 Silicon oxide particle.

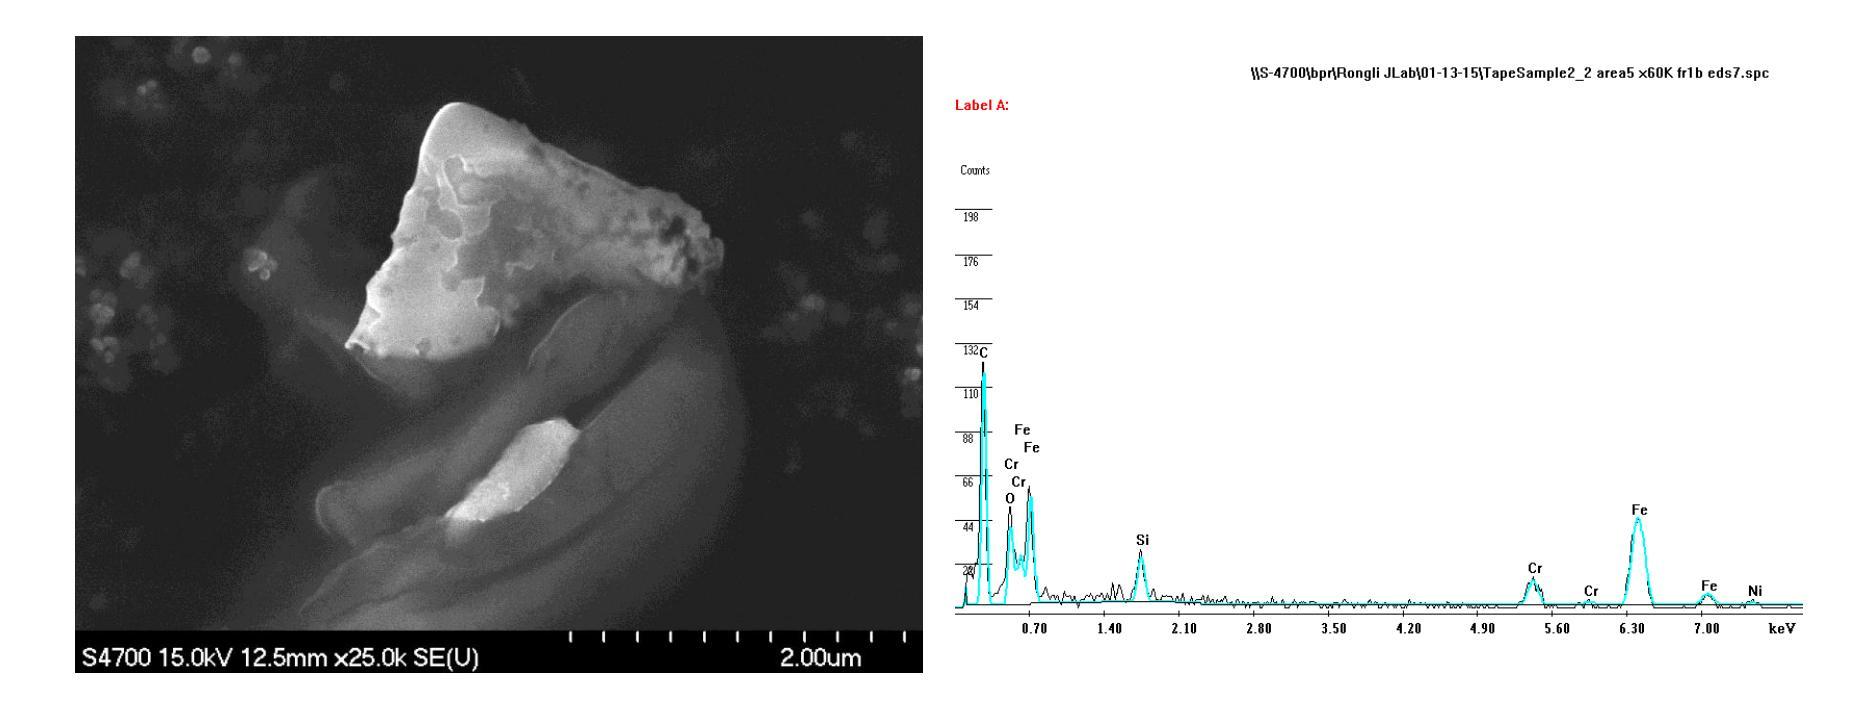
IA355 SS beam pipe 3 o'clock Fe, Ni, Cr, Si

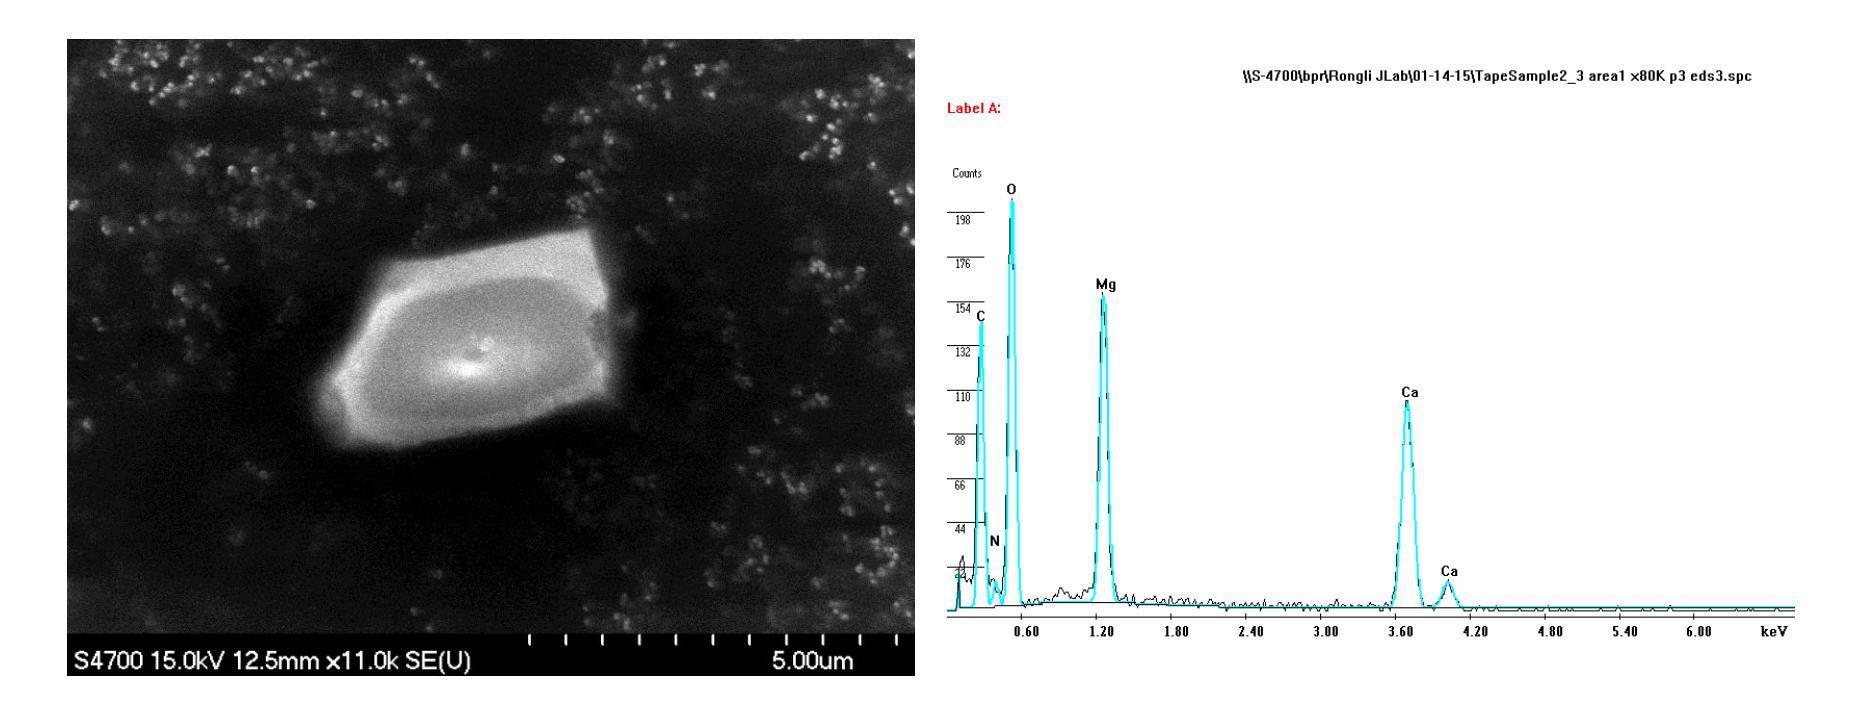
Ca, Mg

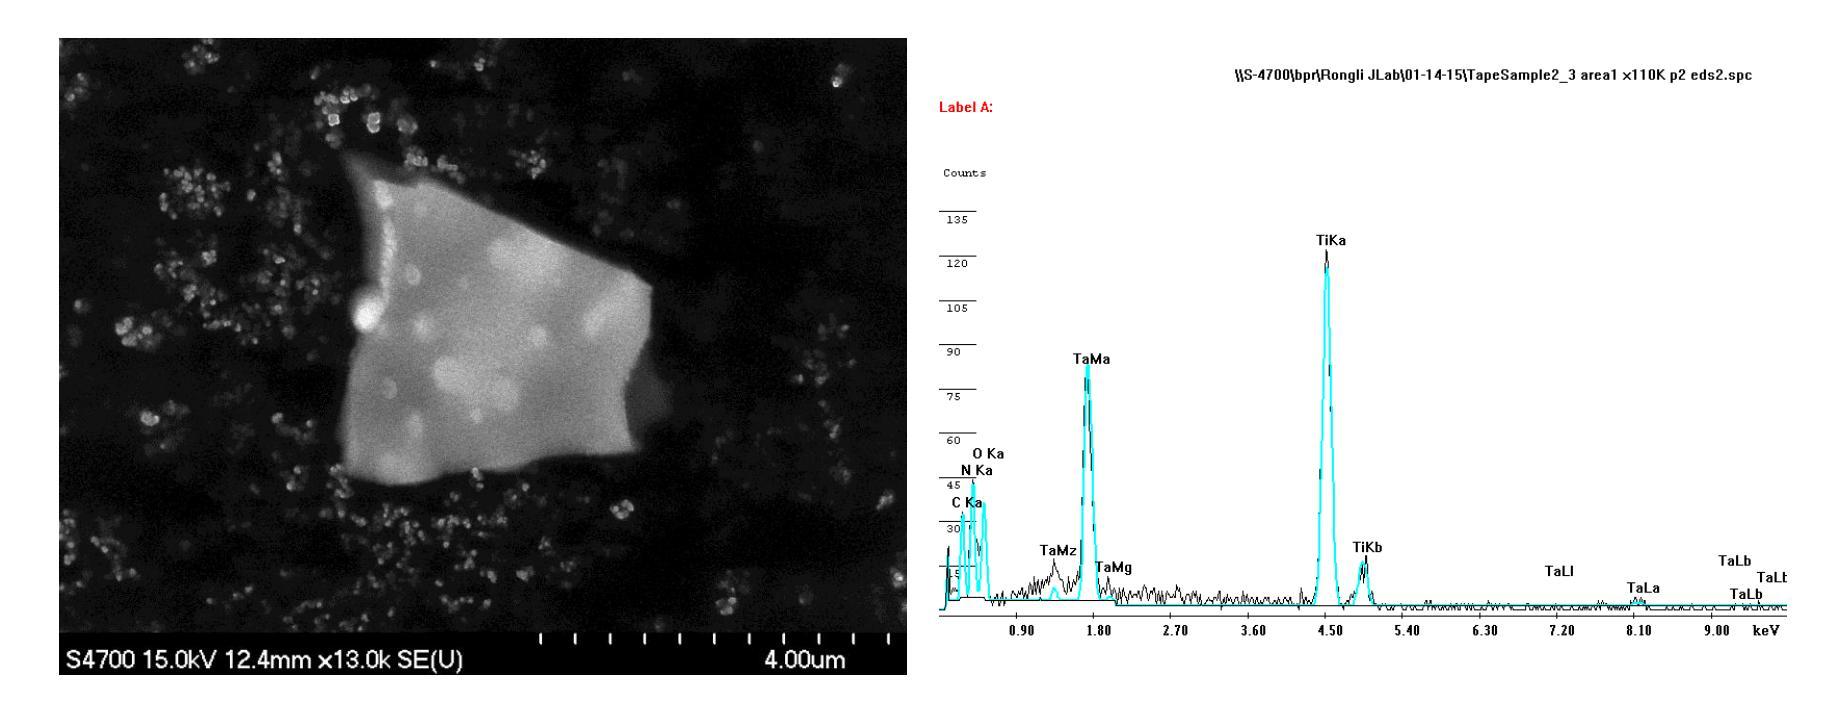
Ti, Ta, (Si?)

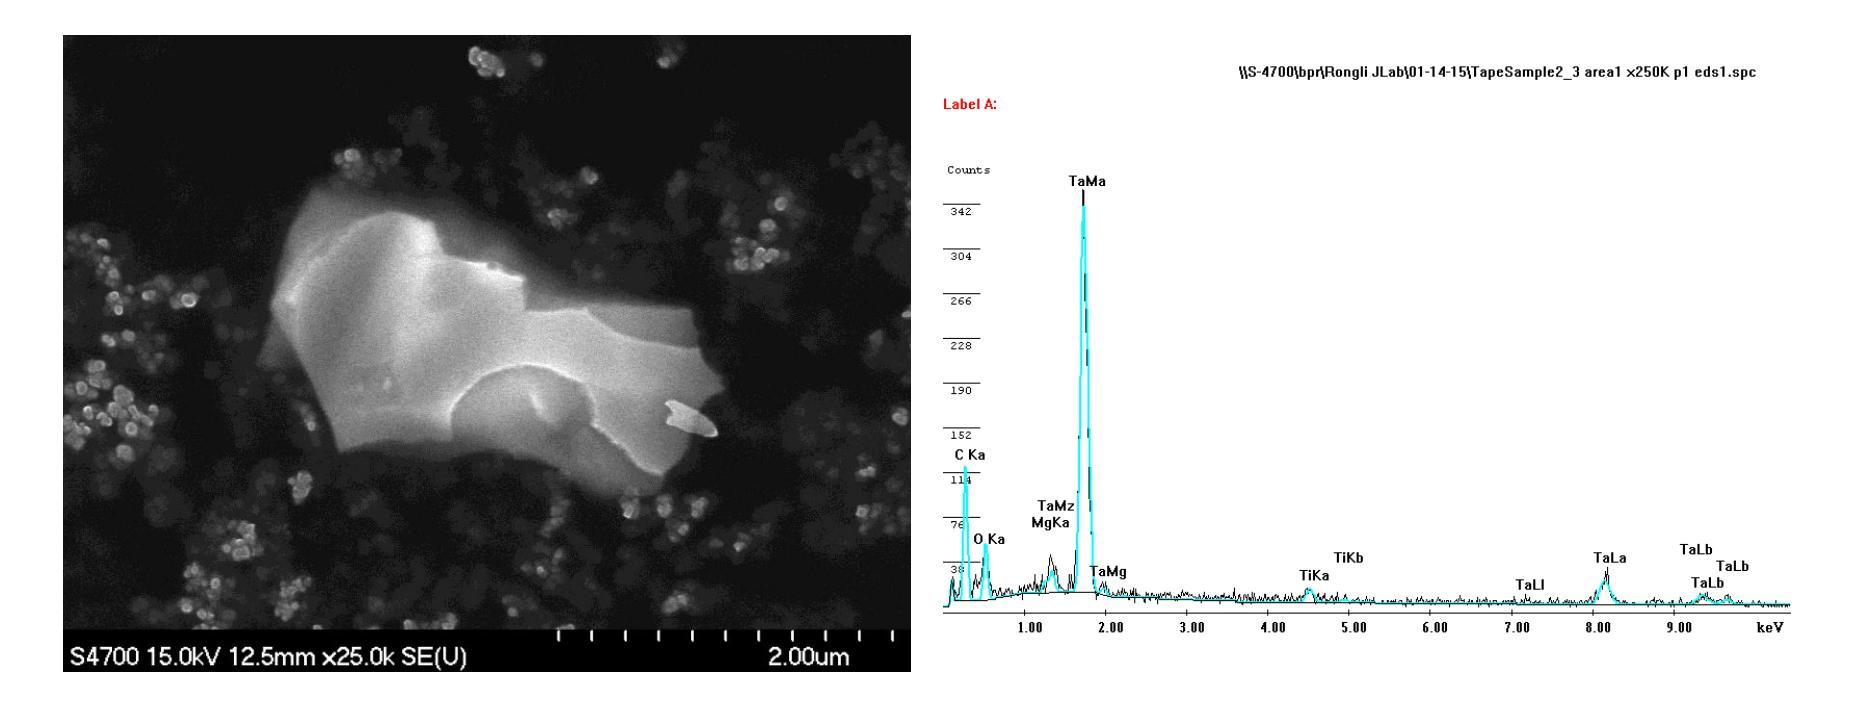
Ta, Ti, (Si?)

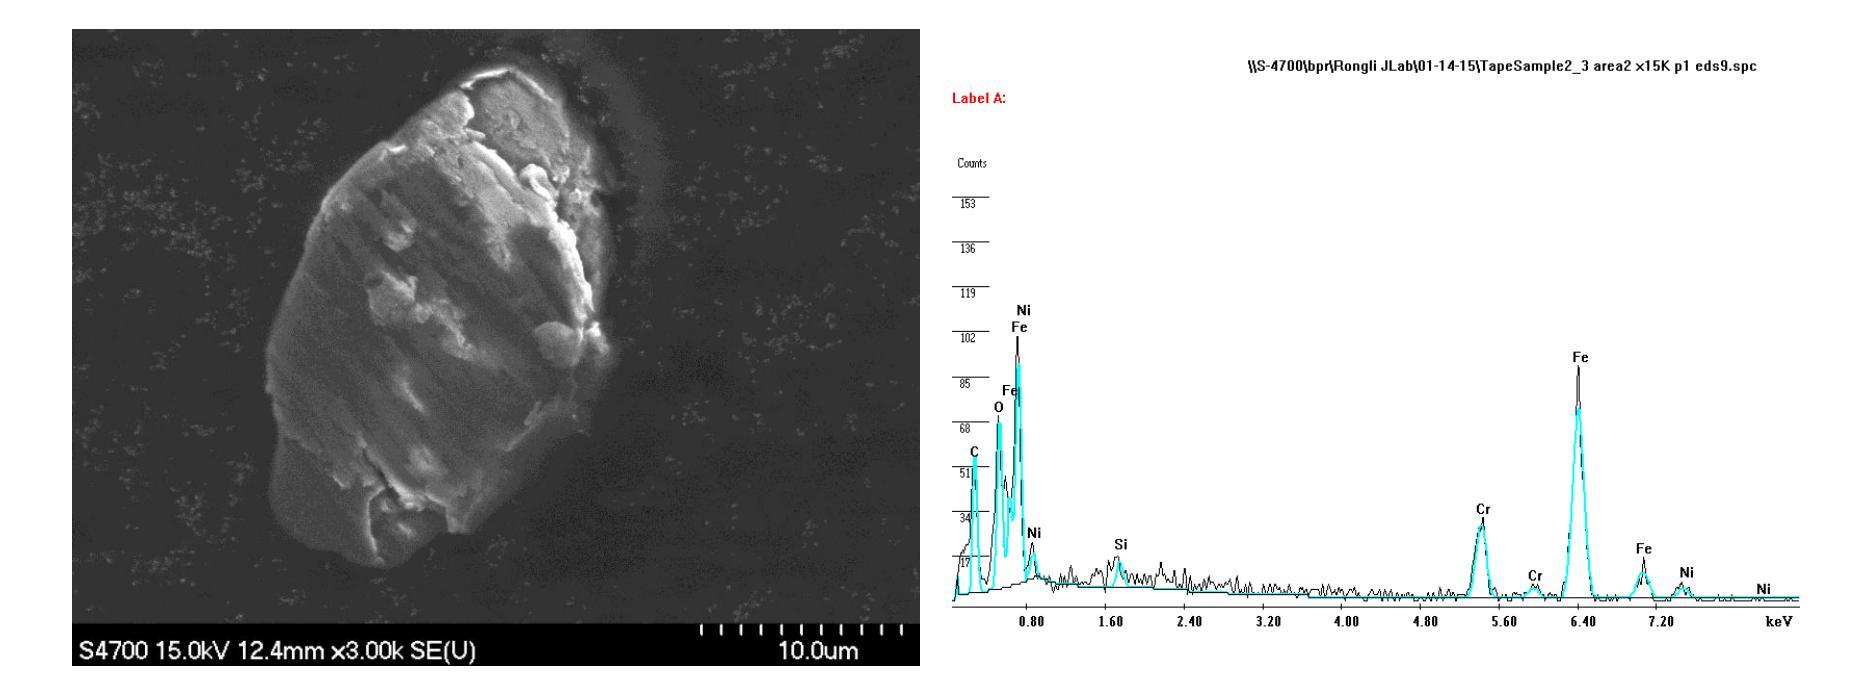
Fe, Ni, Cr, Si
