CEBAF Particulate Field-Emitter Control

Rongli Geng July 15, 2015

C50-12 Rework Cryomodule Cavities

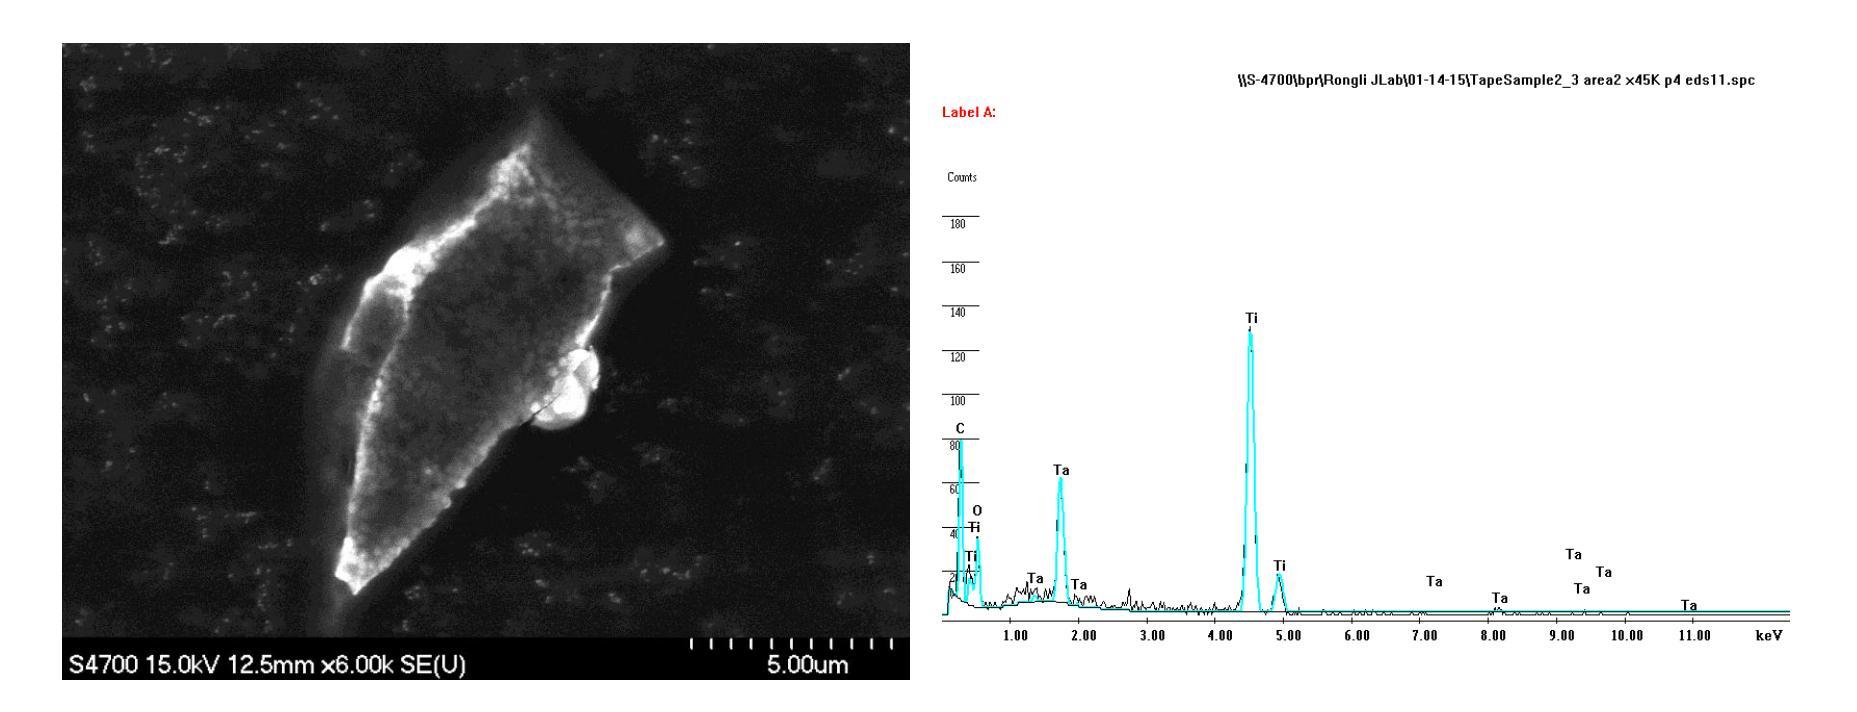
Ti, Ta

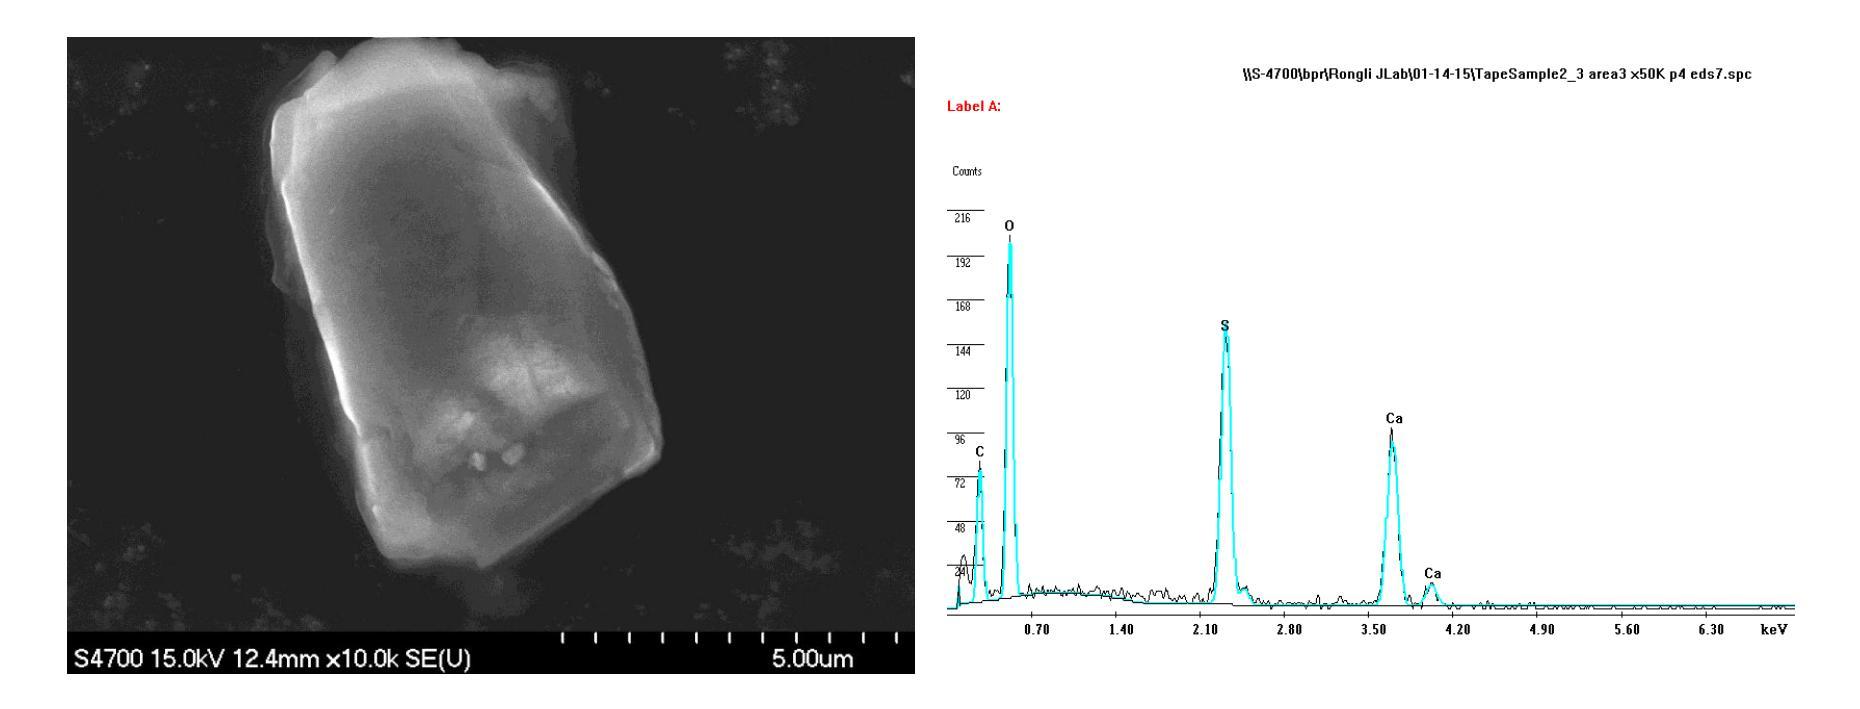
S, Ca

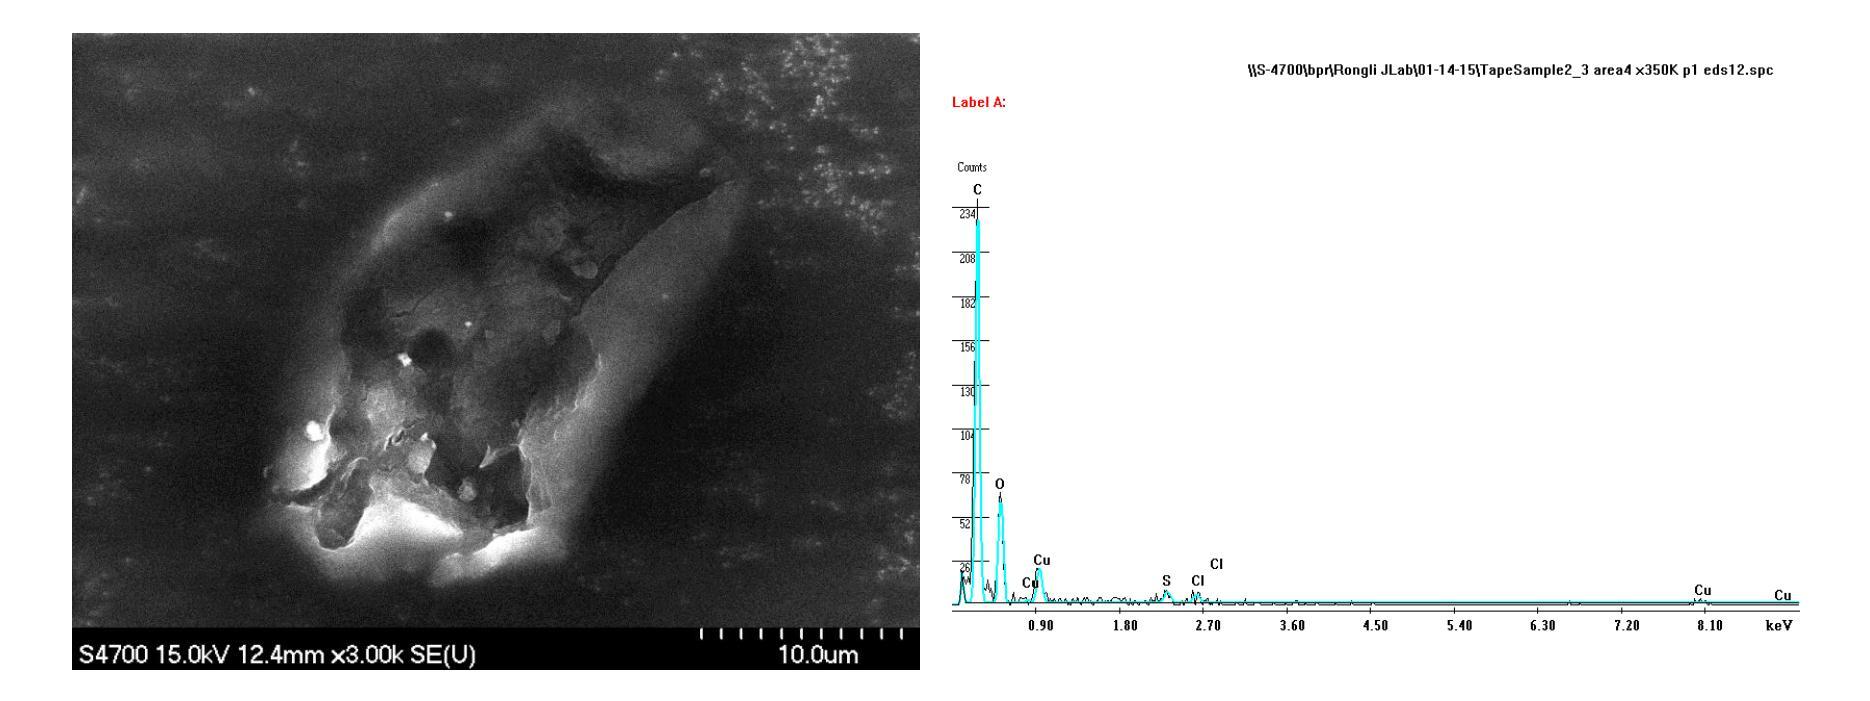
IA355 Nb beam pipe

Cu, Cl, S

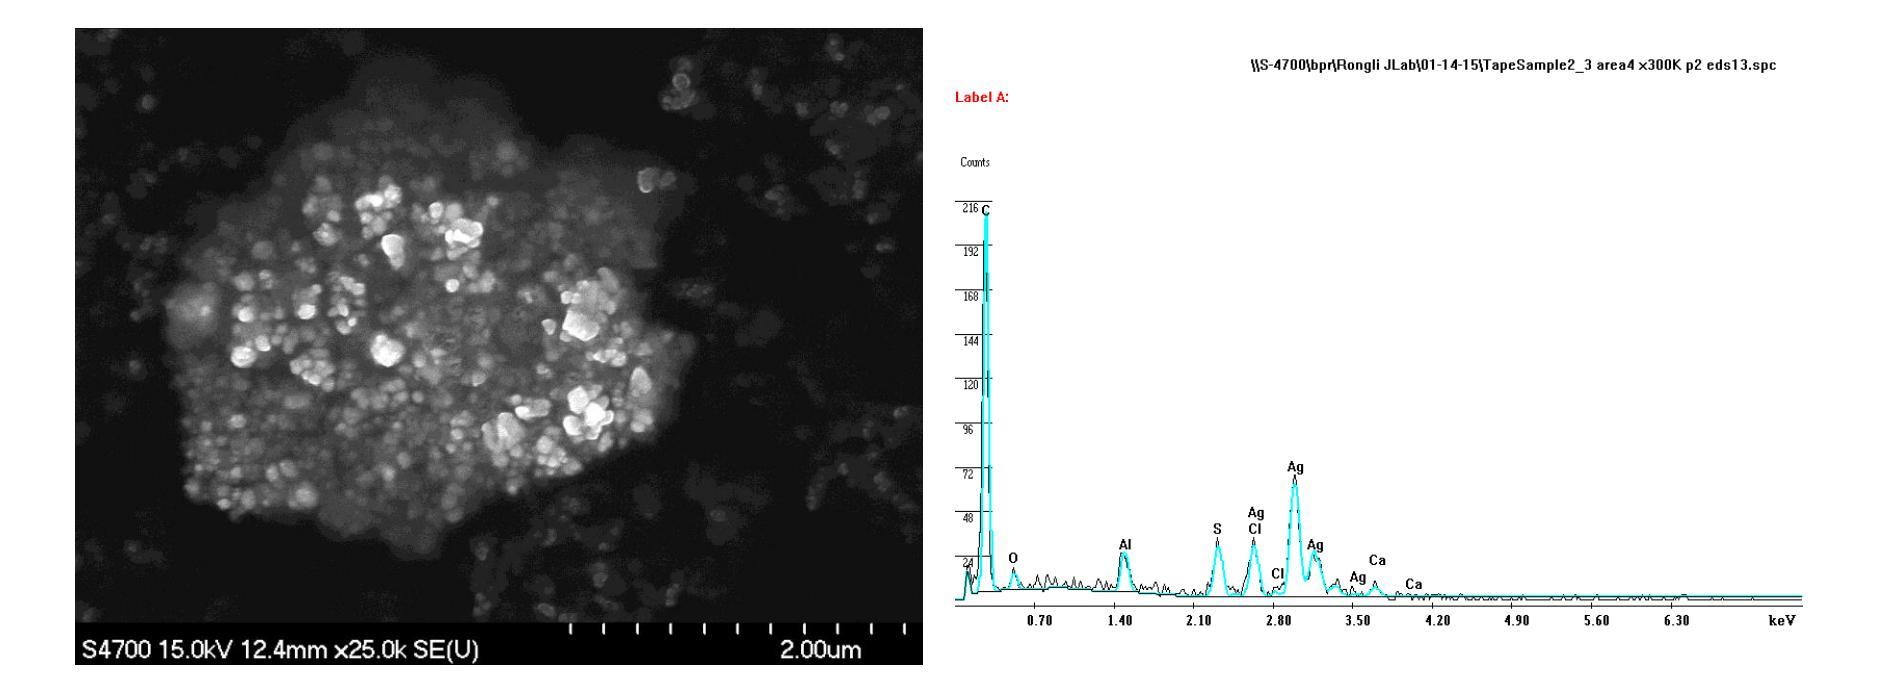
IA355 Nb beam pipe

Ag, Al, Ca, S, Cl

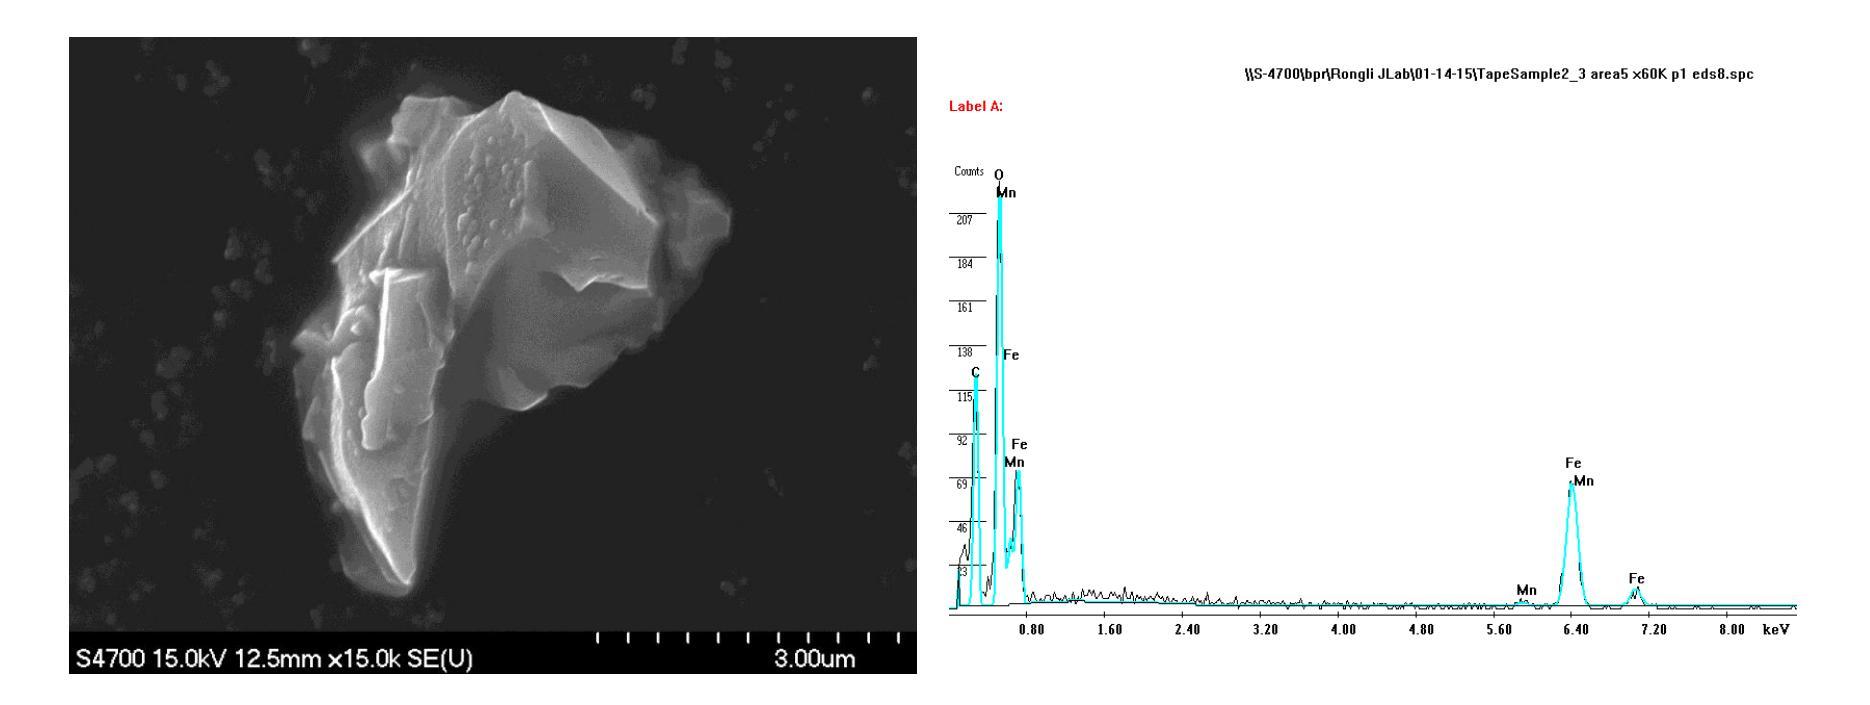
IA355 Nb beam pipe

Mn, Fe

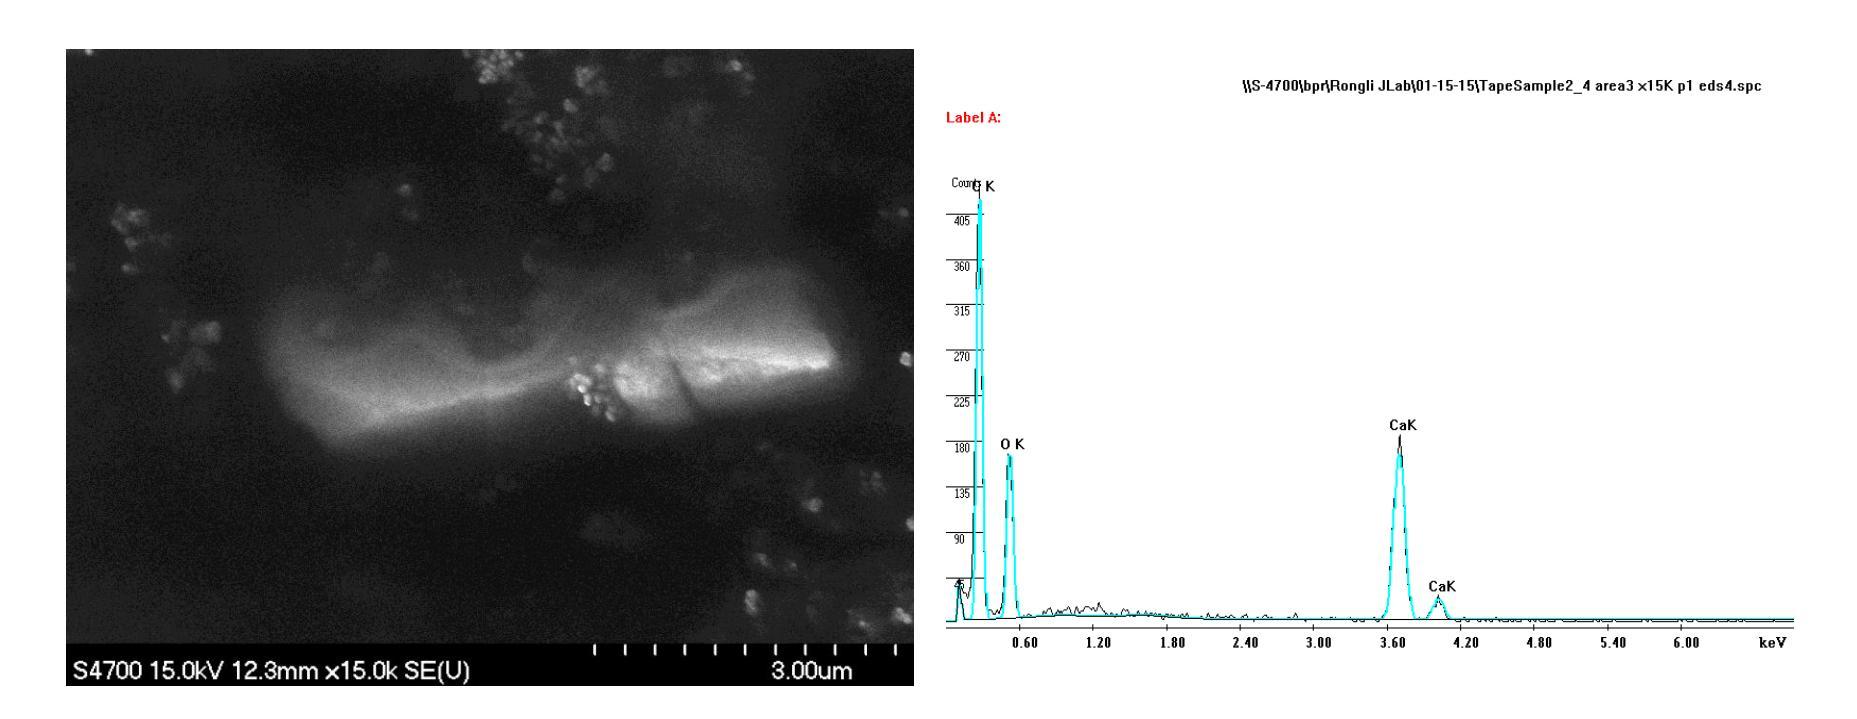
Ca

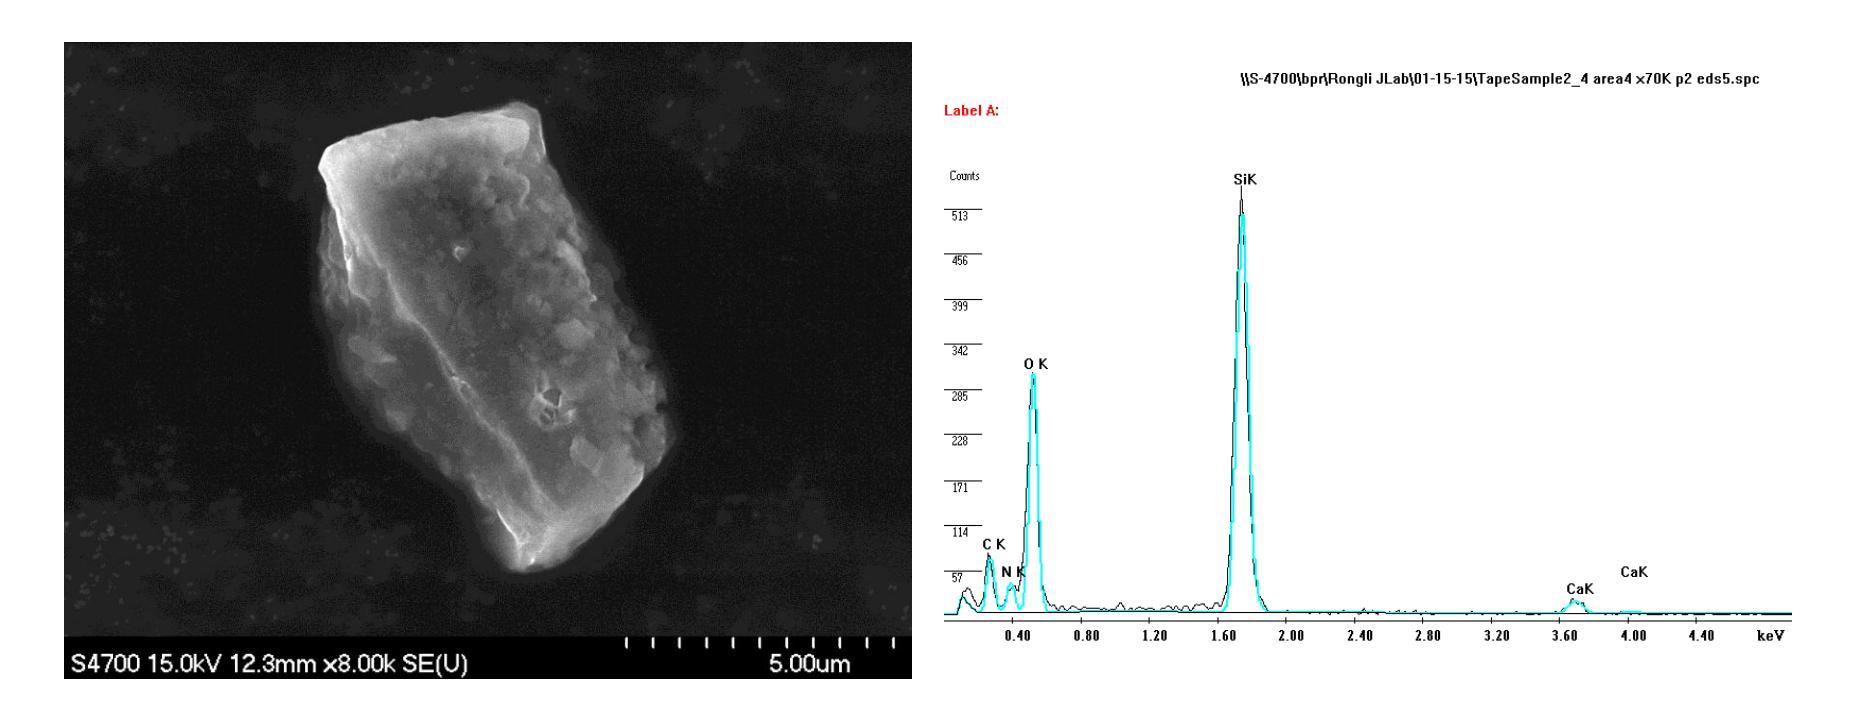
Si, Ca

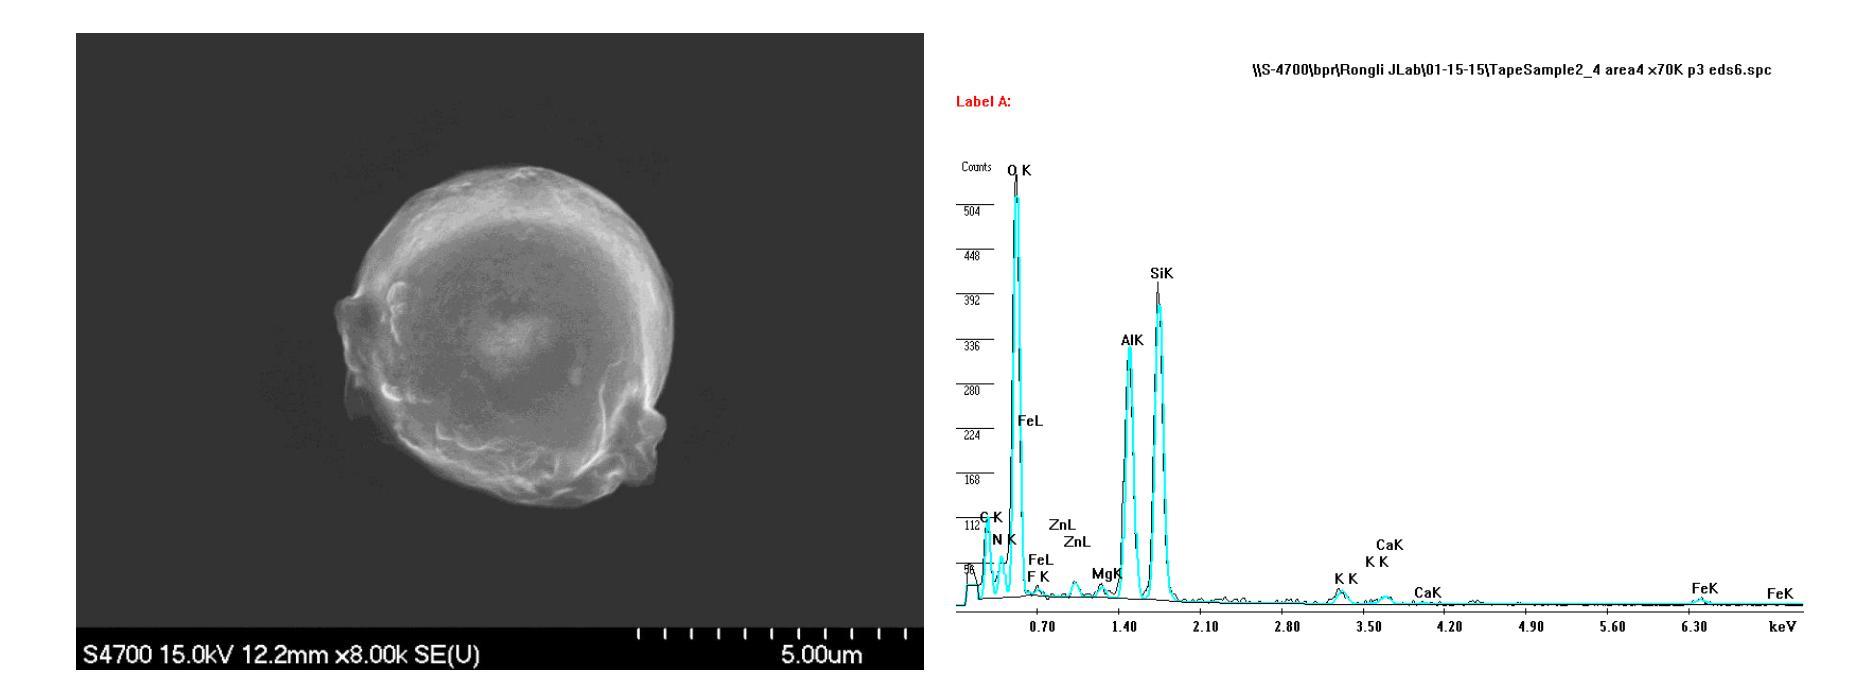
Al, Fe, Zn, Mg, K, Ca, Si,

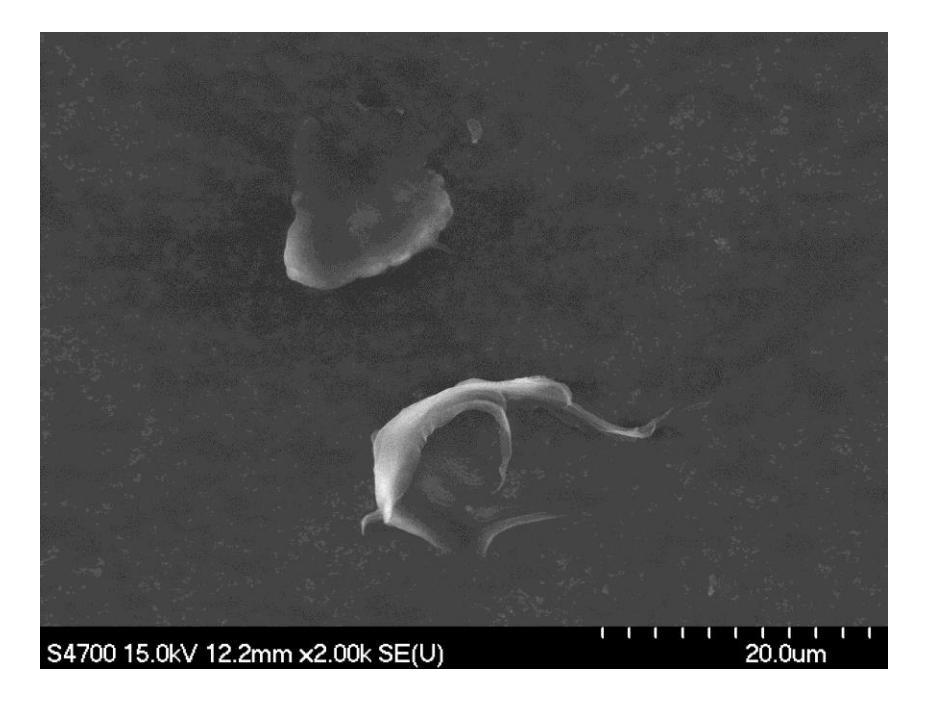
Post-emission "melted" alloy ball?

- Quick EDS analysis showed:
- top particle produced C, O, Al, Si peaks;
- bottom particle produced C & O peaks in ratio similar to that of a carbon tape substrate, hence it's probably a tape artifact.

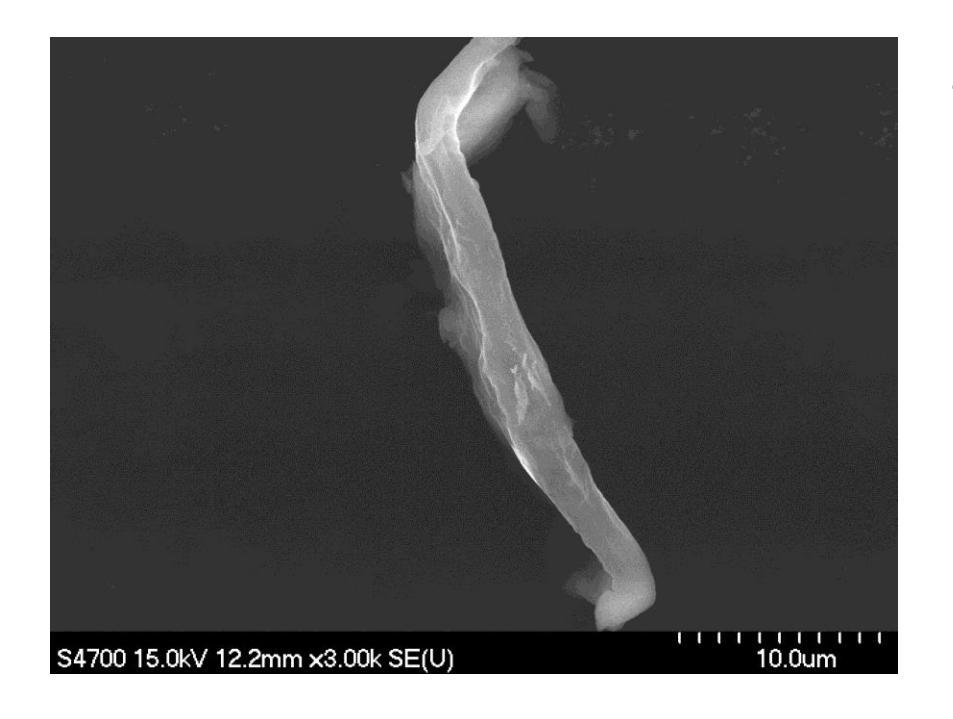
TapeSample2_4 area4 x2K p9ab_q00

Quick EDS analysis showed C and O peaks. O peak is higher than that of a substrate. Particle is charging significantly.

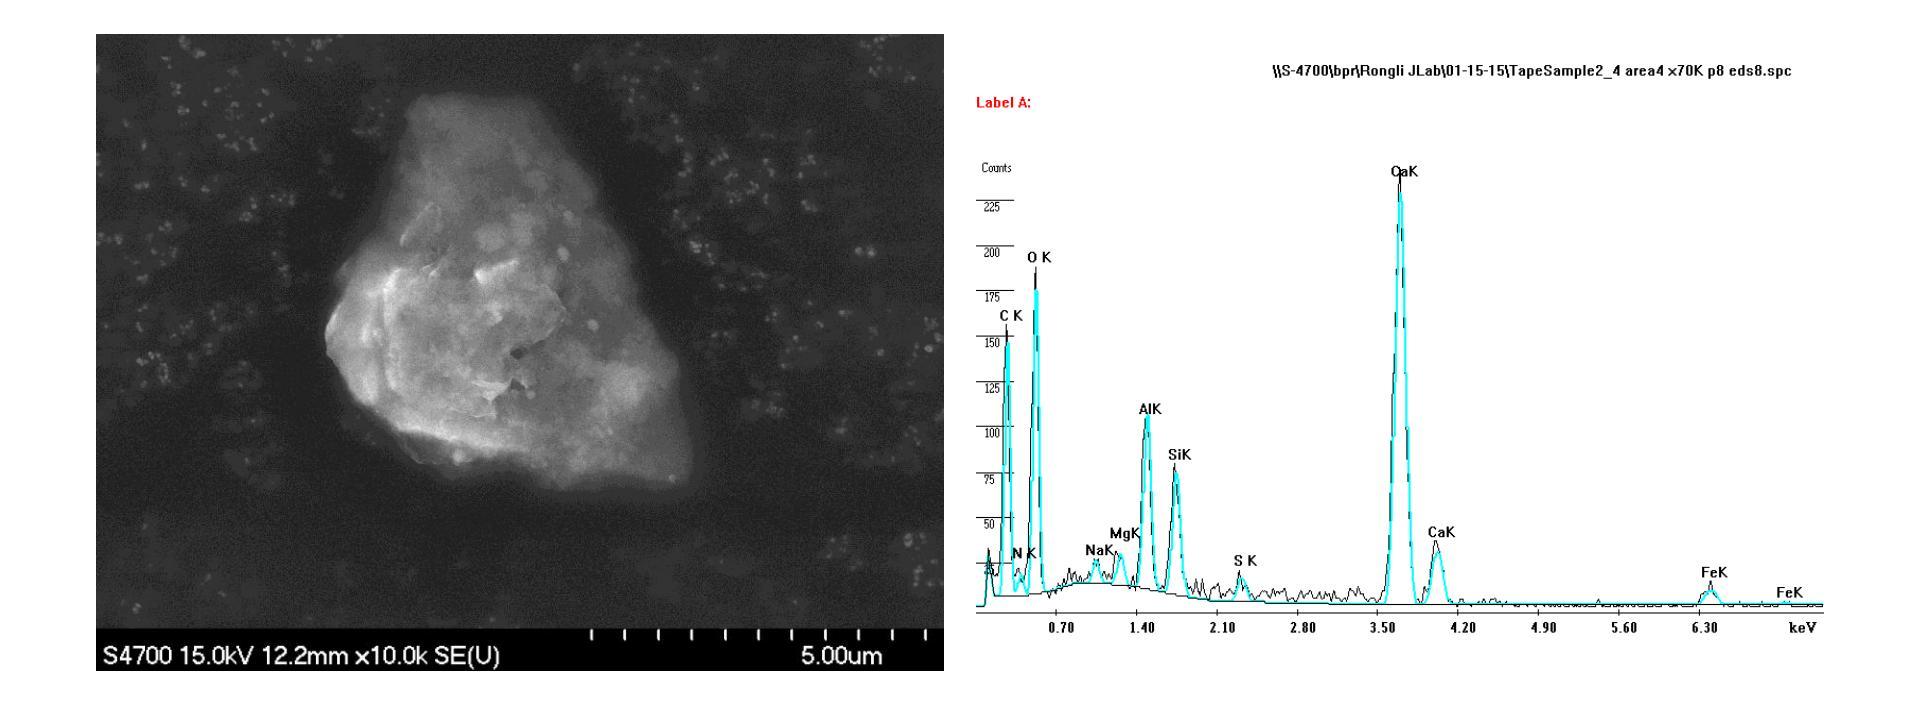
IA355 1st iris Ca, Al, Mg, Na, Fe, Si, S

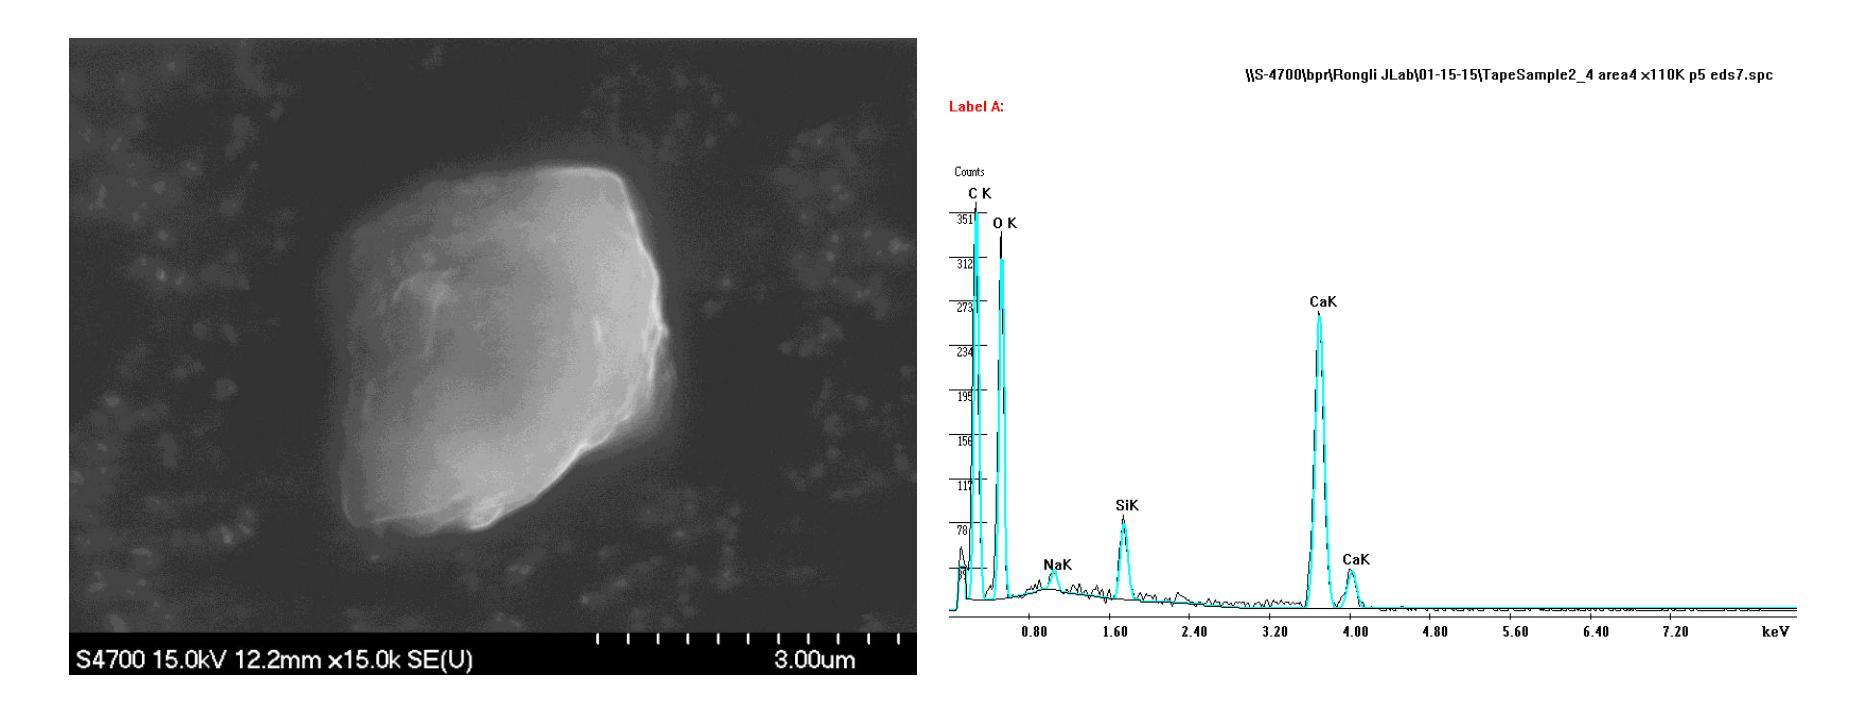
Ca, Na, Si

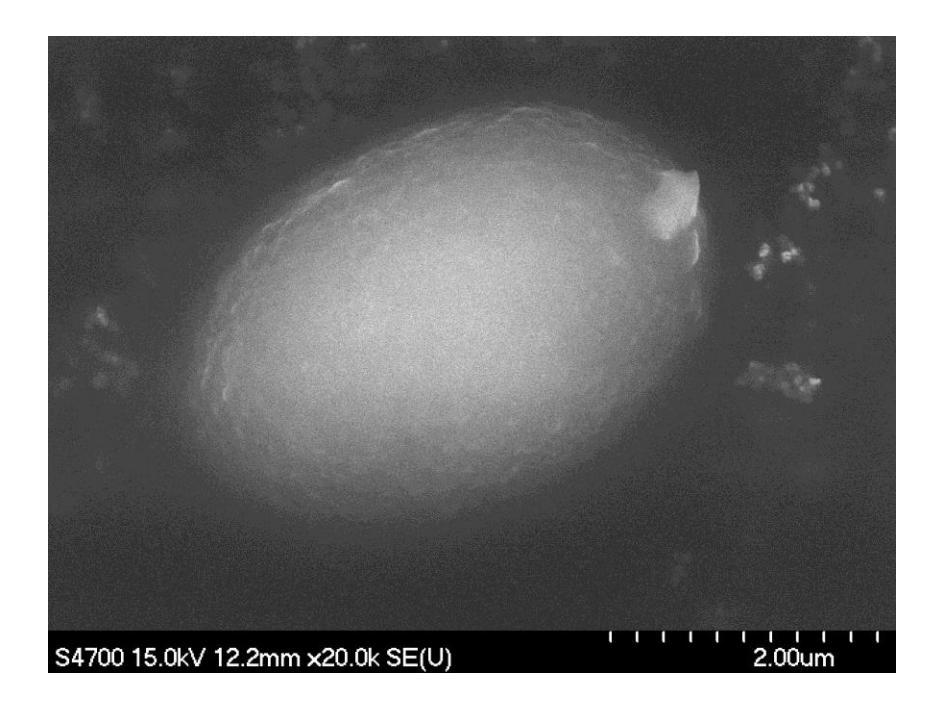
C and O

Quick EDS analysis showed
C and O peaks in the ratio
close to that of a substrate.
No significant charging was
registered. This could be a
carbon tape artifact.

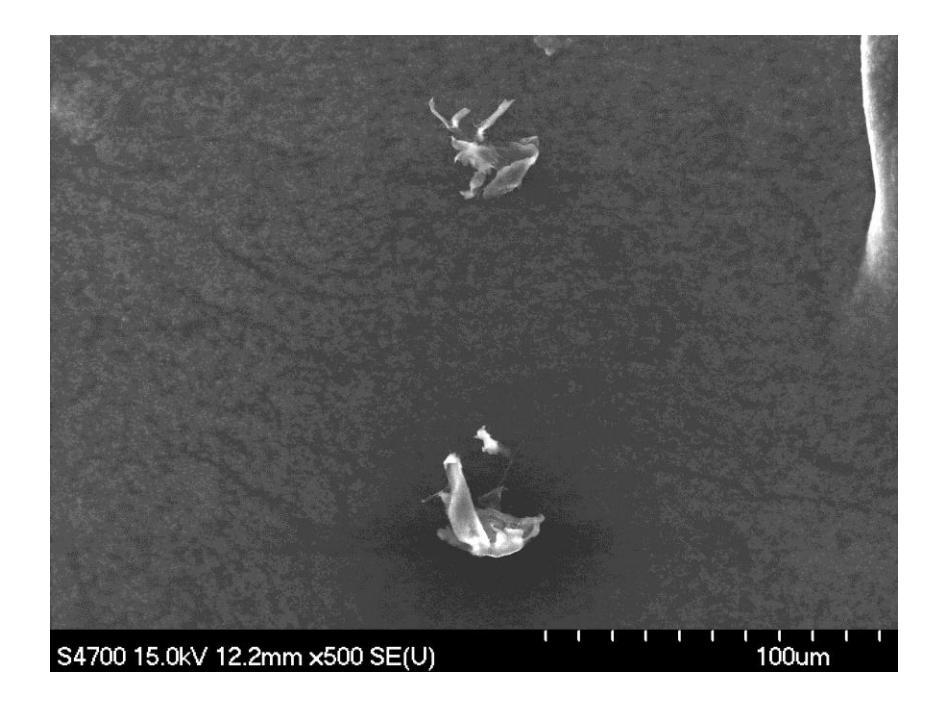
C and O

Quick EDS analysis showed
C and O peaks. O content
was much higher, than that
in the carbon tape
substrate. Both particles
showed significant charging.

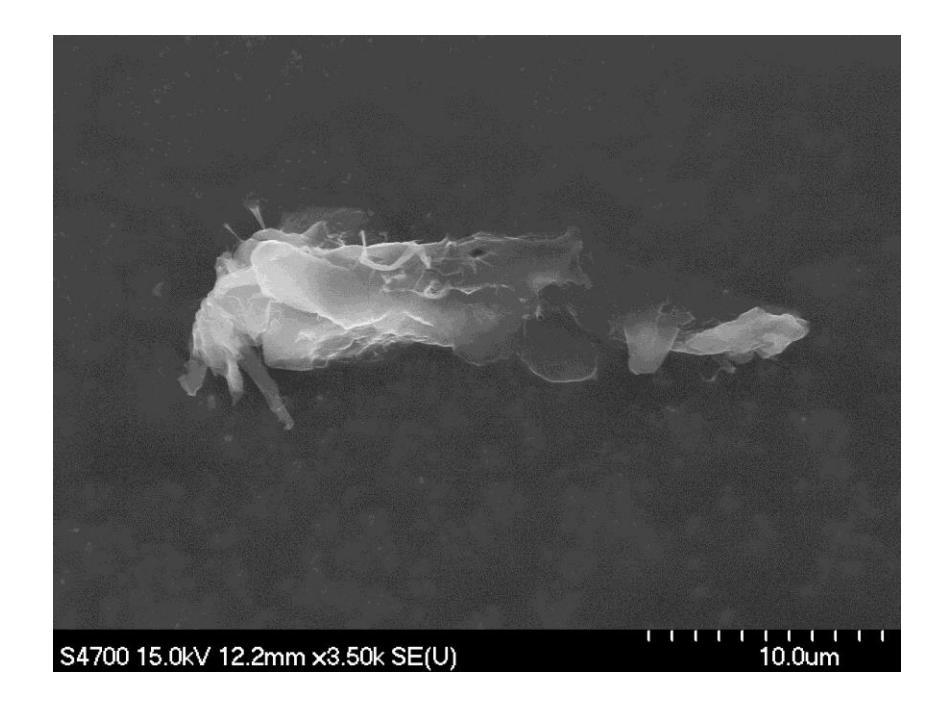
C and O

Quick EDS analysis showed
 C and O peaks. O content
 was much higher, than that
 in the carbon tape
 substrate. Particle showed
 significant charging.

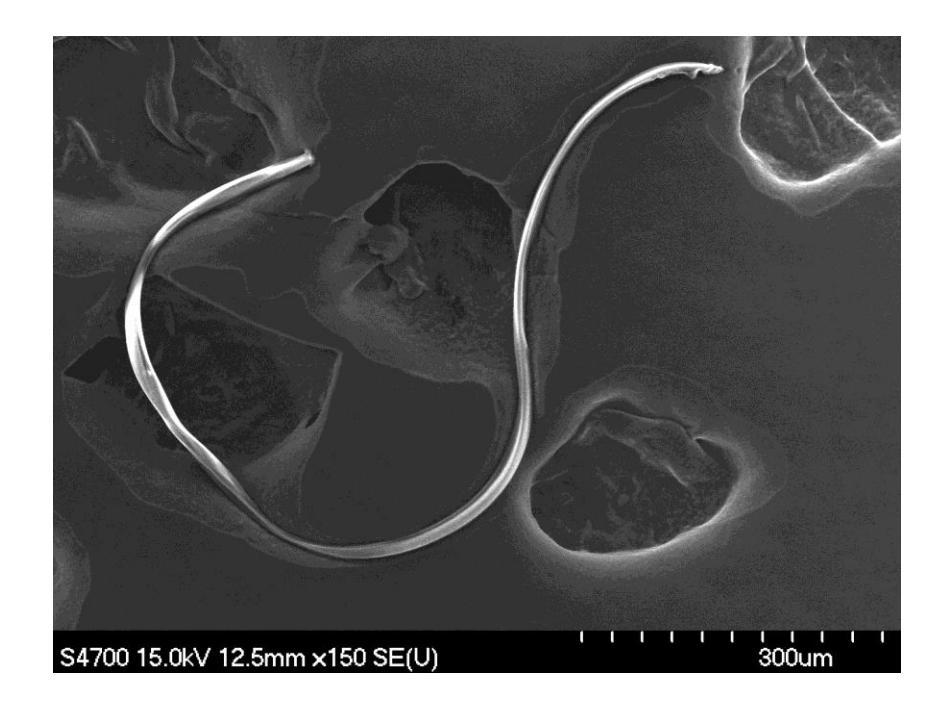
IA355 3rd iris

C and O

Quick EDS analysis showed
 C and O peaks. O content
 was higher, than that in the
 carbon tape substrate. At
 high magnifications the
 thread was charging.

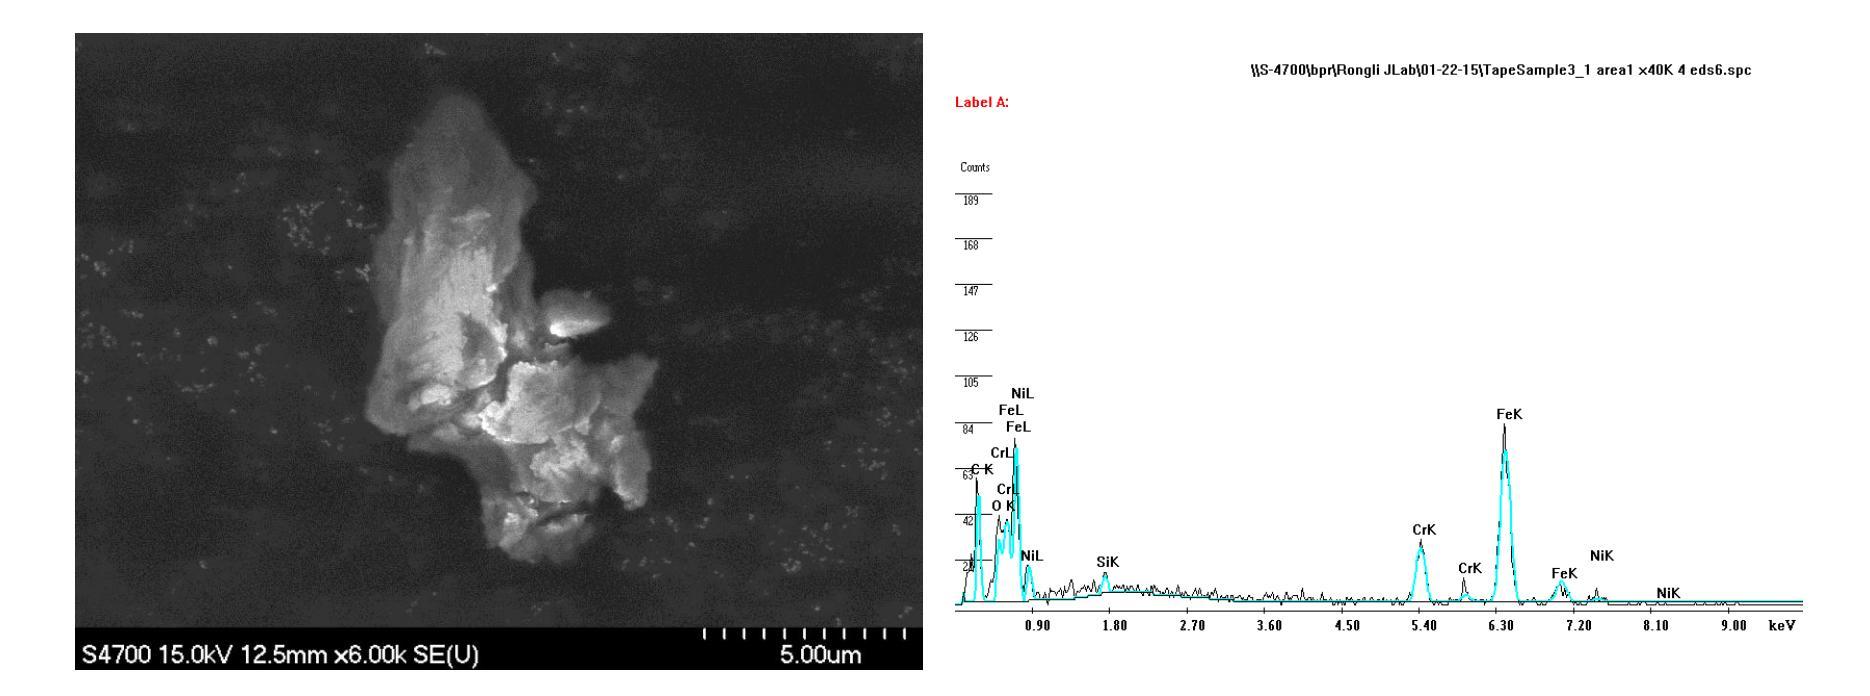
Fe, Ni, Cr, Si

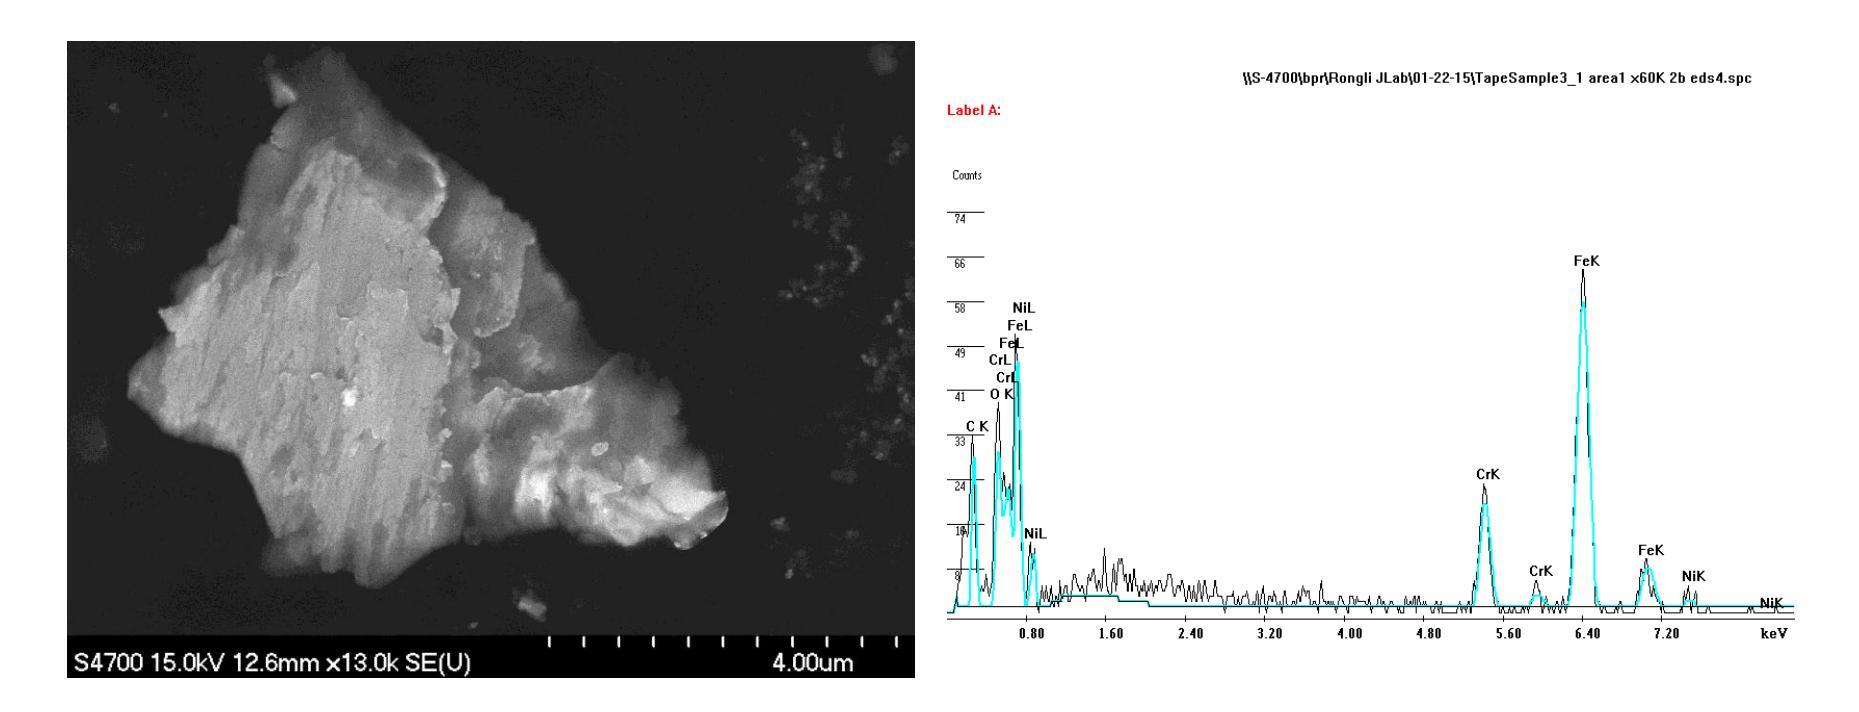
Fe, Ni, Cr

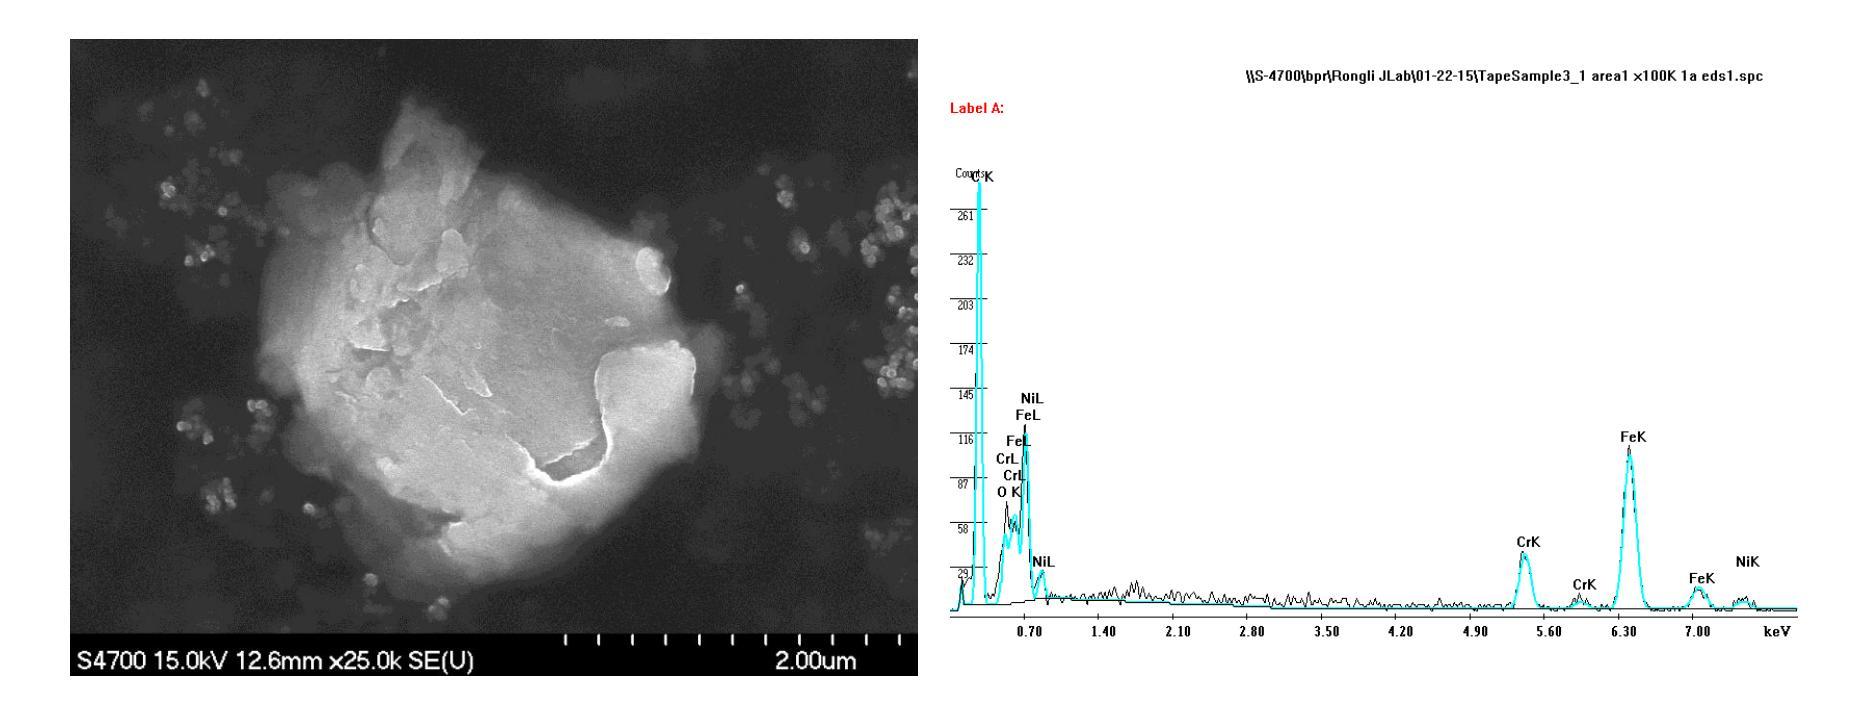
Fe, Ni, Cr

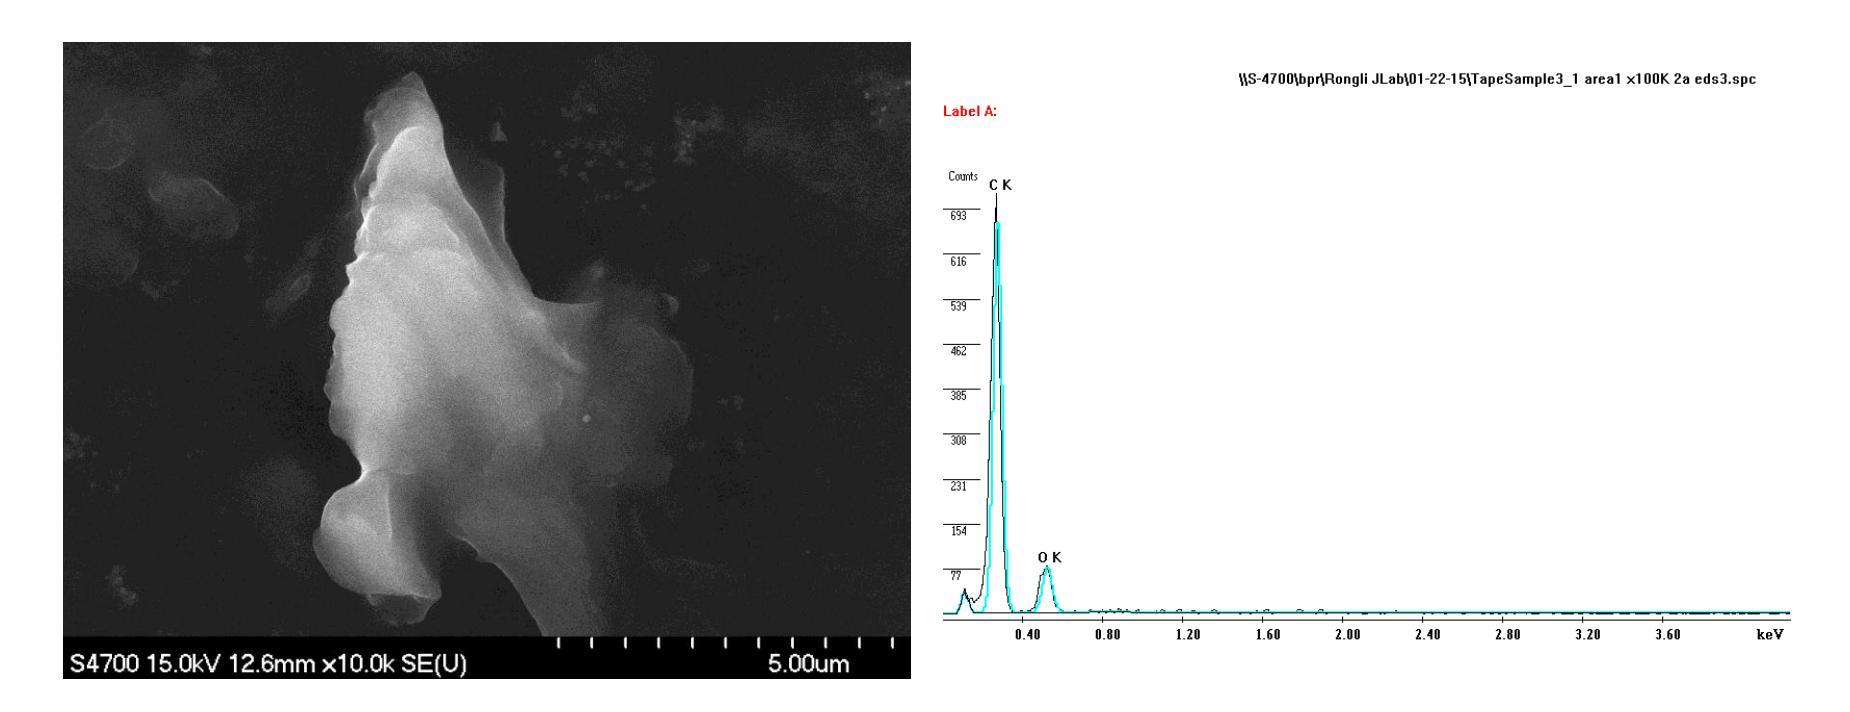
С, О
