CEBAF Particulate Field-Emitter Control

Rongli Geng July 15, 2015

C50-12 Rework Cryomodule Cavities

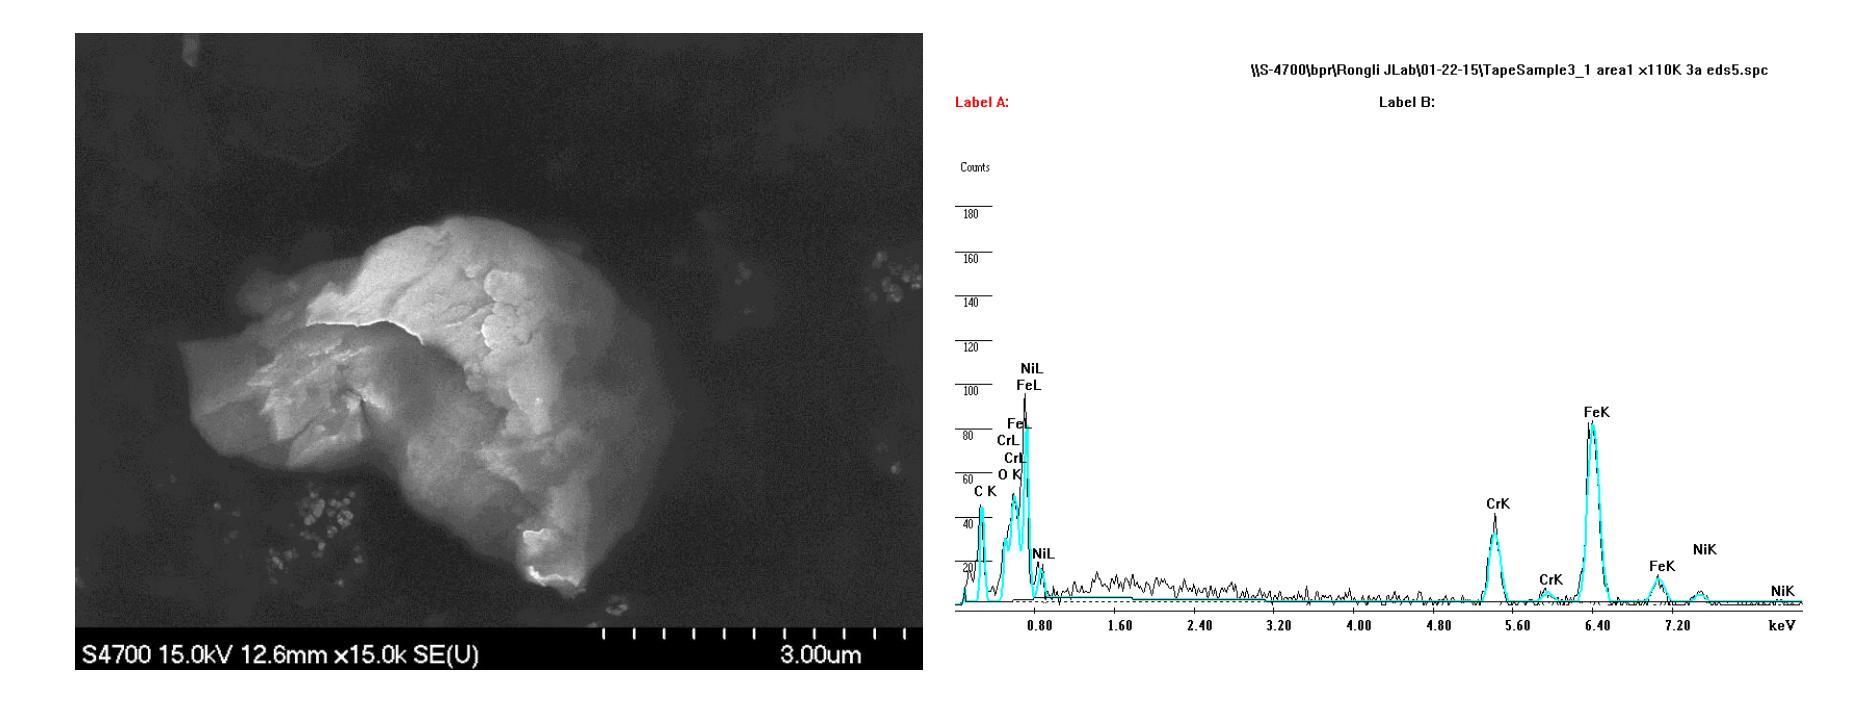
Fe, Ni, Cr

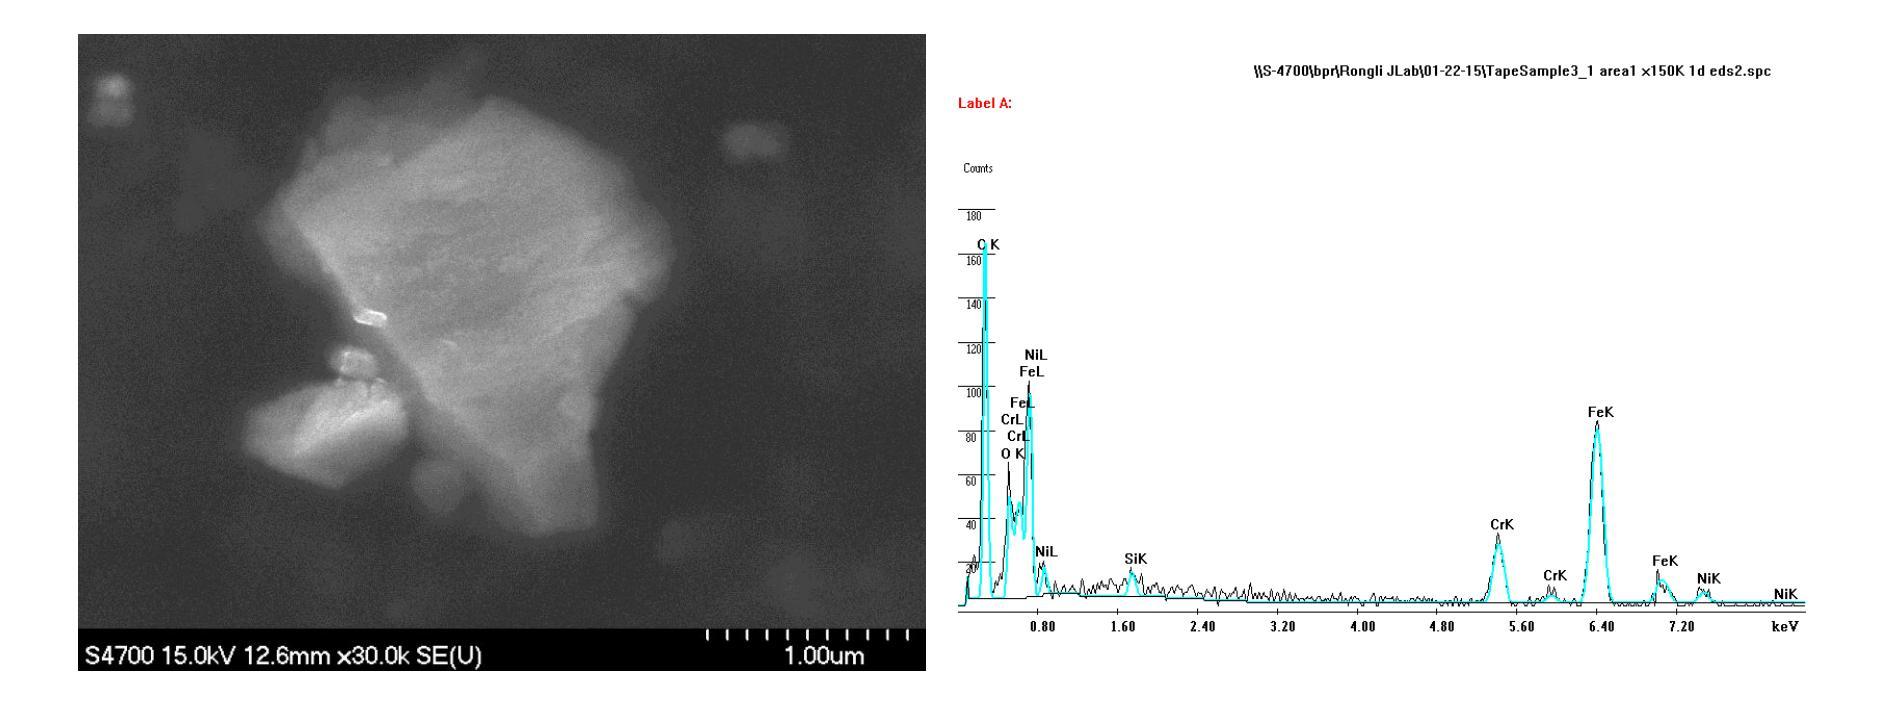
Fe, Ni, Cr, Si

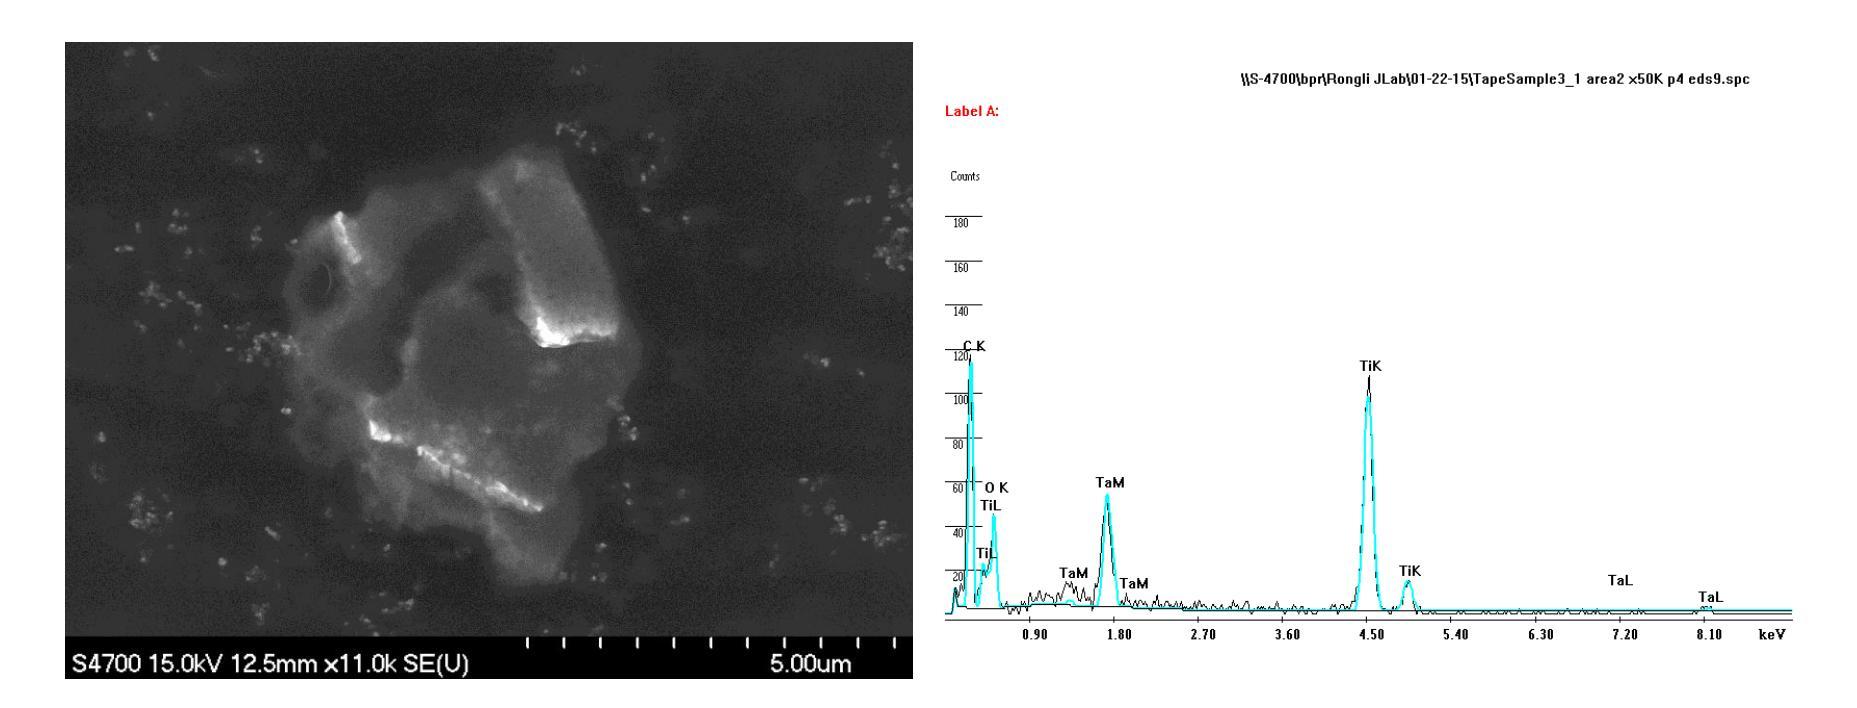
Ti, Ta

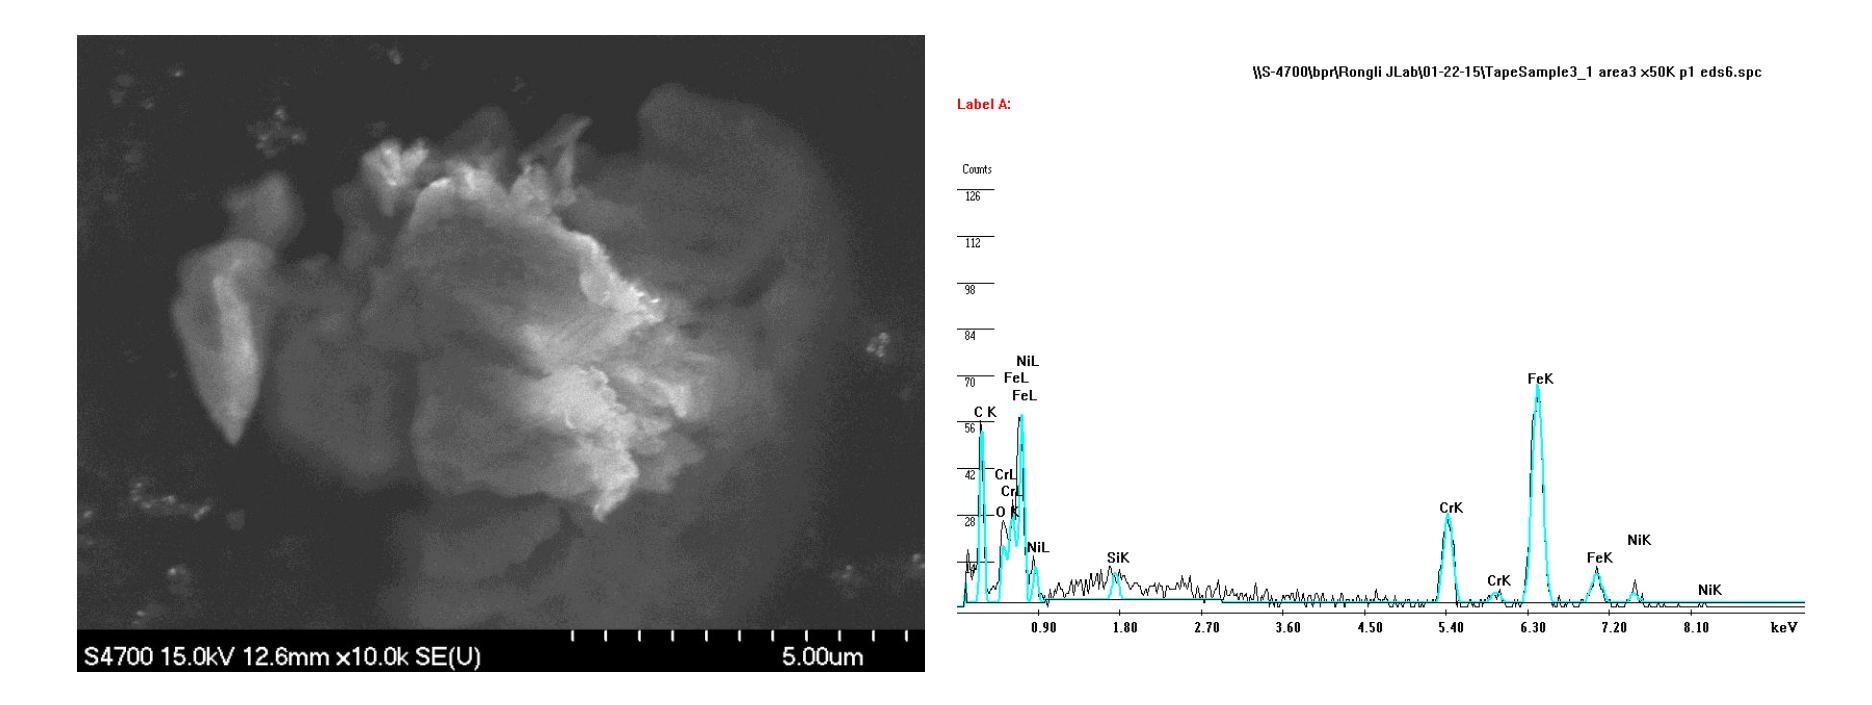
Fe, Ni, Cr, Si

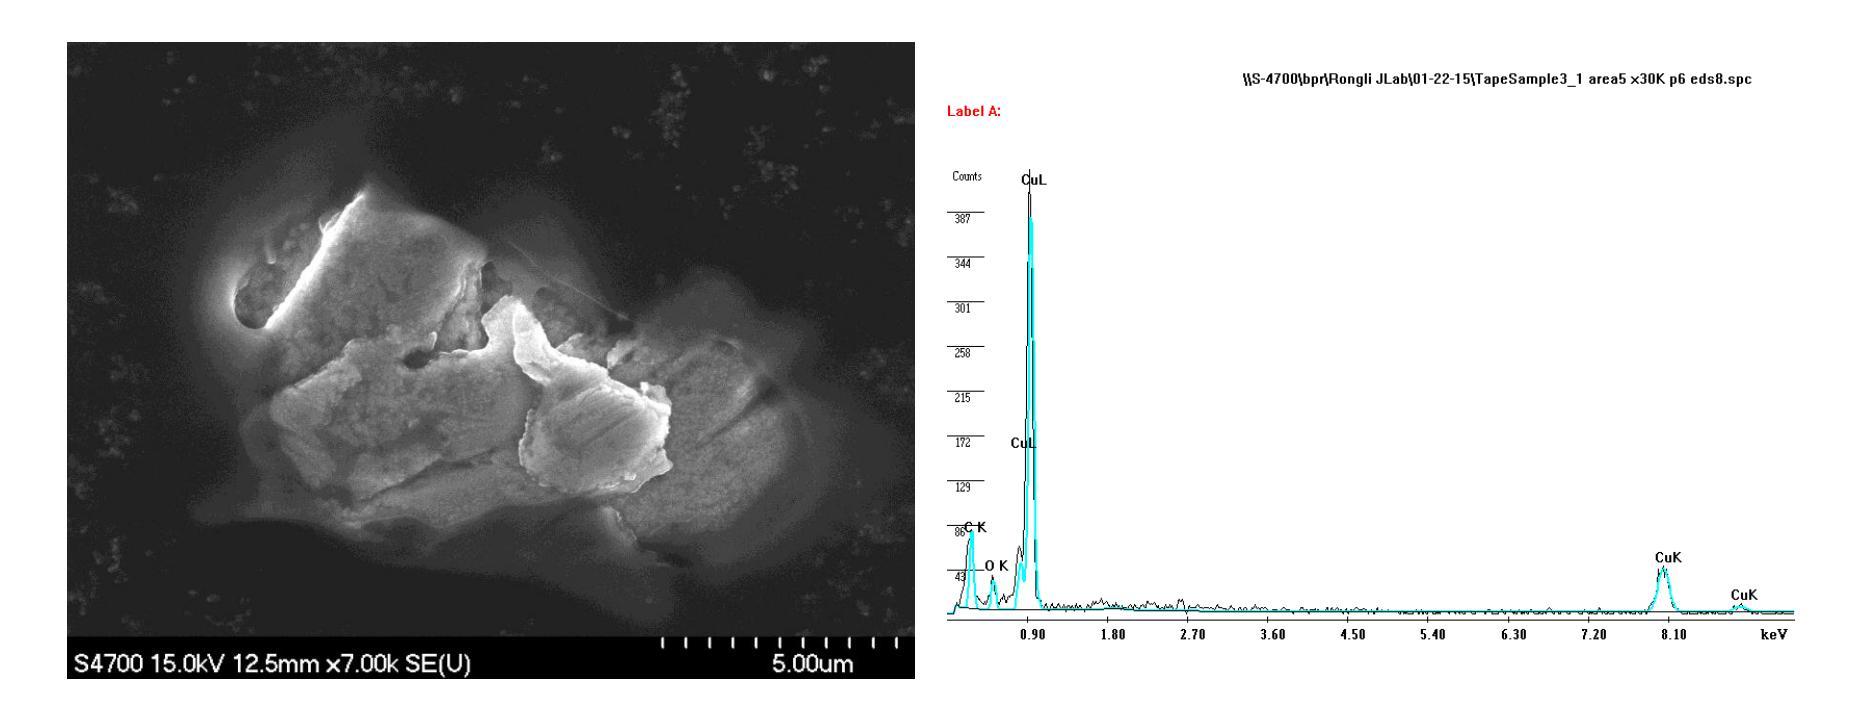
Cu

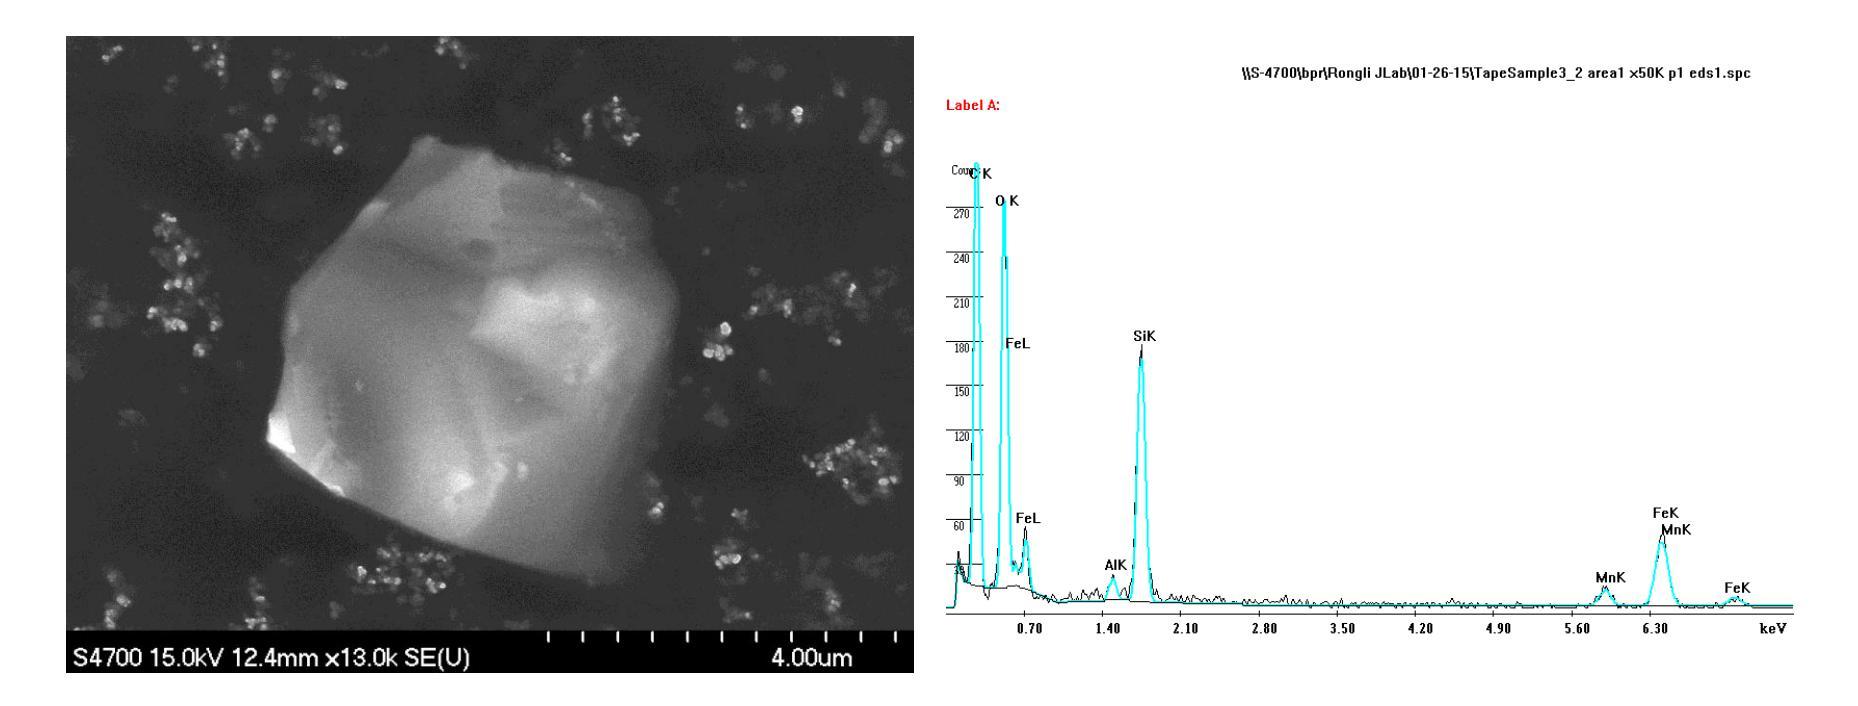
Fe, Mn, Si, Al

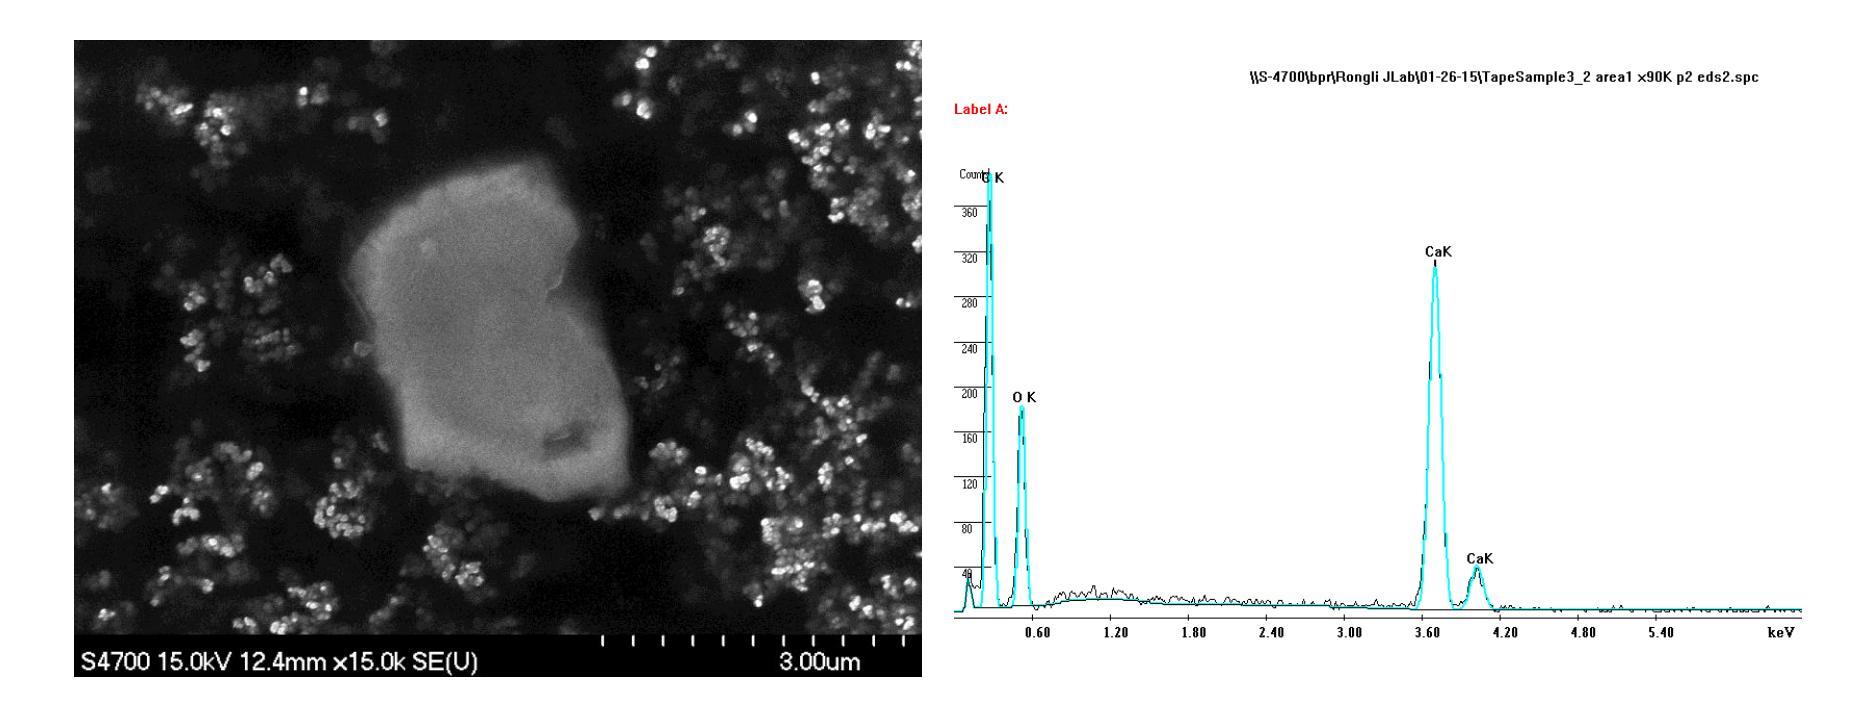
Ca

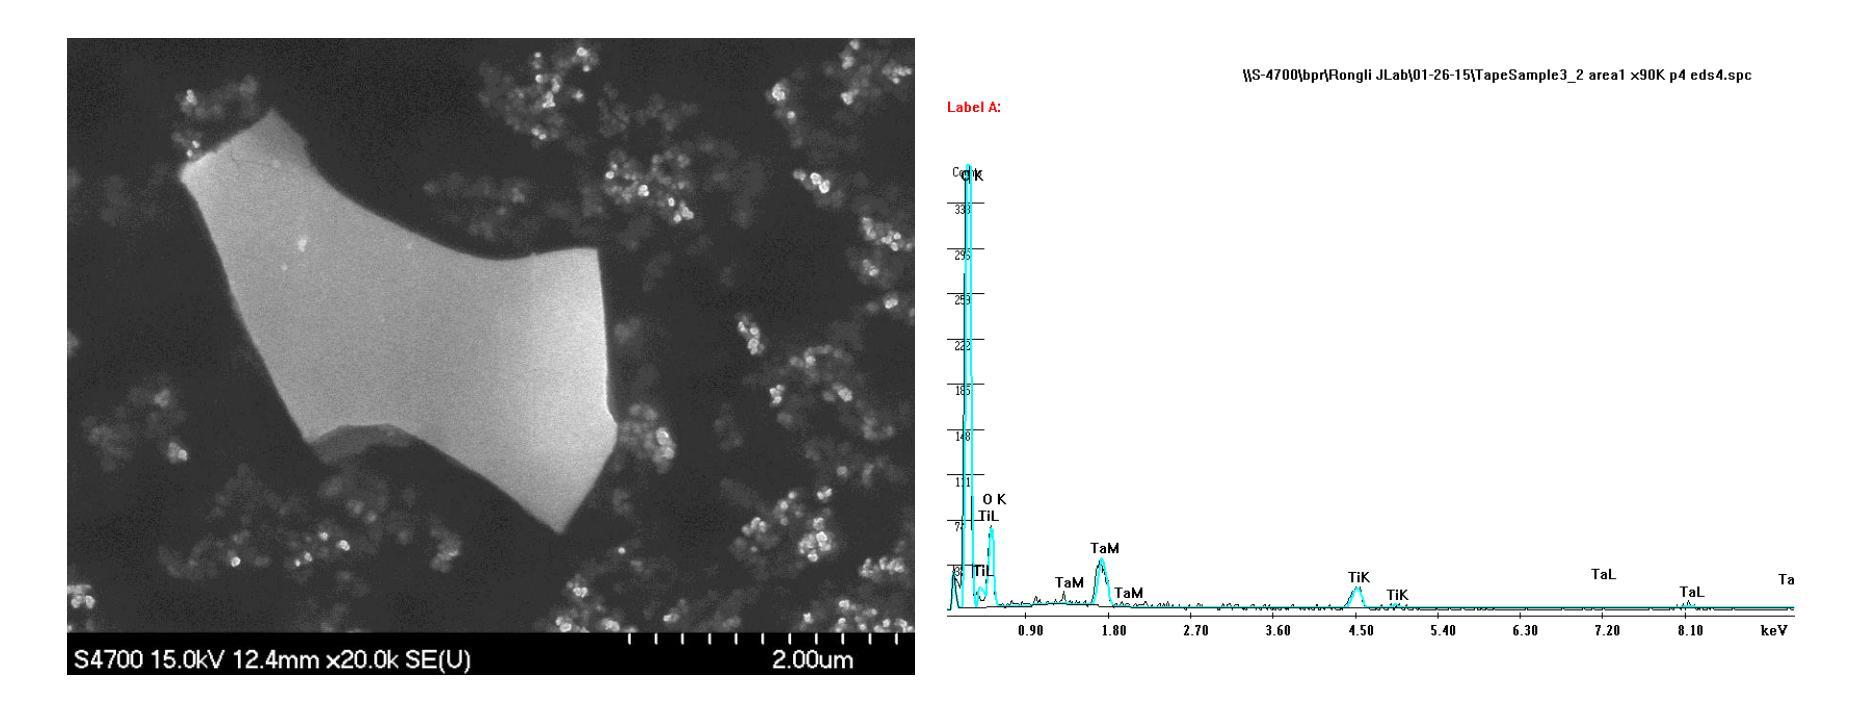
Ti, Ta

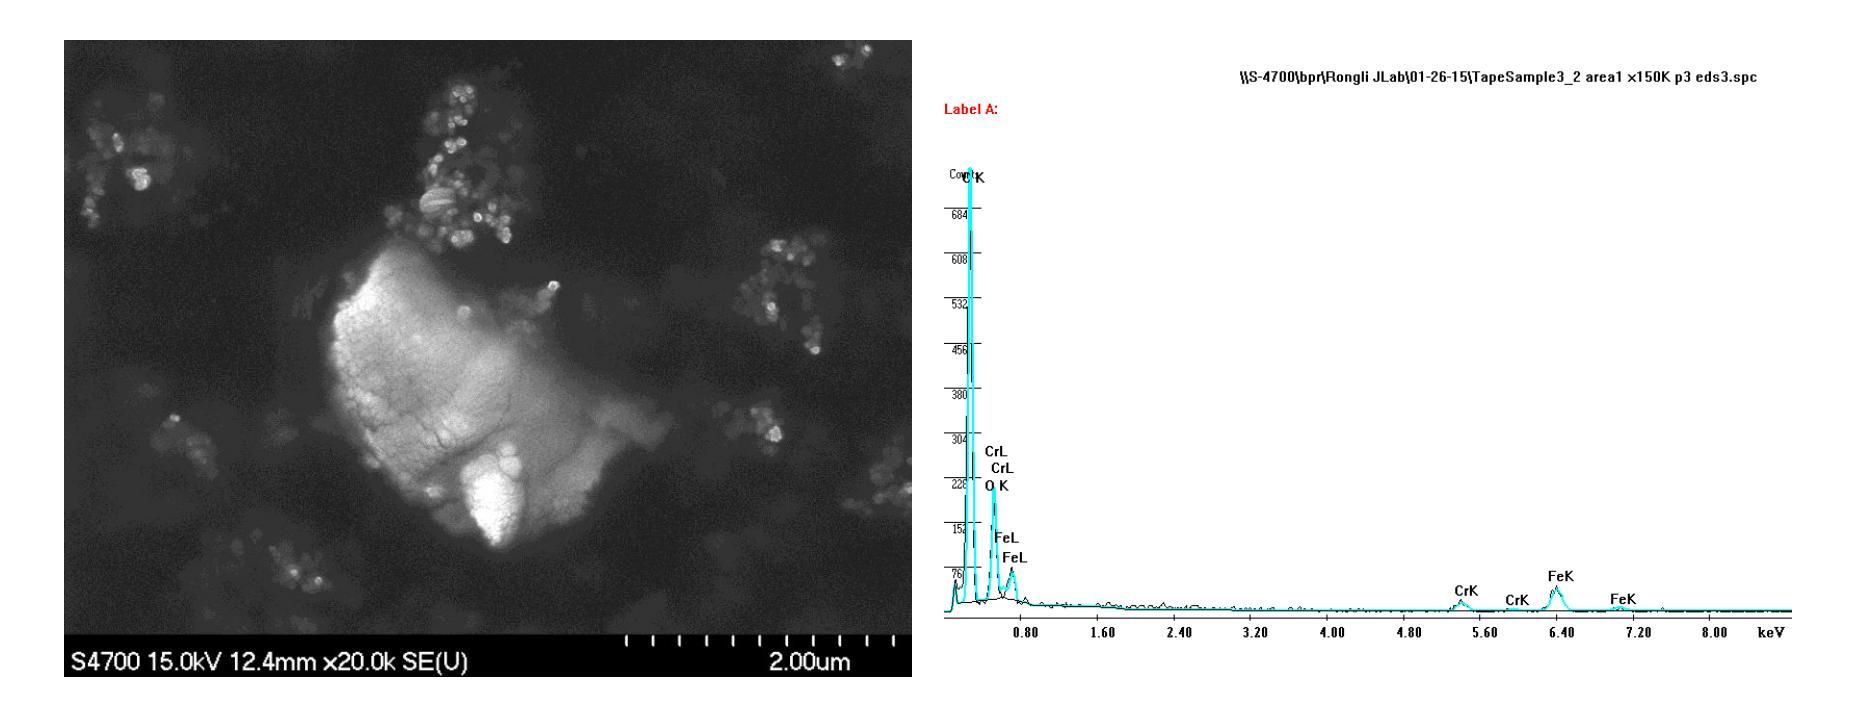
Fe, Cr

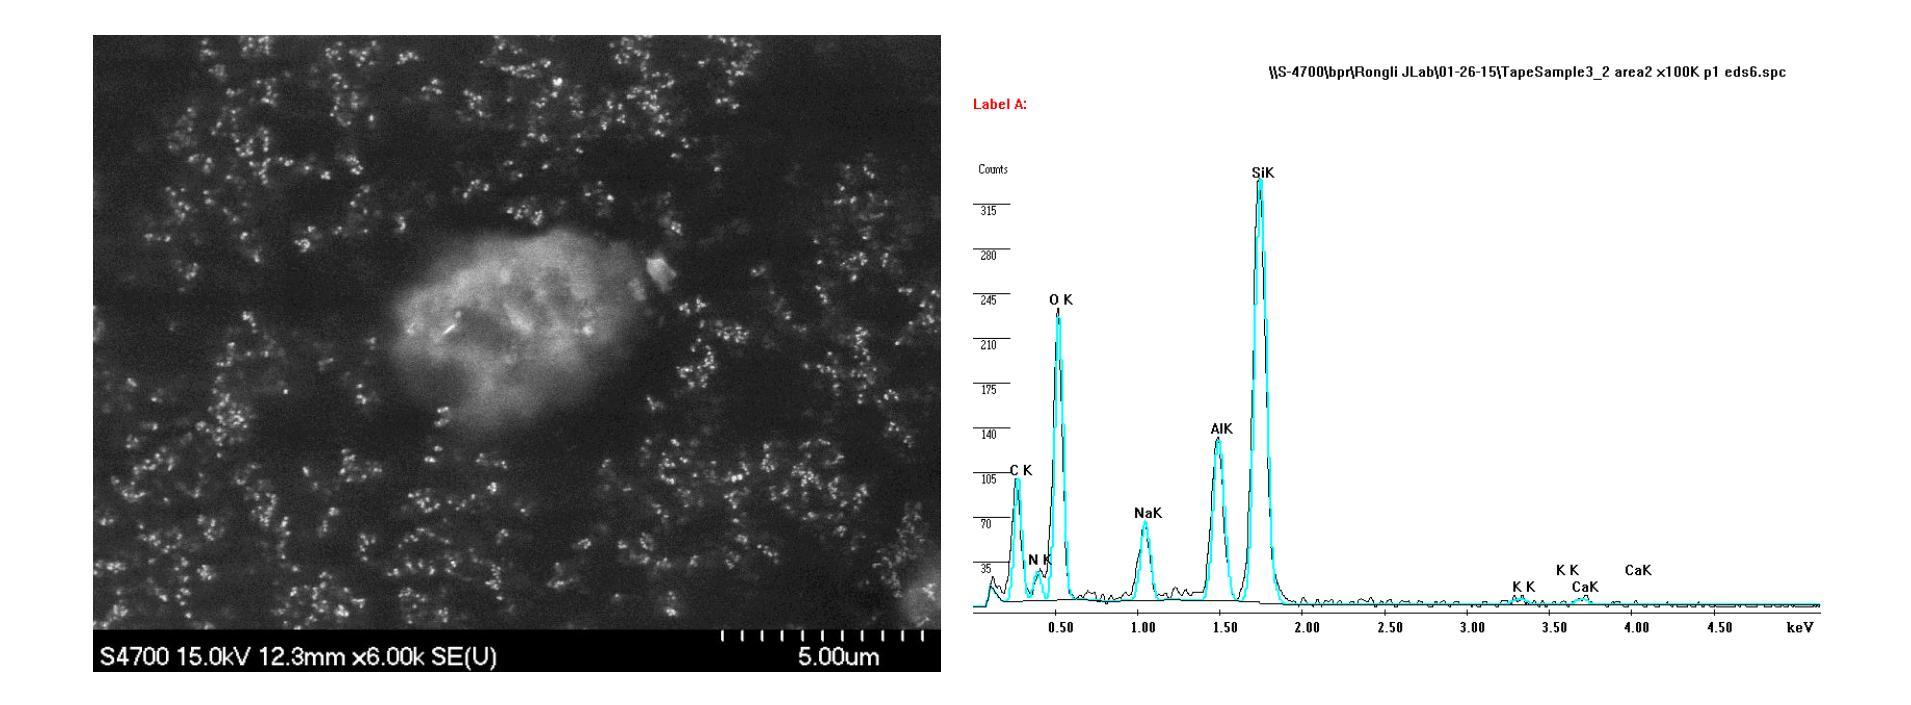
IA351 Nb beam pipe & 1st iris Si, Al, Na, K, Ca

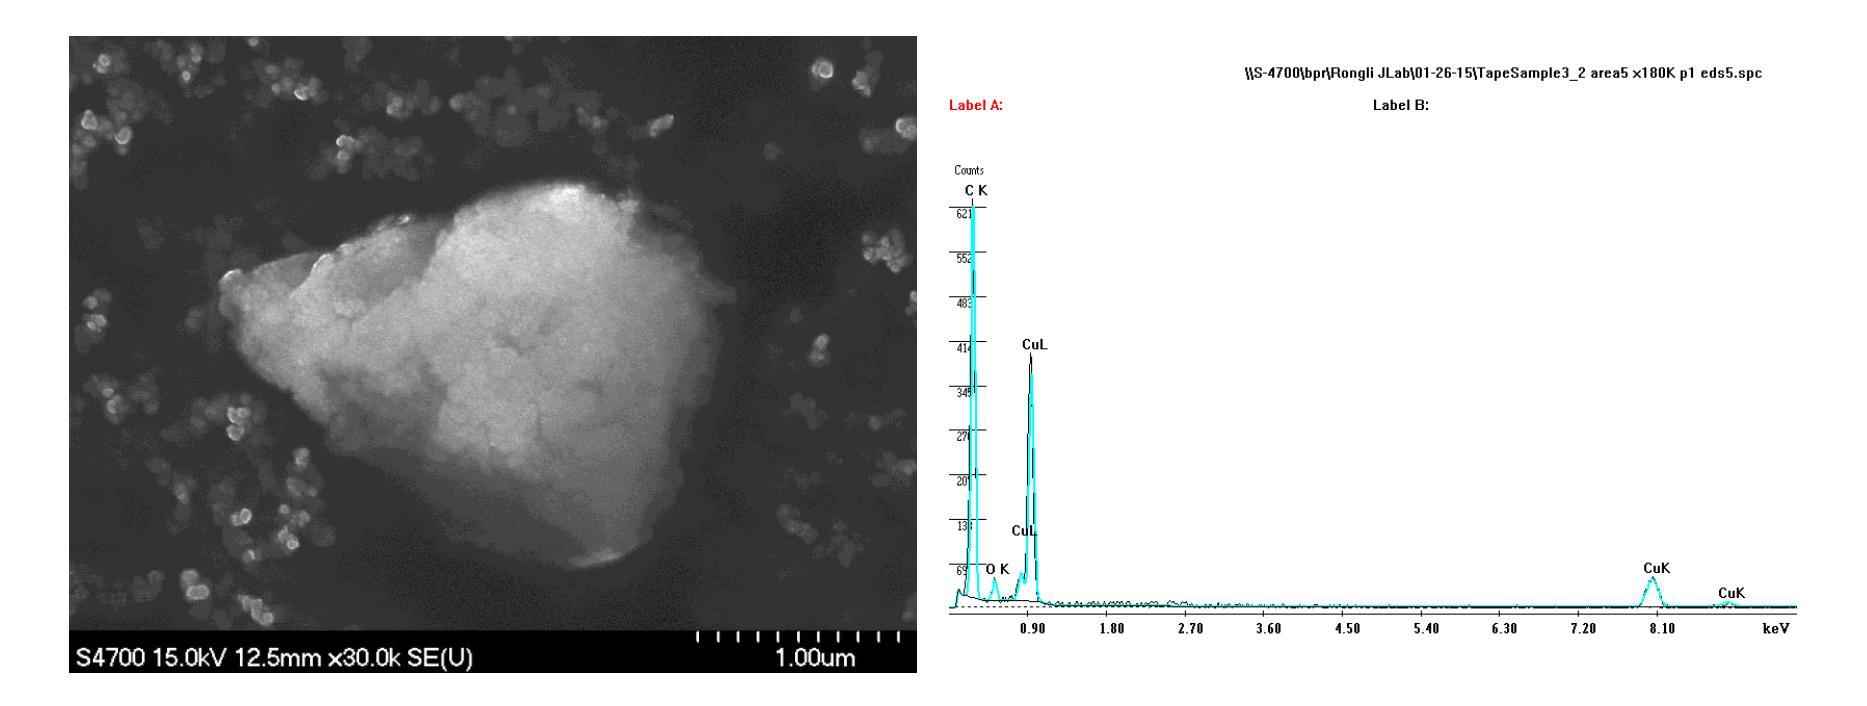
IA351 2nd iris

Cu

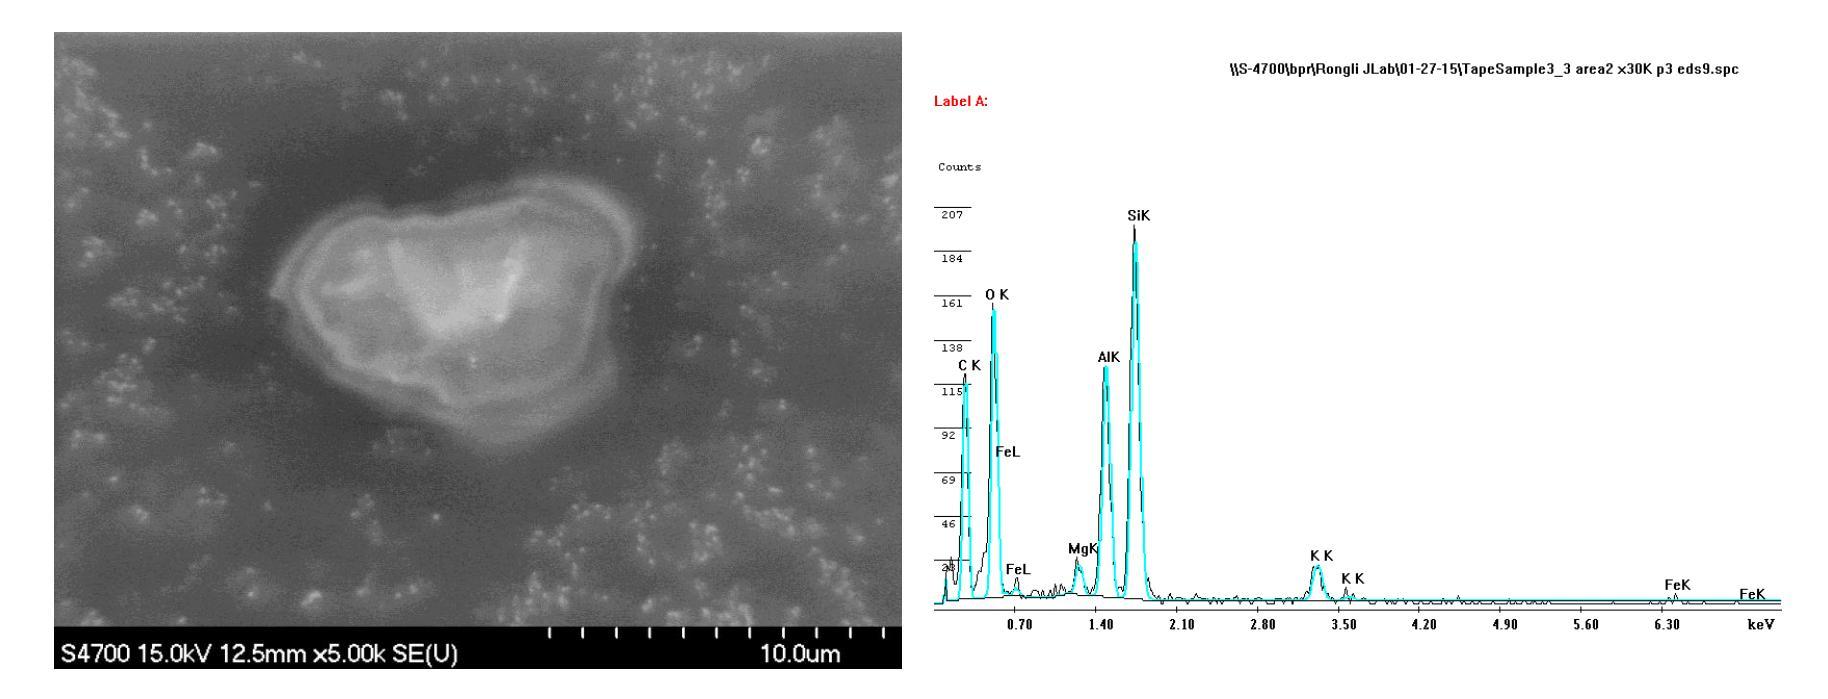
Si, Al, Mg, K, Fe

Post-emission "melted" alloy ball? *Al and Si peaks in combination are typical for clay and could be the signature of "environmental" contamination. Mg, K and traces of Fe could occur in clay too.*

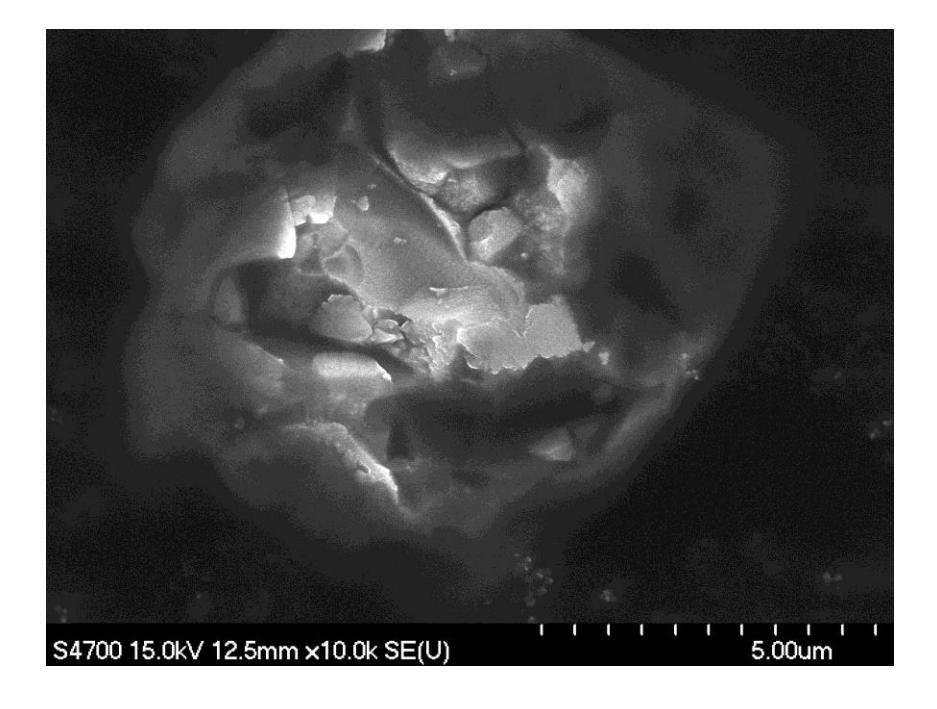
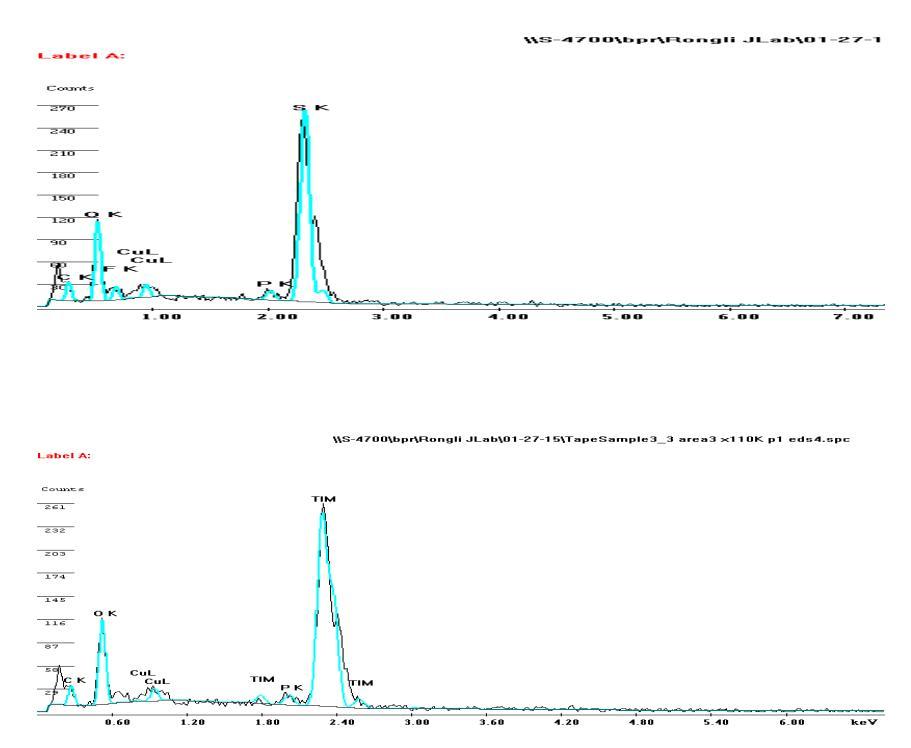
Cu, Ti, P or Cu, S, P

Two possible interpretation of EDS results. To pick correct interpretation additional data or cross-reference is needed.

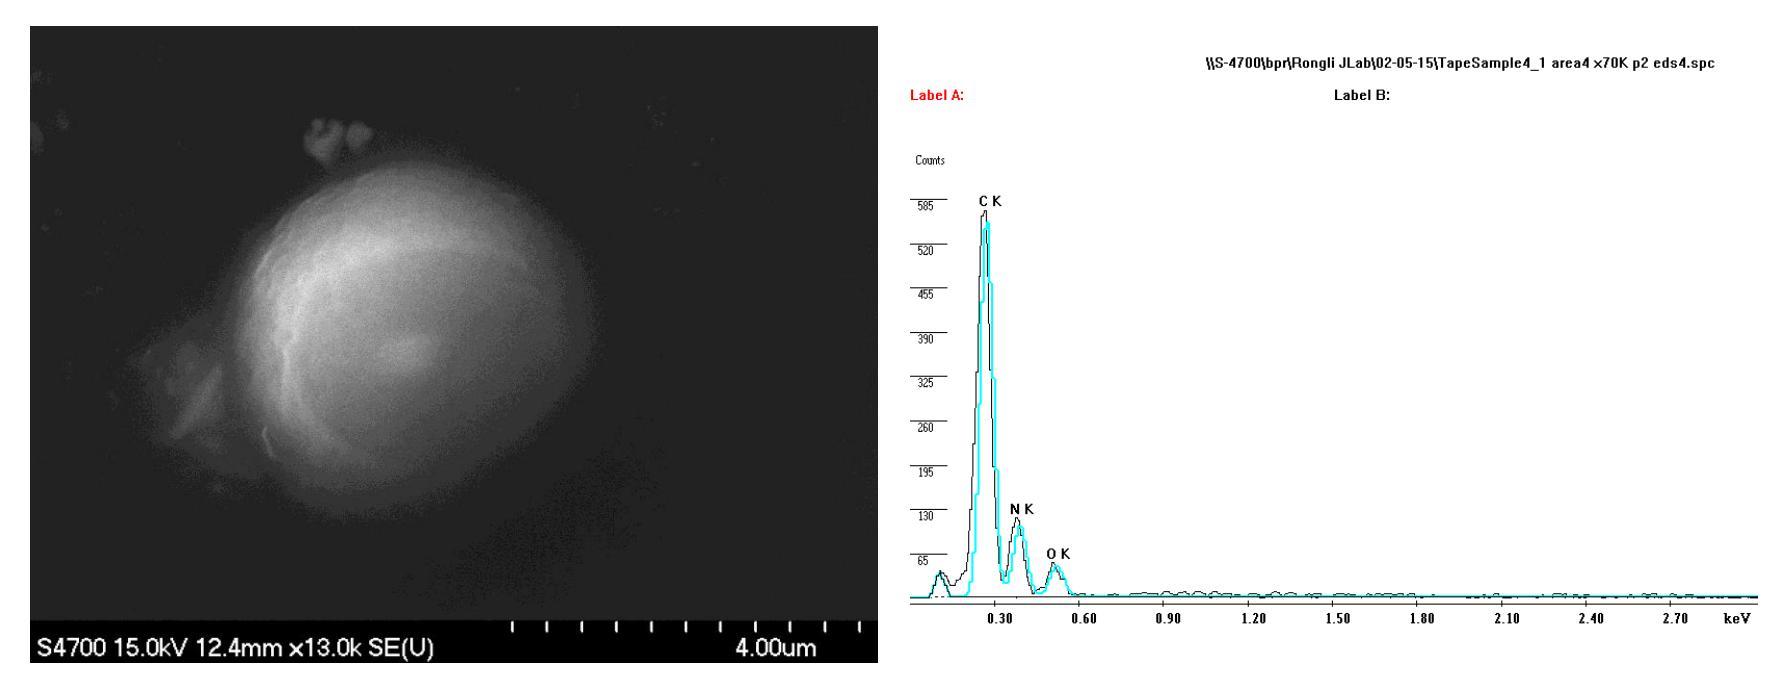
C, N

Any possibility of F instead of N?

Post emission "melted" Carbon ball?

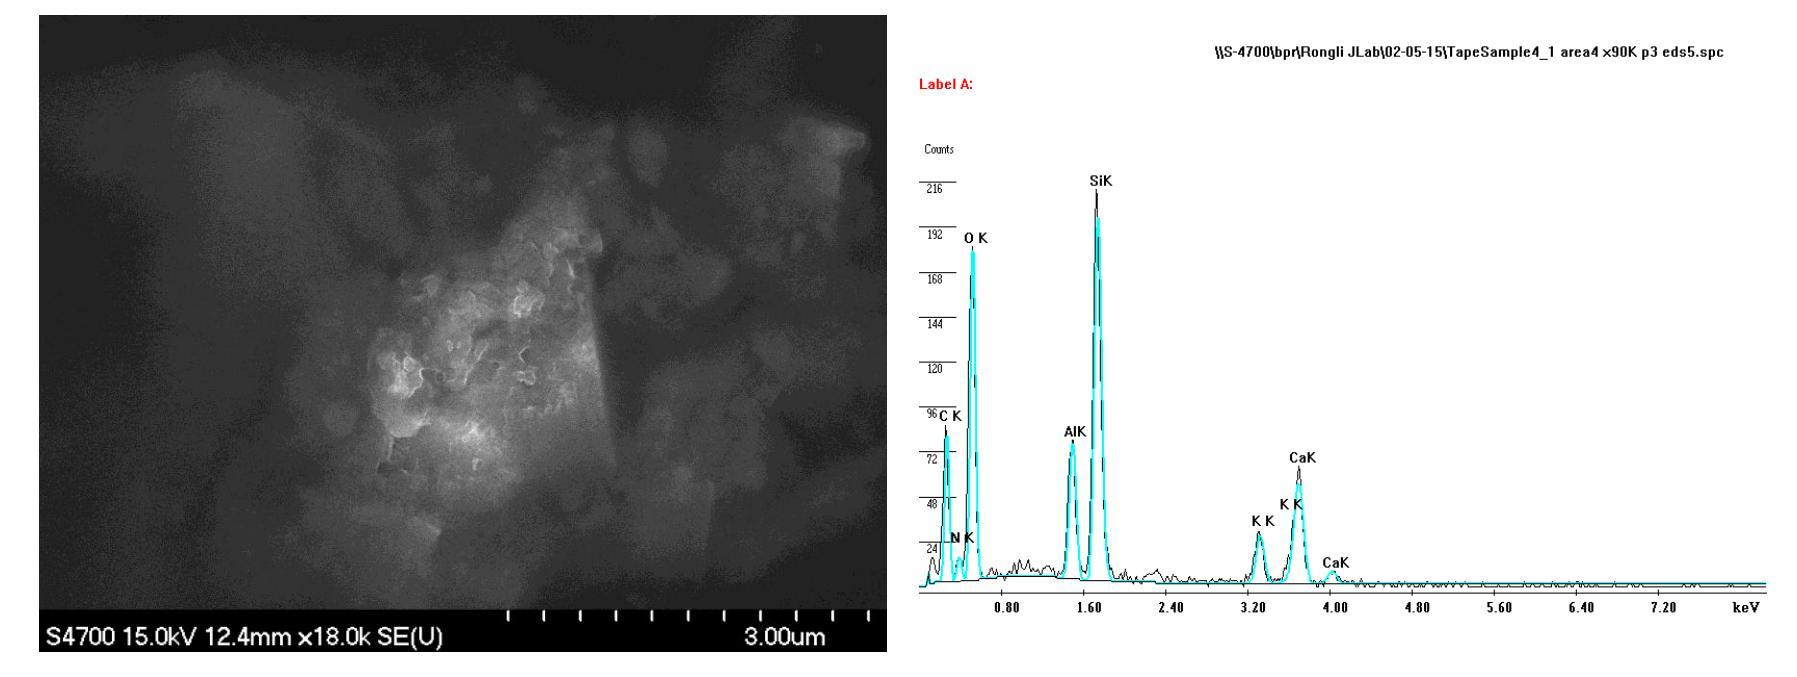
Ca, K, Al, Si

Post emission "partial melted" crystal?

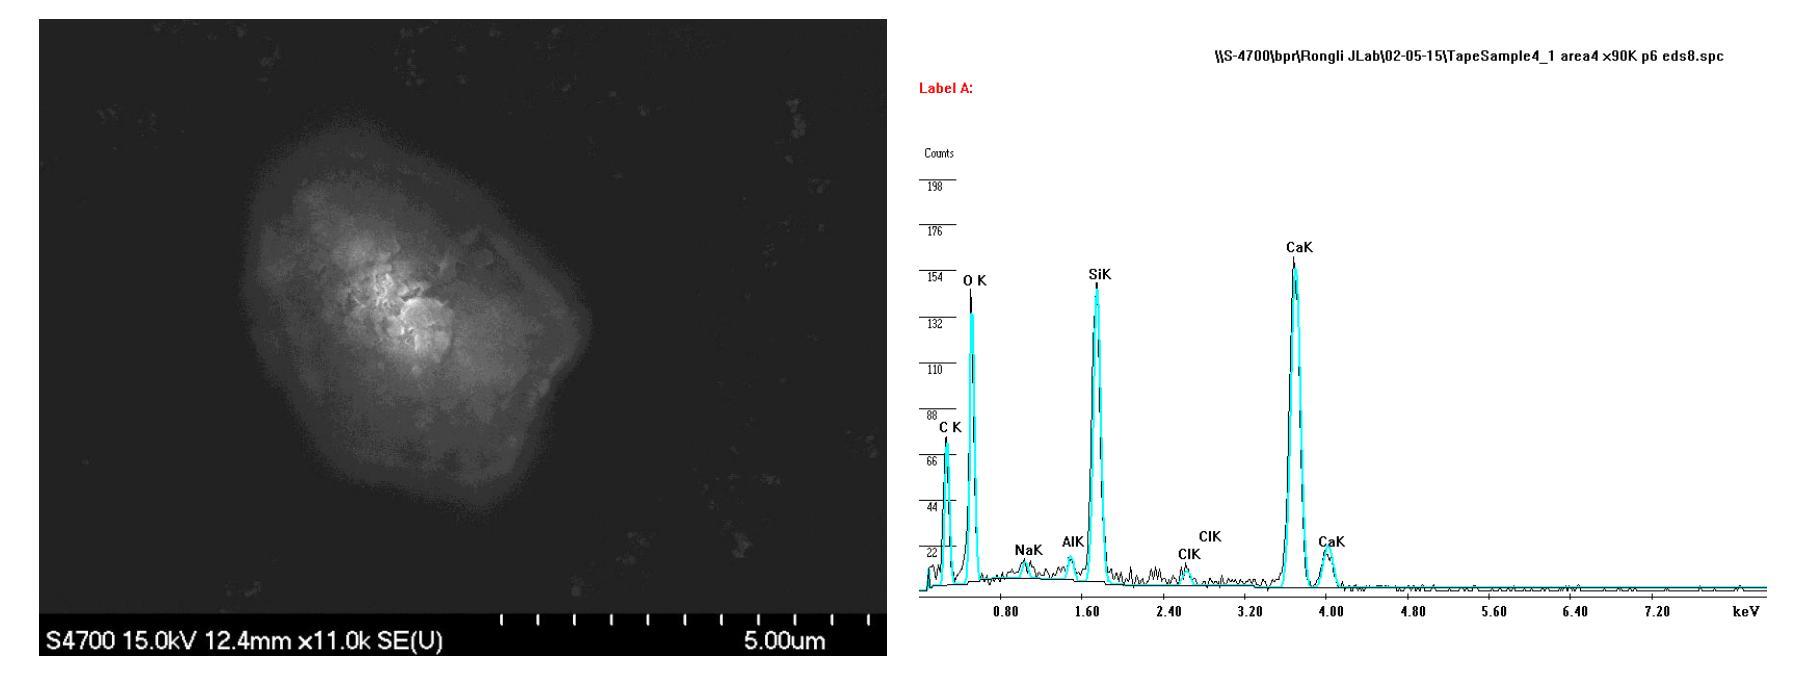
Ca, Na, Al, Si, Cl

Post emission "partial melted" crystal?

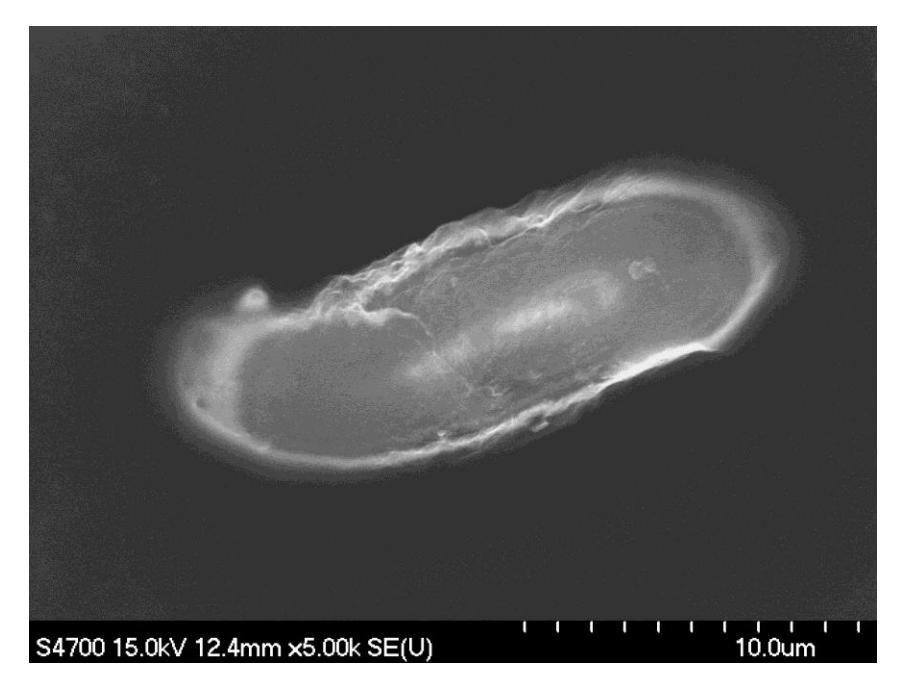
TapeSample4_1 area4 x5K p8_q00

NaCl

Quick EDS showed C,O
(from the substrate) and
peaks of Na and Cl.
Together with really
significant charging it may
indicate that this particle is
NaCl.

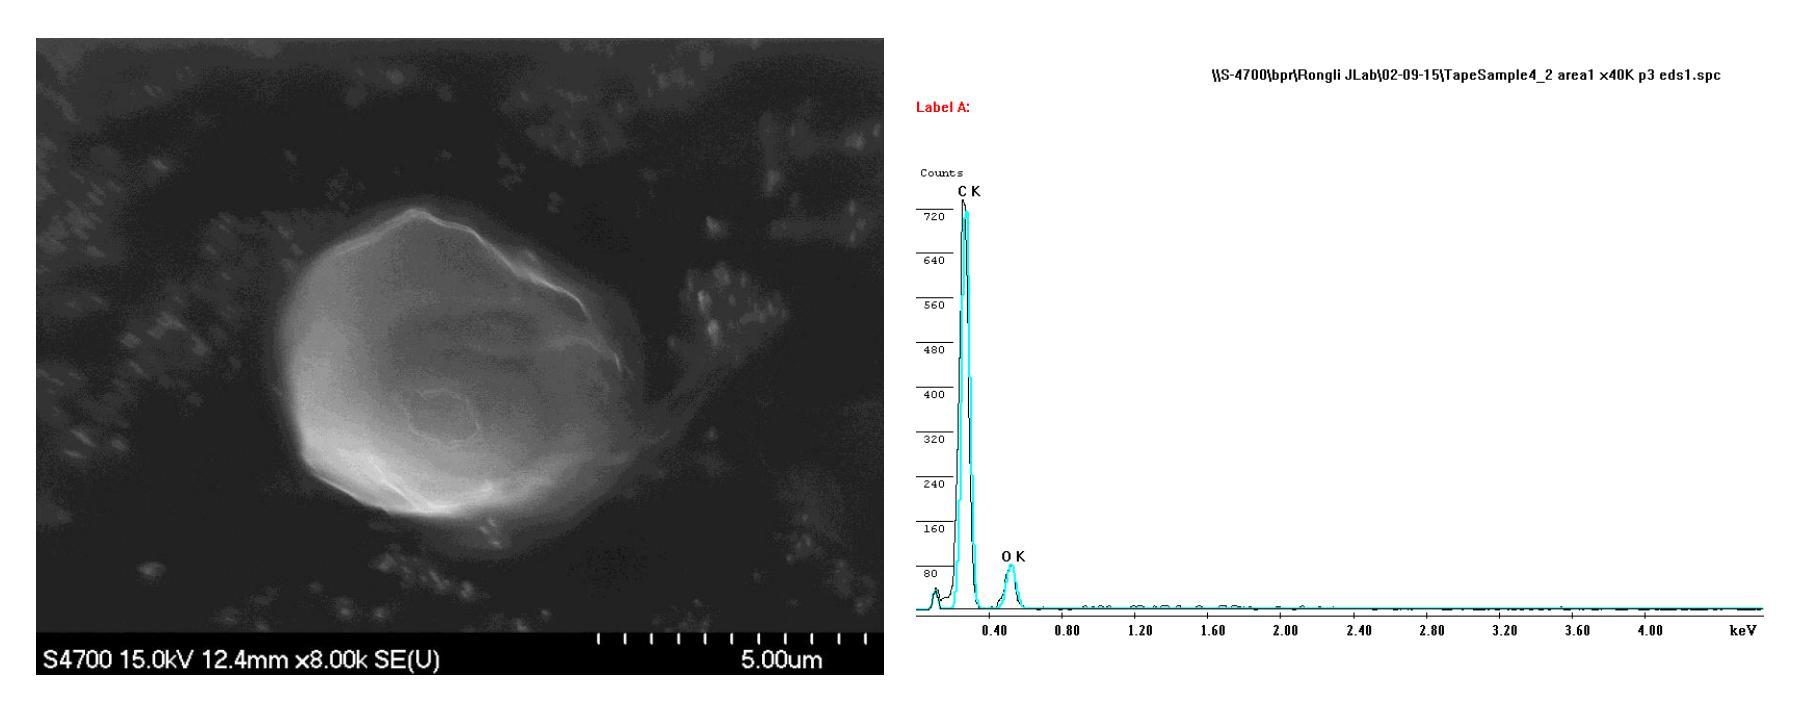
С

Post emission "partial melted" carbon particulate?
