CEBAF Particulate Field-Emitter Control

Rongli Geng July 15, 2015

C50-12 Rework Cryomodule Cavities

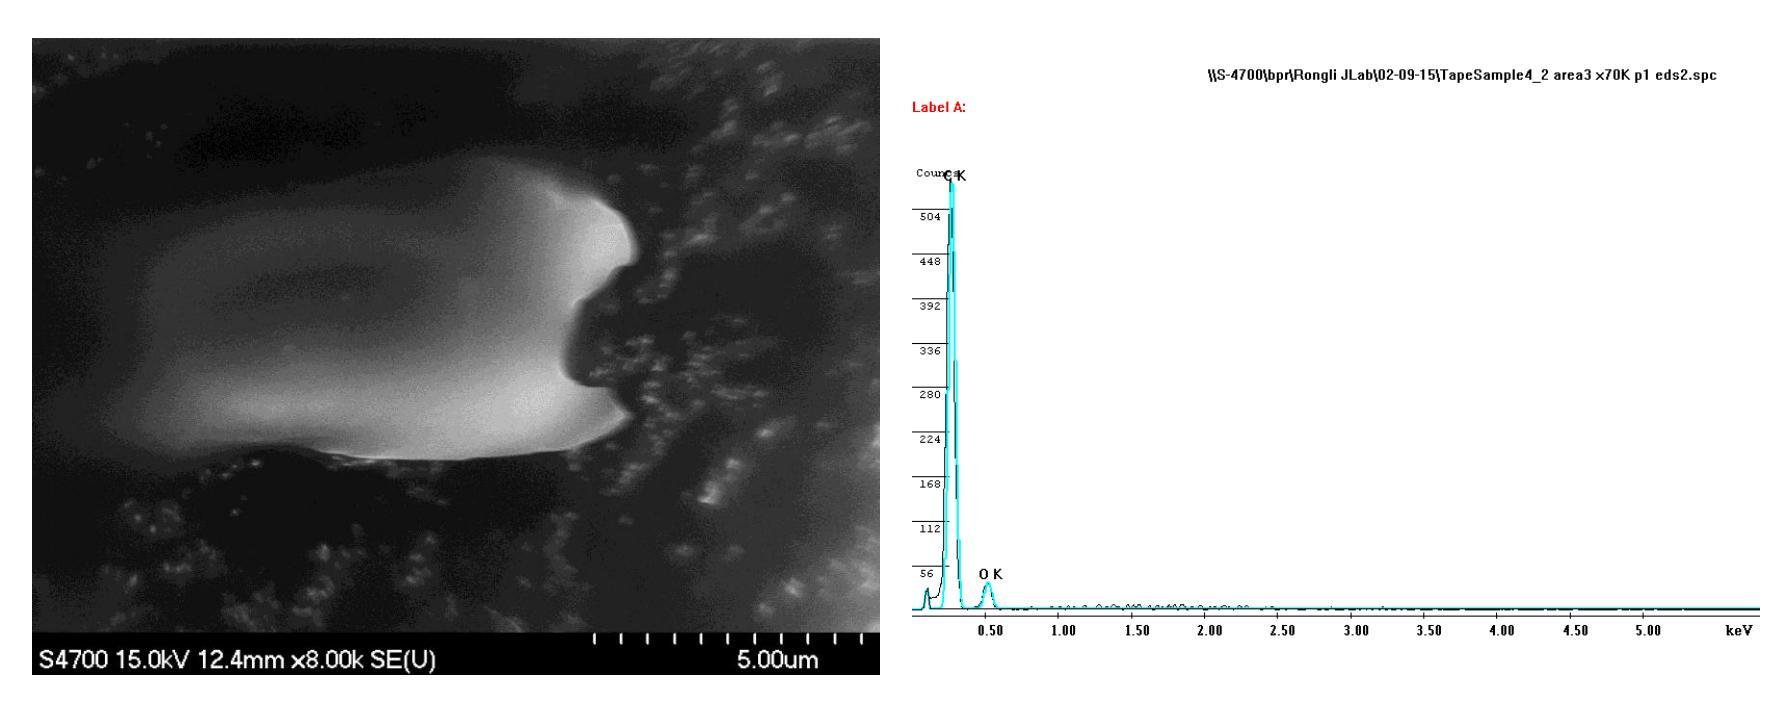
С

Post emission "partial melted" carbon particulate?

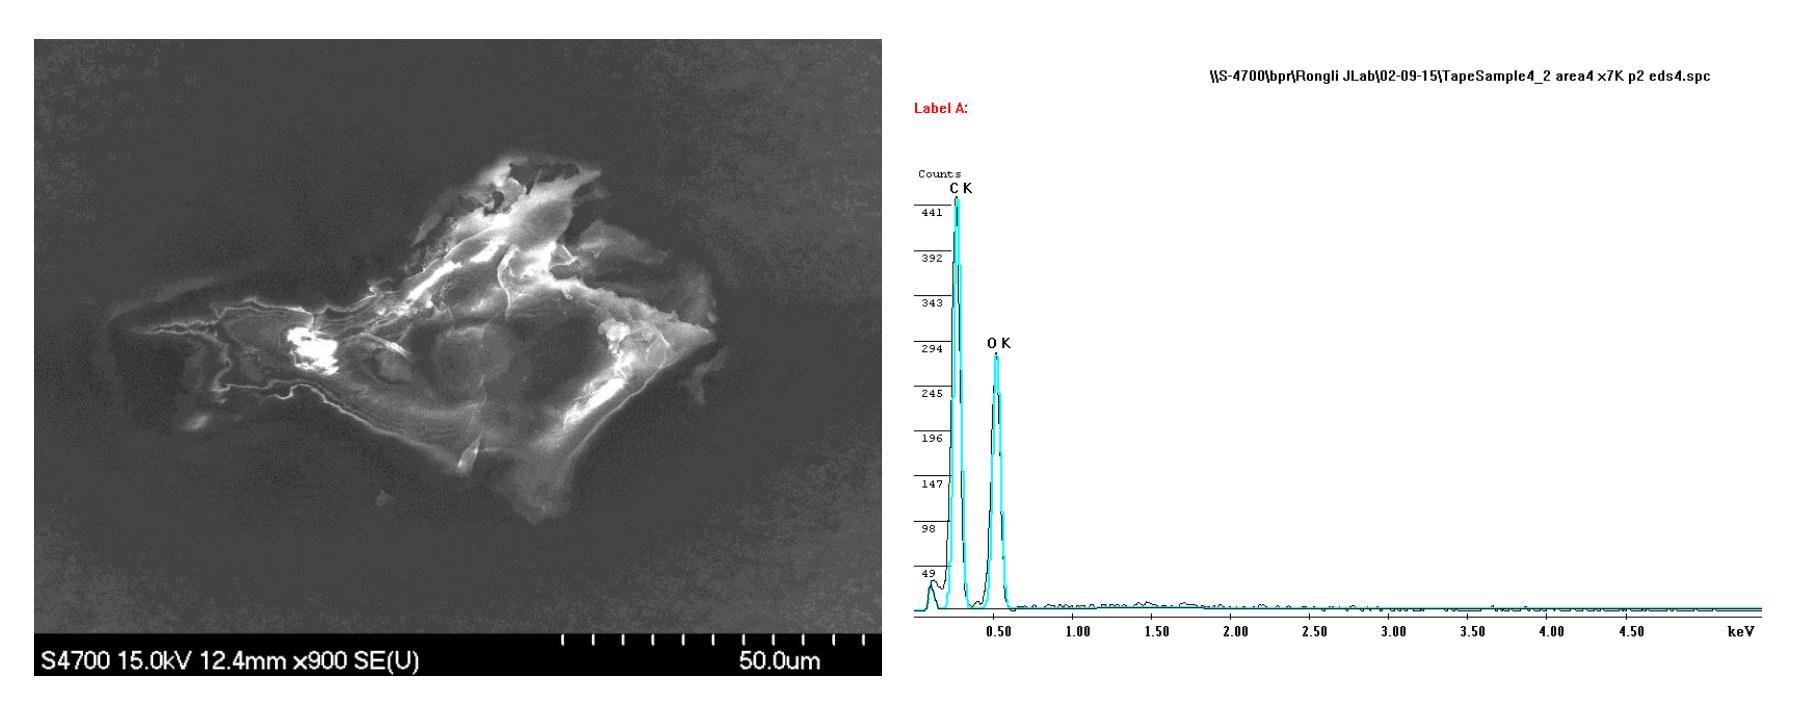
Post emission "partial melted" carbon particulate?

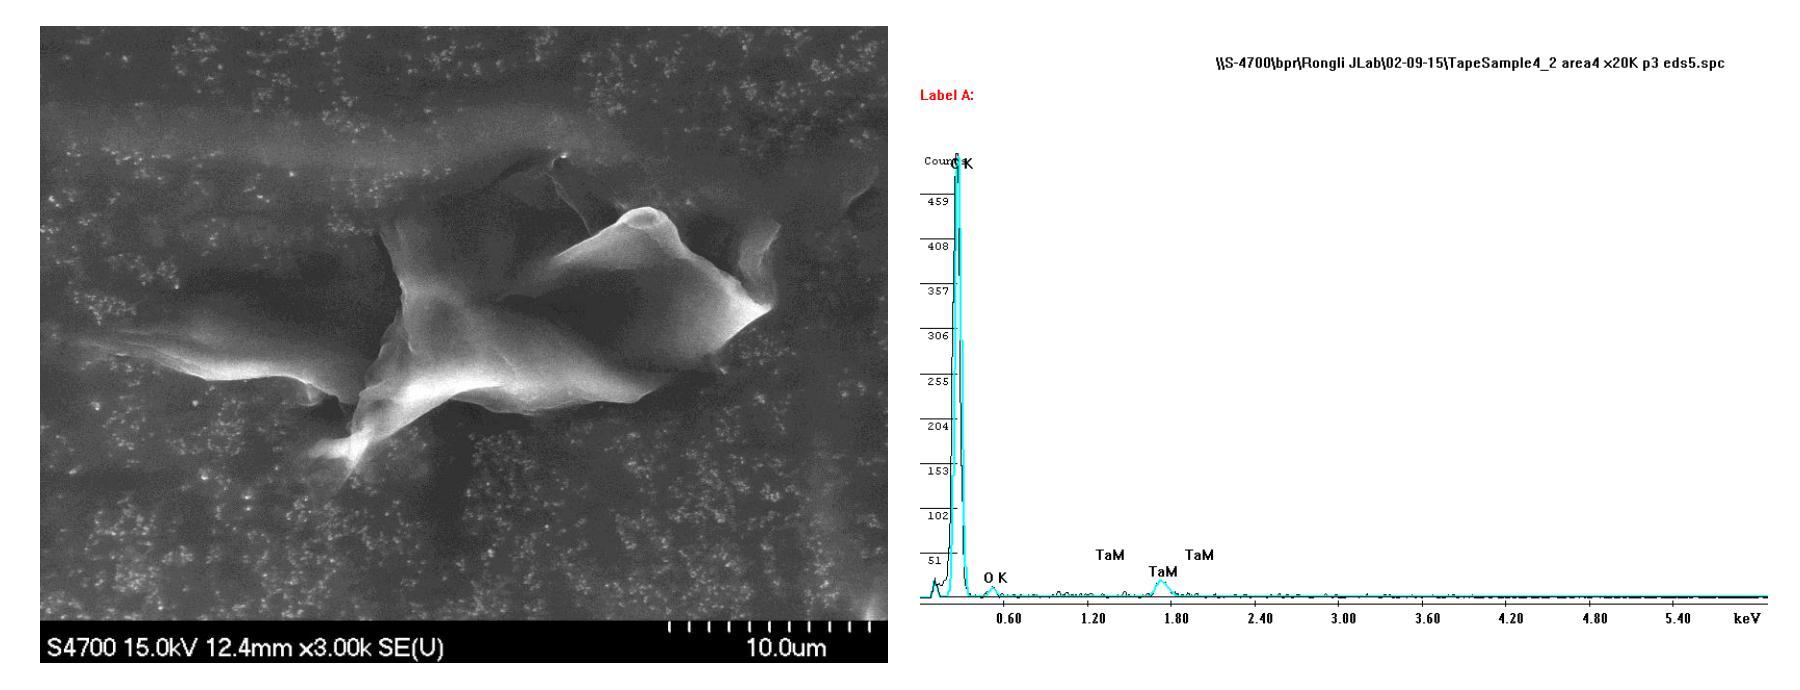
C, Ta

Post emission "partial melted" C/Ta particulate?

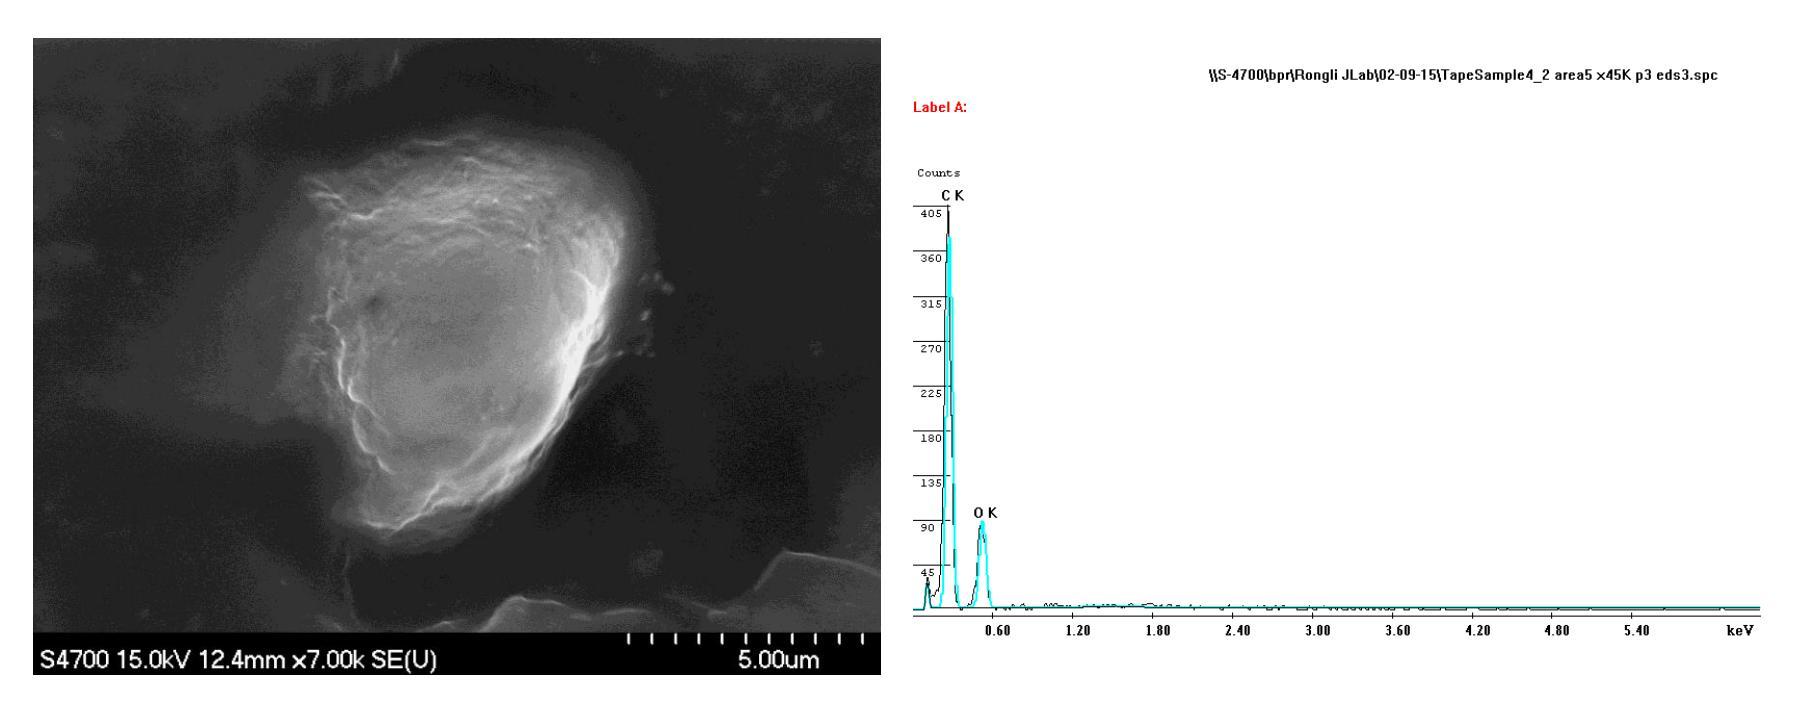
```
С
```

Post emission "partial melted" carbon particulate?

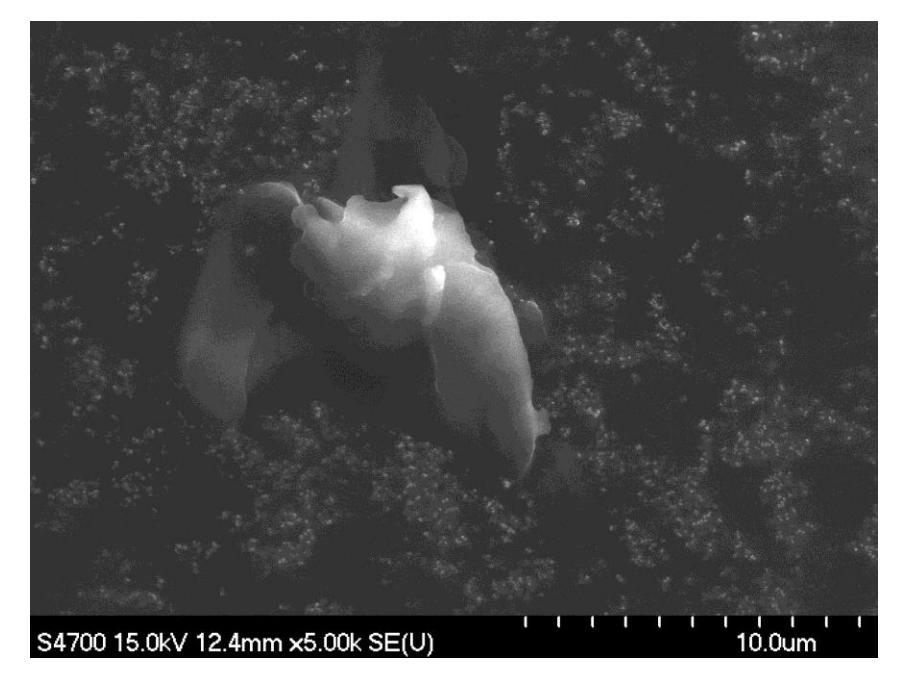
TapeSample4_2 area1 x5K p5_q00

С,О

Quick EDS showed peaks of C and O in the proportion similar to that of the carbon tape substrate. Charging is minimal. This may indicate that the feature is a carbon tape artifact.

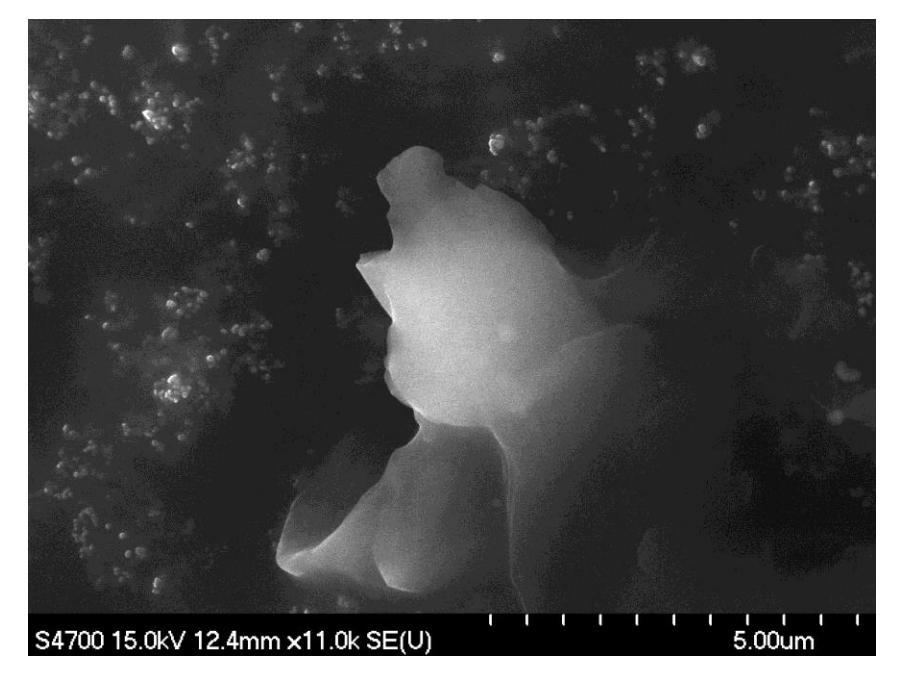
TapeSample4_2 area1 x11K p2_q00

С, О

Quick EDS showed peaks of
C and O in the proportion
similar to that of the carbon
tape substrate. Charging is
minimal. This may indicate
that the feature is a carbon
tape artifact.

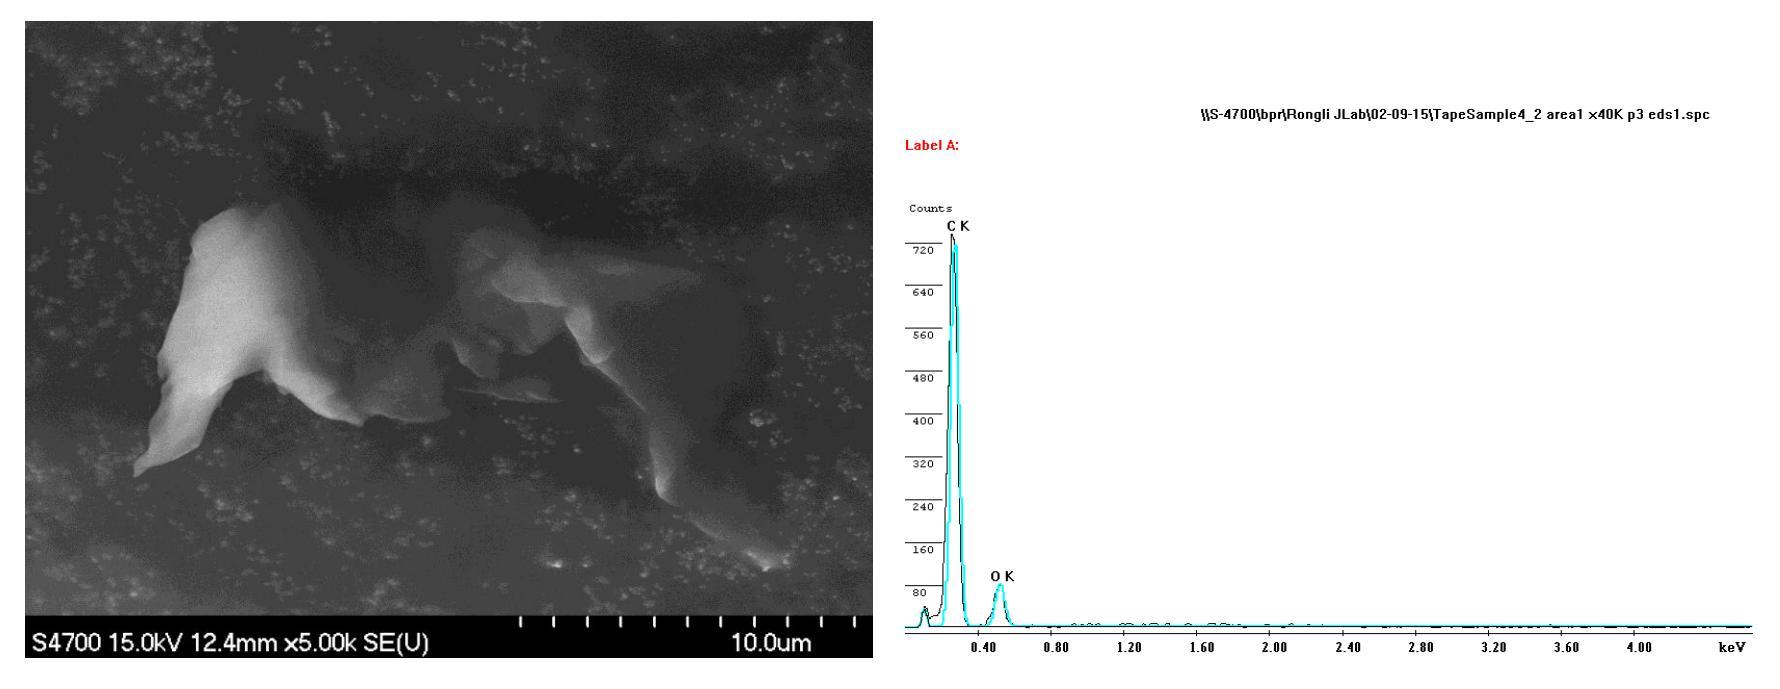
TapeSample4_2 area3 x5K p3_q00

С, О

Note: charging is higher than in previous 2 cases.

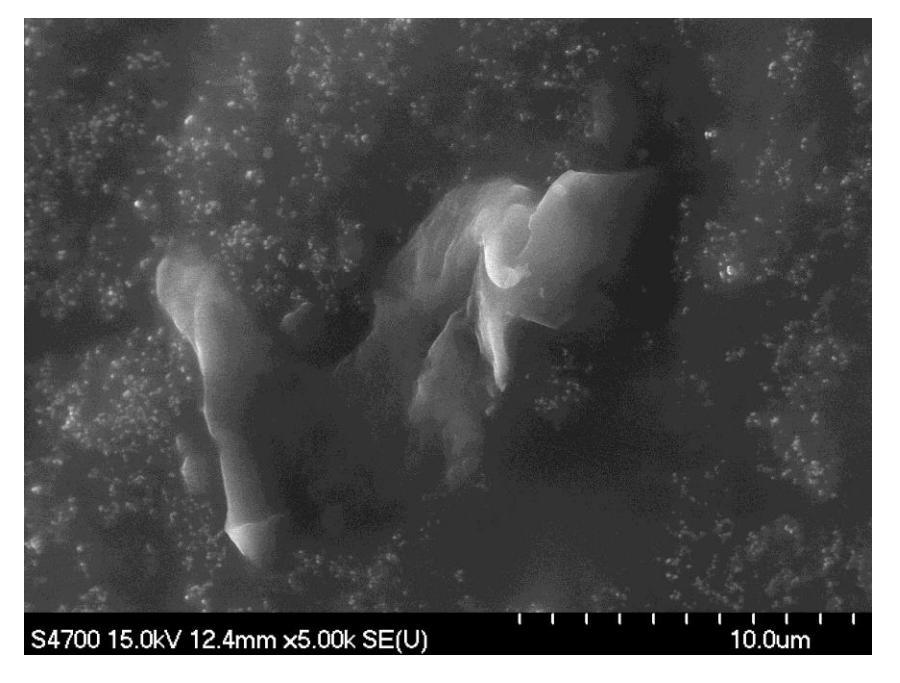
TapeSample4_2 area3 x5K p4_q00

С, О

Quick EDS showed peaks of C and O in the proportion similar to that of the carbon tape substrate. Charging is minimal. This may indicate that the feature is a carbon tape artifact.

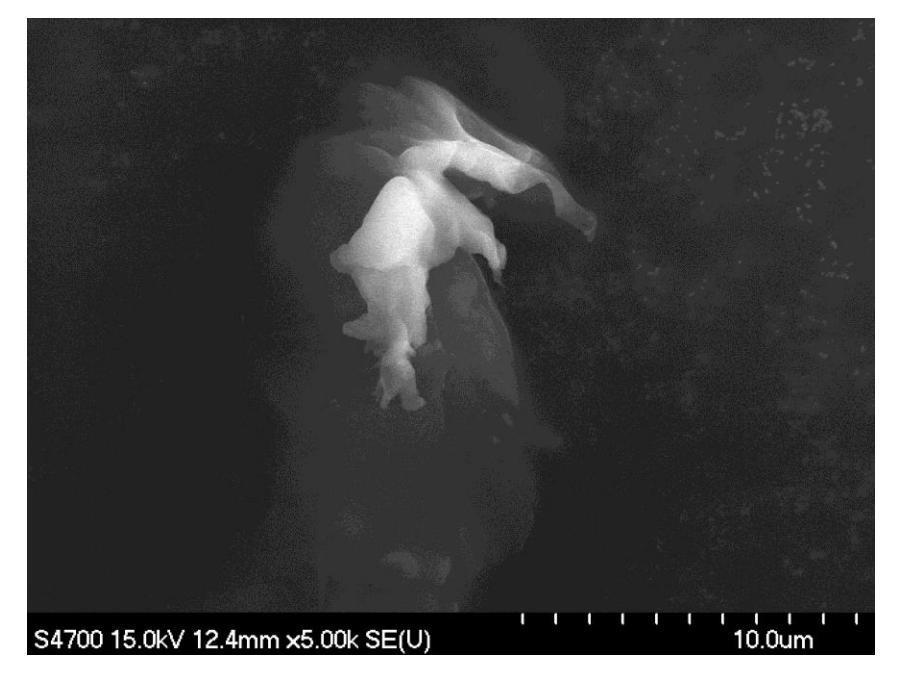
TapeSample4_2 area4 x5K p1_q00

С, О

Quick EDS showed peaks of
 C and O in the proportion
 similar to that of the carbon
 tape substrate. Charging
 occur probably because the
 feature is elevated above
 the substrate.

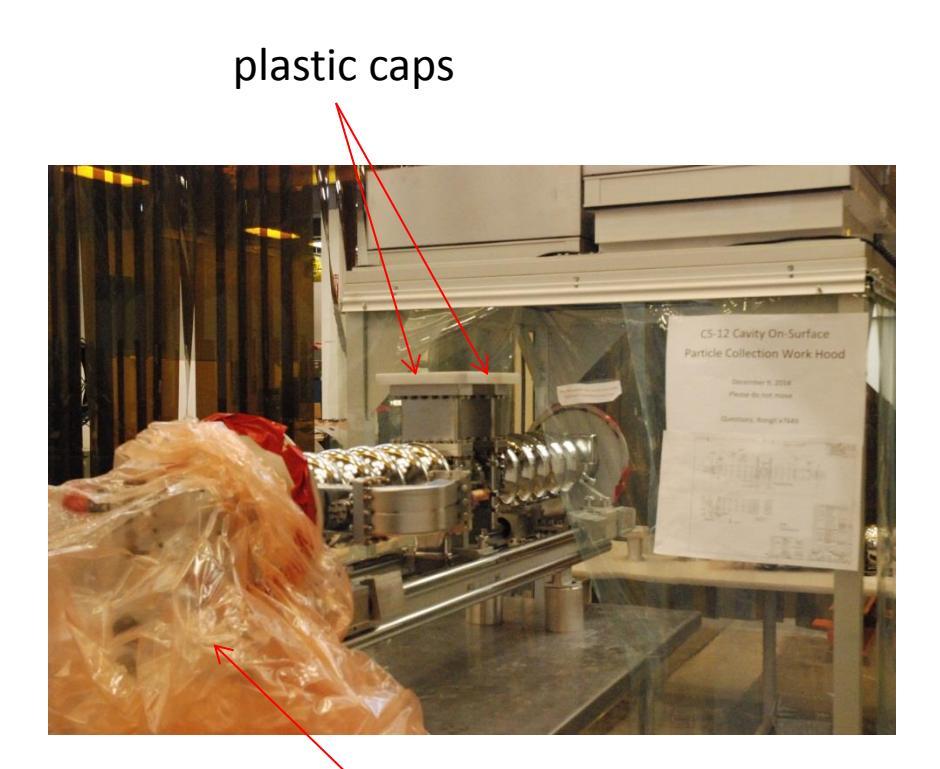
- Wipe gate valve conflact joint area with solventsoaked clean room rags
- Remove 6" blank
- Visual inspect "air side" of the gate valve (photo at right)

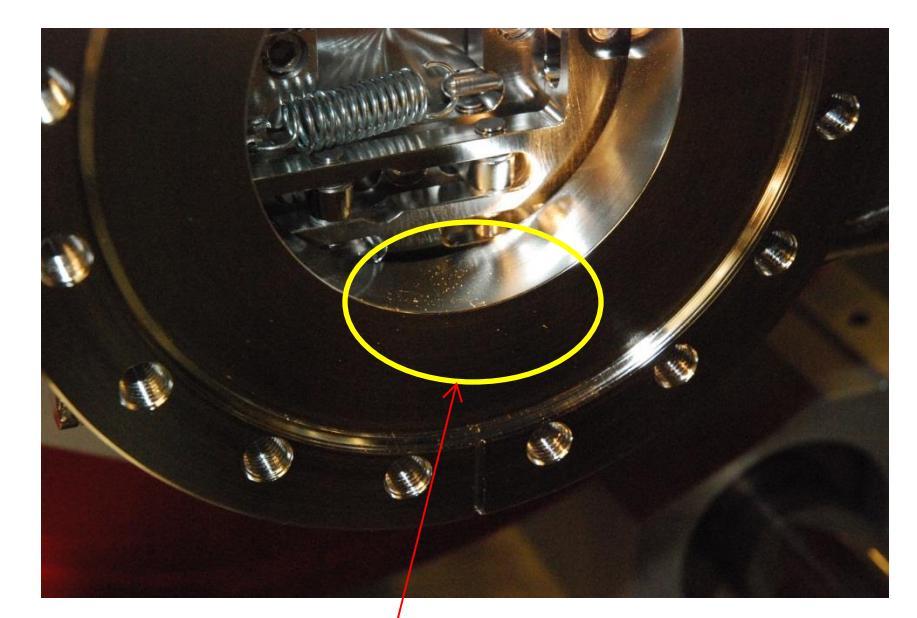
Particulates on inner surface of Gate valve

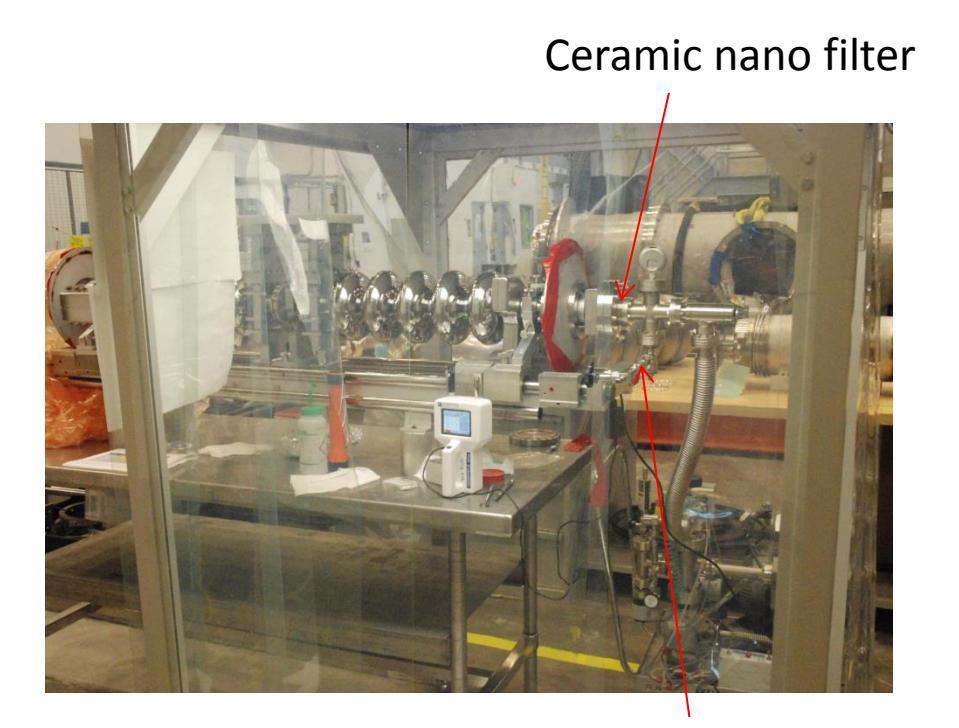
Regular filter in bleeding line

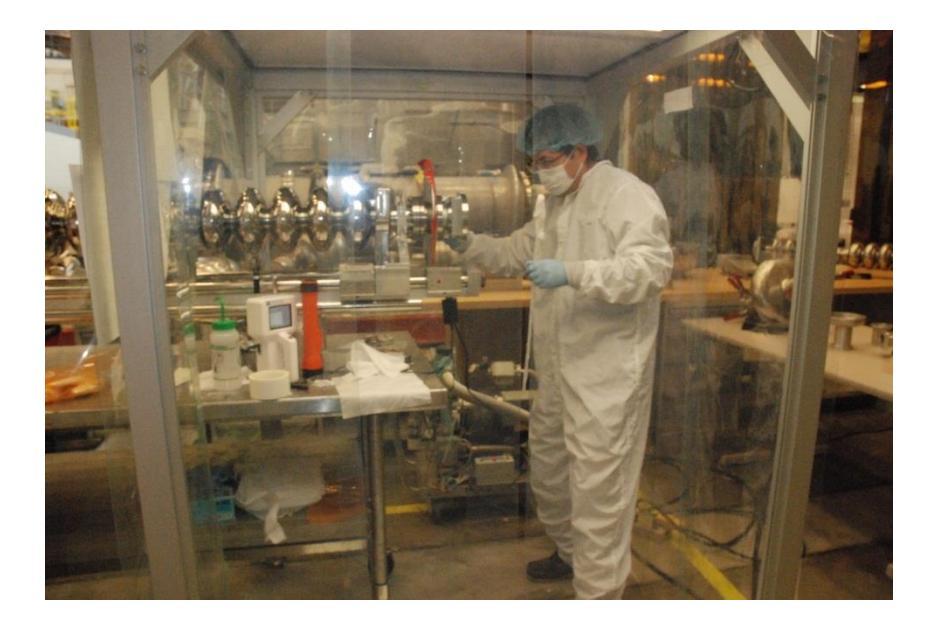
- Close mini-angle valve and needle valve in bleeding line
- Valve in scroll pump to evacuate cavity pair to < -30 in Hg
- Valve off scroll pump
- Pressure quickly rose indicating a big leak in cavity pair
- Cavity pair vented overnight
- Pressure at -2 in Hg after over night venting
- Remove manifold
- Visual inspect inner surface of gate valve housing and beam tube inner surface
